CONSIDERATIONS FOR STOPE GULLY STABILITY IN GOLD AND PLATINUM MINES IN SOUTH AFRICA

Submitted in fulfilment of the requirements for the degree of Master of Science in the Faculty of Engineering.

University of Pretoria

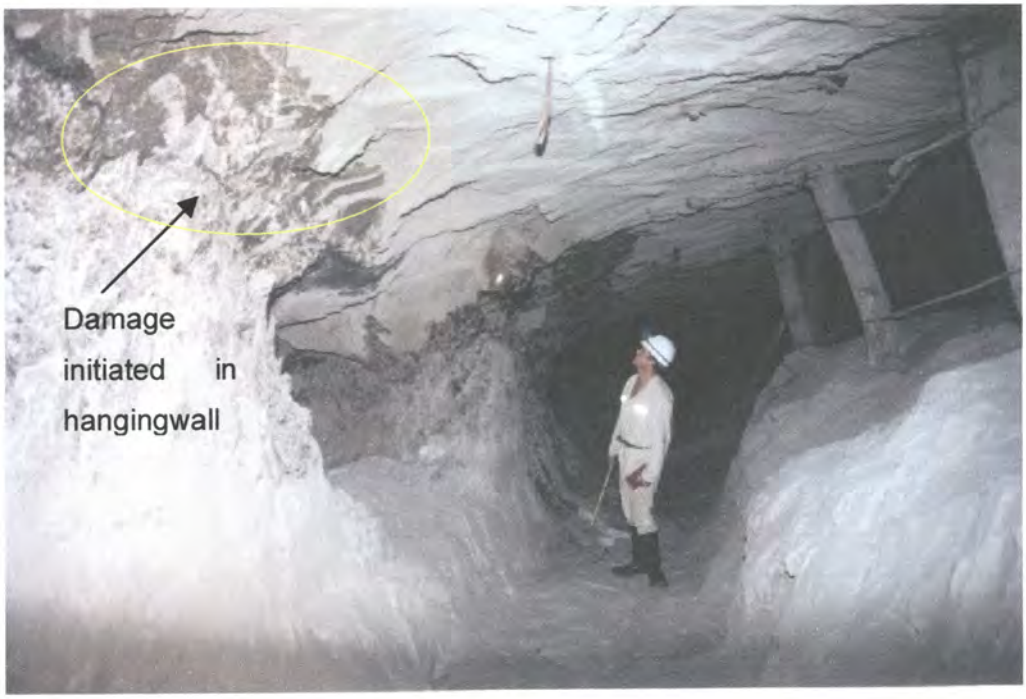
Figure 4.15 - Gully with no siding on the Merensky Reef at 800 m depth. Conditions are stable, although spalling has clearly occurred along the pillar sides. Note that pillar edge damage runs up and into the hangingwall

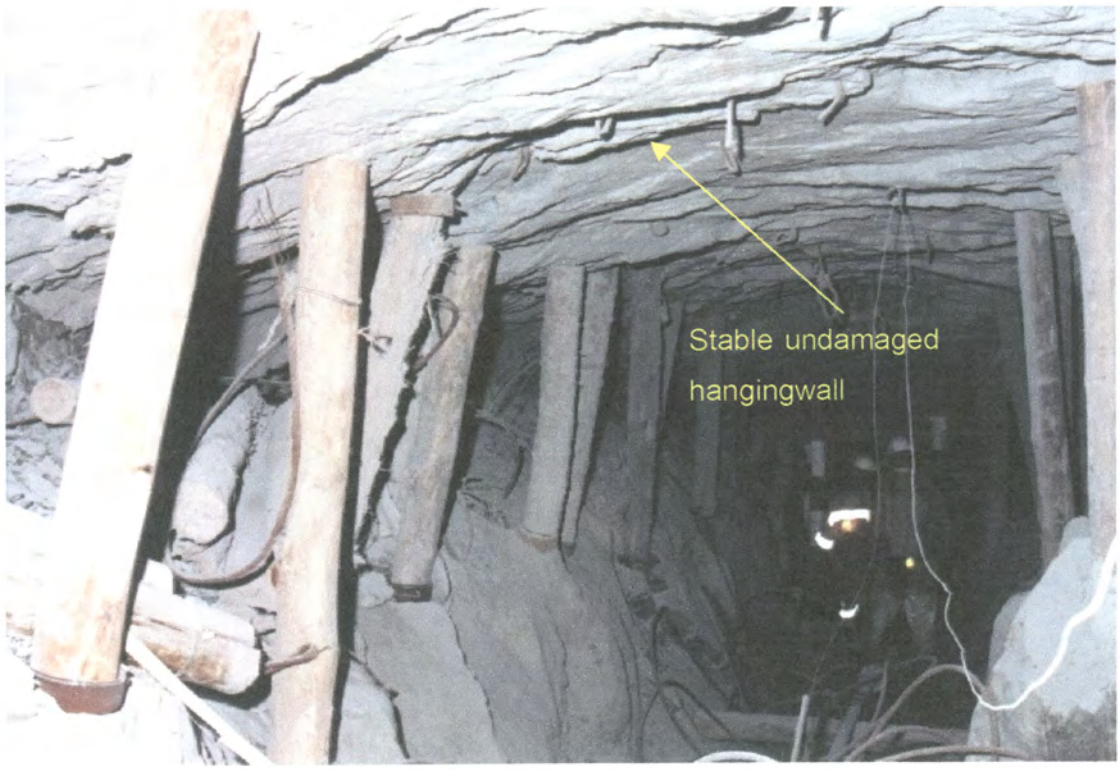
Figure 4.18 – Merensky Reef gully with 1 m siding and timber elongate providing the only support, on both sides of the gully

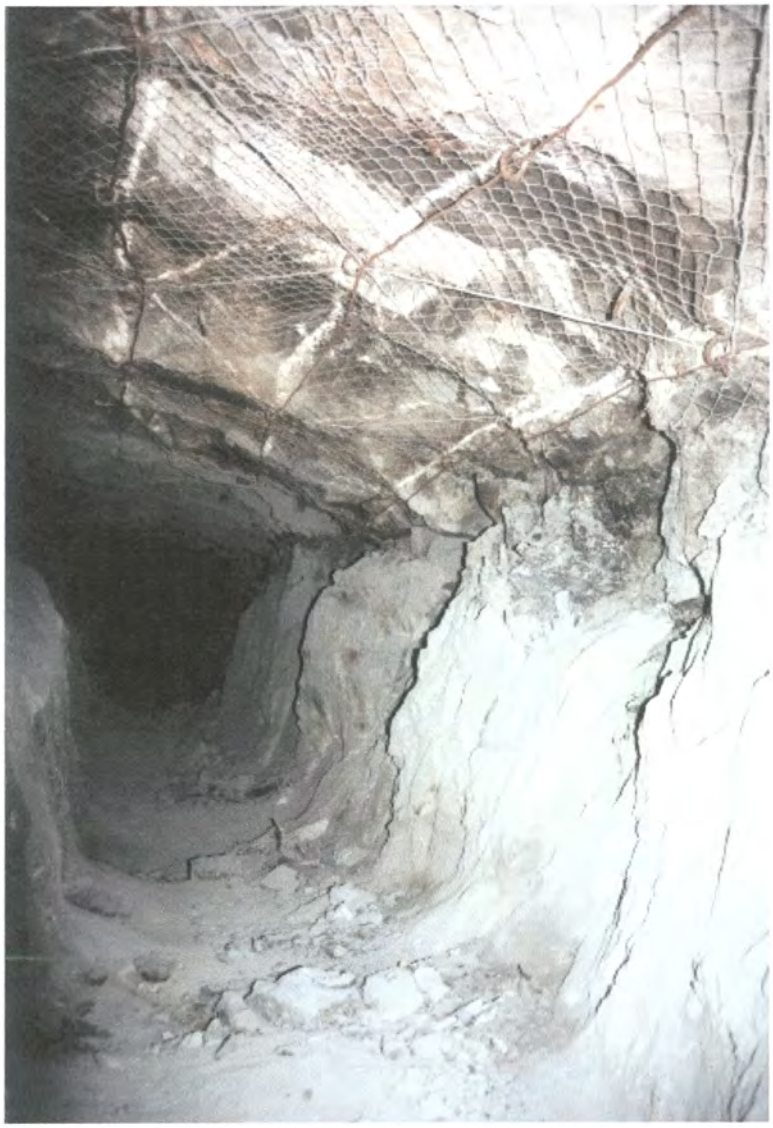
Figure 4.19 - Merensky Reef gully where a crush pillar lies on the gully edge and during crushing has damaged the hangingwall resulting in mesh and lacing application to control minor falls

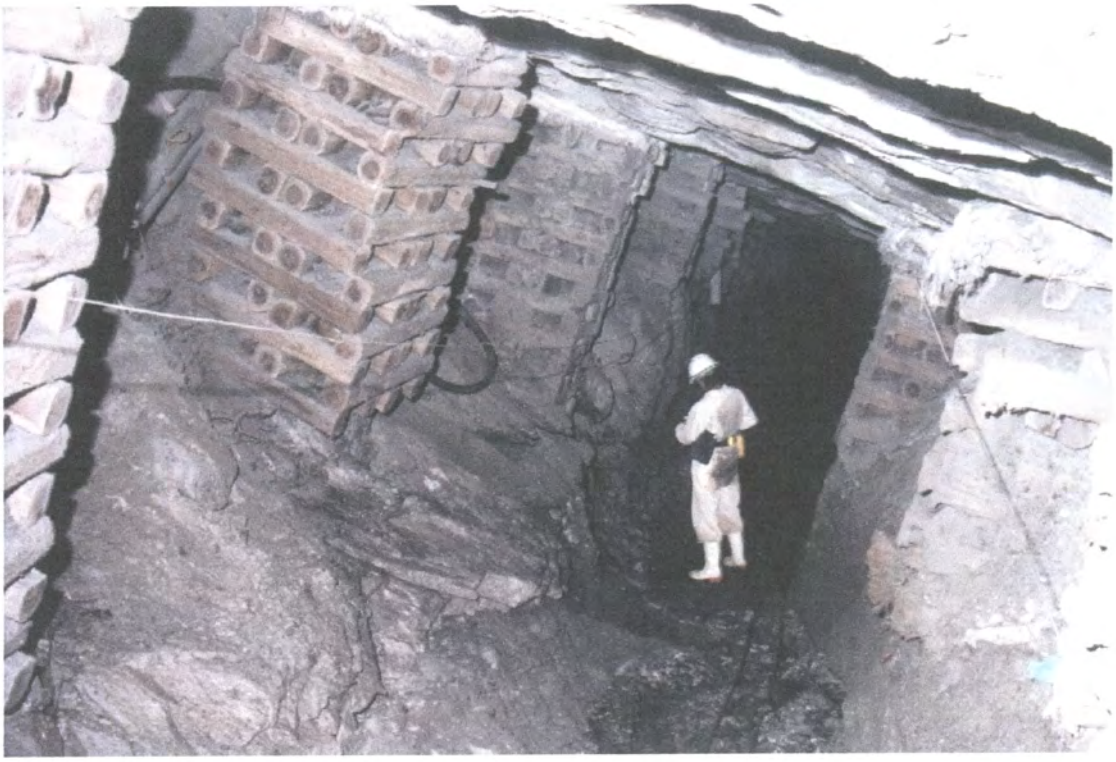
Figure 4.22 – Merensky Reef - footwall lifted gully in wide heading. Due to down dip sidewall integrity, all packs are normal to dip

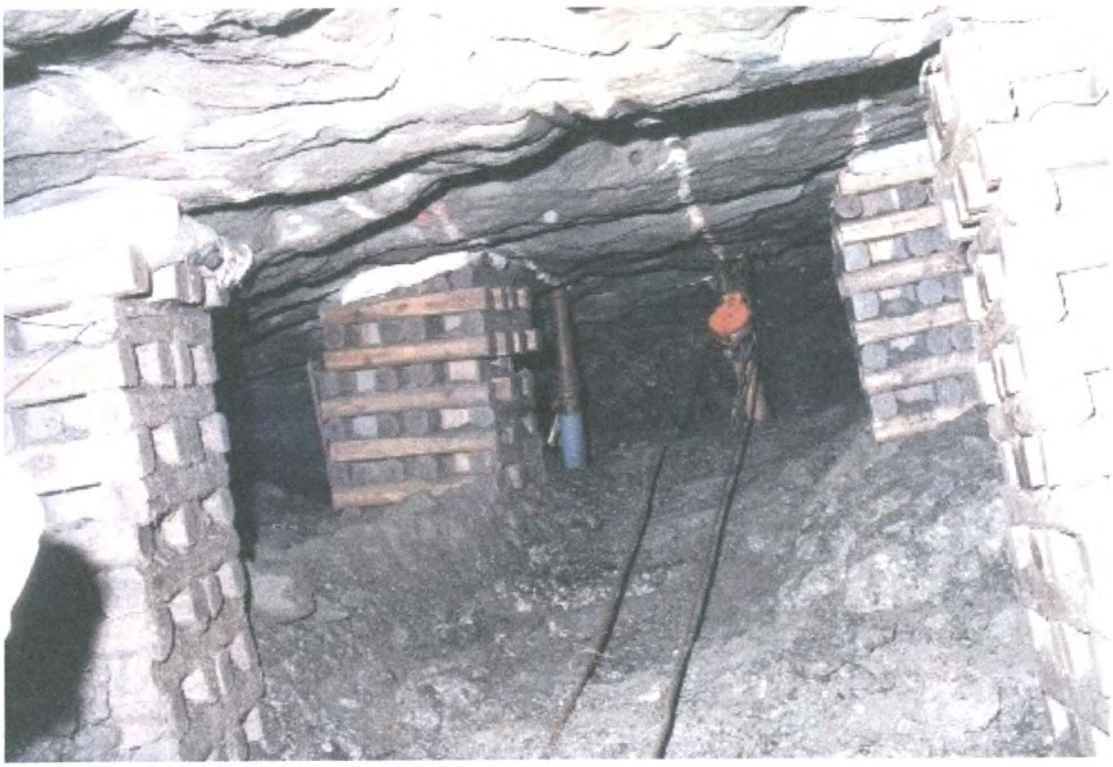
Figure 4.23 - Merensky Reef - conditions in a wide heading with footwall lifted gully

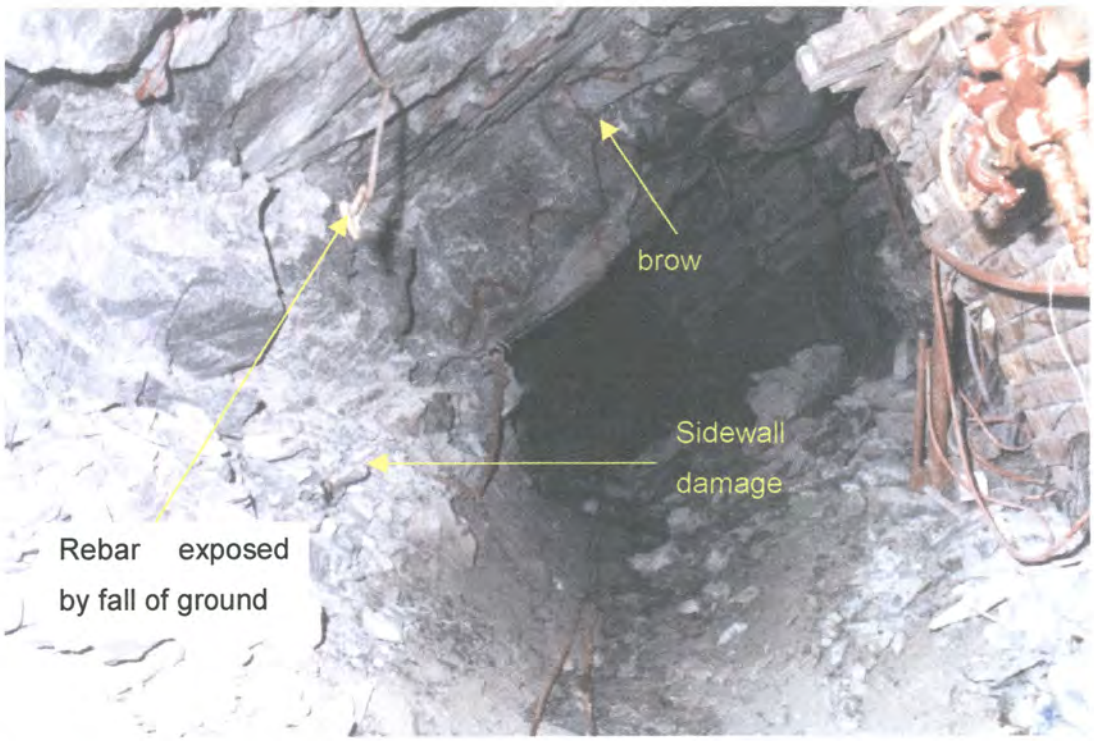
Figure 4.25 - Basal Reef - gully excavated at 2500m with no siding with stress damage causing down dip sidewall and hangingwall instability at 40° dip

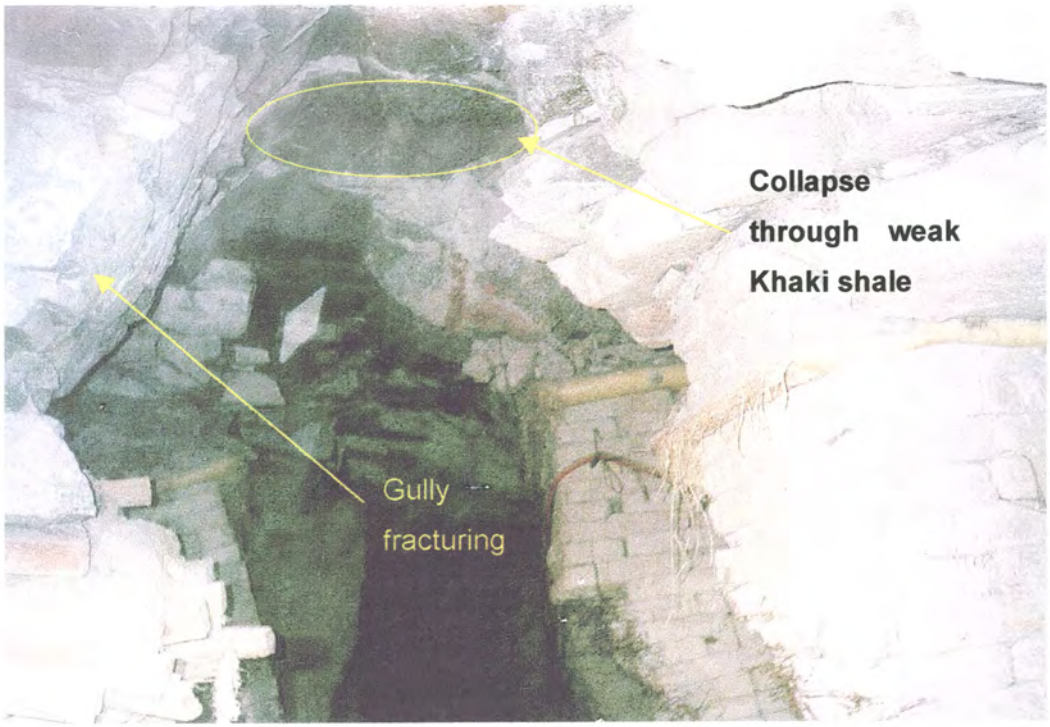
Figure 4.26 - Basal Reef – collapse of gully hangingwall due to fracturing developed around leading ASG heading at 1600m below surface

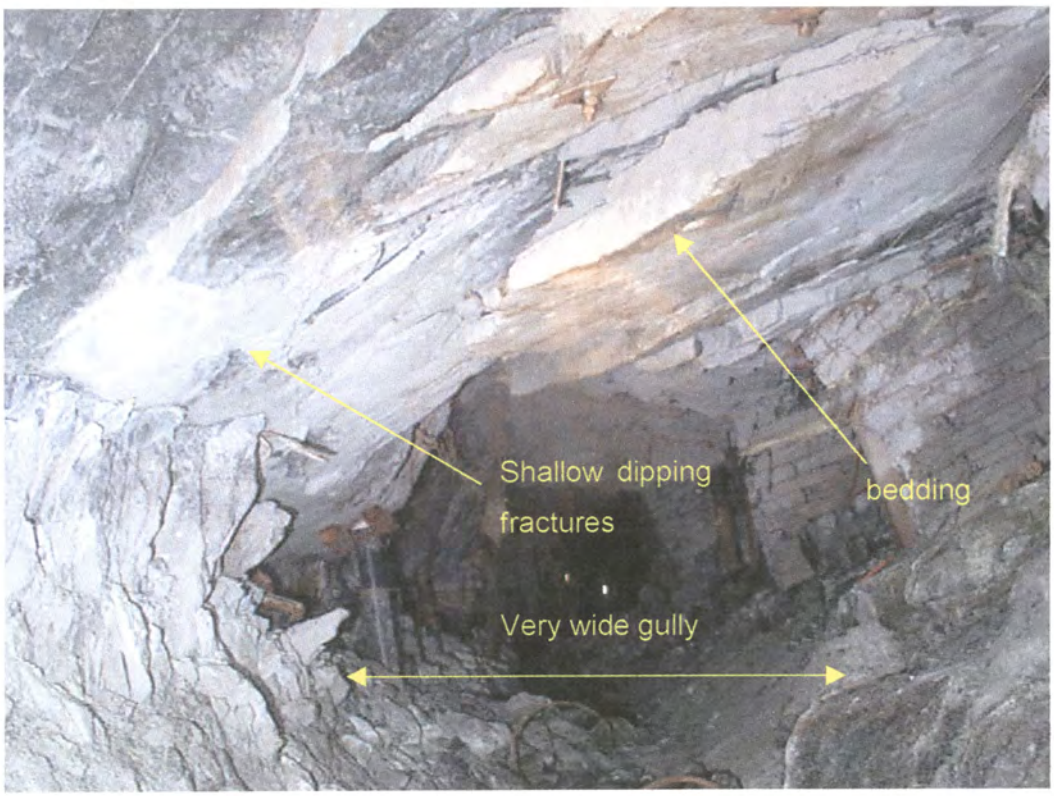
Figure 4.27 - Basal Reef – the effect of a lagging siding on hangingwall conditions – view from face area looking back along gully at 1700m

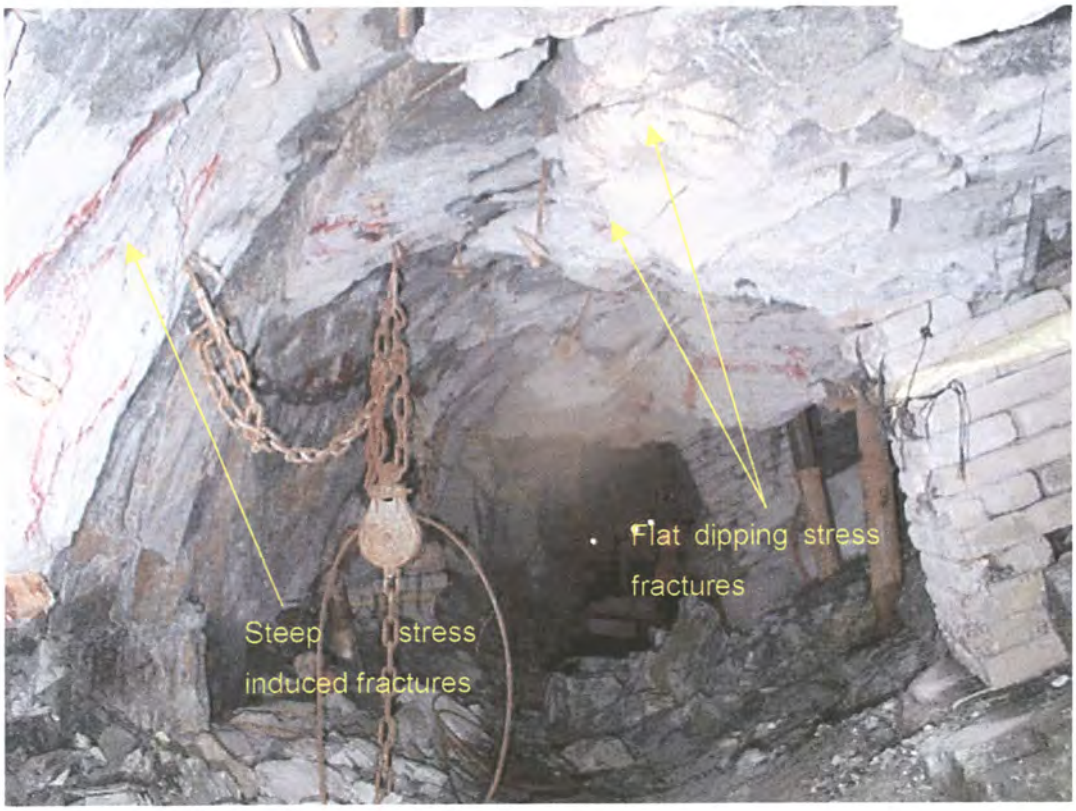
Figure 4.28 - Basal Reef - combined effect of an ASG heading, plus a lagging siding when strata is well bedded at 1700m below surface

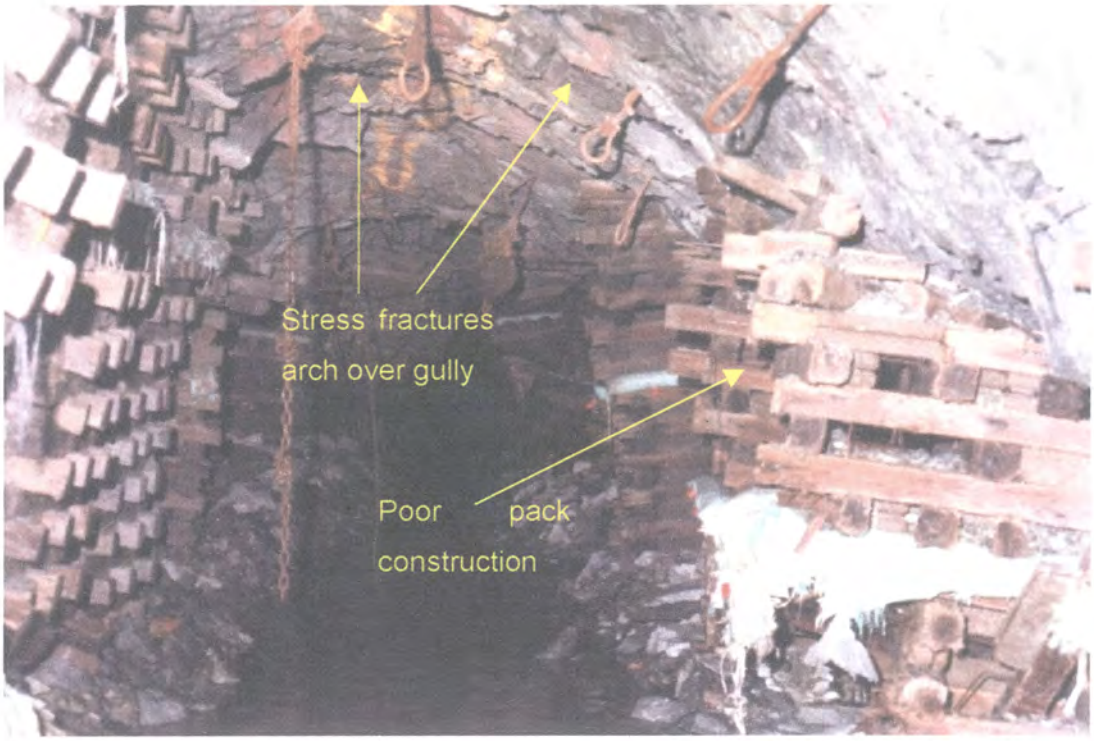
Figure 4.30 - VCR under high stress – Gully advanced as an ASG with lagging siding at 2800 m depth

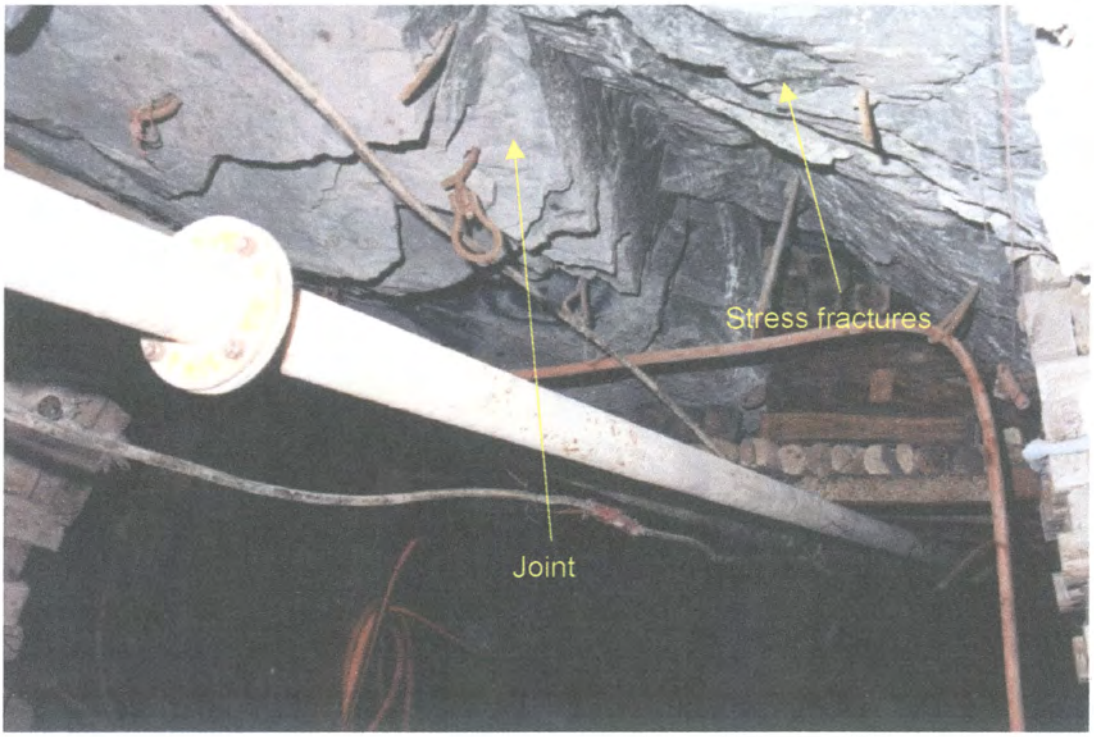
Figure 4.32 – Typical wedge shaped fall caused by the interaction of jointing and stress fracturing around a lagging siding on the VCR

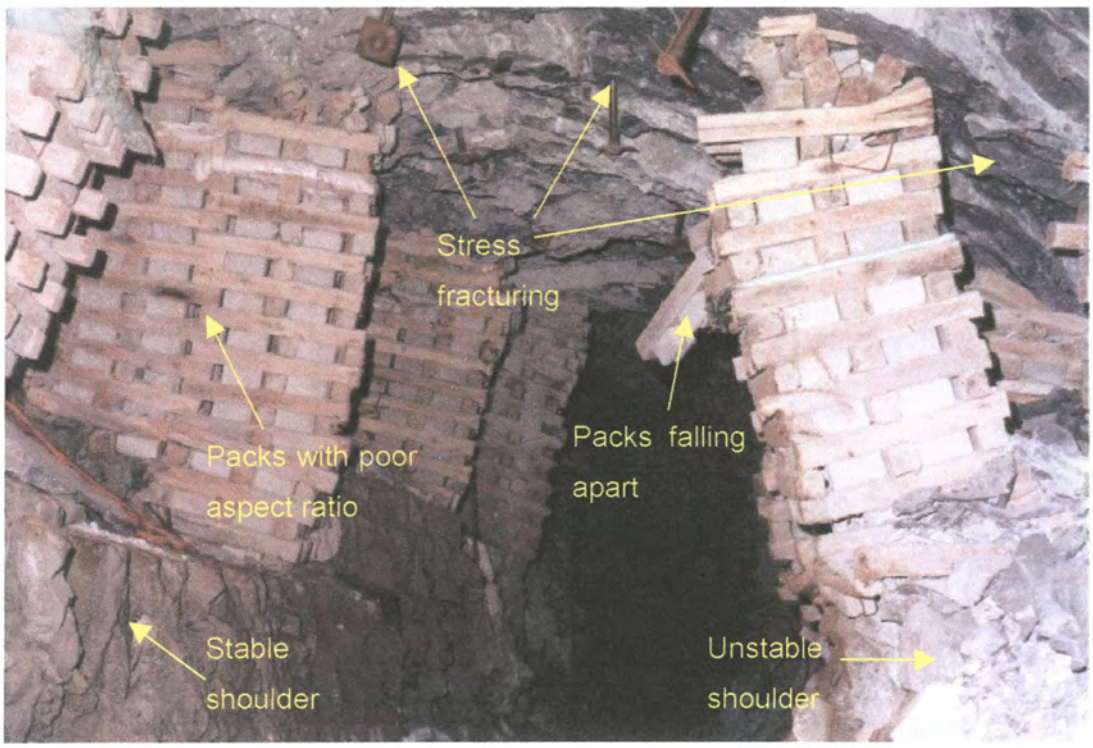
Figure 4.33 – VCR - Typical conditions that may develop along a gully created as an ASG with lagging siding under high stress

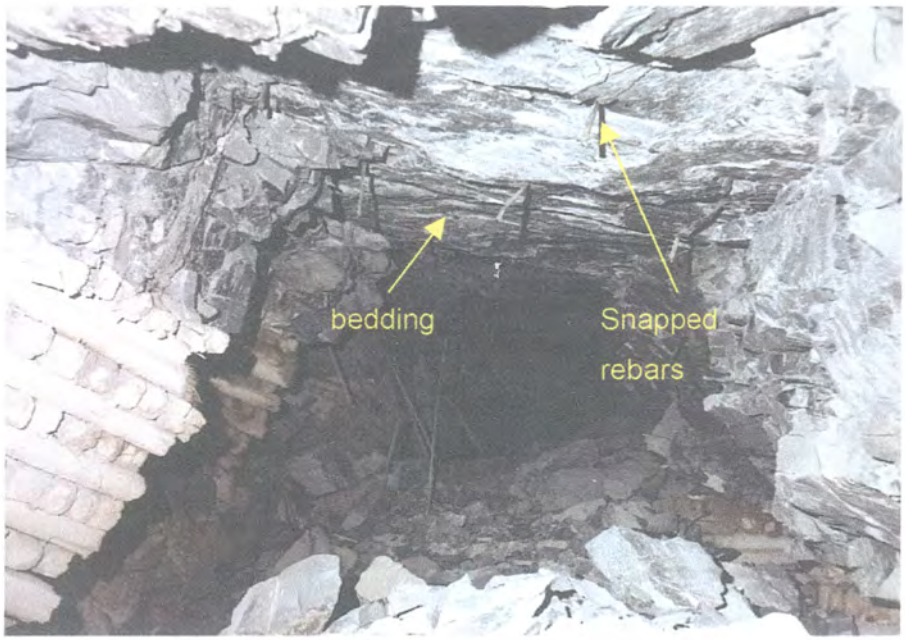
Figure 4.36 - Collapse back along a gully as a result of seismic activity. The hangingwall has collapsed between packs up to a bedding parting. Rebars are snapped or exposed

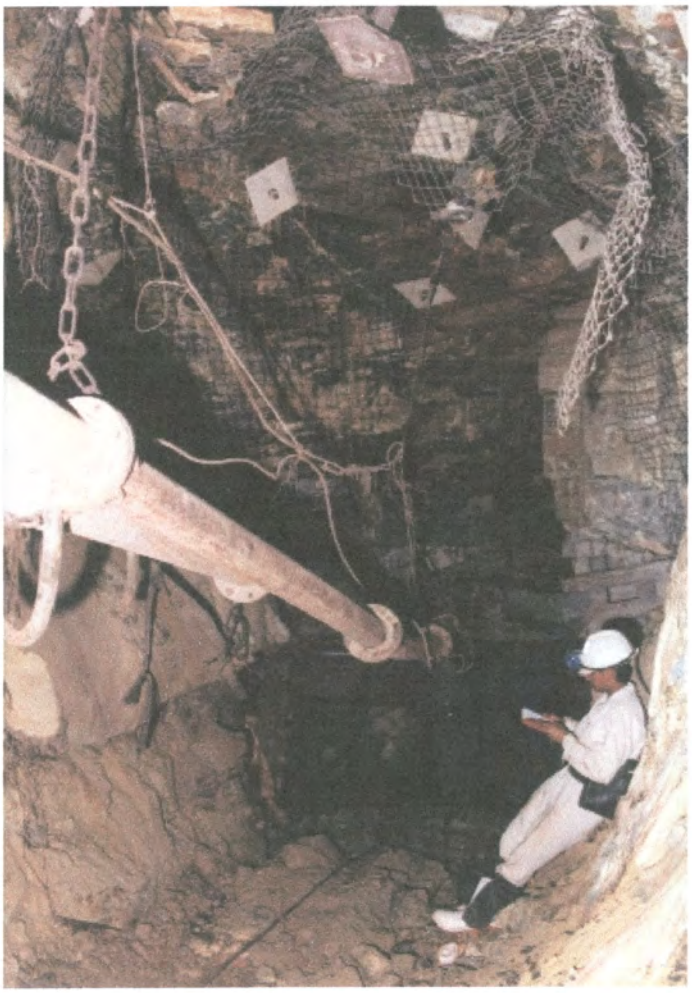
Figure 4.41 - Resin injection used to consolidate a collapsed area over a Carbon Leader dip gully at 3000 m depth
