Characterization of the corrosion layer on iron archaeological artefacts from K2 (825-1220 AD), an archaeological site in South Africa

Farahnaz Koleini[1], Linda C. Prinsloo[2], M.H. Schoeman[3], Innocent Pikirayi[1], Shadreck Chirikure[4]

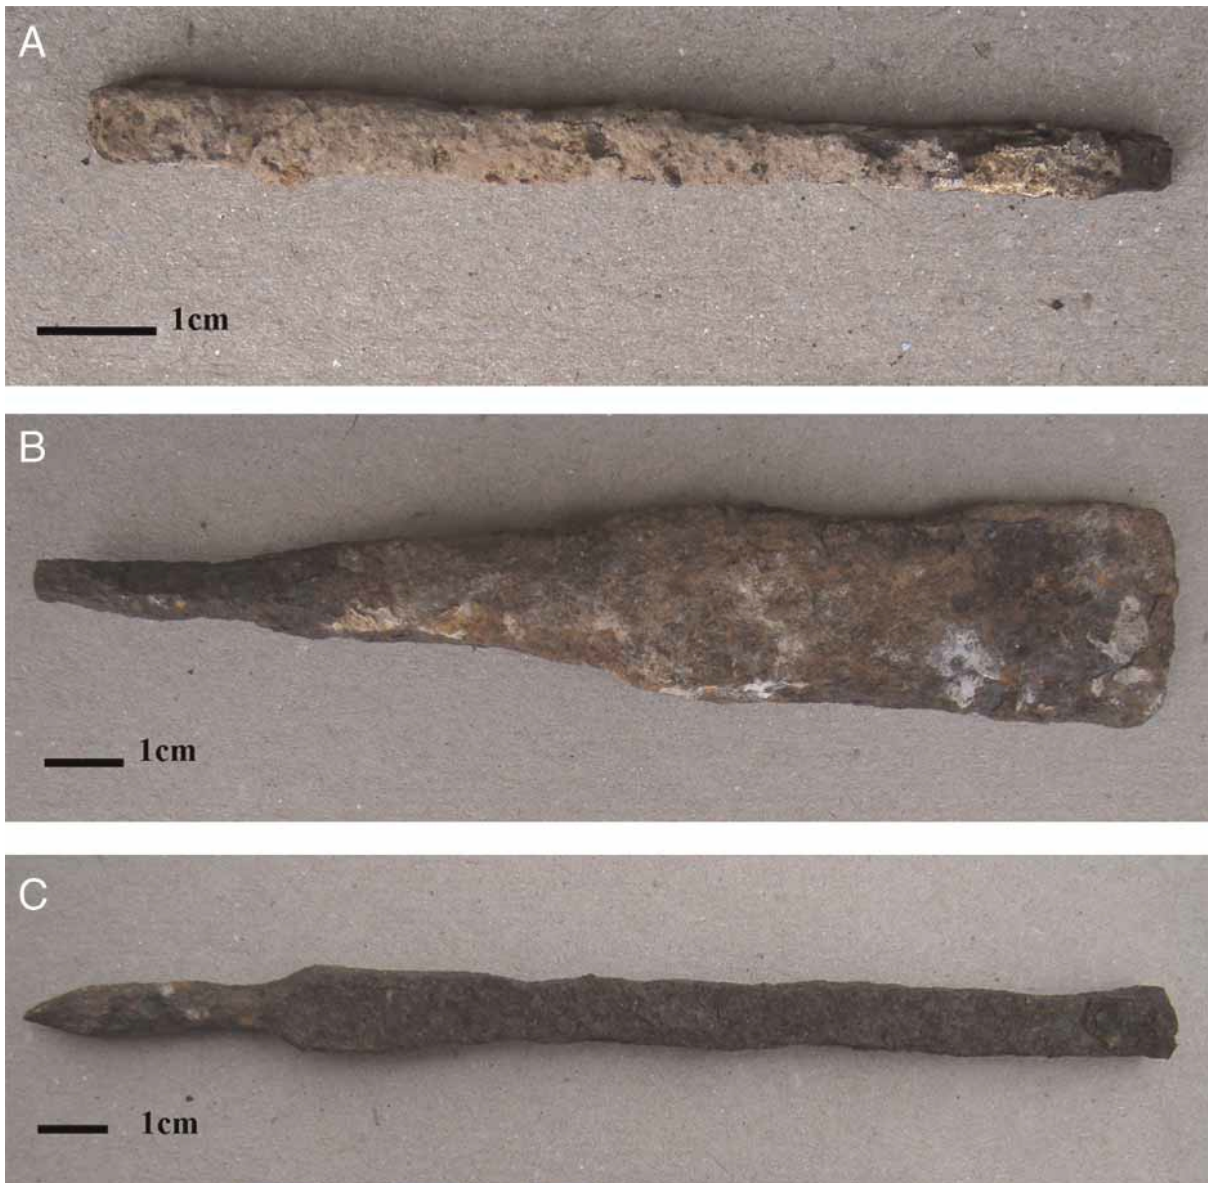
Figure 2. Three iron objects from K2; a) KI1, Bar b) KI3, Adze c) KI5, Drill

The artefacts examined in this study are three iron objects excavated at K2 (Fig. 2) with different corrosion percentages and dimensions (Table 1). Metallography of the samples shows the objects were fabricated from inhomogeneous hypoeutectoid steel with ≤0.2% carbon by weight. The carbon content of the metal phase (iron-carbon alloy) was estimated in a qualitative way by comparing the volume fraction of pearlitic zones in micrographs of the samples to reference data with the same magnification published in Samuels (1980). A small

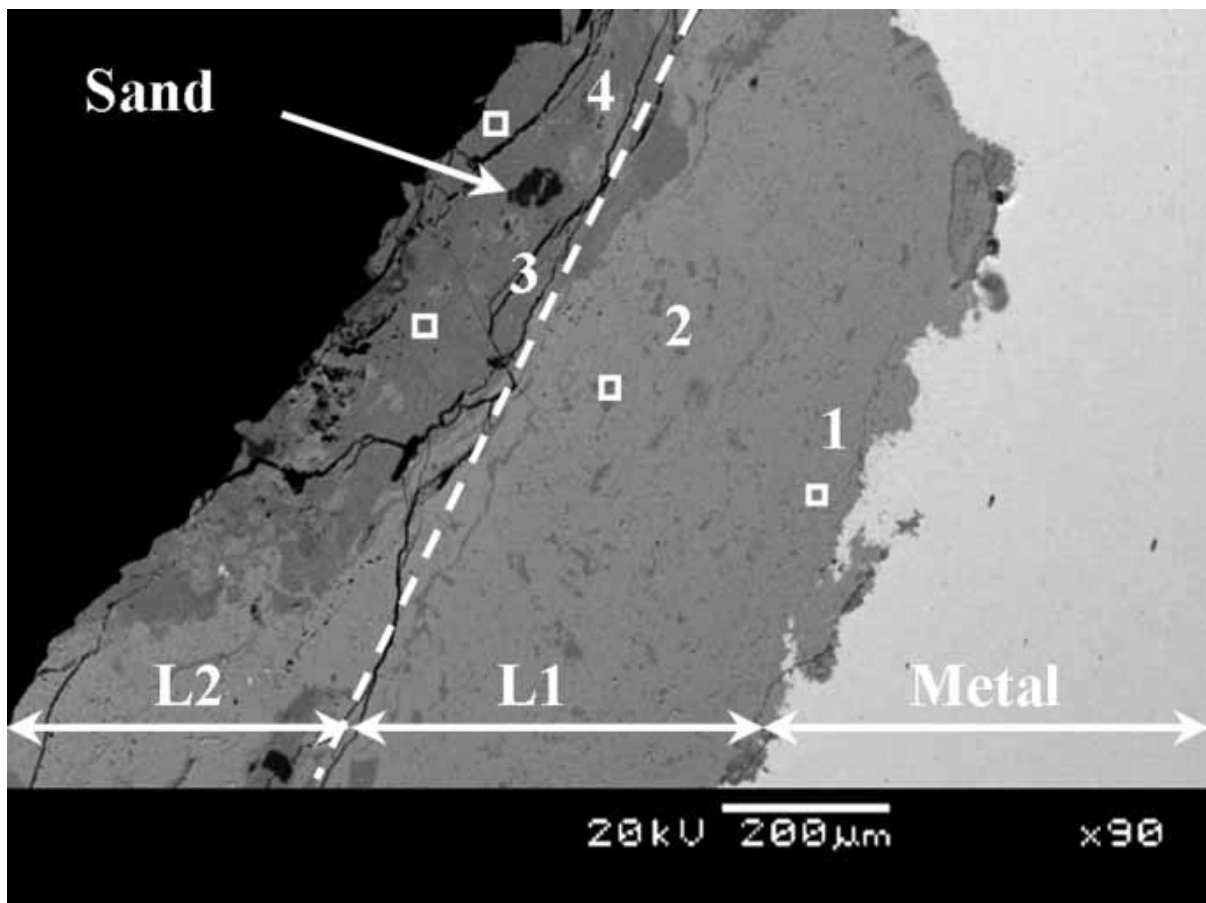
Figure 3. Microstructure of corrosion layers on KI1 (SEM BEI) and positions of electron probe analyser within corrosion layers. The dashed line shows the limit of the original surface.

1. An internal layer (L1) adjacent to the metal surface consisting of different phases of iron compounds which can be seen as different contrasts in a complex structure (Fig.3). The ghost form of two phases of bloomery inclusions which have been dispersed within the metal core are observable in this layer (Figs.4 and 5). This indicates that this layer was part of the object which had been completely corroded. At the corrosion/metal interface in some areas corrosion penetrated to the metal core along these inclusions.

Both layers are porous in their structure and contain numerous tiny cracks. The wide, open crevices in these layers were formed during sampling and are quite new (Figs.3 and 5) while the cracks that were filled partially by corrosion products were formed during the growth of the corrosion layer (Fig.6). EDS results revealed internal and external layers containing different phases of iron products such as iron oxides or oxy-hydroxides with different proportions of oxygen within their chemical structure (Table 3). The phases have non-distinctive stratification and irregular dissemination in the internal and external layers. These characteristics show the silica grains and remnant inclusions are the only overt indicators of the barrier between the limits of the original surface and fossilized burial environment (soil) on the surface (see discussion by Bertholon, 2000).

Compositional examinations of existent corrosion compounds on the surface of artefacts show similarity in their chemical structure. EDS compositional analyses on positions one, two, three and four in Fig. 3 show that iron and oxygen are the main elemental constituent of corrosion products. Meanwhile, the light grey phase has lower amounts of oxygen (Table 3: analysis KI1(L1)1) in comparison to the darker phases of the internal and external layers (Table 3: analysis KI1 (L1)2; (L2)3, 4). Analysis of the internal layer in positions one and two (Table 3: Analysis KI1(L1)1,2) shows low amounts (0.2%) of Mo, Na and Si that might originate from remnant fine inclusions or simply were transported inwards from the environment. Since Na and Mo were not detected within the external layer (Table 3: Analysis KI1(L2)3,4) it is most likely they were derived from the entrapped slags with Mo and Na content present in the metal matrix (Table 2. analysis KI1a). In general the source of Mo and Na in addition to the other elemental constituent of inclusions within the metallic core can be the ore, furnace wall or even fuel. The extraneous elements in the external layer have more diversity (Si, Ca, Mg and P) while their amount increases towards the surface (Table 3. Analysis (L2) in KI1, KI3, KI5). Corrosion phases within two distinct layers on the surface of KI5 have no Ni content (Table 3. analysis KI5(L1)a,b; (L2)a,b). There was also no trace of chlorine detected by EDS in corrosion layers (Table 3).

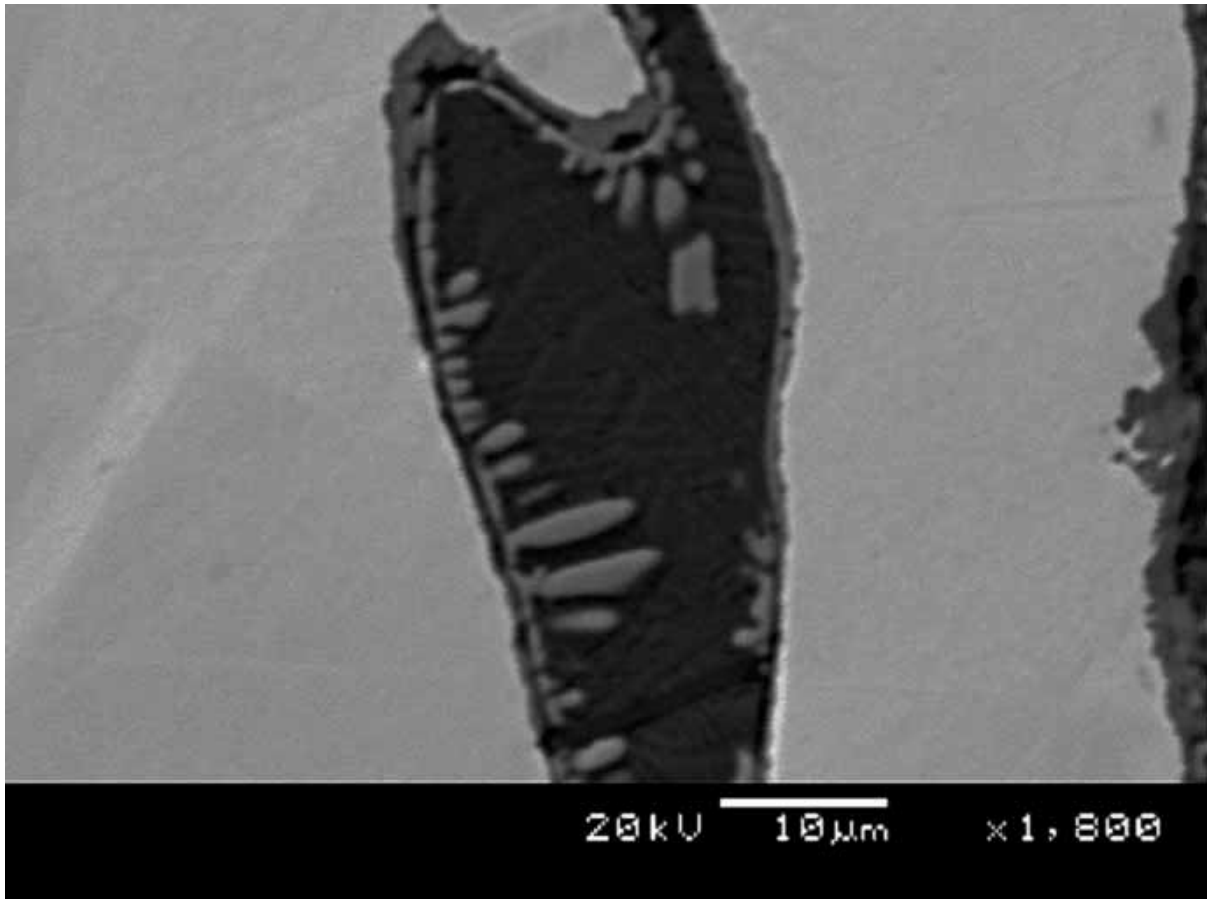
Figure 4. Polished section of KI1 at metal substrate (SEM BEI) showing bloomery two-phase inclusion of wüstite dendrites in dark slag with Mo content (0.2%).

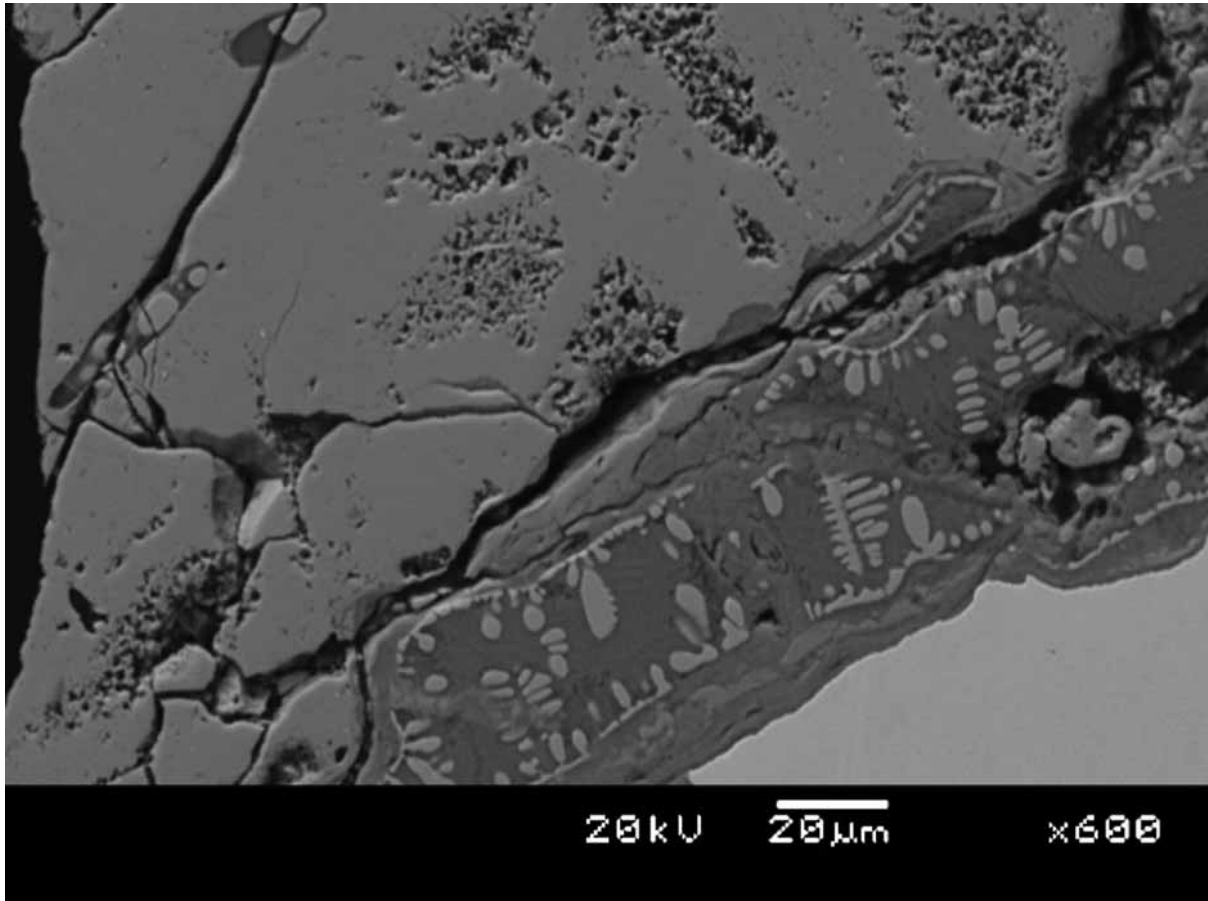
Figure 5. Microstructure of corrosion layers on KI1 (SEM BEI). Remnant bloomery inclusion at internal layer.

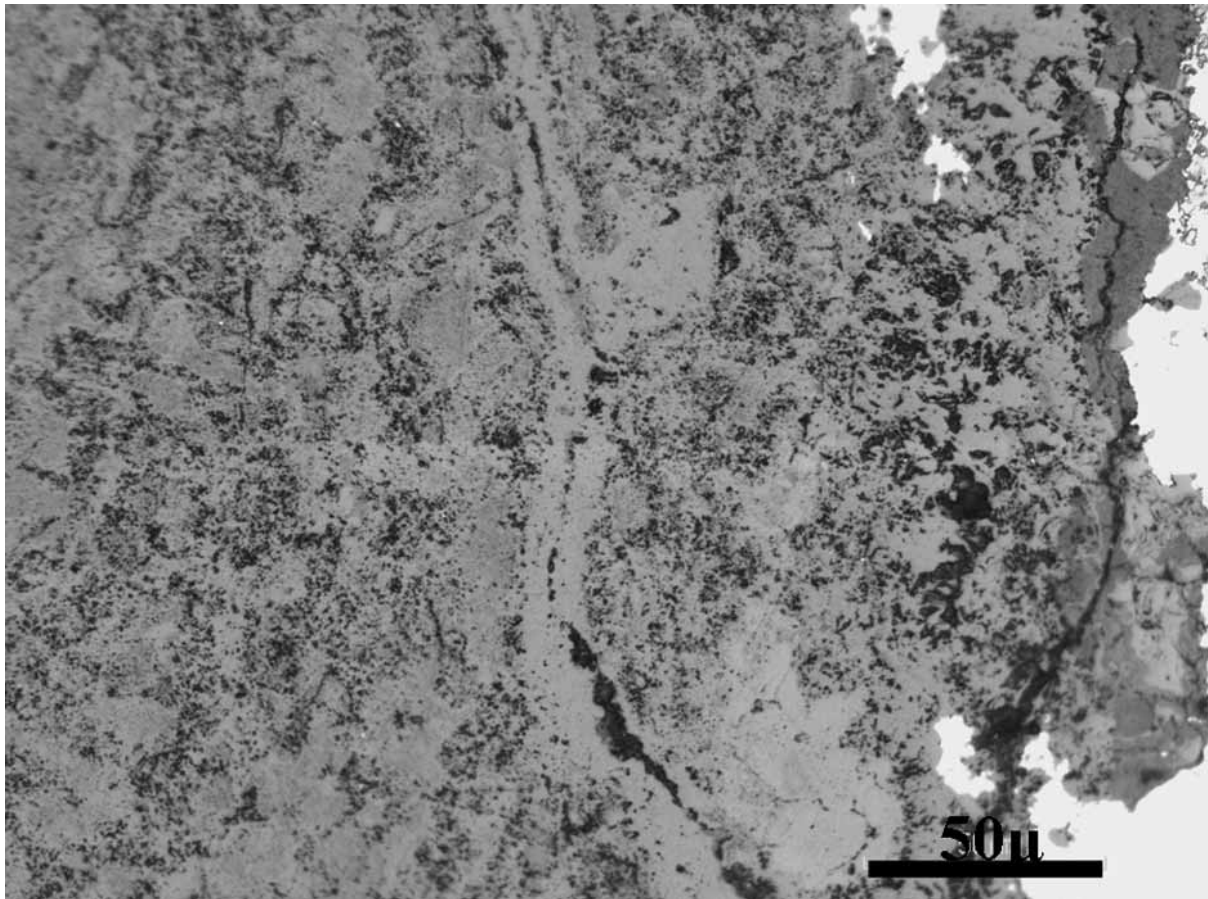
Figure 6. Optical microscopic image of internal layer shows fine cracks together with a porous dark phase.

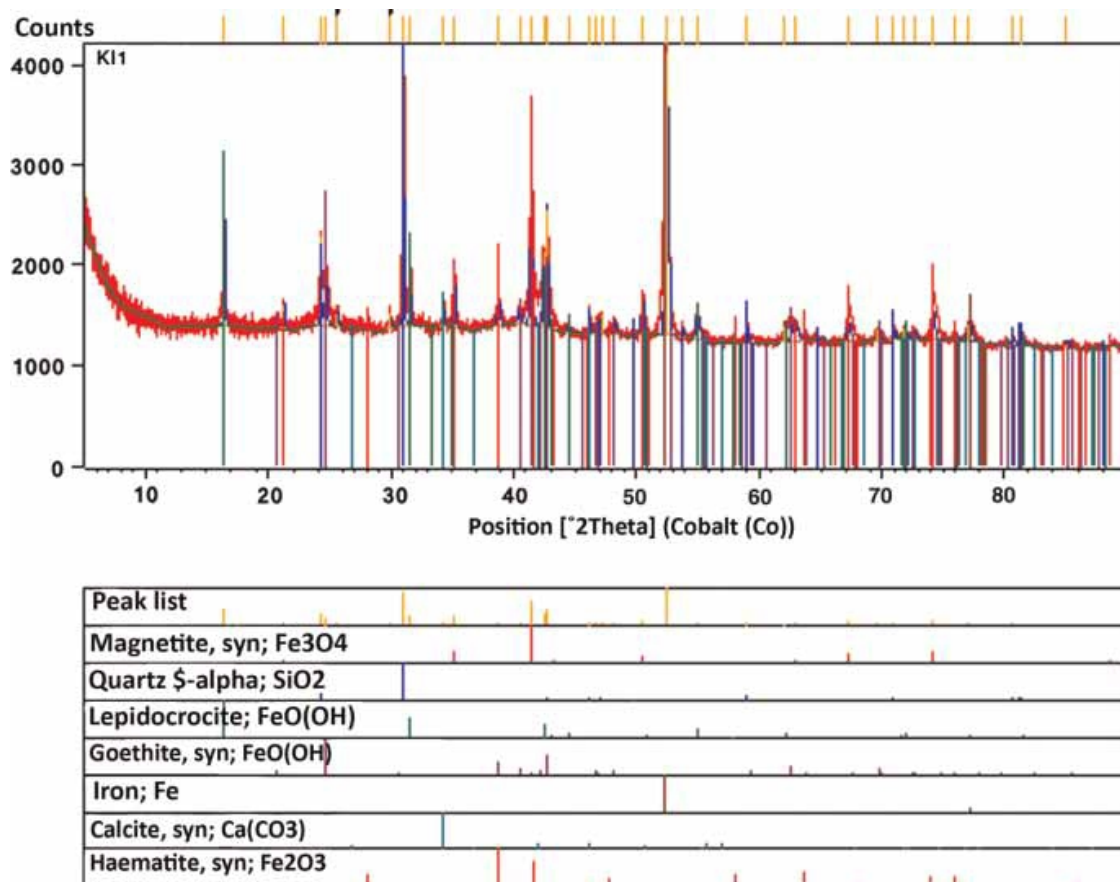
Figure 7. XRD scan of corrosion powder removed from KI1 surface.

Complementary analysis of corrosion products on KI1 was performed with XRD to identify the exact composition of products on the surface. The results revealed the presence of magnetite (Fe_3O_4), lepidocrocite (γ-FeOOH), goethite (α-FeOOH), hematite (Fe_2O_3) and calcite as the main compounds in the crystalline form within corrosion layers (Fig.7). On the basis of EDS results the detected calcium carbonate is related to the surface contaminations concentrated in the external layer (Table 3: analysis KI1(L2)3,4).

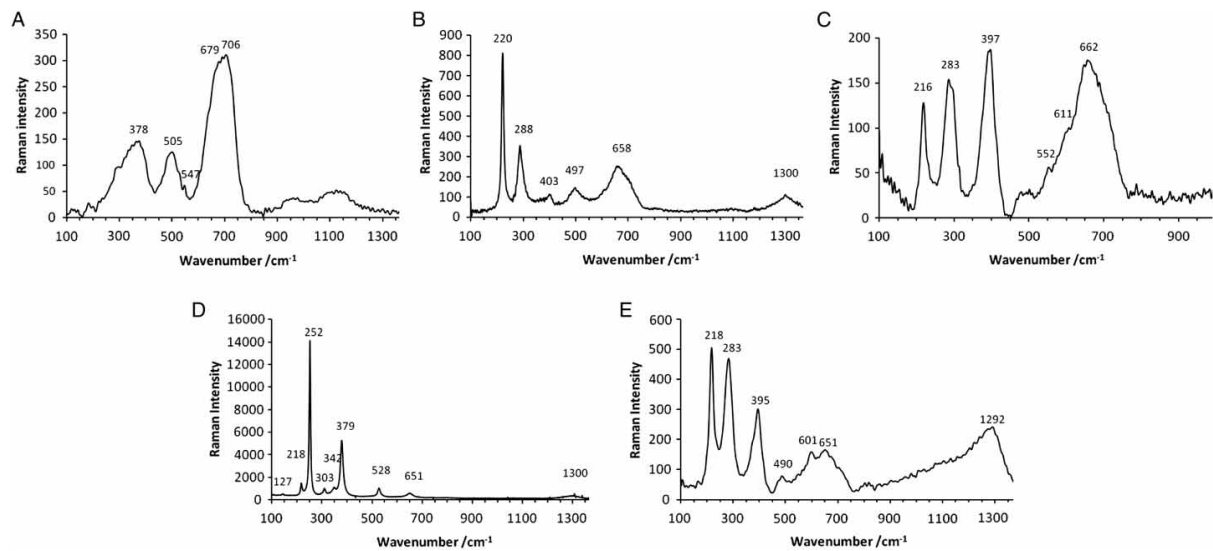
Figure 8. Raman spectra of corrosion products on KI1. λ_0= 647.1 nm. (A) Light phase at internal layer (maghemite). (B) Light phase at internal layer (hematite). (C) Dark phase at internal layer shows admixture of magnetite, goethite and hematite. (D) Lepidocrocite at interface of internal/external layers. (E) Dark phase at external layer shows mixture of hematite and goethite.

Further *in situ* analyses of the mounted samples with micro-Raman spectroscopy identified the position of different phases through their Raman spectra. Identifying the exact composition of each phase was achieved by comparing the results with the Raman spectra of iron oxides/hydroxides published in Bell et al. (1997) and Froment et al. (2008). For facilitating the interpretation of the Raman data the spectral signatures of pure iron oxides and hydroxide are summarised in Table 4. The Raman spectra obtained on the light grey areas in the internal layer are presented in Fig. 8A and 8B. Spectrum (a) with a broad and

strong peak at 679-706 cm^{-1} and weak peaks at 378 and 505 cm^{-1} belong to maghemite (γFe$_2$O$_3$). The weak peak at 547 cm^{-1} may relate to magnetite (Fe$_3$O$_4$) as a part of a material constituent of this phase. The strong peak of magnetite at 670 cm^{-1} overlaps with the broad peak of maghemite in this region. Spectrum (b) is typical of hematite (αFe$_2$O$_3$) with strong double peaks at 220 and 288 cm^{-1}, weak peaks at 403 and 497 cm^{-1} as well as a medium peak at 658 cm^{-1}. The Raman spectrum (c) in Fig. 8 corresponds to the dark grey phase at the internal layer and consists of various bands that can be attributed to an admixture of magnetite, goethite and hematite. Signature doublet strong peaks of hematite with a downshift are observable at 216 and 283 cm^{-1} while the latter is quite broad as a result of overlapping with a goethite medium peak at 300 cm^{-1}. It has been shown that the Raman spectrum of hematite is very dependent on particle size and morphology, production process, orientation of the crystallites, as well as the energy of the exciting radiation (Chernyshova *et al.,* 2007). The shift to lower wavenumbers might be any of these. The strong peak at 397cm^{-1} is characteristic of goethite and overlaps with the weak hematite peak at 403cm^{-1} (Fig.8B) with resultant peak broadening. The shoulder at 482-519 cm^{-1} is due to the overlapping of the goethite and hematite weak peaks at 480 and 497 cm^{-1} respectively. The weak peak at 552 cm^{-1} is associated with goethite whereas the medium peak at 611 cm^{-1} belongs to hematite. The strong broad peak at 662 cm^{-1} can be the signature of magnetite for which in a pure sample is observed at 670 cm^{-1}. Peak broadening is due to the overlapping of the goethite and hematite peaks in this region. A strong peak at 661 cm^{-1} was also reported for a freshly fractured magnetite crystal face at room temperature in de Faria et al. (1997). Figure 8D shows the Raman analysis of a well crystallized area at the interface of the internal/external layer. The strong peak at 252 cm^{-1}, medium peak at 379 cm^{-1} in addition to the weak peaks at

303, 528 and 651 cm^{-1} are the Raman characteristics of lepidocrocite (γFeOOH). The Raman spectrum (e) in Fig. 8 is related to the dark phase in the external layer and shows that it mostly consists of hematite and goethite. In Fig. 8E the doublet strong peaks at 218 and 283 cm^{-1} are the signature of hematite whereas the strong peak at 395 cm^{-1} is characteristic of goethite. Analysing on light phases at external layer rising to a spectra similar to Fig. 8B and revealed that this phase mostly contains hematite.

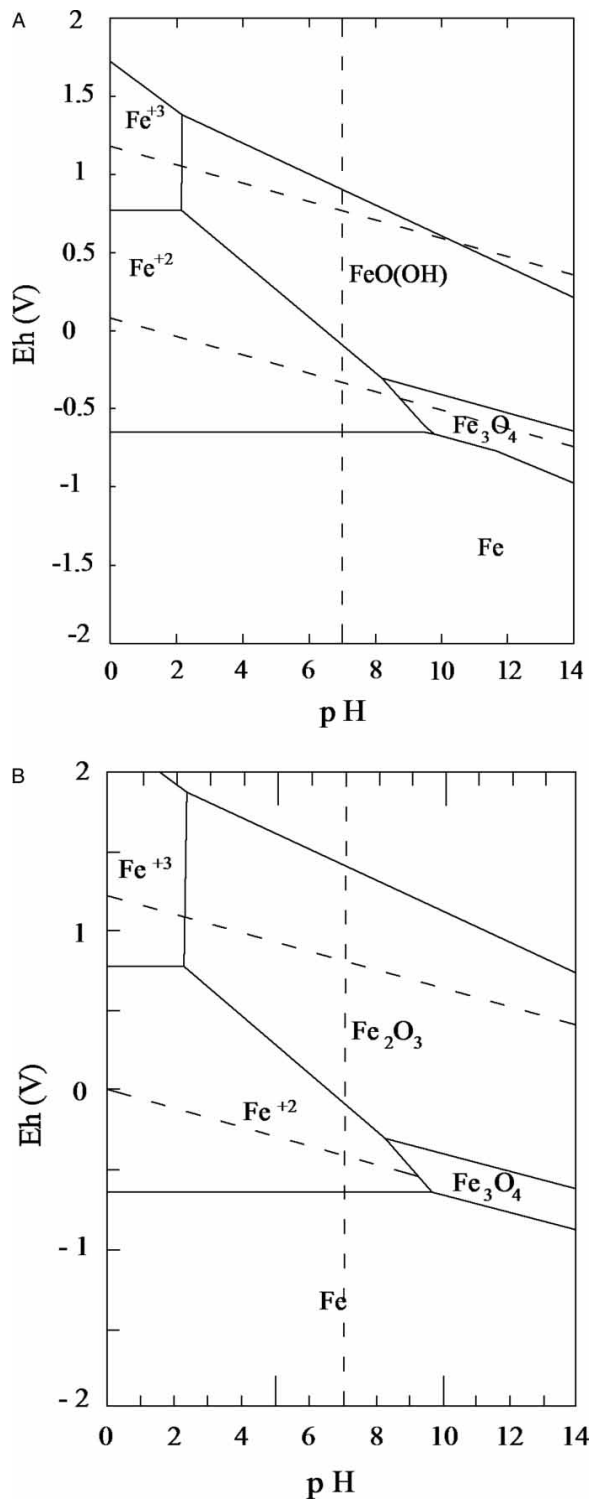
Figure 9. Eh-pH diagrams for the system Fe-H₂O at 25°C. (A) Range of stability of iron(III)oxyhydroxide and magnetite along with stability domain of ferrous ions. (B) Range of stability of hematite. Adapted from: Beverskog and Puigdomenech (1996).

In fact, the diffusion domain of Fe^{2+} ions across corrosion crust toward surface was completely controlled by Eh and pH of corrosion layers' microenvironment. This domain depends on the range of stability of the ferrous ions in specific quantity of Eh and pH that were considered in Pourbaix diagram (Fig.9). With ageing of the corrosion crust, the unstable products gradually transformed to more thermodynamically stable ones. In this process lepidocrocite that usually forms first in transformation of Fe(III)hydroxide was converted to goethite (Stratmann, 1990) while goethite (α-FeOOH) partly altered to hematite in some areas (light phase). The free energy formation of the later reaction is small and enables goethite to remain for a long time (Krauskopf, 1979; Turgoose, 1982) along with more stable products such as hematite. Metastability of lepidocrocite, in addition to its formation which is associated with a high quantity of Fe^{2+} ions in area of formation (Cornell & Schwertmann, 2003), creates this possibility that the corrosion is still continuing in atmospheric condition. Maghemite, which was detected along with magnetite in the internal layer (Fig.8A) could be formed by oxidation of magnetite (Cornell & Schwertmann, 2003) in areas with higher oxygen access, and probably after excavation. On the other hand, lack of maghemite within the discovered corrosion compounds in XRD analysis can be due to its metastability and easy
