USE OF GRID REINFORCEMENT IN HMA OVERLAYS - A TEXAS FIELD CASE STUDY OF HIGHWAY US 59 IN ATLANTA DISTRICT

Lubinda F. WALUBITA[1], Enad MAHMOUD[2], Sang ICK LEE[1], Gisel CARRASCO[2], Julius J. KOMBA[3], Luis FUENTES[4*], & Tito P. NYAMUHOKYA[1]

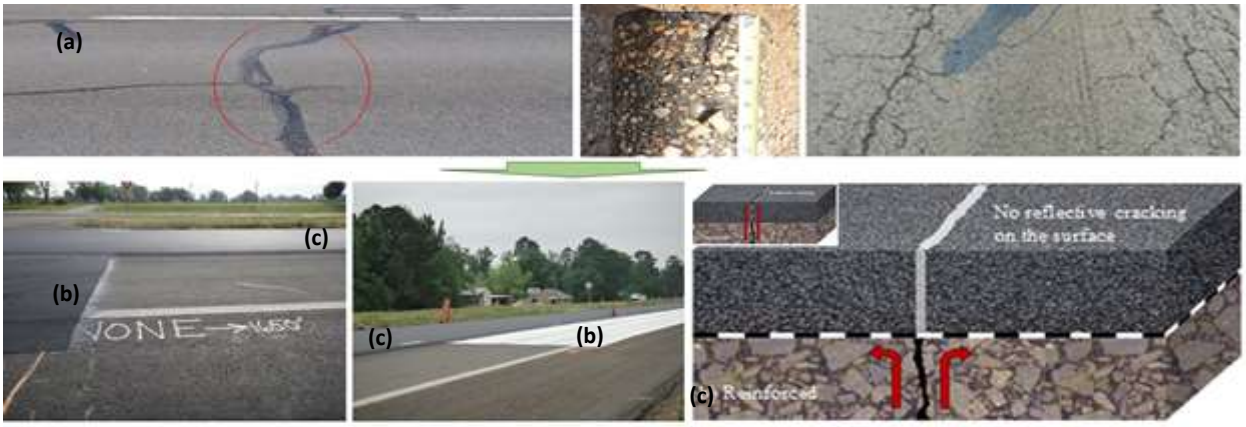
Fig. 1. (a) Old Cracked Pavement, (b) Grid-Reinforcement, and (c) Overlay Construction.

From Fig. 1, it is clearly evident that the primary structural function of the interlayer grid-reinforcement is to mitigate and retard the upward propagation of cracks from an existing cracked pavement to the HMA overlaid surface. The grid-reinforcement aids in prolonging the cracking (reflective) resistance, longevity, and service life of the pavement. In some cases, the grid-reinforcement also serves as a waterproofing membrane for the sub-structure.

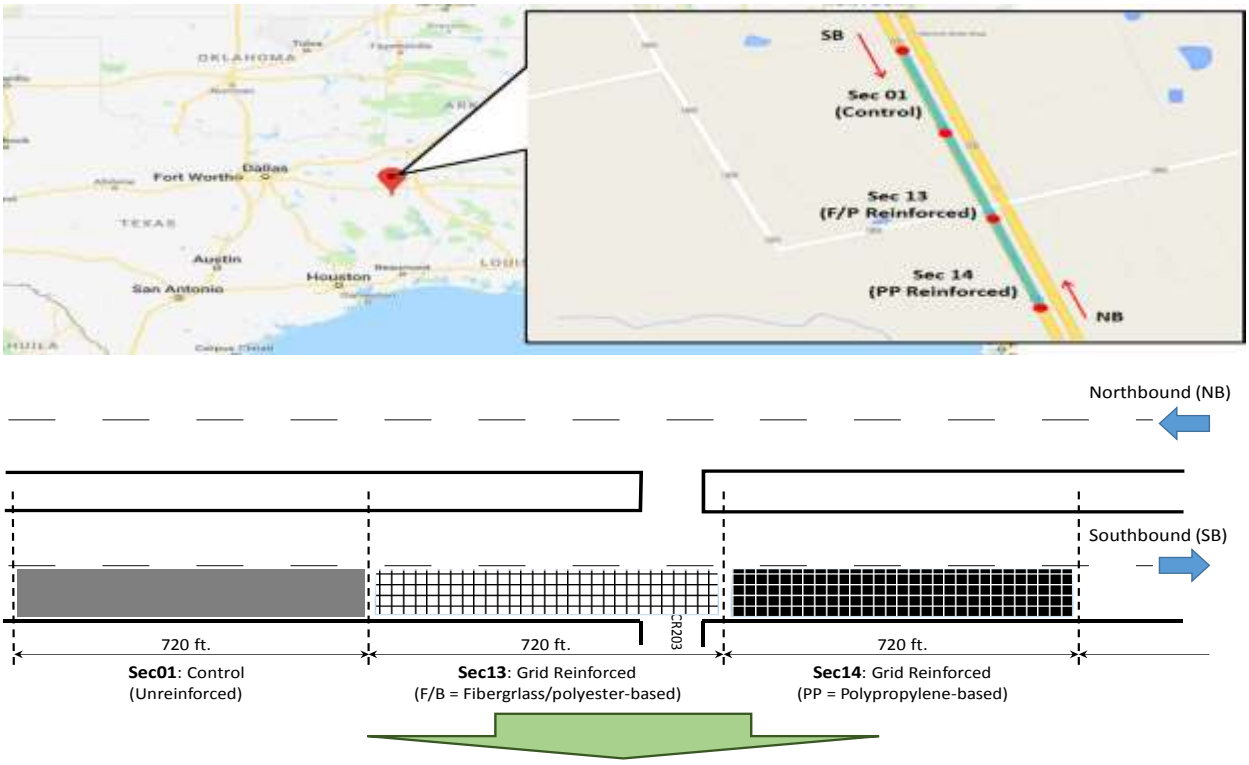
#	Layer	Thickness (Inches)	Year Constructed
4	HMA overlay (Type D = 5.1% PG64-22 with 20% RAP)	2.0	2011
3	Interlayer grid-reinforcement ⇒ **None** for Sec01, **F/B** for Sec13, & **PP** for Sec14		2011
2	Existing HMA	~ 11.5	-
1	Base (lime fly-ash [LFA] treated)	~ 16.0	-
0	Subgrade	∞	-

Fig. 2. US 59 Test Section Location, Plan View, and Pavement Structure.

As documented elsewhere [9], the 11.5 inches thick existing HMA in Fig. 2 comprise of dense-graded HMA mixes, 5/8" nominal maximum aggregate size (NMAS) with about 4.4 to 4.7% PG 70-22 asphalt-binder and limestone/quartzite aggregates. The 16 inches thick LFA treated base layer comprise of about 20 lb/sy lime and 40 lb/sy fly-ash in a dry application.

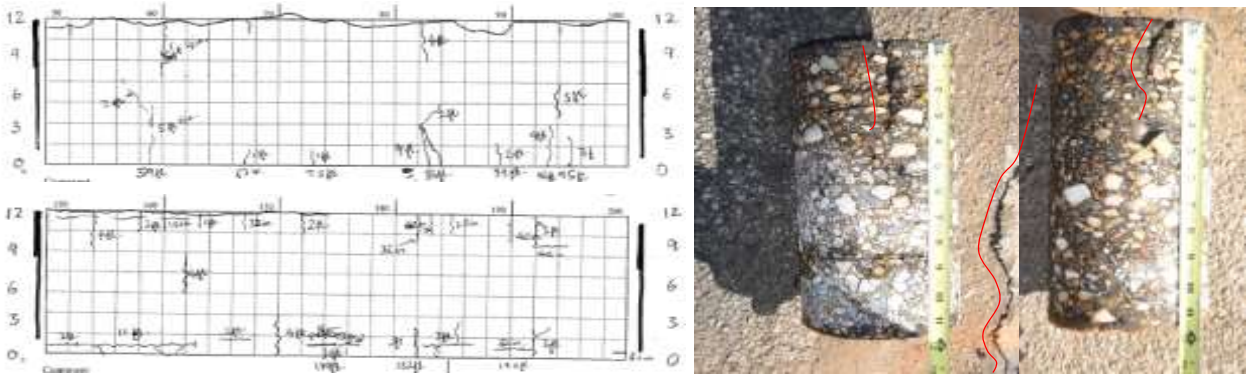
Fig. 3b. Example Pre-Construction Crack-Mapping (Walking) Survey on US 59.

As shown in Fig. 3(b), some of the pre-construction field-testing included coring samples to assess the degree of crack depth and quantify the existing pavement layer thicknesses. As catalogued in the DSS (*11*), other tests included GPR for subsurface condition assessment and existing pavement layer thickness determination, rutting, FWD testing for HMA modulus and pavement strength characterization, and dynamic cone penetration (DCP) testing for base/subgrade modulus, strength, and thickness characterization.

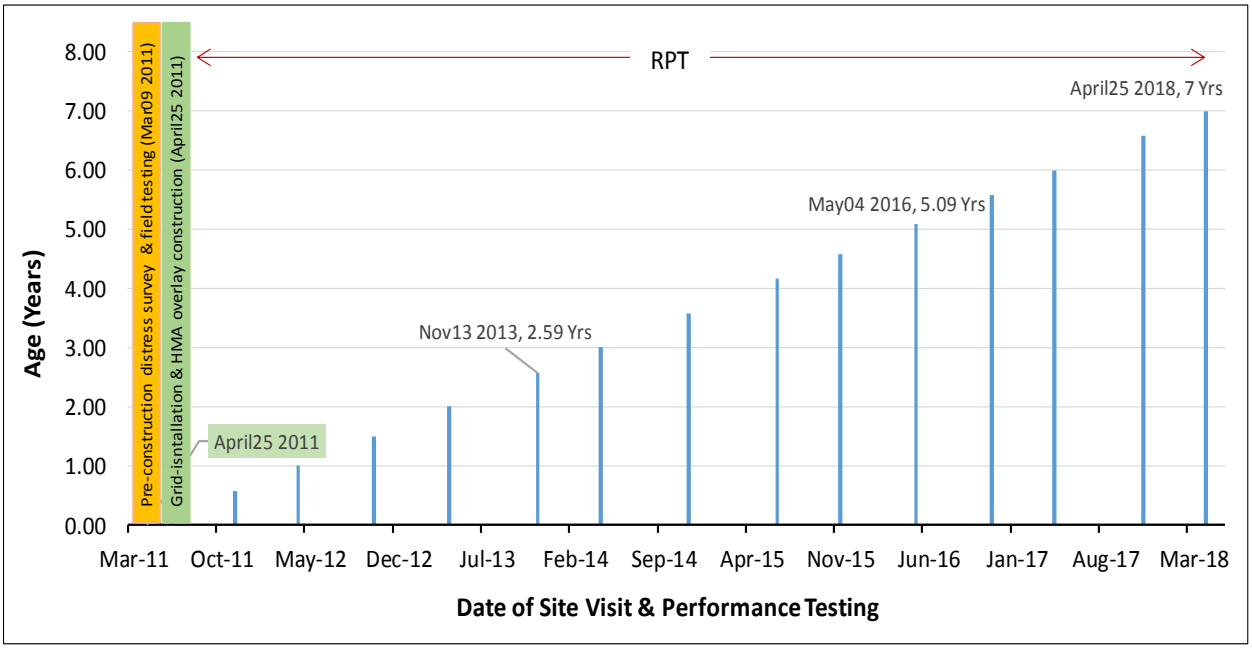
Fig. 5. RPT Field Plan and Schedule for the US 59 Overlay Test Sections.

Since overlay construction on April 25, 2011, Fig. 5 shows that the test sections clocked 7 years of service on April 25, 2018. Pre-construction distress surveys were conducted on March 9, 2011. In line with the ongoing database (DSS) project, the next site visit and RPT is tentatively scheduled for spring 2019.

As documented in the DSS and shown in Fig. 5, the RPT comprise of the following performance evaluations and field testing: GPR (subsurface defects); crack (walking) surveys/measurements; surface rut measurements (using a straightedge); raveling (aggregate loss); bleeding; temperature measurements (air and PVMNT); high-speed profiles and surface roughness (IRI and PSI); FWD (surface deflections, layer modulus, and pavement strength); DFT-CTMeter (friction characteristics and surface texture); coring (as needed); traffic measurements (volume counts and vehicle weights); taking pictures; etc. [9]. The respective field tests are listed in Table 1.

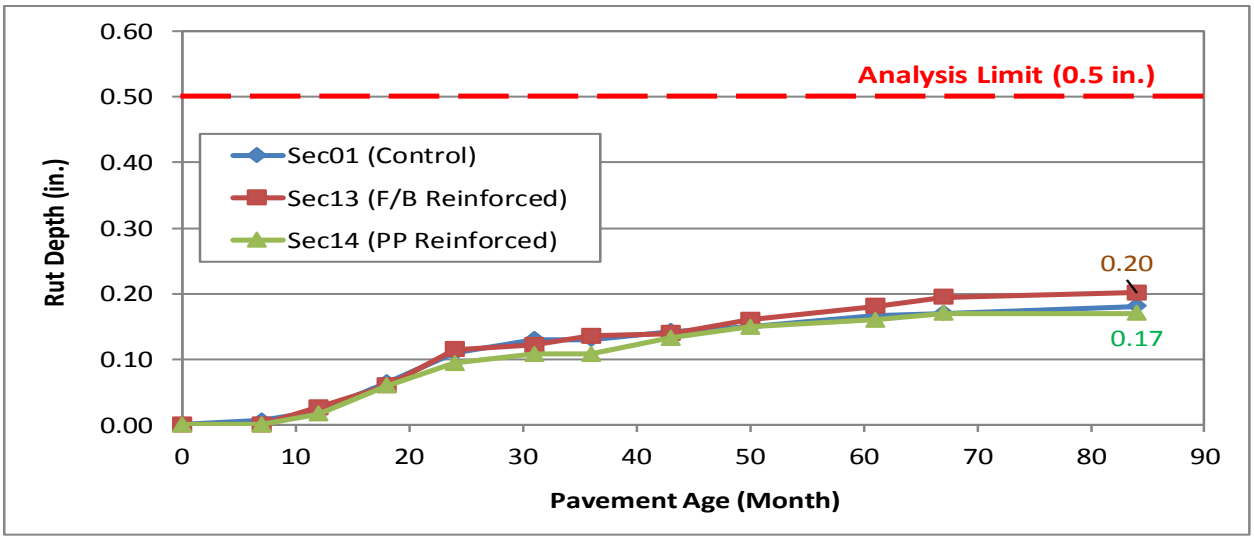
Fig. 6. Pavement Surface Rutting.

Fig. 6 shows that the surface rutting performance of the three test sections are indifferent and well below TxDOT PMIS' 0.50 inches rutting criteria; with Sec13 (0.20 inches) on the slightly higher side and Sec14 (0.17 inches) on the lower side [9]. For the same traffic level, temperature conditions, and pavement structure, the performance results in Fig. 6 infers that the interlayer grid-reinforcements, namely F/P and PP, had no major structural impact on the rutting performance of the HMA overlay on US 59 during the 7-years' service life that performance was monitored.

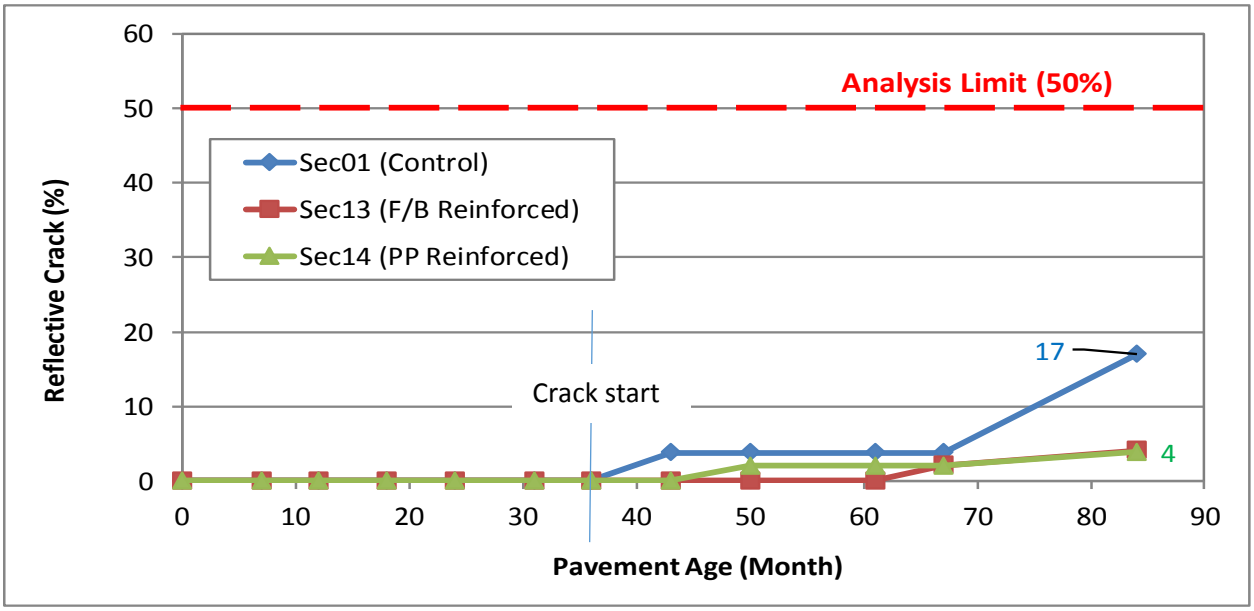
Fig. 7. Reflective Cracking on the Pavement Surface.

As theoretically expected, the un-reinforced Control section (Sec01) exhibited more reflective cracking than the grid reinforced test sections, Sec13 and Sec14. After 7 years of service, the reflective cracking on Sec01 is 17% versus 4% for the grid-reinforced sections, i.e., 4.25 times more cracking (Figure 7). In the 7th year, Fig. 7 shows that about 4.25 times more cracks had reflected thru to the pavement surface on the Control section (Sec01= 17%) than on grid-reinforced sections (Sec13 and Sec14 = 4%), clearly illustrating that the grid reinforcements have mitigated/retarded the reflective-crack propagation.

Fig. 7 further shows that reflective cracking on Sec01 started just after 3 years (36 months) of service followed by Sec14 at 3.6 years (43 months) and lastly, Sec13 at 5.1 years (61 months). The cracking on Sec01 seems to have accelerated after the 67th month, from about 4% to 17% in the 84th month. While the percentage of cracking is virtually the same (4%) in the 7th year, cracking on Sec14 (PP) started appearing

on the pavement surface about 18 months earlier than on Sec13 (F/B). Overall, the cracking on the test sections is still significantly less than the M-E PDG manual of practice and TxME's 50% terminal threshold to warrant any immediate maintenance/rehab attention. However, from the shape of the graph in Fig. 7 and assuming that the deterioration rate remains the same, Sec01 is theoretically not expected to last five more years prior to reaching the 50% terminal criterion – particularly if a more stringent 25% terminal criterion is considered. Note that in lieu of 50%, some literature also recommends a 25% threshold [9].

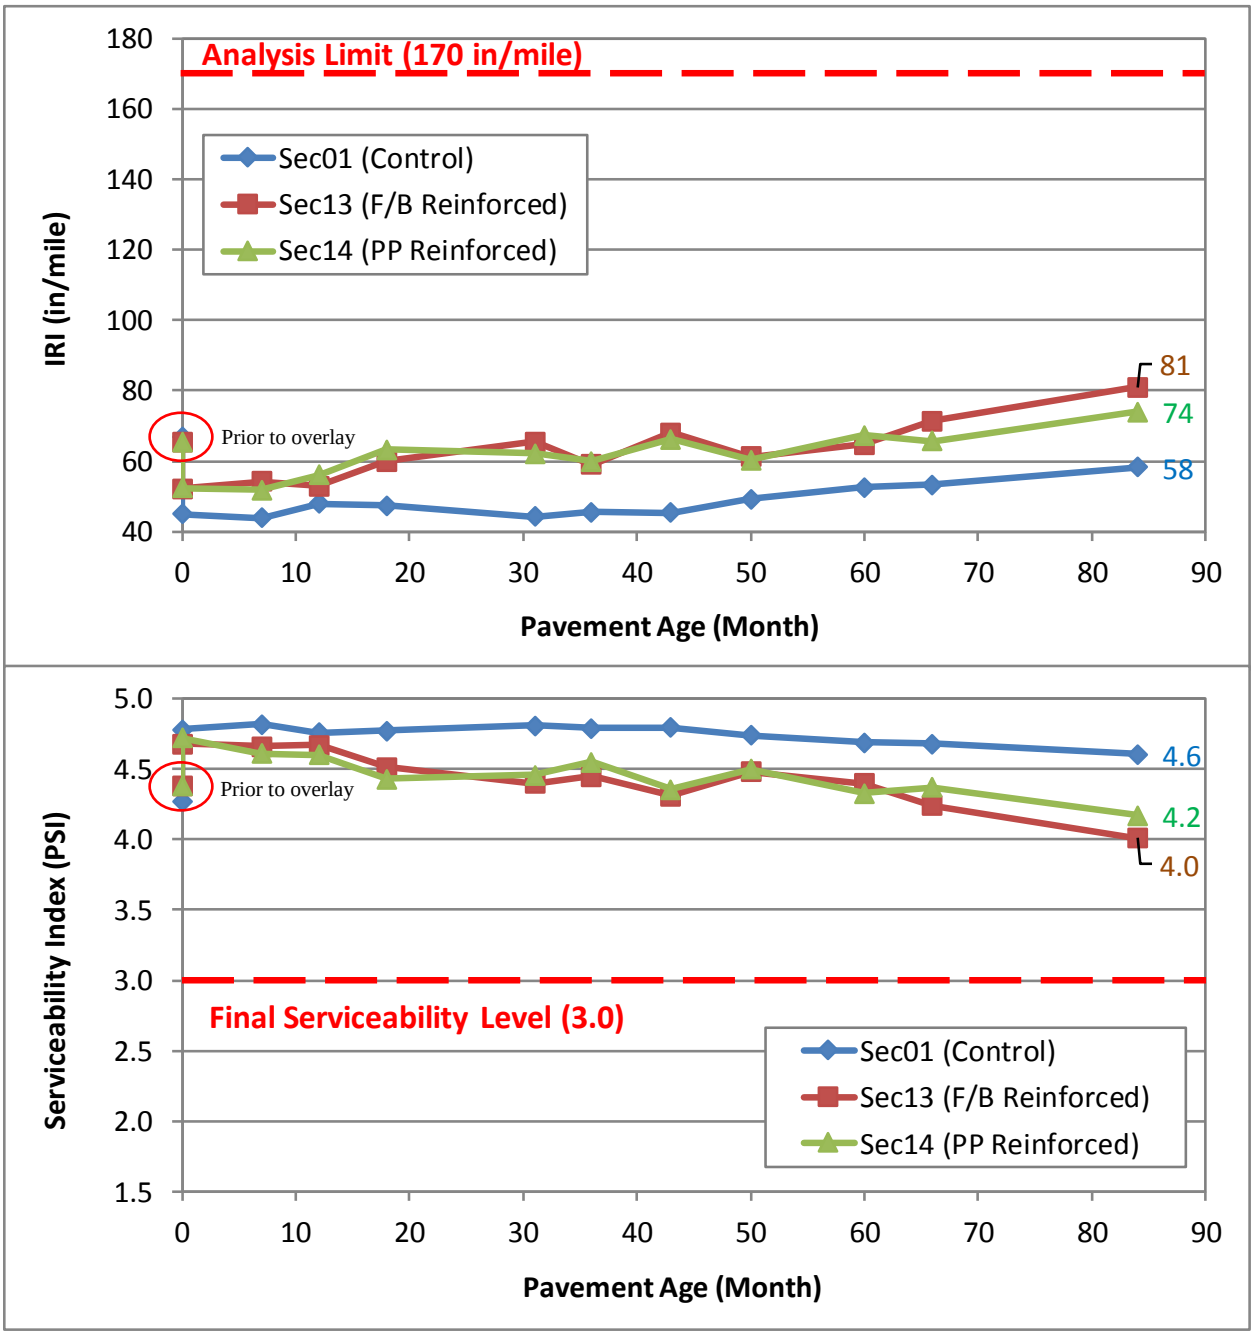
Fig. 8. Pavement Surface Roughness (IRI) and Serviceability Index (PSI).

Pavement surface roughness/smoothness (IRI) and serviceability index (PSI) were measured and quantified based on the high-speed profile (longitudinal) measurements. With an IRI of 81 and 74 in/mile for Sec13 and Sec14, respectively, in comparison to Sec01 (Control) with 58 inch/mile, Fig. 8 suggests that the grid reinforcements have an impact on the pavement surface smoothness/roughness, particularly if not well installed. Right from construction and throughout the 7-years' service life, Sec01 (Control) has exhibited a smoother pavement surface with the lowest IRI value, with Sec13 (F/B) being the least at 81 in/mile in the 7th year – all subjected to the same traffic level, climatic conditions, and similar pavement structure. Although all the test sections are still well below FHWA's condition rating criterion of IRI $\leq$ 170 inch/mile, the results suggest that, for the 7-years' service life evaluated, the PP grid material was a little superior to F/B in terms of providing a smoother pavement surface [9].

As evident in Fig. 8, the trend in the PSI results is similar to that of the IRI results, with Sec01 (Control) exhibiting superior performance, i.e., highest PSI values, in fact, 4.6 in the 7th year of service. For the grid-reinforced sections, Sec14 (PP) is slightly better than Sec13 (F/B), i.e., 4.2 versus 4.0. Using PSI $\geq$ 3.0 as the tentative terminal threshold based on the Texas pavement manual, the PSI performance is thus far rated as satisfactory on all the test sections [9]. Note however that the grid-reinforced sections started with higher initial IRI and lower initial PSI values than the Control section right from construction at month zero. By and large, the rate of deterioration (when considering the slopes of the IRI and PSI plots in Fig. 8) on all the three test sections, seems to be hardly different, albeit that the grid-reinforced sections have high IRI and lower PSI values, respectively. However, it is apparent from Fig. 8 that the higher IRI (and lower PSI values) of the two grid-reinforced test sections seems to have started right from the time of construction and therefore, could be mostly construction related, e.g., grid installation, HMA placement, compaction issues, etc. This disparity in the initial IRI and PSI values at the time of construction appears to have continued throughout the service life of the test sections, and, hence, while deteriorating at nearly the same rate, they are performing poorer than the Control section in terms of the IRI and PSI magnitudes. For instance, minor dips (0.25 ft. width and 0.15 in. depth) were measured on the grid-reinforced test sections (during QC/QA profile measurements just after construction) while no noticeable dips or dumps were measured/observed on the Control section. So, these dips may have likely contributed to the higher initial IRI and lower initial PSI values of the grid-reinforced sections as shown in Fig. 8.

It should also be noted that although, in theory, one expects grid materials to be smooth, in reality, this may not always be the case, and in fact, the grid might introduce some minor irregularities to the pavement surface (short wavelength) as evident in this case study (Fig. 8). In the end, it's all about a balance between the benefits gained in terms of reflective crack resistance versus any losses in smoothness. In this case study, however, the minor disparity and increase in pavement surface roughness due to grid-reinforcement is insignificant compared to the superior performance gained in terms of reflective crack resistance shown previously in Fig. 7. As shown in Fig. 9, a plot of the IRI versus PSI was also generated to establish a correlation between these two parameters.

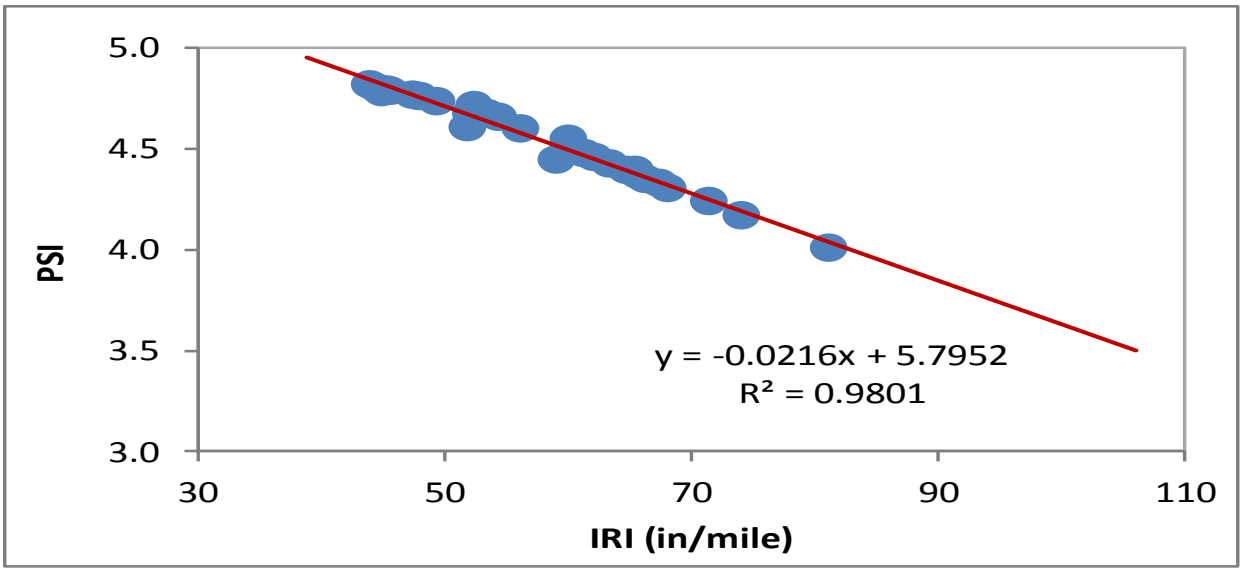
Fig. 9. Graphical Plot of the PSI-IRI Linear Relationship.

At a correlation coefficient of 98% (i.e., R^2 = 0.98), Fig. 9 shows an inverse proportional relationship between IRI and PSI with a regression model of the following linear format:

Where a and b are regression constants 0.0216 and 5.7952. Mathematically, the graphical illustration in Fig. 9 and Equation 1 indicates that as the IRI increases, the PSI correspondingly decreases. This allows for computing one parameter if one of them is known, i.e., PSI from IRI and vice versa. For example, using Equation 1, TxDOT's IRI threshold value corresponding to a PSI = 3.0 would be 129.40 in/mile. And similarly, FHWA's PSI corresponding to IRI = 170 in/mile would be 2.12.
