## CHAPTER 3: MATERIAL AND METHODS

### 3.1.2 General literature, maps and other data.

#### 3.1.2.1 Kromme River:

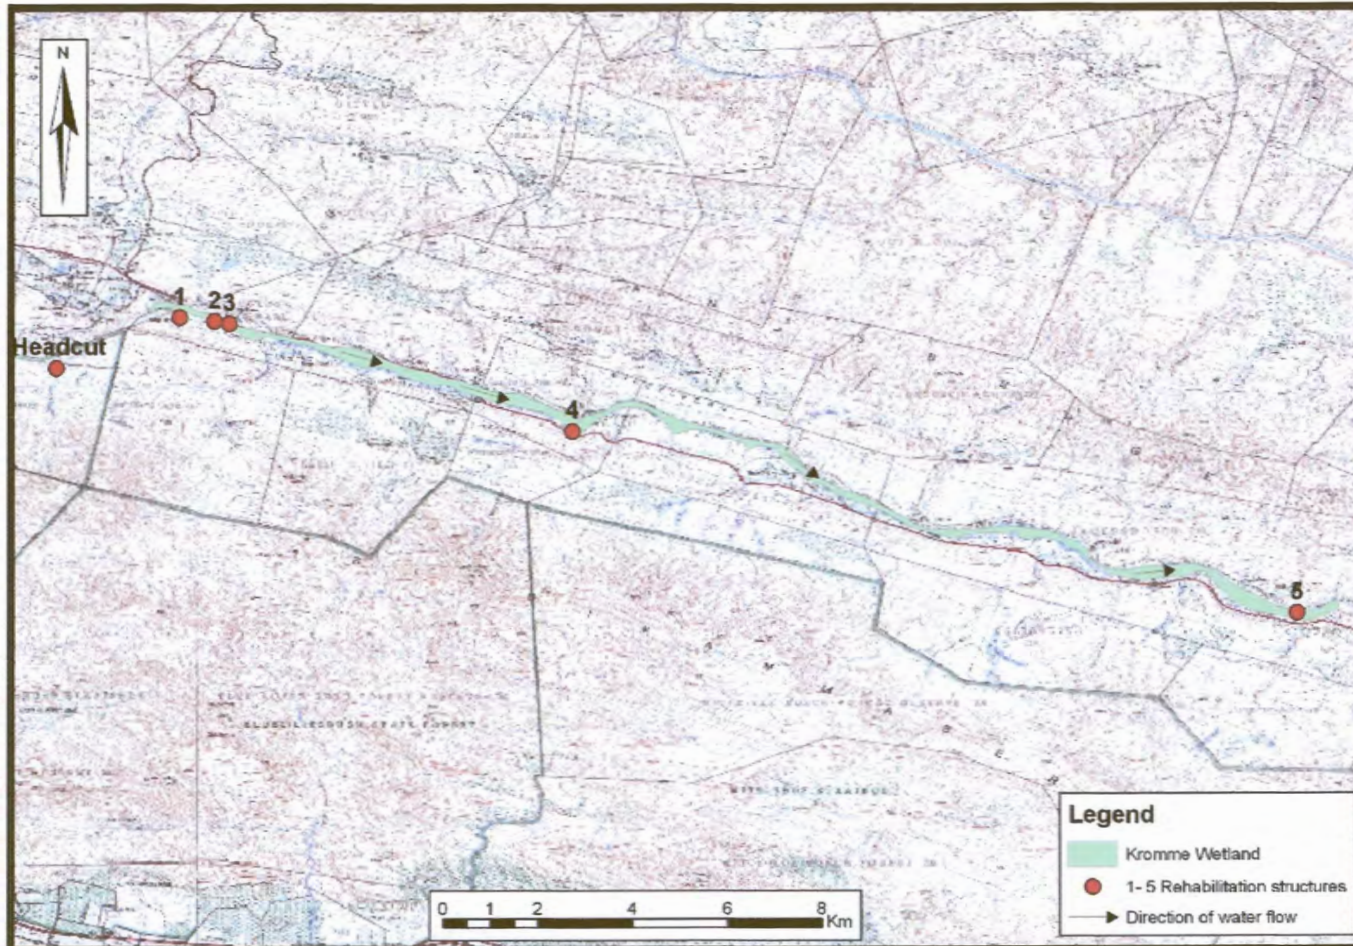
Figure 9: Topographical maps (3324 CD, 3324CC, 3323 DD) showing the locations of the rehabilitation structures 1- 5 as well as the headcut of the Kromme Wetland in the Eastern Cape.

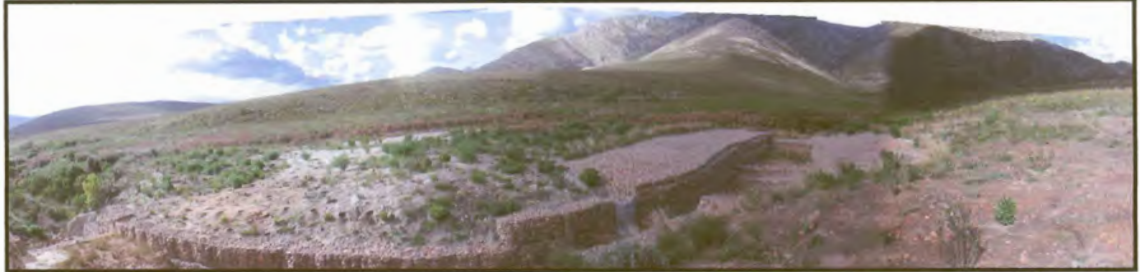
Site no.	Problems	Rehabilitation action	Desired results
23° 58' 22" 33° 52' 21"	Headcut erosion at a side tributary in the upper catchment area (Figure 9 & 10). The fynbos vegetation differs from the palmiet ( <i>Prionium serratum</i> ) that dominates the main wetland in the Kromme River.	Gabion and concrete structure.	<ul style="list-style-type: none"> <li>Structures must act as silt traps.</li> <li>Rehabilitation of indigenous vegetation. must protect the soil.</li> </ul>
<b>1</b> 23° 59' 45" 33° 51' 46"	Eroded river channel in river bed of 8.5 m wide and 3.5 m deep.	3.5 high concrete gravity structure (Figure 11) 4 m wide at bottom and 8.5 m overflow width build on rock foundation.	<ul style="list-style-type: none"> <li>Structures must act as silt traps.</li> <li>Rehabilitation of indigenous vegetation must protect the soil.</li> <li>Lift water table.</li> <li>Dissipate the energy of floods.</li> <li>To prevent further erosion of the wetland.</li> </ul>

**Figure 10: Landscape around the headcut at a tributary of the Kromme River. This rehabilitation was done in a first order stream and not in a wetland.**

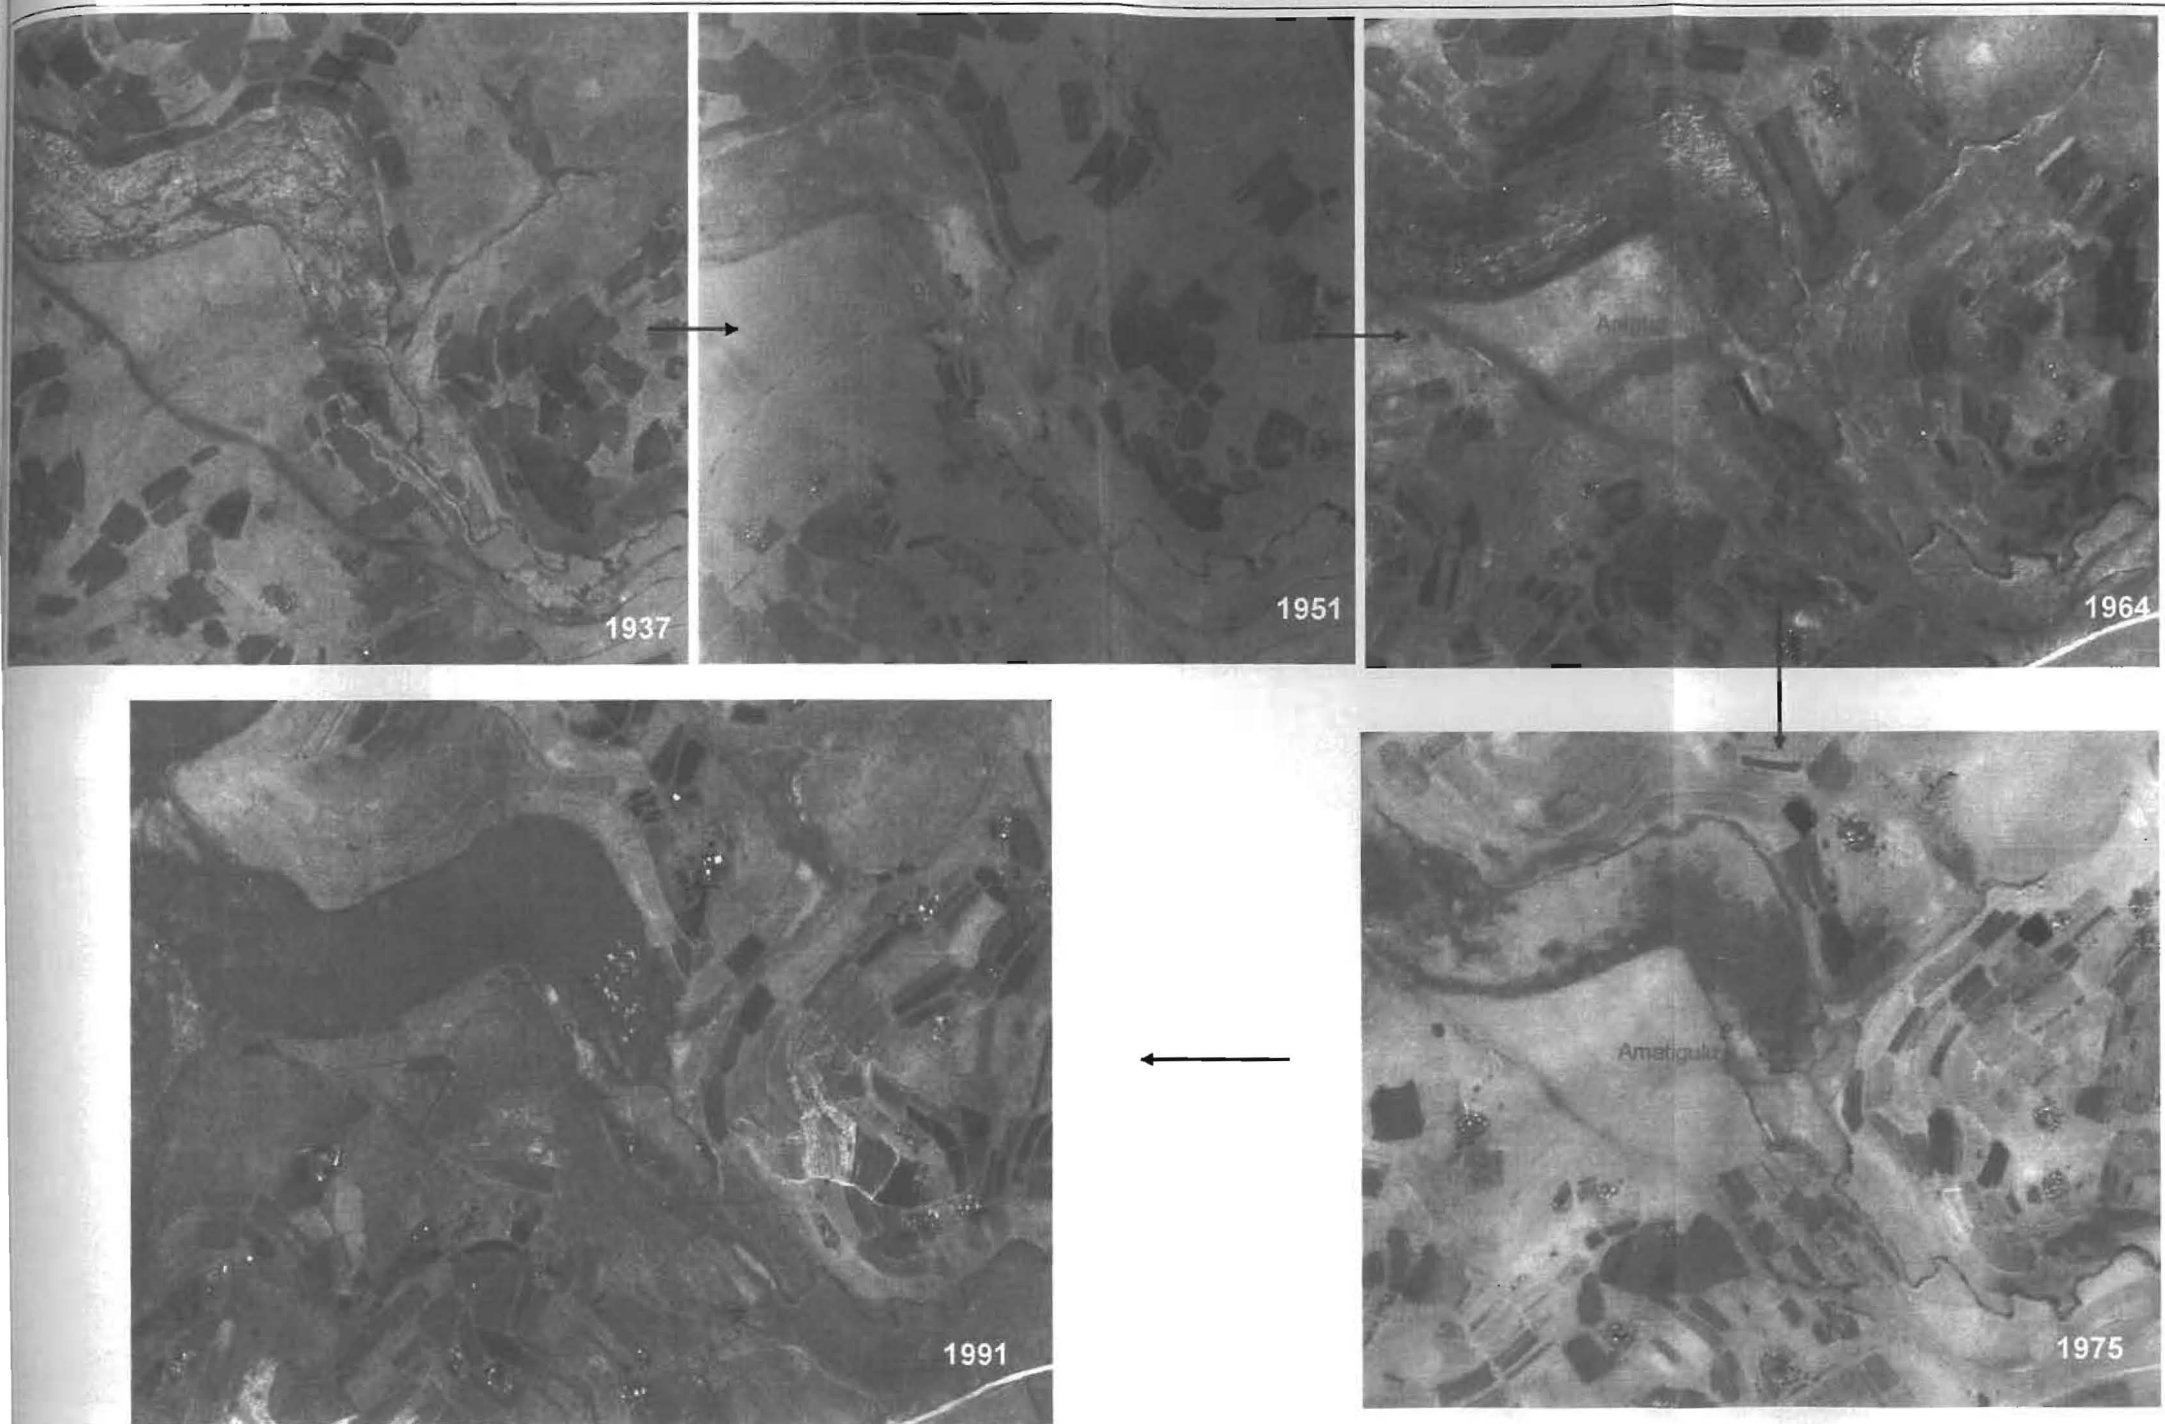
Aerial photographs of the two sites, Amatikulu (Figure 20) and Uvova (Figure 21) clearly show landscape changes from 1937 to 1991.

- Erosion channels and headcuts.
- Hydrological regime.
- Land cultivation.
- Density of vegetation.
- Bare soil.
- Visibility of water.
- Infrastructure.

Figure 20 : Site 1 : Amatigulu. Aerial photographs depicting landscape changes.

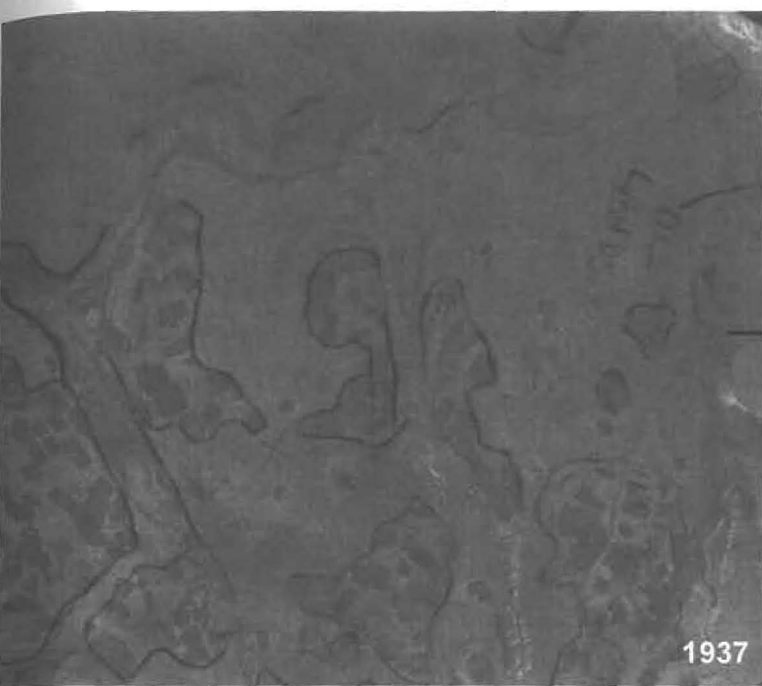
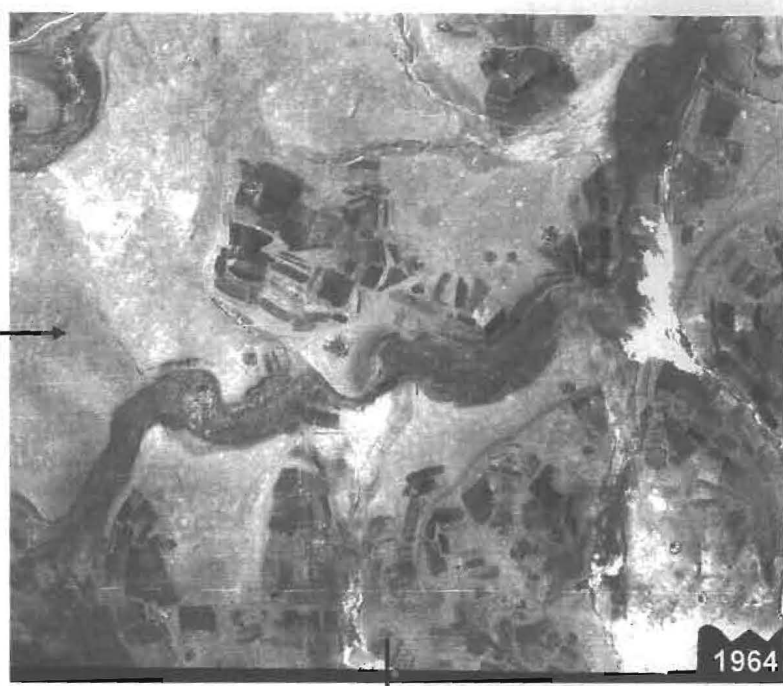
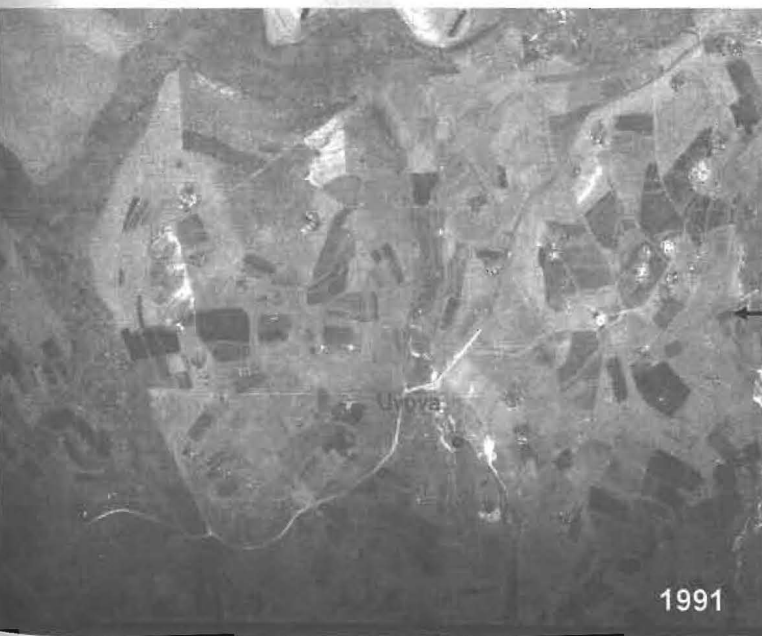
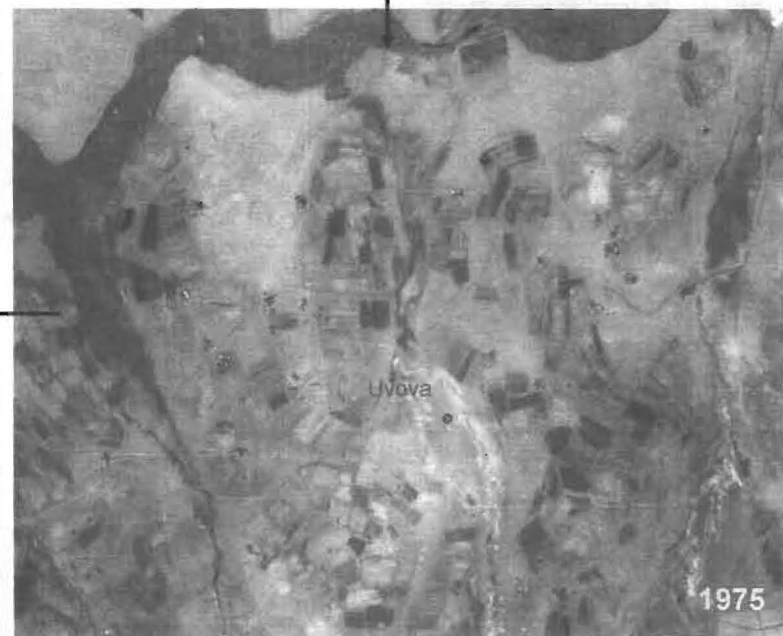
Figure 21 : Site 2 : Uvova. Aerial photographs depicting landscape changes.

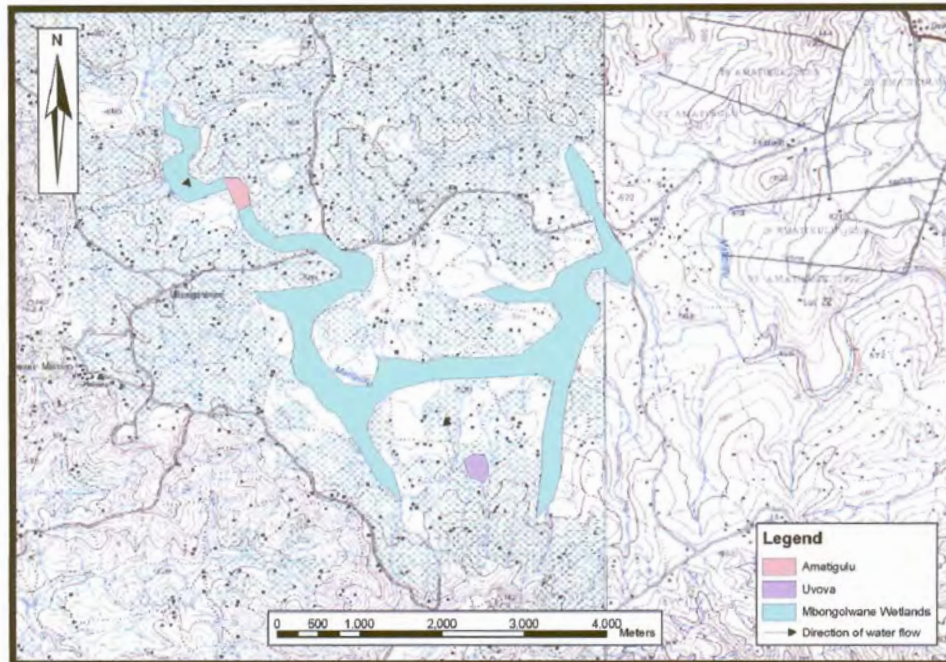
The Mbongolwane wetland in KwaZulu-Natal meanders for 12 km. There are two sites at Mbongolwane that had work scheduled for 2002/3. Two large chutes were planned, one in the wetland at Amatigulu, the second is on a stream which enters the wetland at Uvova. The concern at the Amatigulu site is the area of wetland under threat from the continued and extensive movement of the headcut and the associated gully. This wetland area is largely permanently saturated and characterized by diffuse flow. The hydrological consequences of further erosion are therefore potentially very significant. It would therefore be important to monitor the overall hydrological state of this upstream area.

**Figure 23: Topographical maps (2831CC & 2831 CD) showing the locations of the two rehabilitation structures (Uvova and Amatigulu).**

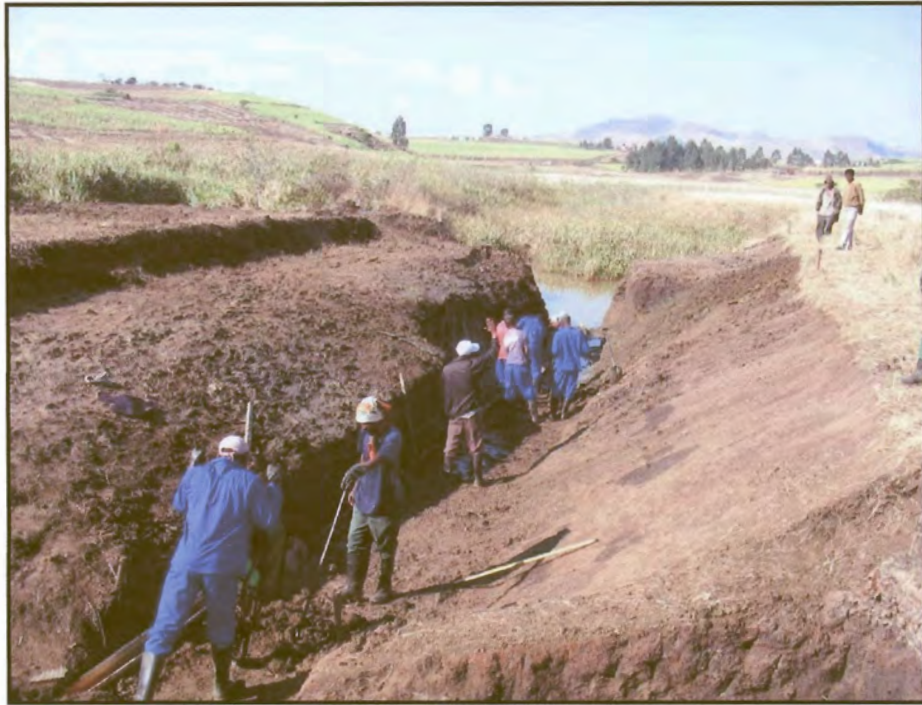
Astrup (2002) commented that all the preparatory work at both the sites was totally destroyed (Figure 24). Flood waters gushed through the sites and caused serious erosion on the chute preparation (Figure 25, 26, 27, 28, 29 and 30). Astrup (2002) explained further that it was impossible to start again with chute preparation due to water flow and the loss of precious work time. The risk of spring rains would threaten chute preparation work started at this stage. Large volumes of water flowed through the Amatigulu site right up until August. A decision was taken to re-plan a structure for the winter of 2003 (M. Astrup, *pers. comm.*).

**Figure 25: Before flooding. Photo taken downstream on 4 July 2002 at the Amatigulu site.**

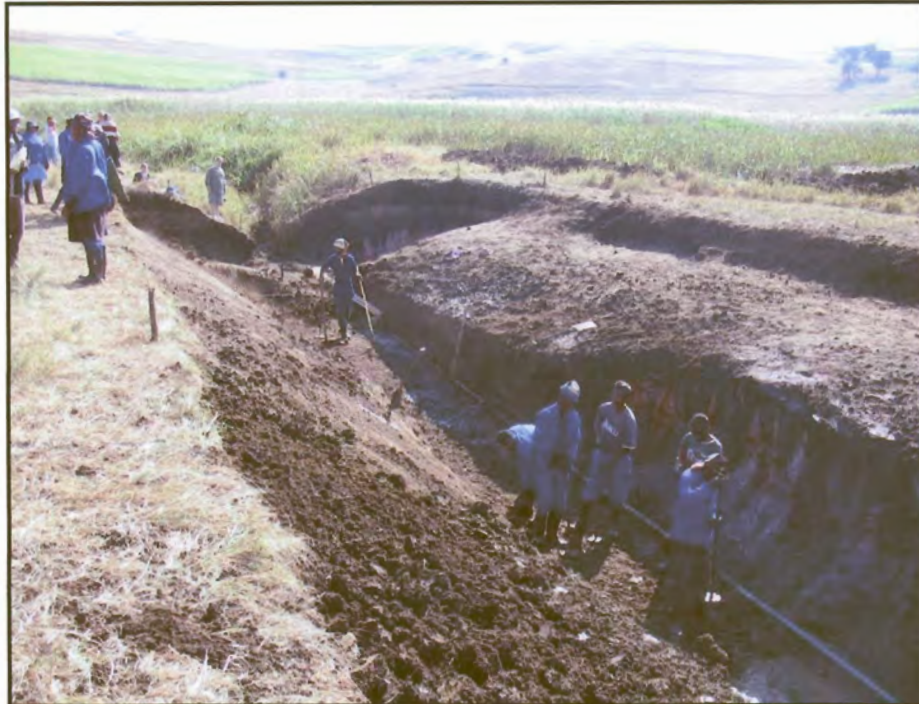
**Figure 27: Before flooding. Photo taken up stream on 4 July 2002 at the Amatigulu site.**

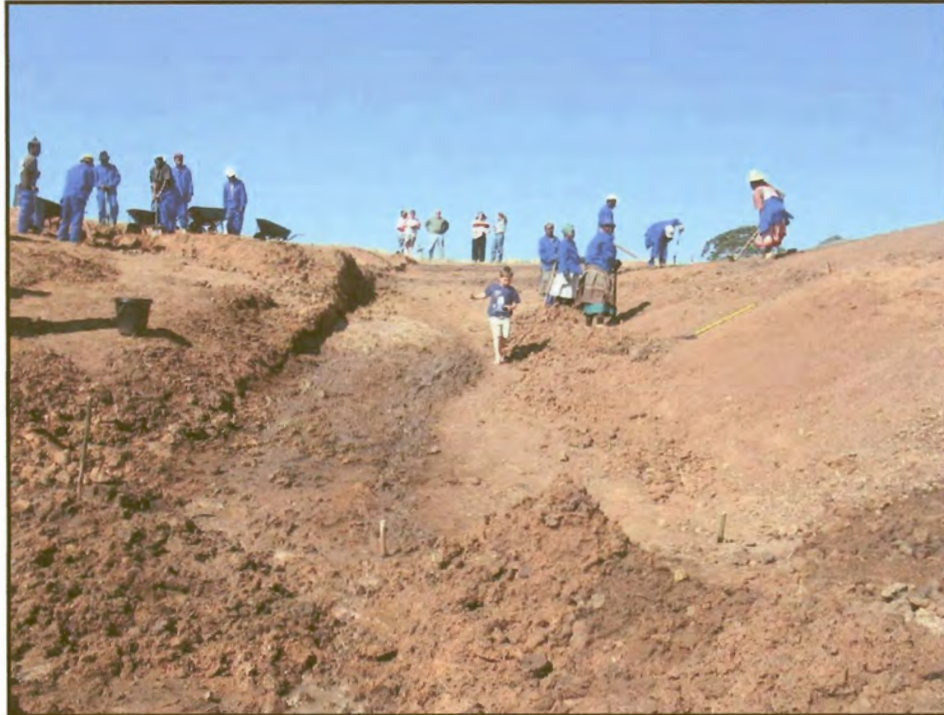
**Figure 29: Before flooding. Photo taken on 4 July 2002 at the Uvova site.**

At the Uvova site a re-assessment was done, together with Mr. Bill Russel (WfWet consultant), for the construction of:

A 25 - m long sand bag groyne (Figure 31 a) to divert the stream flow away from the headcut site of the donga, together with an earthen embankment with a small buttress weir 300 mm high and 45 m long (Figure 31 b) across the stream so as to evenly spread water flow. In addition, a 500 mm high earthen embankment (storm drain) (Figure 31 c) was constructed directly above the headcut site so as to ensure water does not enter at this point. Reparation work on the Uvova site was done during September and October 2002 (Figure 31 d).

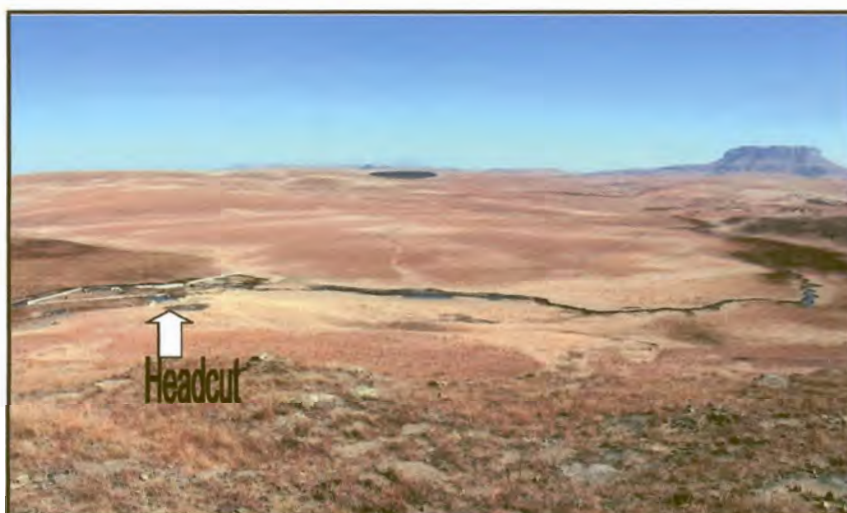
An aerial survey of the Wilge catchment by Rand Water revealed a headcut at the outlet of a wetland on the farm Wilge River 319 (hereafter referred to as the Wilge River wetland). The wetland rehabilitation has been performed on this portion of wetland in the upper catchment of the Wilge River (N. Collins, *pers. comm.*) (Figure 33).

**Figure 33: The Wilge River Wetland and rehabilitation structure at the headcut.**
