CHAPTER 16 – REFERENCES

LIQUID PHASE DIFFUSION BOND REPAIR OF WESTINGHOUSE 501F, ROW 3 VANES

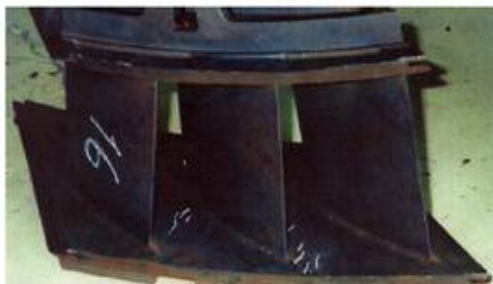
Figure 2 shows typical cracking on the shroud and fillet areas as revealed by FPI (fluorescent particle inspection), while fig's 3, 4 and 5 show individual cracks in more detail. These cracks are wide 2.5mm (0.1") and hence conventional narrow gap brazing cannot be utilised as a repair technique. The hook fit area, which needs to be rebuilt, is shown in fig 6.

Figure 2 – Typical cracking on the shroud and fillet areas

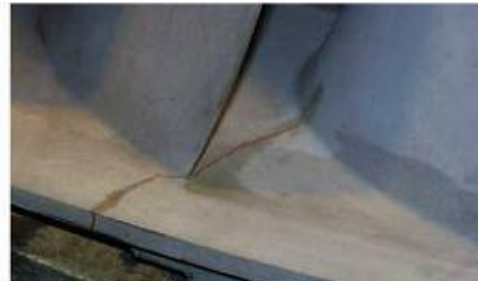
Figure 3 – Typical crack on the vane segment

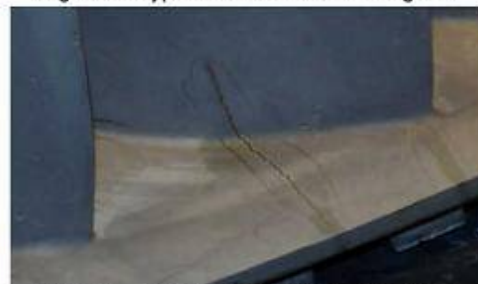
Figure 4 – Typical crack on the vane segment

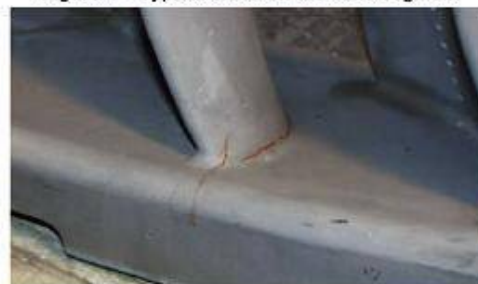
Figure 5 – Typical crack on the vane segment

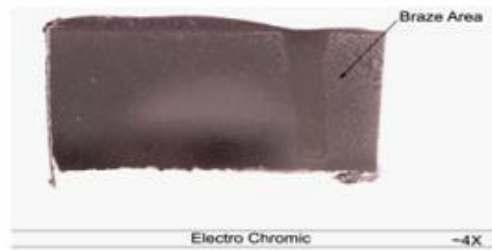
The cracks repaired (in fig's 35 – 41) using the LPDB process, were sectioned and a conventional metallurgical analysis was conducted. Figure 43 shows a macrograph taken through the crack. The paste has filled the complete cavity of the crack and there is good bonding to the sidewalls of the routed out crack. A semi-quantitative and qualitative analyses on the base metal and joint can be seen in fig's 44 and 45. Essentially the elements of Co, Cr, Ni and W were found in the X-45 base metal as seen in figure 44. The LPD bonded repaired joint not only had the same elements as the base metal, (except for Ta, which is present in the chemistry of the "Sermafill" paste) but the elements only differed by 1% when comparing the chemistry of the 2 regions.

Figure 43 – Macrograph taken through a crack repaired with the "Sermafill" process

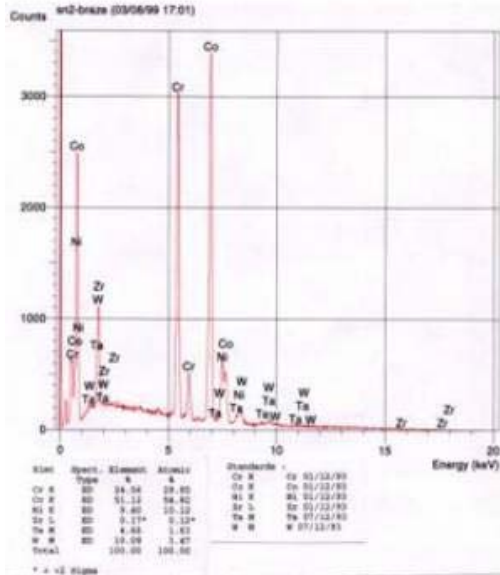
Figure 45 – Semi-qualitative and semi-quantitative analysis of the crack repaired region i.e. the “Sermafill’ed” joint.

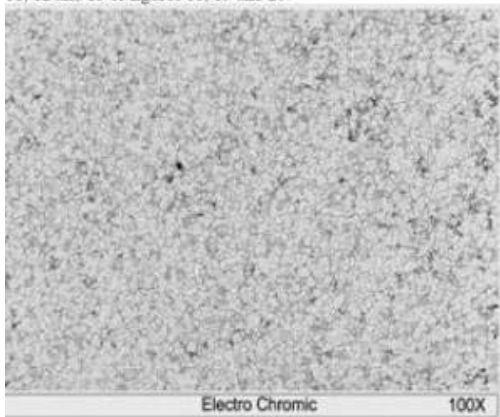
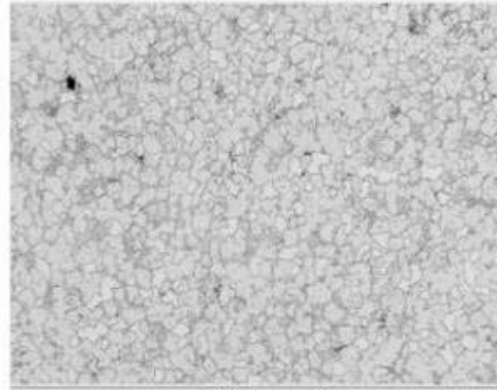
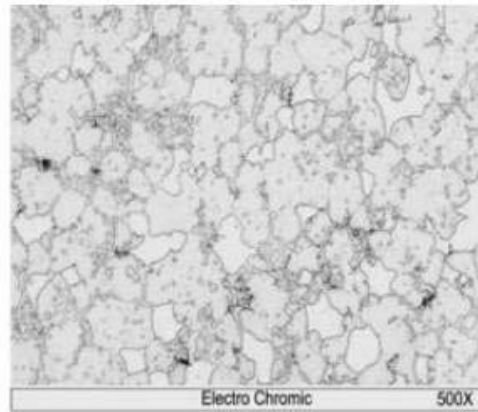
Figures 46, 47 and 48 show at different magnifications, the microstructure of the repaired crack region using the “Sermafill” process. The microstructure is similar to that present in figures 11, 12 and 13 or figures 18, 19 and 20.

Figure 46 – Microstructure of the crack repaired region using the LPDB/“Sermafill” process. Mag. 100X

Figure 47 – Microstructure of the crack repaired region using the LPDB/ “Sermafill” process. Mag. 200X

Figure 48 – Microstructure of the crack repaired region using the LPDB/ “Sermafill” process. Mag. 500X

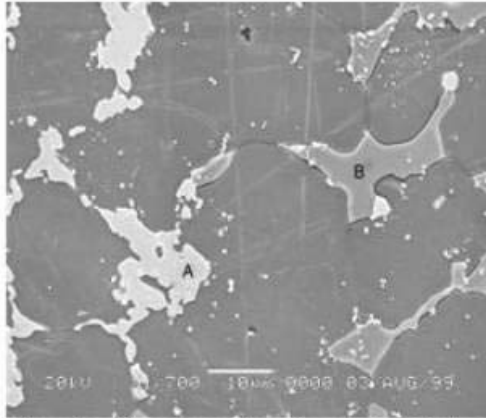
The phases seen on the grain boundaries in fig 49, are either W-borides or carbides, and Cr-borides or carbides respectively, as represented in the semi-qualitative and quantitative analyses seen in fig’s 50 and 51. As the EDAX system on the SEM could not detect either B or C it was difficult to precisely state the phases that formed in the joint. From the phase morphology it is probably a Cr-carbide phase and W-boride phase that is present in the repaired area.

Figure 49 – Phases present on the grain boundaries of a crack repaired area

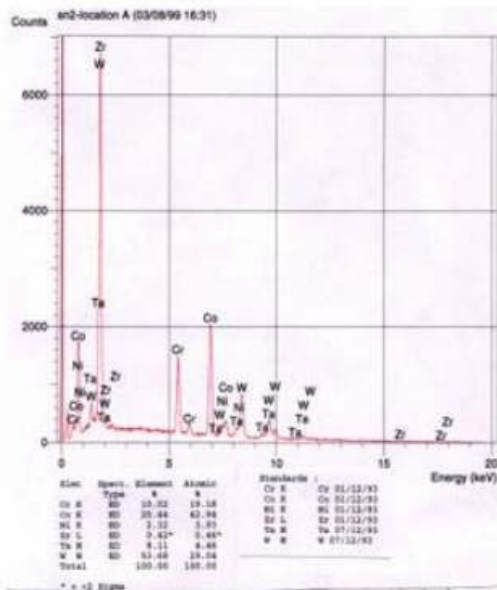
Figure 50 – Semi-qualitative and semi-quantitative analysis of the phase "A", along the grain boundary of a repaired crack using the LPDB/ "Sermafill" process.

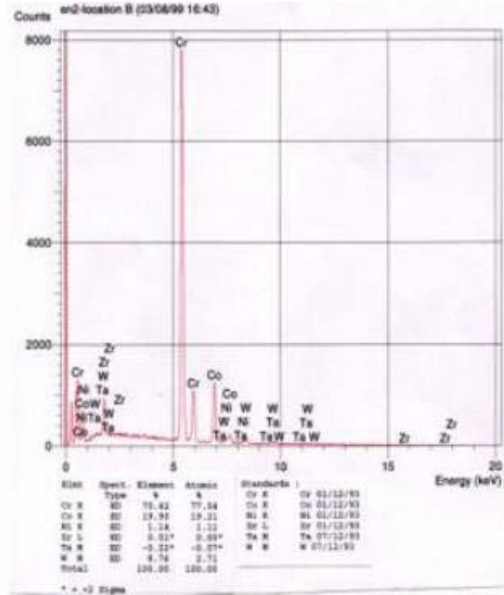
Figure 51 – Semi-qualitative and Semi-quantitative analysis of the phase "B", along the grain boundary of a repaired crack using the LPDB/ "Sermafill" process.

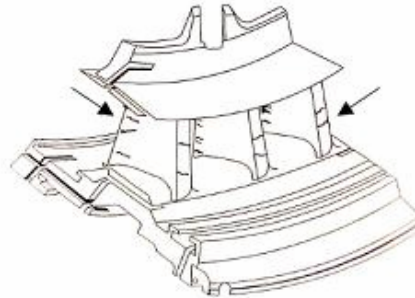
The largest width of cracks found on these engine sets was 1.5mm (0.059"). Therefore for the process qualification the mechanical property tests (namely tensile and stress rupture) were undertaken on samples where the joint gap was 1.5mm (0.059"). The process is not limited to this gap and the largest gap repaired to date has been 10mm.

Figure 3 – Typical view from the concave side, showing leading, trailing and shroud/buttress cracking on the Alstom Tornado 2nd stage stator segment.

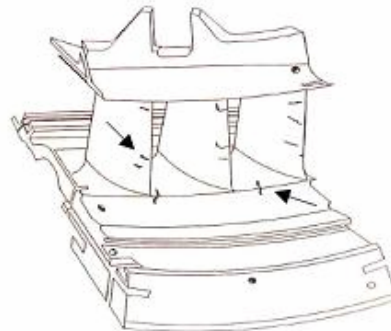
Figure 4 – Typical view from the convex side, showing leading, trailing and shroud/buttress cracking on the Alstom Tornado 2nd stage stator segment.

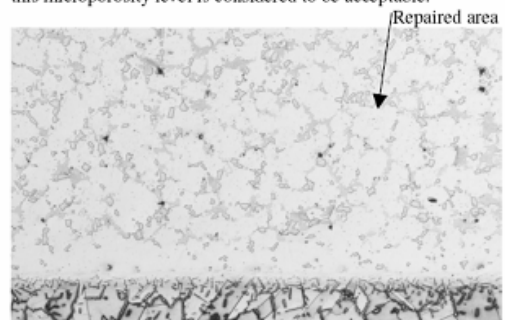
Figures 14 and 15 show the excellent bonding/ adhesion to the vane material. A fine-grained microstructure is evident. Some minor microporosity can be seen in the micrograph, but this microporosity level is considered to be acceptable.

Figure 14 – Micrograph taken through the repaired area showing a fine-grained microstructure. Mag. 75X

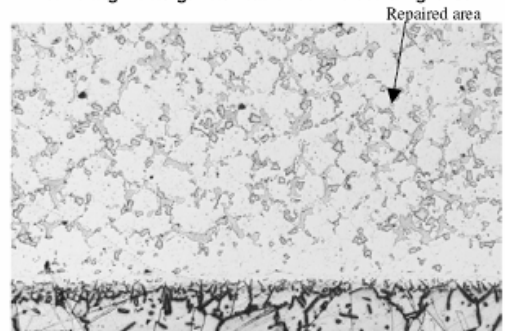
Figure 15 – Micrograph taken through the repaired area showing excellent bonding to the vane material. Mag. 75X

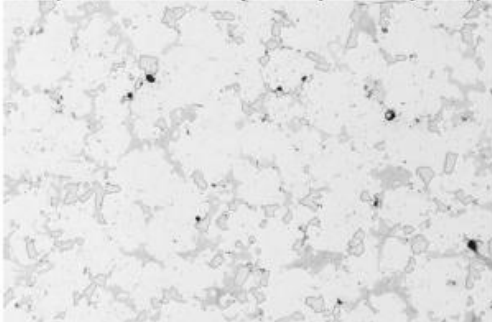
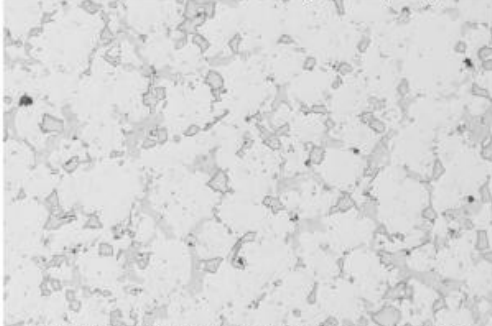
Figures 16 and 17 show the fine-grained structure of the LPDB joint, with intermetallic phases dispersed intergranularly.

Figure 16 – Microstructure of the LPDB area, showing intermetallic phases dispersed intergranularly. Mag. 150X

Figure 17 – Microstructure of the LPDB area, showing intermetallic phases dispersed intergranularly. Mag. 150X

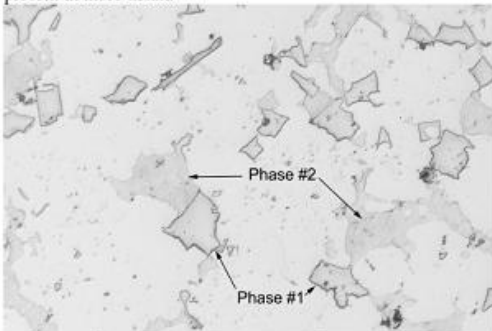
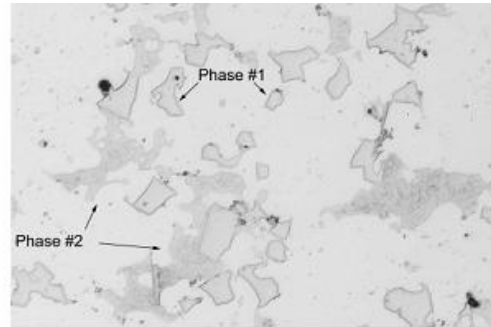
Figures 18 and 19 show the intermetallic phases that are present in more detail.

Figure 18 – Intermetallic phases present in the joint. Mag.400X

Figure 19 – Intermetallic phases present in the joint. Mag. 400X

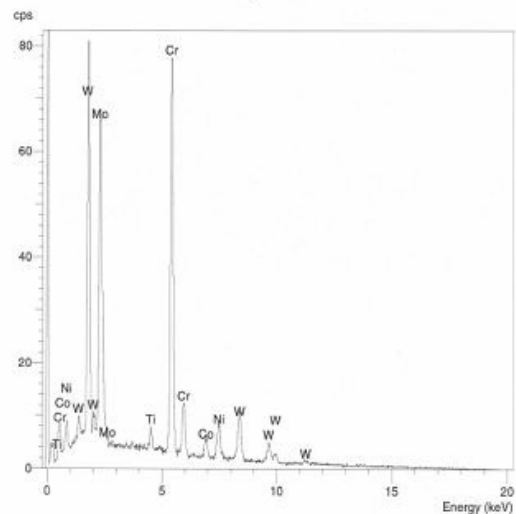
Figures 20 and 21 show semi-qualitative analyses of the phases labeled phase #1 and phase #2 in Figs. 18 and 19. Table 7, shows the semi-quantitative analyses of the phases labeled phase #1 and phase #2 in Figs. 18 and 19. As can be seen in Fig. 20 and Table 7, the “blocky” phases #1 are Cr/W rich phases; whereas, the phases #2 are Ni rich phases as seen in Fig. 21 and Table 7. Energy dispersive spectrometry was utilised for this work, and hence neither Boron nor Carbon could be detected. Therefore it is difficult to precisely state what phase is present in the joint. Nevertheless, it is probably a boride or carbide phase that formed. Unfortunately there was no thin window on the EDAX to detect Carbon or Boron.

Figure 20 – Semi-qualitative analysis of the phase #1 shown in Figs. 18 and 19.

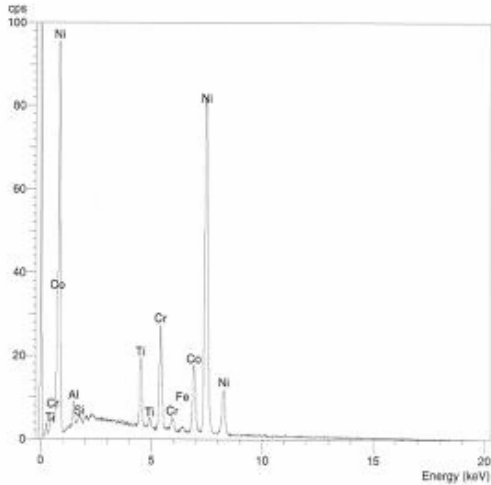
Figure 21 – Semi-qualitative analysis of the phase #2 shown in Figs. 18 and 19

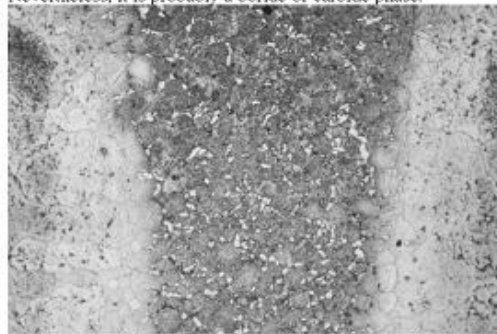
Figure 24 shows the microstructure of the repaired area. It consists of a fine-grained structure and there is good bonding/adhesion to the sidewalls. The joint interface can be clearly seen in Fig. 25 and there is no lack of sidewall bonding. Figure 26 shows the joint to consist of equiaxed grains with intermetallic phases dispersed intergranularly. These intermetallic phases can be clearly seen in Fig. 27. These “bright blocky” phases were determined to be Cr-rich intermetallic phases as seen in Fig. 28 and Table 8. Energy dispersive spectrometry was utilised for this work, and hence neither Boron nor Carbon could be detected. Therefore it is difficult to precisely state what phase is present in the joint. Nevertheless, it is probably a boride or carbide phase.

Figure 24 - Micrograph taken through the repaired area showing a fine-grained microstructure. Mag. 45X

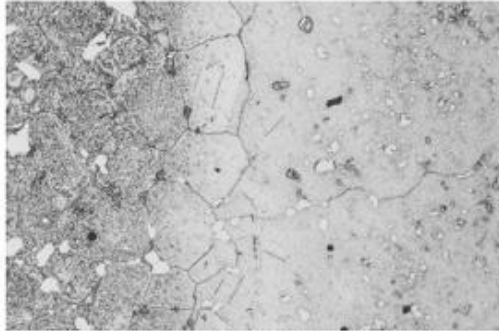
Figure 25 - Micrograph taken through the repaired area showing excellent bonding to the sidewalls of the routed out crack. Mag. 150X

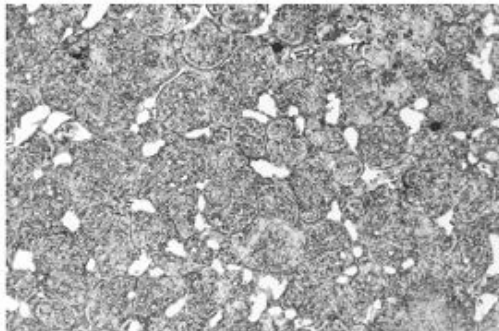
Figure 26 - Microstructure of the LPDB area, showing intergranular intermetallic phases. Mag. 150X

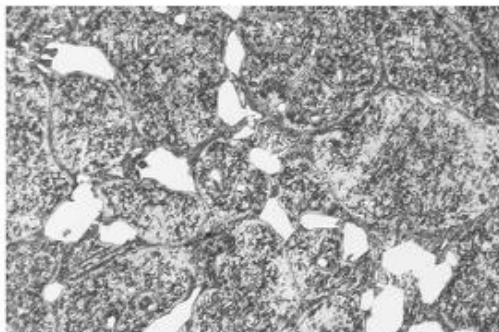
Figure 27 - Intermetallic phases present in the joint. Mag. 400X

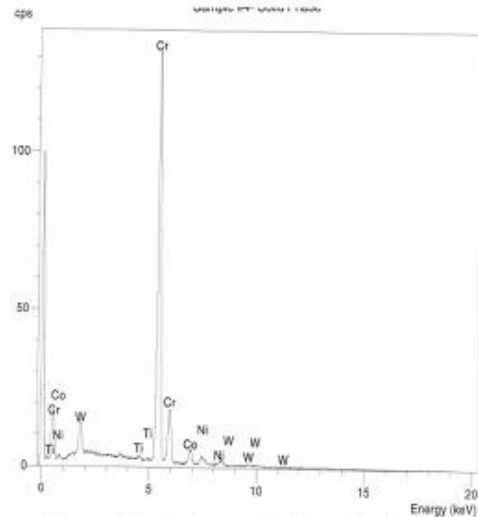
Figure 28 - Semi-quantitative analysis of the intermetallic phases, which are dispersed intergranularly.

Intermetallic phase	Ni	Cr	W	Co	Ti	Al
Intergranular phase	2.7	83.7	8.4	4.7	0.5	0.1

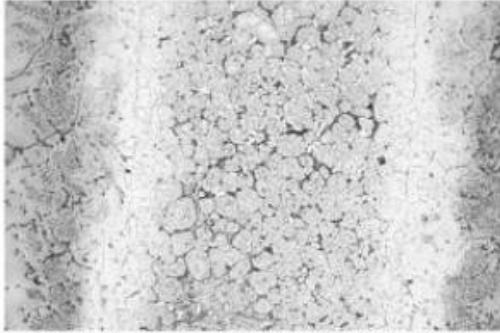
The samples used to produce the mechanical test results shown in Tables 4 and 5, were also analysed. As a reminder a filler metal of 50% IN738 powder and 50%BRB braze was utilised. As seen in Fig. 29 the joint in the stress rupture sample consist of a mixture of fine and coarse grains with a continuous layer of intergranular intermetallic phases. This is in contrast to the discrete isolated and discontinuous intermetallic phases that were present in the joints seen in Figs. 24-27. Figure 30 shows that the traditional type wide gap braze bonded well to the sidewalls of the stress rupture sample and in fact failure did not occur in this region, but through the centre of the joint. Figure 31 shows the continuous intergranular intermetallic phases present in the joint. The bright "blocky and dark grey intermetallic phases can be clearly seen along the grain boundaries. Figure 32 shows these intergranular intermetallic phases more clearly and the phases labeled phase #1 and phase #2 were analysed.

Figure 29 – Micrograph of the joint in the stress rupture sample of a traditional type wide gap joint. Mag. 45X

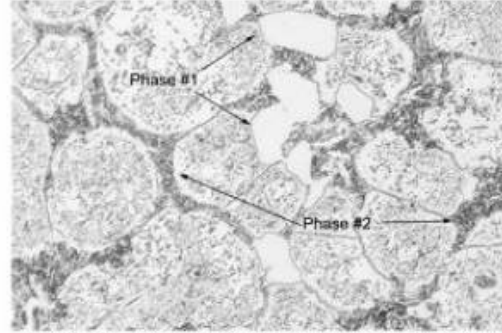
Figure 32 – Intermetallic phases present in the joint. Mag. 400X

Figures 33 and 34 show semi-qualitative analyses of the phases labeled phase #1 and phase #2 in Fig. 32. Table 9 shows the semi-quantitative analyses of the phases labeled phase #1 and phase #2 in Fig. 32. As can be seen in Fig. 33 and Table 9, the “blocky” phases #1 are Cr rich phases; whereas, the phases #2 are Ni rich phases as seen in Fig. 34 and Table 9. Energy dispersive spectrometry was utilised for this work, and hence neither Boron nor Carbon could be detected. Therefore it is difficult to precisely state what phase is present in the joint. Nevertheless, it is probably a boride or carbide phase that formed. Unfortunately there was no thin window on the EDAX to detect Carbon or Boron.

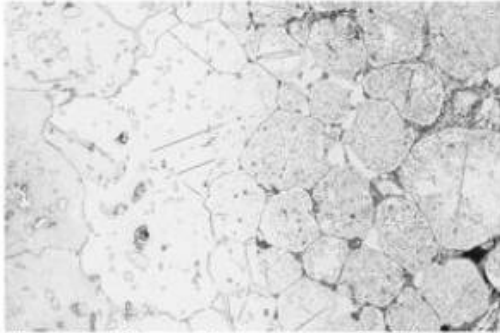
Figure 30 – Micrograph showing good bonding to the sidewalls of the stress rupture sample. Mag. 45X

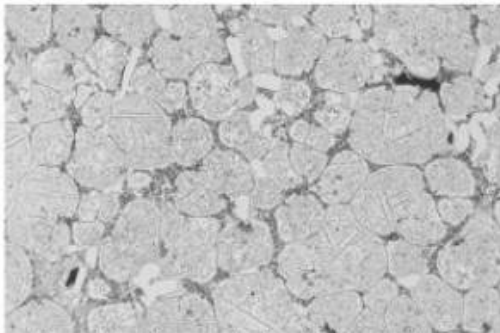
Figure 31 – Micrograph showing the continuous intergranular intermetallic phases present in the joint. Mag. 150X

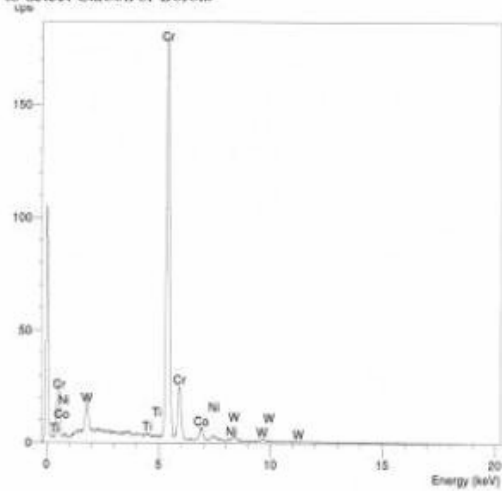
Figure 33 – Semi-qualitative analysis of the phase #1 shown in figure 32.

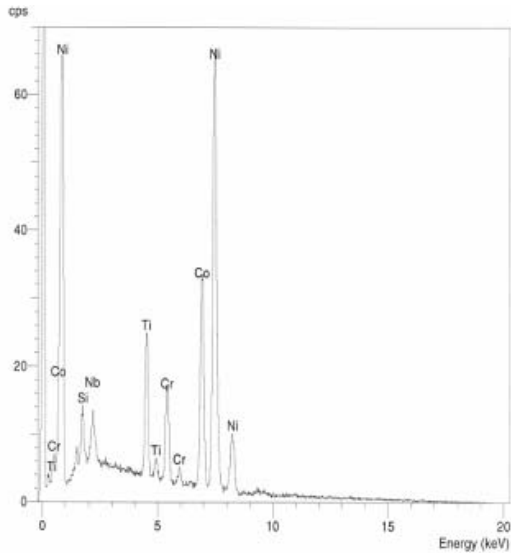
Figure 34 – Semi-qualitative analysis of the phase #2 shown in figure 32.

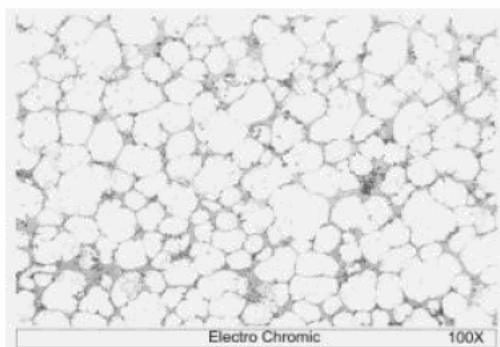
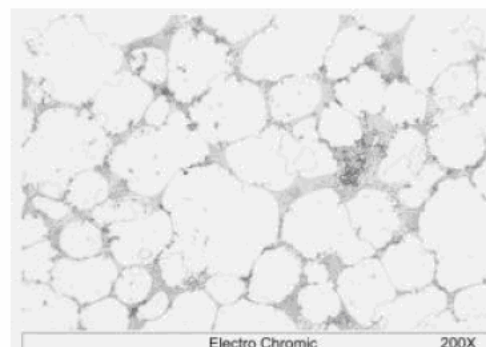
Figures 7 and 8 shows the microstructure of the traditional type wide gap brazed joint on an X-45 base metal. The X-45 powder particles are surrounded with a network of elongated brittle boride phases. This network of brittle boride phases in the wide gap joint, is the predominant reason for the reduction in mechanical properties, including elongation. Figure 9 shows an area in the wide gap brazed joint, along the grain boundary, where 3 phases were analysed. The 3 phases identified were 2, Ta-rich phases (probably Ta-carbide) and a Cr-W rich boride phase as seen in Table 10. (The EDAX system on the SEM could not detect the elements C and B).

Figure 7: Traditional type wide gap joint on an X-45 substrate.

Figure 8: Traditional type wide gap joint on an X-45 substrate.

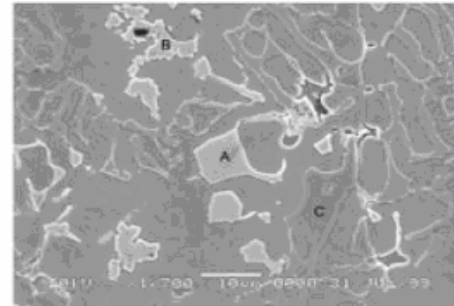
Table 10. Semi-quantitative analysis of the phases present in the traditional type wide gap braze

Figure 9: Location where the phases were identified.

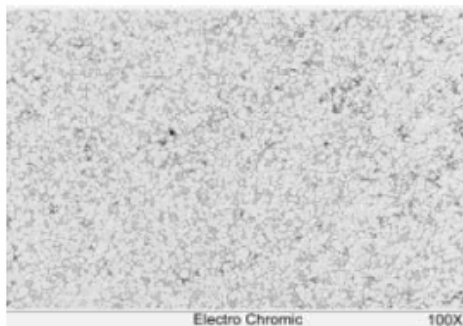
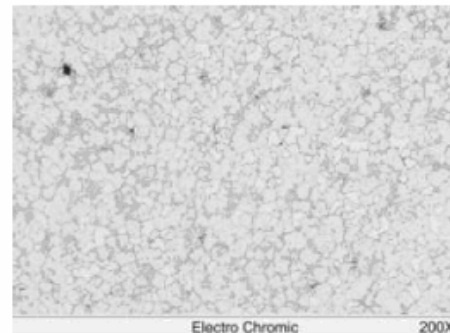
Figures 10 and 11 shows the microstructure of the alternative type wide gap brazed joint on X-45 base metal. The wide gap brazed area is a finer grained structure (as seen in Figures 10 and 11) when comparing with Figures 7 and 8. The boride phases are discrete phases as seen in figure 11, and are not a network of elongated brittle boride phases as compared with those in Figure 8. The absence of the network of brittle boride phases in the wide gap joint, is the predominant reason for the increase in mechanical properties, including elongation. Figure 12 shows an area in the wide gap brazed joint, along the grain boundary, where 2 phases were analysed. The 2 phases identified were probably a W-Cr rich boride phase and a Cr carbide phase as seen in Table 11. (The EDAX system on the SEM could not detect the elements C and B).

Figure 10: Alternative type wide gap joint on an X-45 substrate.

Figure 11: Alternative type wide gap joint on an X-45 substrate.

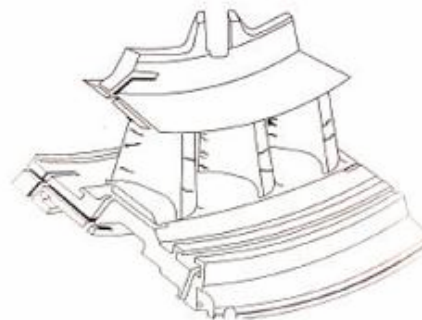
During the industrial turbine engine operation, cracks develop on the vanes as a result of thermal fatigue. Other damage found includes pitting and dents resulting from corrosion/oxidation and FOD (foreign object damage) respectively. Erosion damage is also commonly found on the airfoils. This paper describes the vacuum wide gap diffusion brazing repair process used to repair all of the above-mentioned damage, including braze build up. As a means of qualifying the high temperature diffusion braze process, both metallurgical and mechanical property evaluations were carried out. The metallurgical evaluation consisted of optical and scanning electron microscopy. The wide gap diffusion brazed area consisted of a fine-grained structure with carbide and intermetallic phases dispersed both intergranularly and intragranularly. The mechanical evaluations undertaken were tensile tests, stress rupture tests and low and high cycle fatigue tests. These results were equivalent to mechanical properties of the IN738, IN939, and Rene 80 Ni-based superalloys, which are the base metals that many of the vanes are cast from.

Figure 2 – Typical view from the concave side, showing leading edge, trailing edge and shroud/buttress cracking on the Alstom Tornado 2nd stage stator segment.

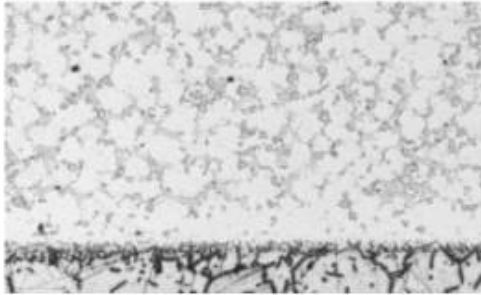
Figure 8 shows the excellent bonding/ adhesion to the IN738 vane material. A fine-grained microstructure is evident. Some minor microporosity can be seen in the micrograph, but this microporosity level is acceptable. Figure 9 shows the fine grained structure of the alternative type wide gap brazed joint, with intermetallic phases dispersed intergranularly.

Figure 8 – Micrograph taken through the repaired area showing excellent bonding to the vanematerial. Mag. 75X

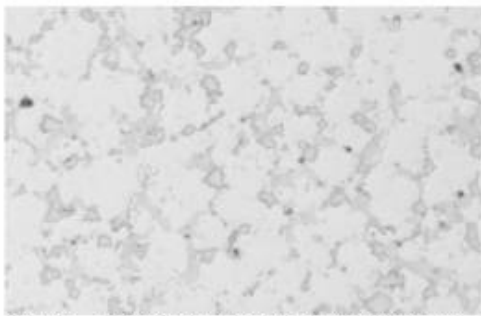
Figure 9 – Fine grained microstructure of the alternative wide gap brazed joint with intermetallic phases dispersed intergranularly. Mag. 150X

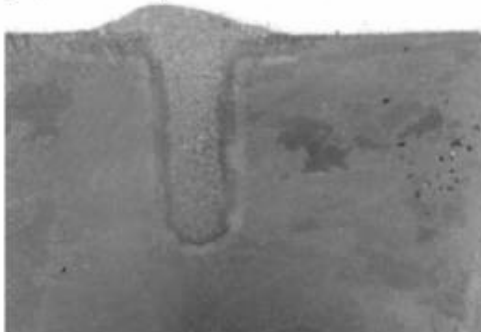
Figure 10 shows the macrograph of a cross section taken through the alternative wide gap braze repair of the IN939, Tornado 2nd stage stator segment. As can be seen the filler metal has flowed completely down to the bottom of the crack and has bonded excellently to the sidewalls of the routed out crack. Also the microporosity is less in the joint, when compared to that of the base metal.

Figure 10 – Macrograph of the joint taken through the alternative wide gap braze repair of the Tornado, 2nd stage stator segment. Mag. 5X

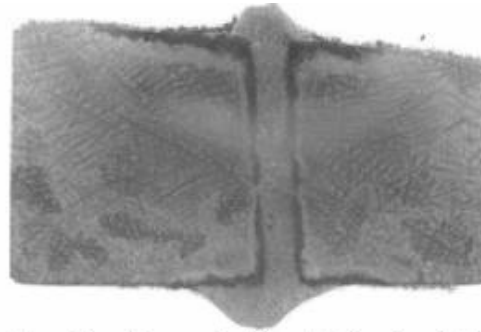
Figure 11 shows a cross section taken through a “through” crack at the trailing edge of the airfoil. Once again there is good bonding to the sidewalls of the routed out crack.

Figure 11 – Macrograph of the joint taken through the alternative wide gap braze repaired area of the Tornado, 2nd stage stator segment. Mag. 5X

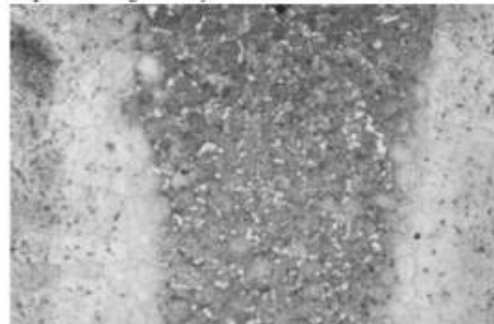
Figure 12 shows the micrograph of the repaired area. It consists of a fine-grained structure and there is good bonding/adhesion to the sidewalls. Figure 13 shows the joint to consist of equiaxed grains with intermetallic phases dispersed intergranularly.

Figure 12 - Micrograph taken through the repaired area showing a fine-grained microstructure. Mag. 45X

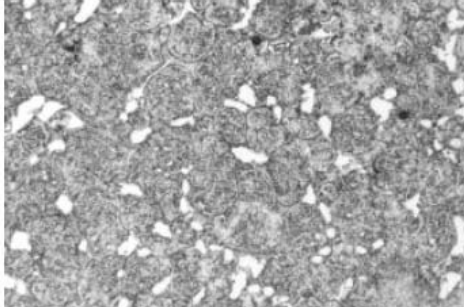
Figure 13 - Microstructure of the alternative type wide gap brazed joint, showing intergranular intermetallic phases. Mag. 150X

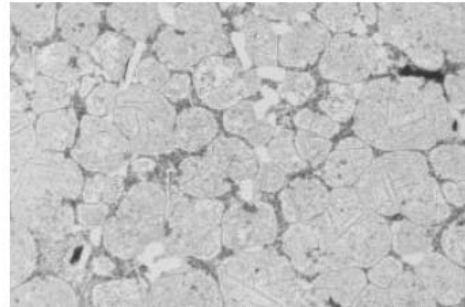
The traditional wide gap brazed samples used to produce the mechanical test results shown in Tables 5 and 6, were also analysed. As a reminder a filler metal of 50% IN738 powder and 50%BRB braze was utilised. As seen in fig 14 the joint in the stress rupture sample consist of a mixture of fine and coarse grains with a continuous layer of intergranular intermetallic phases. This is in contrast to the discrete isolated and discontinuous intermetallic phases that were present in the joints seen in fig's 12-13. Figure 15 shows the continuous intergranular intermetallic phases present in the joint. The bright “blocky and dark grey intermetallic phases can be clearly seen along the grain boundaries.

Figure 15 - Micrograph showing the continuous, brittle intergranular intermetallic phases present in the traditional type wide gap brazed joints. Mag. 150X

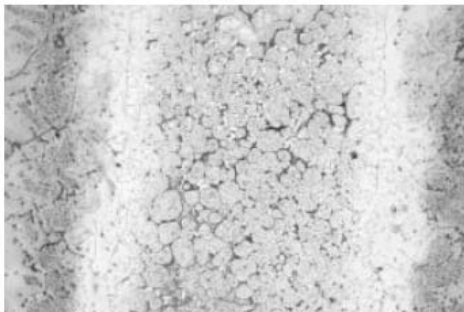
Figure 14 - Macrograph of the traditional type wide gap brazed joint taken from a stress rupture sample. Mag. 45X
