A STUDY OF THE PEDESTRIAN PUBLIC WAYS IN SÃO PAULO CITY CENTRE, BRASIL, FOCUSING ON WHEELCHAIR USERS

S H T VIZIOLI, G C BRUNA¹ and P T PERES²

KEYWORDS: Post-Occupancy Evaluation; accessibility; wheelchair; downtown São Paulo

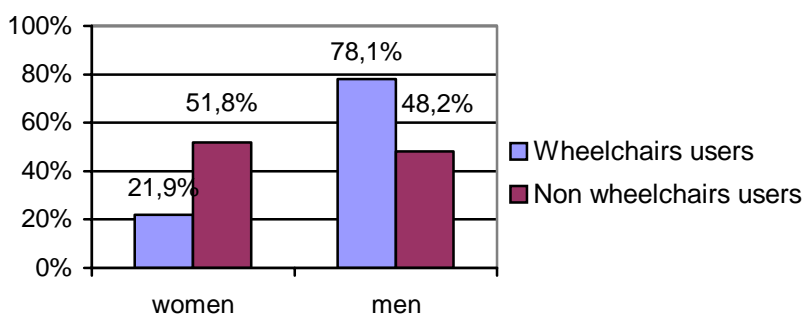
Figure 7: Wheelchair users' gender profile

The results of the questionnaires reveal that in the group of wheelchair users, only 21,9% were women, while of the non-wheelchair users, 51,8% were women. Comparing this information with the 2000 Census, where there is no significant difference between disability in females and males, it was found that in downtown São Paulo, a difference does exist, i.e. for various reasons, very few woman wheelchair users go to downtown São Paulo as shown in Figure 7.

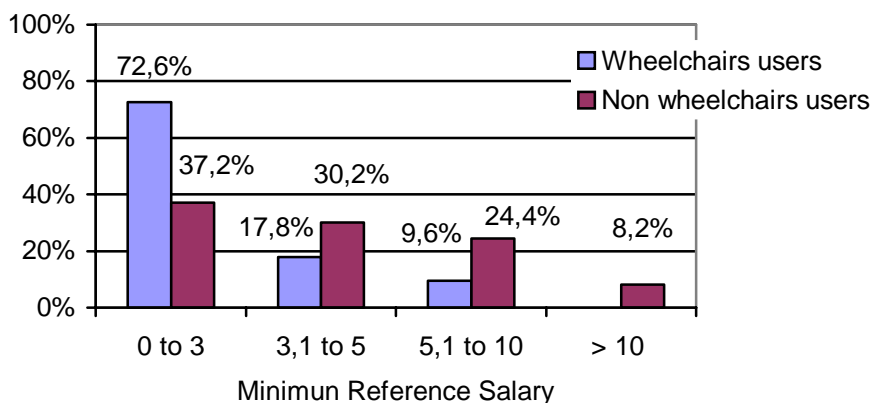
Figure 8: Family income per month

According to the verified profile, the wheelchair users who utilise downtown São Paulo belong to a lower socio-economic category than the non-wheelchair users who were interviewed (Figure 8). The numbers shown in Figures 7 and 8 prove that the circulation spaces of the study area cannot be included in the concept of universal design: women wheelchair users do not risk going to the downtown area and the wheelchair users group with a family income above 3 on the minimum national salaries scale is small, that is, they do not use the sidewalks of downtown São Paulo. The answers showed a combination of factors, but it can be stated that there are certain groups that do not use the downtown circulation spaces.

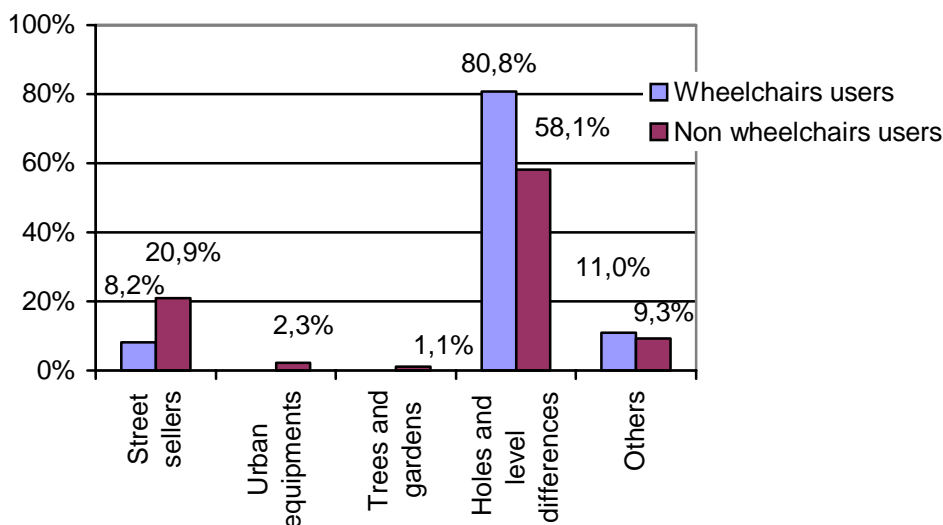
Figure 9: Main obstacles on the sidewalks

The questionnaire results showed that both the wheelchair and non-wheelchair users considered that the holes and level differences were the main obstacles in the circulation space (Figure 9). It was assumed that the wheelchair users would regard as obstacles on the sidewalks the street furniture or the stands of the street vendors due to the small free space available for wheelchairs. However, the numbers show that other details, e.g surface maintenance (loose slabs, holes, drain grills) are more important factors for pedestrians, whether wheelchair users or not. The results of the users' satisfaction regarding the number of kerb ramps in downtown São Paulo for both groups were not entirely negative.

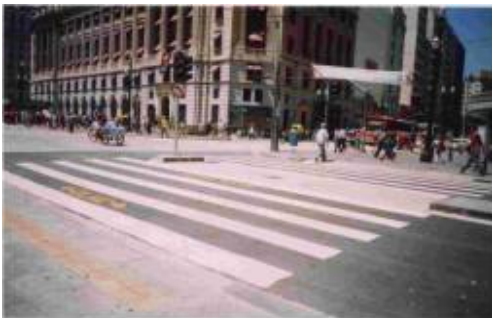
In 2004 in São Paulo, there were many works of "revitalisation" of urban spaces, among them the Municipal Theatre which had the pavement re-built. Many kerb ramps were also built in a broad extension of the area, as shown in Figure 12. Another case was the alteration of the surface of the sidewalks and the installation of pre-molded kerb ramps in João Cachoeira Street carried out by a partnership between private and public enterprises (Municipal City Hall, the Brazilian Association of Portland Cement and the merchants of the neighborhood). These actions should be followed by the other administrative areas as well as by architects and professional engineers.

Figure 12: Crosswalk at the same level of the road in front of the Municipal Theatre.
Photo: SHTV/2005

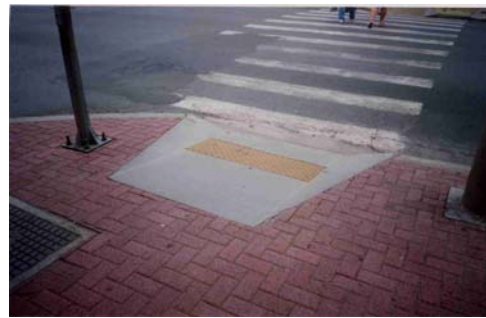
Figure 13: João Cachoeira Street. Pilot project with pre-molded kerb ramps.
Picture: SHTV/2005
