# A CONTRACTOR'S PERSPECTIVE ON BITUMEN RUBBER ASPHALT MANUFACTURE AND PLACEMENT

Herman I J Marais

Technical Director, Much Asphalt (PTY) LTD, Main Reef rd (R29), Benoni, 1500,  
South Africa. [herman.marais@murrob.com](mailto:herman.marais@murrob.com)

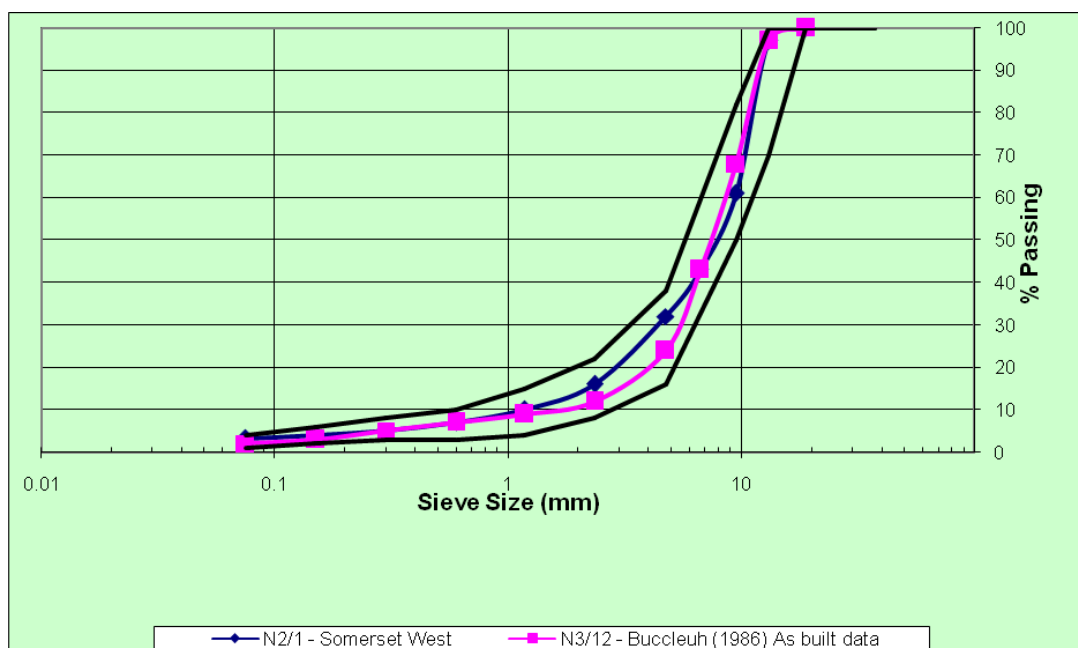
**FIGURE 1** Gradings of early BRASO mixes

The first BRASO was done in 1984 and the initial mix was placed as a trial on a severely distressed pavement as a holding action on the old N3 – Potgieter et al (1998). Due to the success of the BRASO it was then later specified on two major SANRAL projects which were done in 1986 with the one project in Gauteng on the N3/12 in Johannesburg on a very busy interchange. This asphalt performed very well and was partially milled and then overlaid in 2003 – again with a BRASO. The other project was in the Western Cape on the N2 -1 – Swartklip to Somerset West where it was used as an overlay of a distressed concrete pavement. This asphalt surfacing is still intact after 25 years of service. This is after early indications were that this layer was failing due to stripping of the binder from the aggregate in the middle third of the asphalt layer. The stripping was attributed to high viscosities of the bitumen rubber binder (above 50 dPas) at the time of mixing – Lourens et al (1989). The asphalt was however left in place and no deformation or failures were noticed. It was due to the success of these two BRA projects that BRASO was again specified on various projects in Gauteng and later in the Western Cape. Both the BRASO mixes had binder contents in the region of 8.0% and average Marshall void contents were 6.6% for the Gauteng project and 6.1% for the Western Cape project.

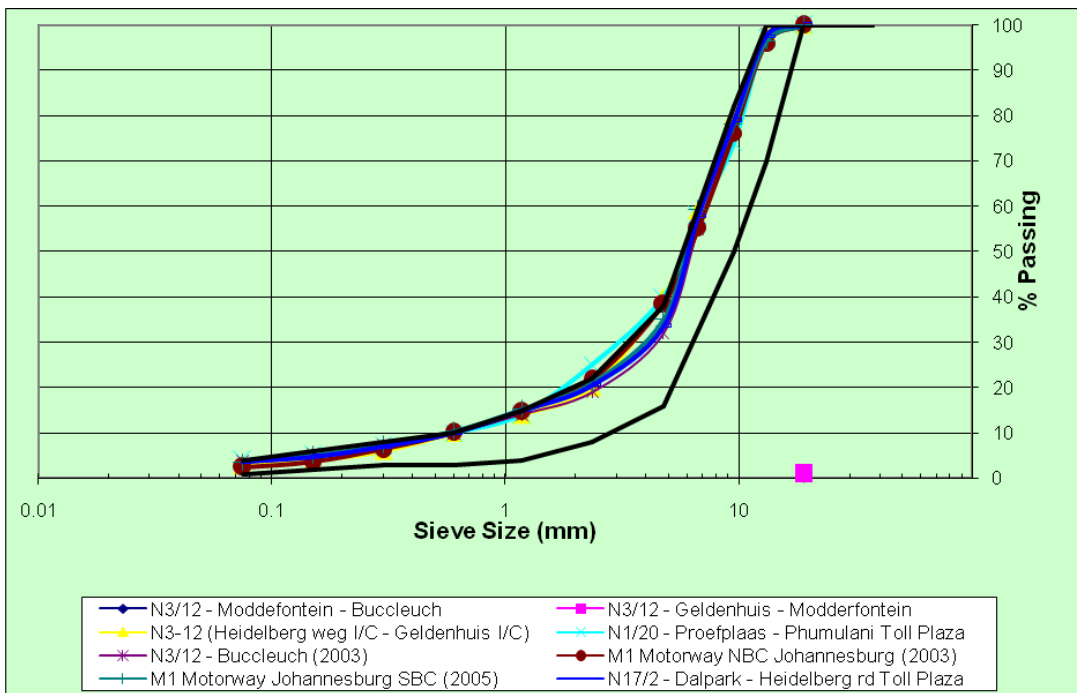
**FIGURE 2 BRASO Gradings 1998 – 2005**

The BRASO that was constructed in this time period had very similar grading curves as well as binder contents as can be seen in Figure 2, with binder contents ranging from 7.3% – 7.5%. This is in contrast with the first two major BRASO projects where their gradings were coarser and the binder content was in the region of 8.0%. The grading curves are consistently finer than the original two BRASO projects and are close to the upper envelope of the COLTO grading specification. The Marshall void contents were in general also lower and ranged from 4.1% to 5.2% with one project having an average void content of 6.6%, as shown in Table 1.

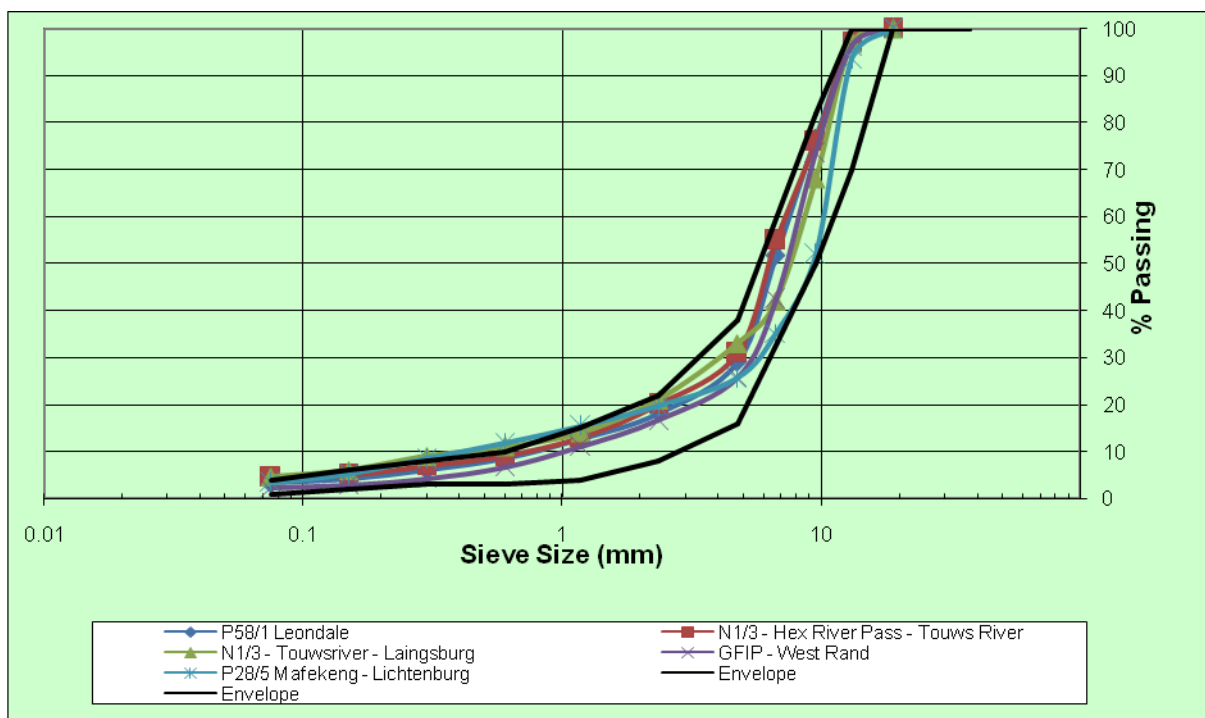
**FIGURE 3 BRASO gradings 2005 – 2010**

Although the gradings of the first two projects constructed in this time period were similar to all the BRASO mixes paved in the previous time period the rest of the mixes were coarser and closer to the middle of the envelope. The BRASO of the GFIP projects on the West Rand was purposely made coarser in order to simulate the first BRASO that was done in the Western Cape as it was also paved on a concrete pavement. The binder contents of the BRASO mixes ranged from 7.1% to 7.8% but last mentioned binder

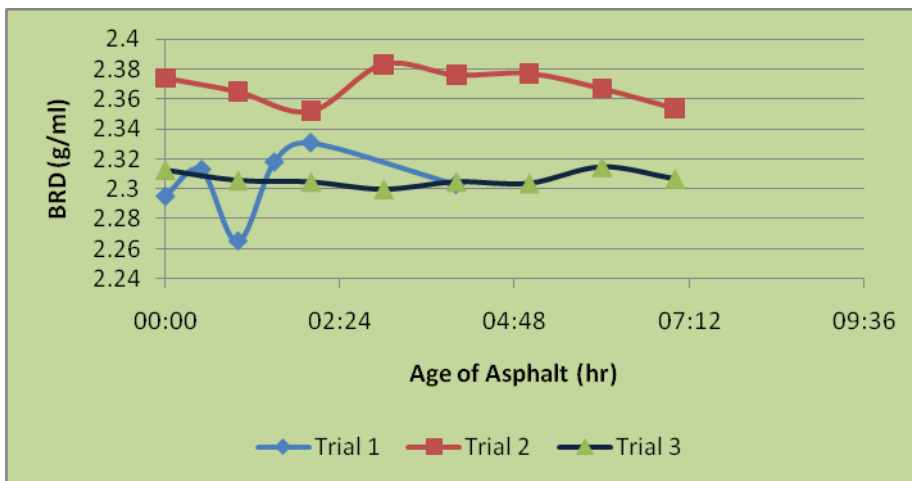
**FIGURE 4: Effect of Age of Asphalt on Marshall BRD**

The influence of time on the viscosity of bitumen rubber binder during which it is kept at elevated temperatures is well documented, and one would expect the BRASO to compact easier at the same temperature as the viscosity of the binder reduces over time. In an effort to determine the influence of time, various time trials have been done on different BRASO mixes. The asphalt was kept on a delivery truck to simulate what would happen on a construction site where the asphalt was kept at elevated temperatures for extended periods of time. Samples were taken at different time intervals and the volumetric properties determined by compacting Marshall briquettes. The compaction temperature was kept the same for all the samples and the Bulk Relative Density was performed on the briquettes. The BRD test results were inconclusive and it could not be proven that the BRD increase over time as would be expected, and this could be an indication that the Marshall volumetric properties are not giving a true reflection of compactibility of the BRASO. (Refer to Figure 4). It should however be noted that these trials were performed on BRASO of which the binder was manufactured using 1 – 2% of extender oil and 19% - 20% of rubber crumbs as is predominately the case in South Africa.
