A CASE STUDY OF PERMEABILITY DETERMINATION AT LONGITUDINAL JOINTS ON AN AIRPORT ASPHALT PAVEMENT

E HORAK¹, WJvdM STEYN² and ABM HORAK³

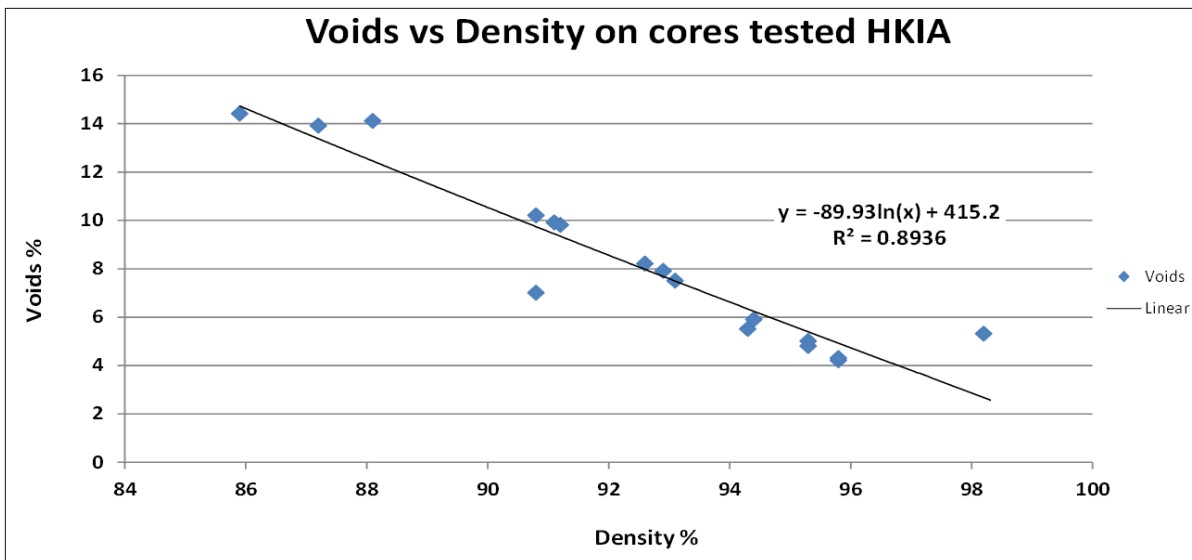
Figure 4. Correlation between voids in the mix and density determined from cores.

Figure 4 shows that voids in the mix versus density obtained from cores have a good correlation with R^2 , or coefficient of determination, of 0.89 for the data set. The high R^2 value indicates that there is a very good linear correlation between the voids and the density. This conclusion is logical as lower density is mostly due to higher voids in the mix.

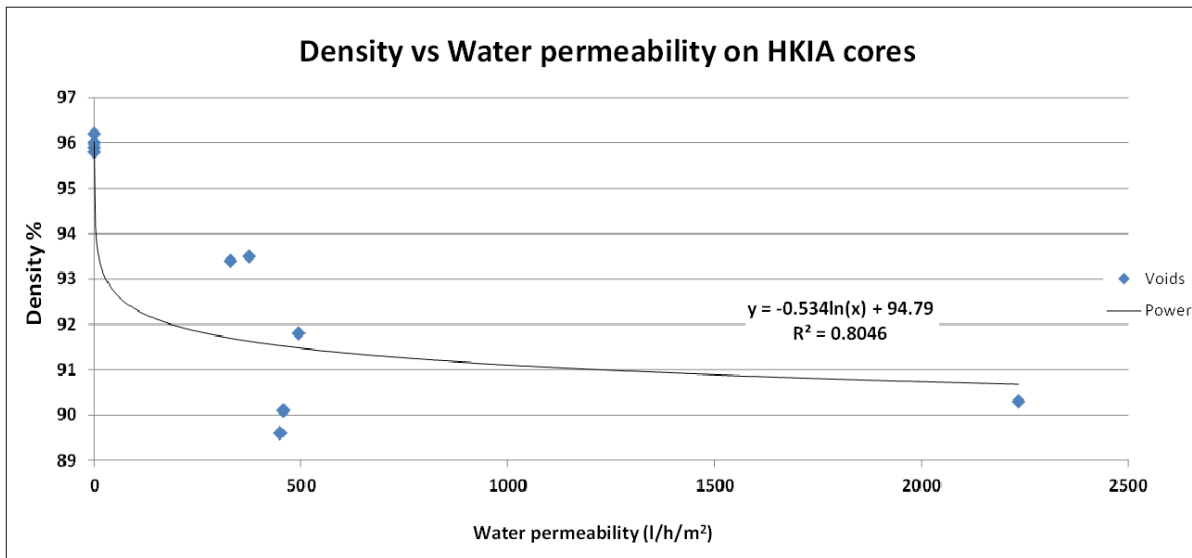
Figure 5. Correlation of Density versus water permeability.

The scatter diagram for density versus water permeability is shown in Figure 5 for the data set available. The logarithmic function fit to the data set has a R^2 value of 0.8, which is high and indicate that the correlation has a high confidence value. The interpretation is that as soon as the density drops below 93% the permeability increases significantly and below 92% it accelerates to even higher permeability values. This conclusion is also as expected and in line with correlations and conclusions drawn from previous work (4).

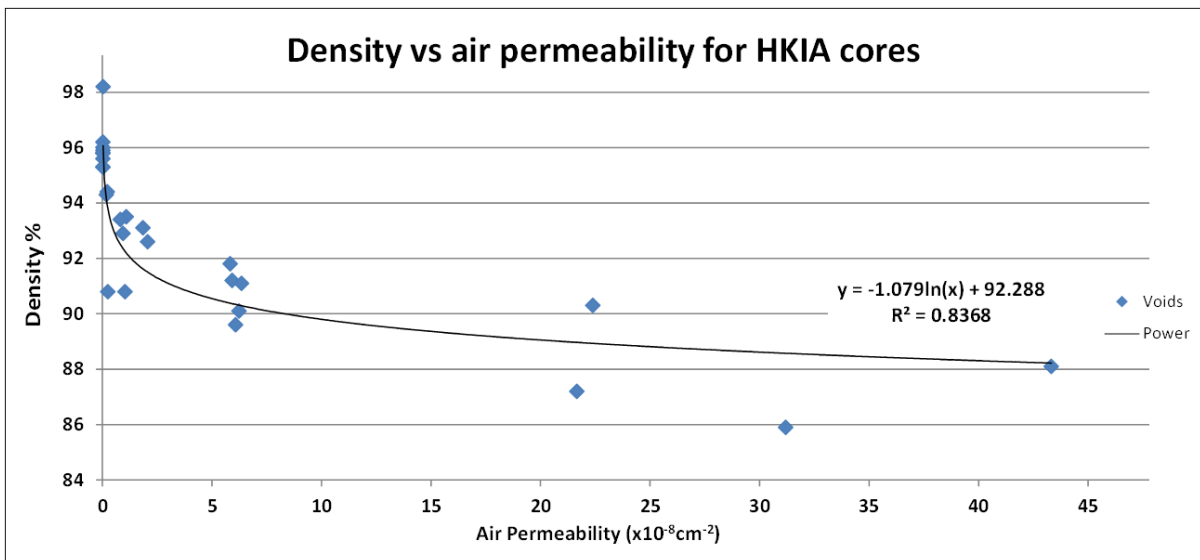
Figure 6. Correlation between air permeability and density

The air permeability versus density on Figure 6 shows a similar good correlation with a logarithmic function fitted with a R^2 value is 0.84. This fit is even better than that determined for the water permeability.

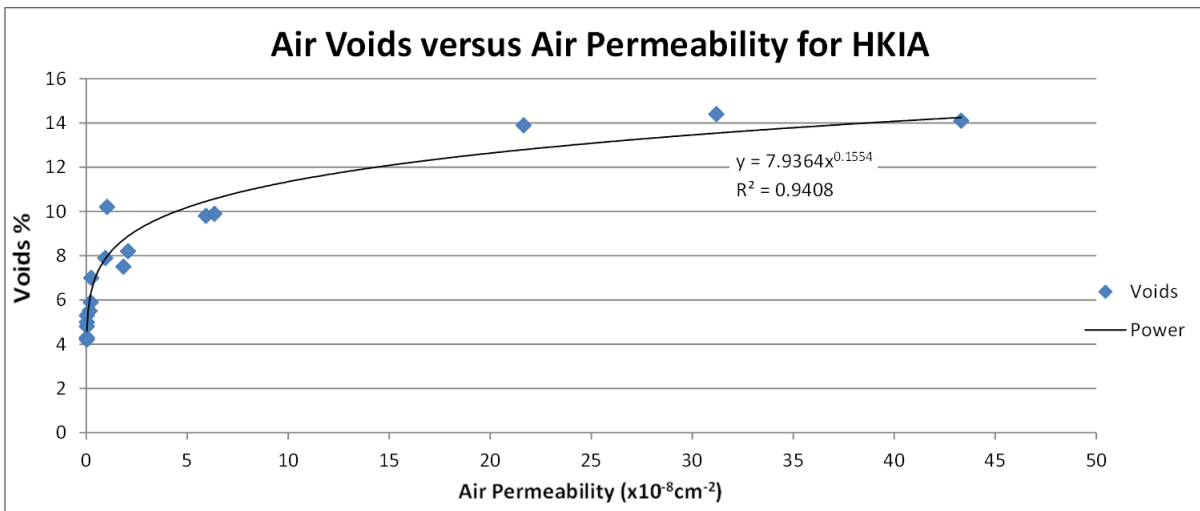
Figure 7. Correlation between air permeability and air voids

Literature elsewhere shows that if air voids increase above the threshold value of 7% that permeability will increase significantly. (4, 15). In Figure 7, this threshold value is confirmed with air permeability values and shows an exponential increase in air permeability beyond 8% voids. This correlation between air voids and air permeability has a very good R² value of 0.94.
