access audit

an empirical study on accessibility of existing buildings

3.6 Audit: Alkantrant Library and Multipurpose Hall, Lynnwood, Pretoria

3.7 Audit: Constitutional Court Law Library of South Africa, Constitution Hill, Johannesburg

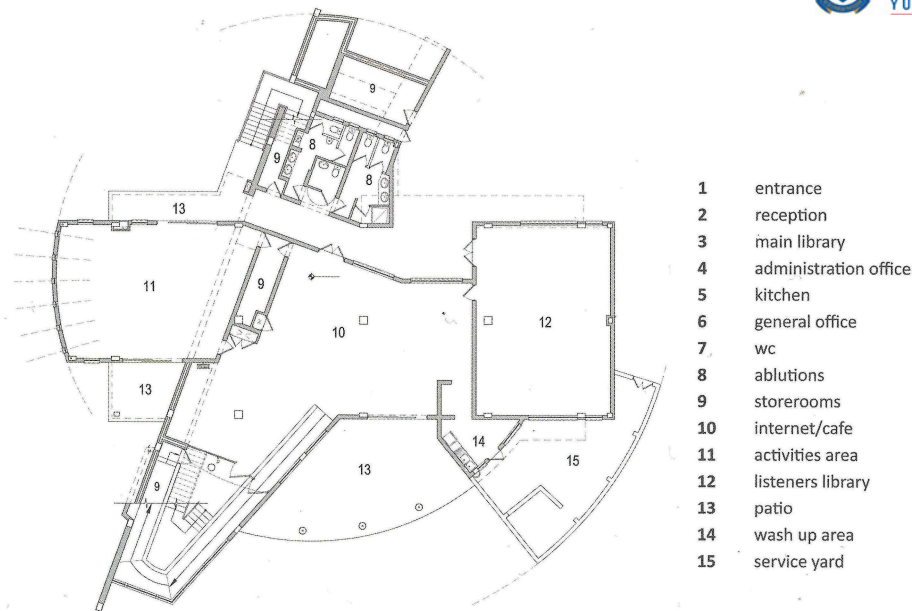
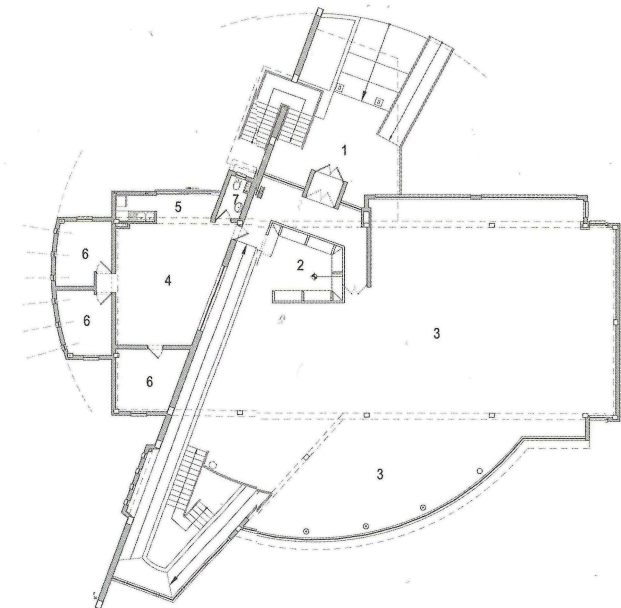
illus. 3.1. Floor plans of the Alkantrant Library and multipurpose hall (not to scale)

The Alkantrant Library has a ramp that does not conform to inclusive design guidelines. The ramp does not have a handrail on either side and the landing and ramp length and surface finish is problematic. The library's accessible toilet is located on the lower level and this can only be reached by an extended route. No family room is available. The lighting on the main level is adequate and does not have excessive glare.

The Listener's Library contributes to access to information for visitors with visual impairments. The entrance door and counter and adjacent circulation widths do not allow for wheelchair circulation. The library staff is willing and able to assist persons with disabilities. The entrance thresholds do not present any tripping hazards. On the lower level the lighting level and quality is problematic.

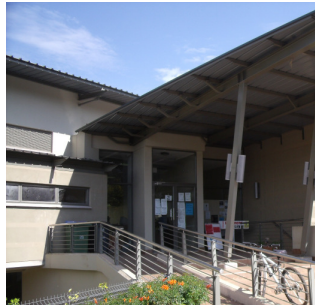
illus. 3.3b Alkantrant Library Ramp 1, stair 1

Ramps 2 and 3 do not have handrails on either side. The suggested norm is a handrail on both sides. This presents a challenge for the elderly, the visually impaired and wheelchair users alike seeing as the Listeners Library is located downstairs. Ramp 1 has adequate handrails and balustrades. Stair 1 has good handrail placement and stairs are in nonslip tiles. Stair 3 has an interrupted handrail and sharp corner detail. Stair 2 is only three steps and does not present any challenges. See Illus. 3.2.

Ramps 1, 2 and 3 have a gradient of 1:12 which is the minimum requirement by law. Ramp 3 is a very long distance and rises 1600mm which then needs a landing. At the top end of ramp 3 an opening with a door is in immediate proximity of the end of this ramp. By law and suggested practice it must be placed at least 1200mm away from the end of the ramp. See Illus. 3.2.

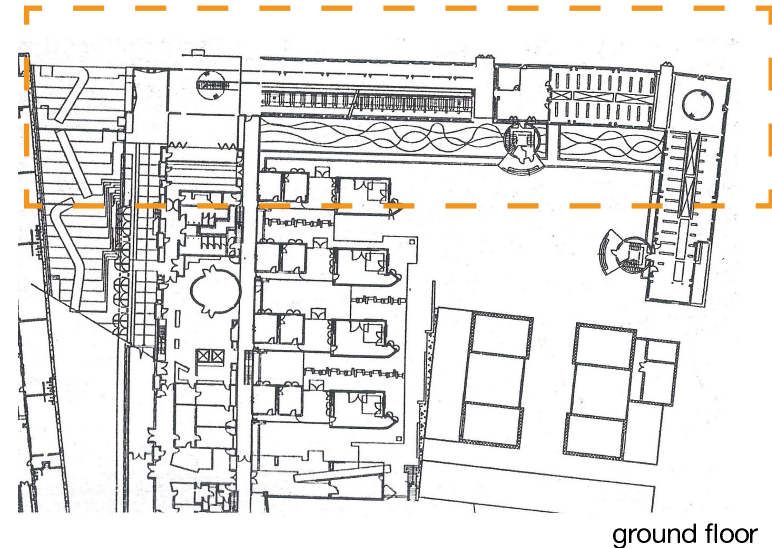
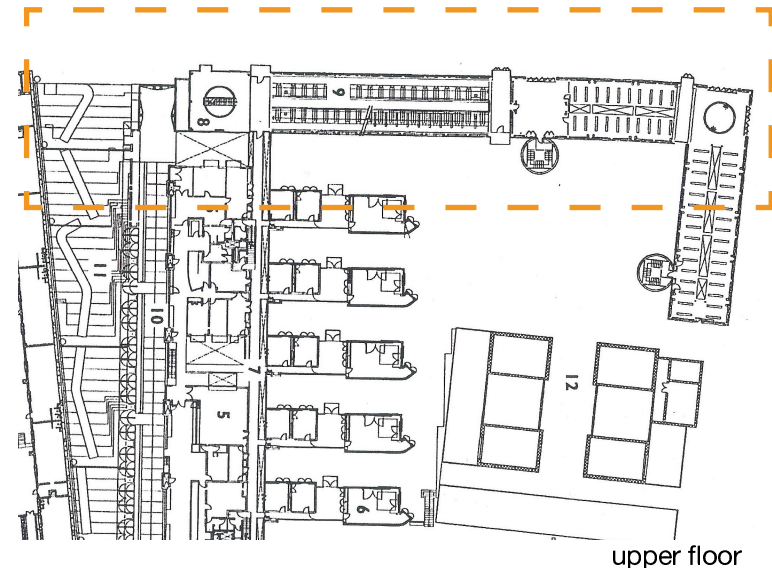
illus. 3.6 Floor plans of the Constitutional Court with Law Library indicated (not to scale)

The library can be seen as a wing of the main building and it forms a long narrow structure on the opposite side of the court chambers. See illustration. 3.6. The library houses 40 000 volumes at its present state, and the design allows for the collection to expand to 400 000 volumes (Constitutional Court, 2011). It also houses access to Internet and electronic resources, especially of international origin (ibid.). The public reading room is one of the main gathering spaces in the library and is (with prior arrangement) open to the public.
