CHAPTER 5

RETRIEVAL STUDY

5.1 Introduction

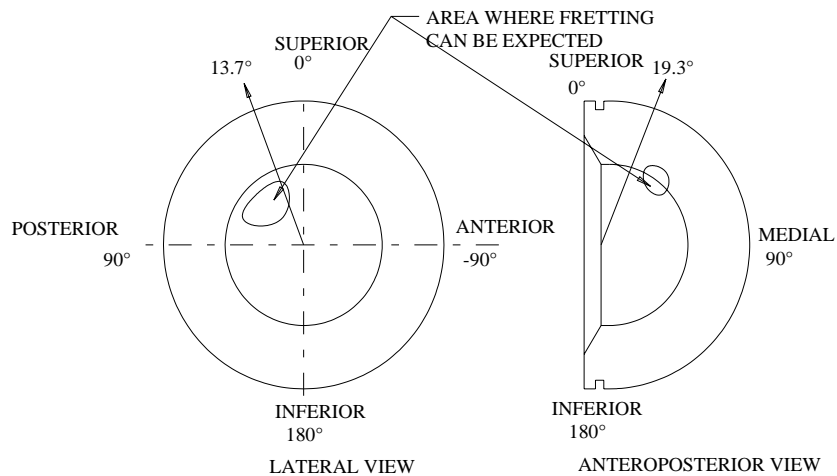
Another defect became clear when the acetabular cups were treated with the dye penetrant spray, namely areas of adhesion wear that had taken place. An acetabular cup with these areas clearly visible is shown in Figure 5.16 with a schematic layout of the positioning of this adhesion wear shown in Figure 5.17. This defect is also investigated further making use of the stereoscope as well as the electron microscope.

Figure 5.17: Schematic layout to indicate position of adhesion wear mark

At the position indicated in Figure 5.17, the contact stress of an implant is the highest. Adhesion wear is most likely to occur at this point where there is a combination of the different actions. The extension and flexion movement of the leg under load will force the lubricant from the bearing surface, while the abduction/adduction rotation and flexion movements of the leg will provide the energy input to cause adhesion wear or extrusion of material.

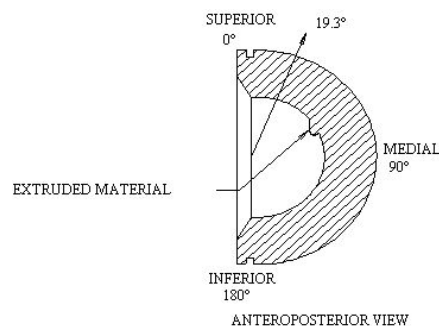
The indication is that material was extruded from the bearing surface. Some brown discolouring/deposit (indicated by arrow) can be seen in the grooves where material flowed over it. The schematic layout in Figure 5.27b shows a cross section of the described surface phenomenon.

Figure 5.27b: Schematic of material extruded from the bearing surface

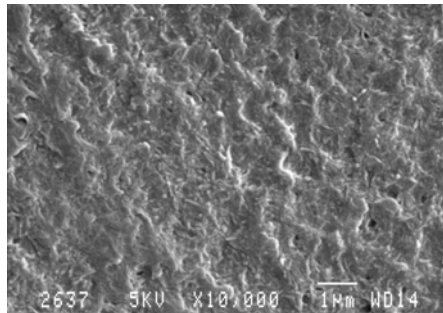
Figure 5.32: Electron microscope image of virgin UHMWPE sample (magnification x 10 000)

If the images in Figures 5.32 and 5.33 are compared, no difference can be seen between the virgin and deformed material, even under a magnification of 10000. The structure of the brown discolouring is totally different from that of the virgin or deformed UHMWPE and therefore the composition of the brown layer will have to be determined. (See paragraph 5.6.) The rest of the photographs for the electron microscope investigation into the brown discolouring can be seen in Annexure C and the photographs investigating the structure of UHMWPE can be seen in Annexure D.

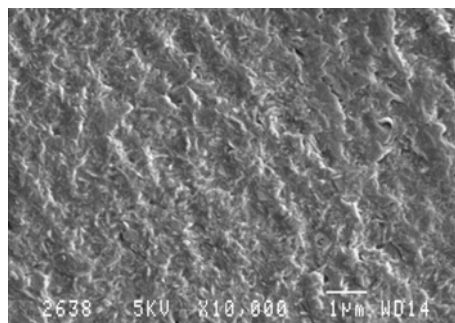
Figure 5.33: An electron microscope image of deformed UHMWPE (magnification x 10 000)

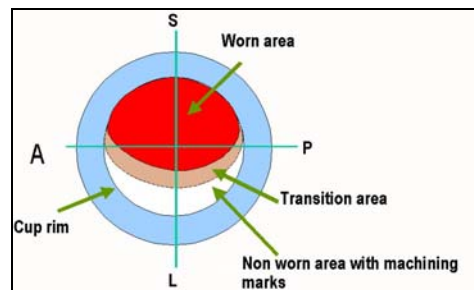
To allow for smooth operation from the first day after implantation, the acetabular component is manufactured to allow for a maximum clearance of 0.5 mm on the diameter of the femoral ball. The allowance for the fit together with the angle at which the load is transferred into the joint results in an off-centre wear pattern as shown in Figure 5.34.

Figure 5.34: Anatomical cup orientation with position of worn area

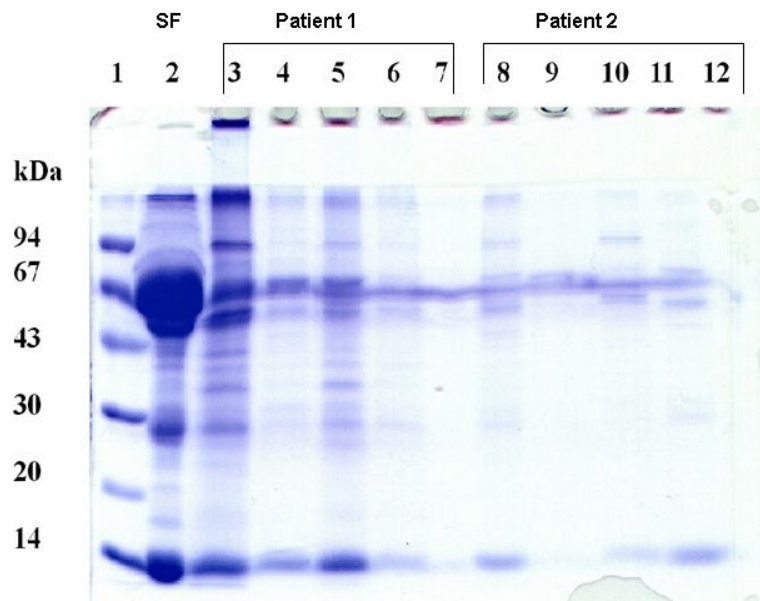
A sample of the results obtained for samples from the different acetabular cups, can be seen in Figure 5.48. Column 1 defines the markers to indicate the molar mass of the proteins. Column 2 is the analysis of a sample of synovial fluid retrieved from a patient. From the analysis of the fluid, it can be seen that there is a concentration of protein at 67 kDa as well as at 30 and 14 kDa. From literature (<http://www.ehime-u.ac.jp/~manabet/act01eng.htm>; Rybicki & Purves, 1996), it is found that the protein with a mass of 67 kDa is human serum albumen (HSA). Columns 3 to 6 give the results of the samples taken from a cup retrieved from a 72-year-old male patient eight years after implantation. This prosthesis was fitted with a 28 mm zirconium femoral head. Column 7 is a separator. Columns 8 to 12 represent the results obtained for a cup retrieved from a 42-year-old male

patient 4 years after implantation. This prosthesis was fitted with a 32 mm alumina head. From the results in Figure 5.48, it is clear that in both cases there is a presence of HSA, although the presence is not as marked as in the synovial fluid. A possible explanation for this is that the mechanism of lubrication in the cup is boundary lubrication and therefore the deposits detected were accumulated over a period of time.

Figure 5.48: Electrophoresis analysis of synovial fluid and retrieved proteins from acetabular cups

The rest of the results can be found in Annexure F. The results indicate that proteins were deposited on the inside of the cups. Owing to deposited proteins, the coefficient of friction between the femoral head and the acetabular cup will probably increase, depending the percentage deposited proteins, resulting in more heat being released. Existing research has found that deposited proteins alone do not provide sufficient lubrication (Wang et al., 1998). These deposited proteins could possibly cause third body wear.

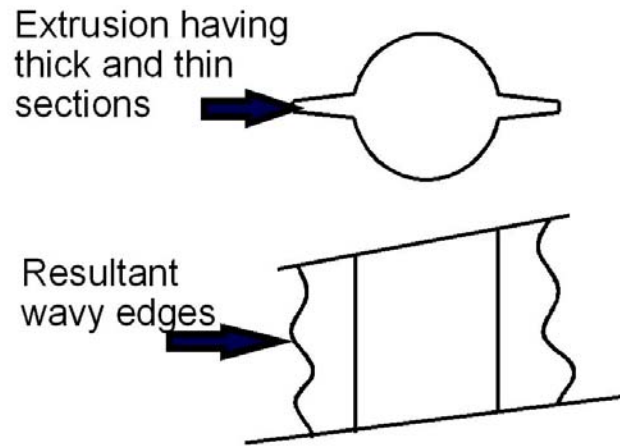
The formation of the wavy edges can be compared to defects found in the extrusion of aluminium. (See Figure 5.50.) The temperature of the thinner material drops at a faster rate than the temperature of the material in the middle. When the material in the middle shrinks during the cooling-off process, the thinner material on the outside that has already cooled off is put under compression causing wavy edges.

Figure 5.50: Schematic explanation of formation of jagged/wavy edges during extrusion
