THE EFFECT OF DISCONTINUITIES ON THE ERODIBILITY OF
ROCK IN UNLINED SPILLWAYS OF DAMS

MSc

Sofia Pitsiou

December 1990

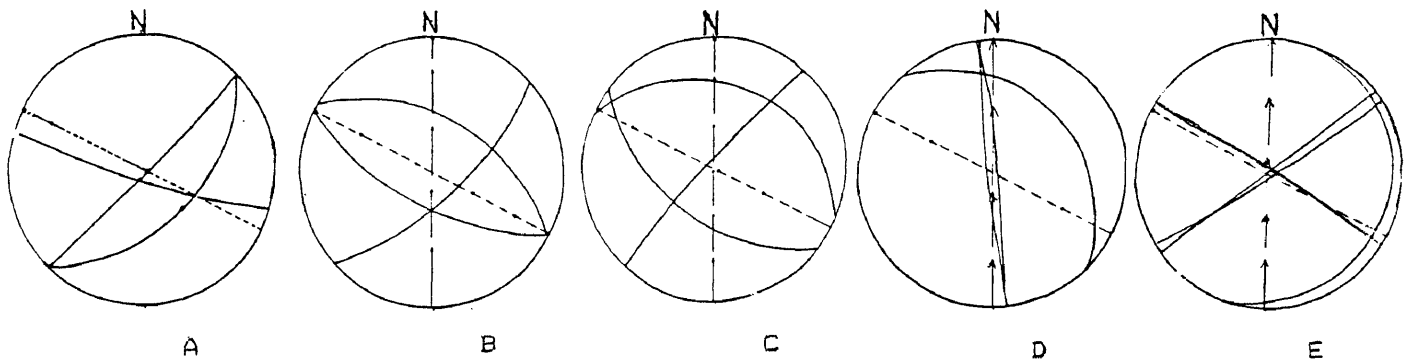
Fig.6.6 Stereographic projection of the discontinuity planes (—), the water flow direction (— →) and the deep scoured gorge (- - -).

From Fig.6.6, it can be seen that joints, striking NW-SE and resulting from down-drag along the fault occur. There are joint sets striking parallel to the direction of the fault and obliquely to the direction of the water flow. Two sets occur close to the fault zone, one striking parallel with the water flow direction and the other, a sub-horizontal joint with almost similar strike. Sliding because of water pressure must have taken place along lines of intersection between beds, dipping almost parallel to the water flow, and the joints striking almost parallel to the water flow direction. Joints caused during folding and/or faulting, occur on the right side of the channel as well. The open bedding planes caused the damage when the water flow washed out the infilling material of weathered sandstone, reducing cohesion and forming loose rock blocks due to the presence of the vertical joints (Plate 10). It was indicated by Maeyens (1976) during research before the completion of the dam that the presence of subvertical joints with cohesion near zero and faults was causing instability problems at the quarry site which was to be the future spillway channel.

The faulting, presence of open, closely spaced joint sets and the long period of water flowing along vertical and sub-horizontal discontinuities, are some of the factors which gave rise to the erosion process. Faults in the channel introduce non-uniform conditions, causing concentrated movement of the water mass flowing along the channel and differential behaviour of the rock mass. Further erosion can eventually result in damage to the downstream side of the dam and the outlet work, as water is channelled along the eroded trench against the left wall of the spillway during overflow conditions. The rock on this flank is susceptible to further erosion and eventual breakthrough. Backfill downstream of the spillway wall has also been eroded, leaving foundation rock exposed. For remediation purposes, a number of concrete walls constructed across the eroded gorge (founding on solid rock) and backfilling of the compartments with the largest possible rock blocks, grouting of the voids with cement and protection of the immediate downstream area against undercutting, were proposed by Barnard (1986).

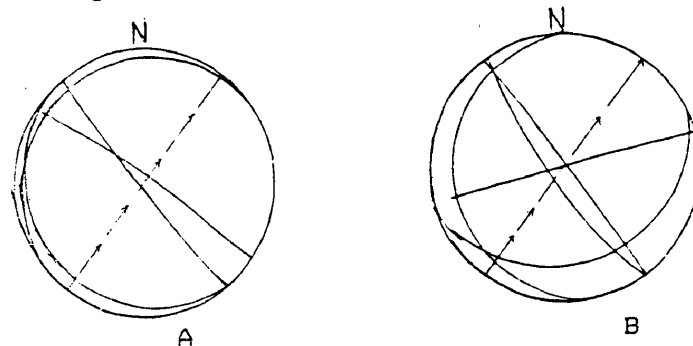
In the rock mass, five joint sets can be observed, some parallel and others perpendicular to the water flow direction, forming cubic rock blocks of different size. The joints are open and the joint surfaces are slightly rough and undulating. Wherever joint filling occurs, it is soft silty material. It is usually the vertically dipping joints that are open. Most of the joints, as well as their lines of intersection, dip against the water flow direction, reflecting the water backwards (Fig.6.9).

Fig.6.9 Stereographic projection of the discontinuity planes (—) and the water flow direction (— —).

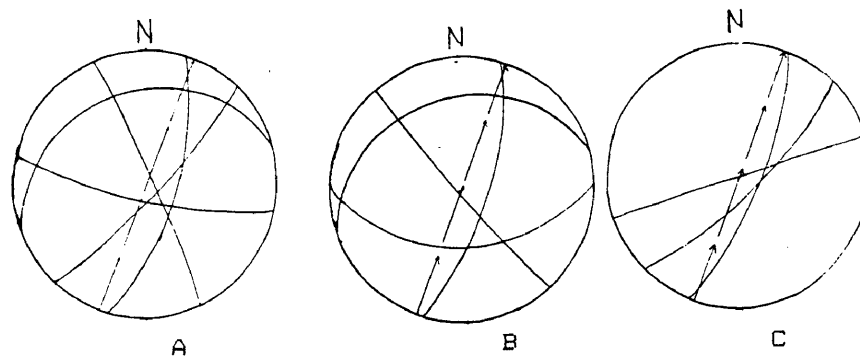
The first position, near the first channel on the right side, is the most eroded area. The RQD is less than 5 per cent and the number of joint sets is six. Joints are continuous, with spacing mostly about 80mm - seldom 400mm - and separation between the joint walls of 1-5mm. Where gouge exists, it is sandy material, sometimes with plant roots. Thin iron oxide stains the surfaces and indicates water circulation through the joint planes. Near to the second channel where the grain size of the rock mass becomes larger because of recrystallization, there are four major joint sets. The joints are closely spaced and tight, except one joint set, where separation of up to 200mm was observed. The filling material, where it has not been washed out, consists of sand. In the third position, close to the side, there are three main joint sets with many tight, curved and discontinuous random joints. The joints are mainly tight and the spacing varies between 3mm and 250mm (Fig.6.10). The hardness measured with the Schmidt Hammer Test varies from position to position, but average value of 40 corresponds with

Fig.6.10 Stereographic projection of the discontinuity planes (—) and the water flow direction (— —).

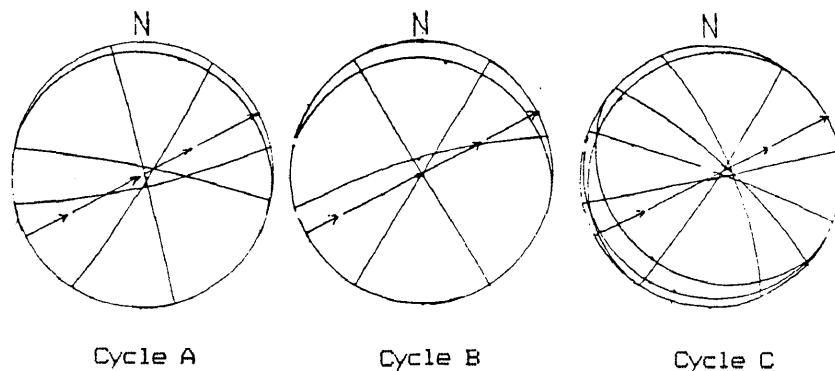
material of weathered shale. On the doleritic mass, four joint sets occur. They are all tight (with one exception of 50mm), widely spaced, with rough walls and hard, brittle filling material. In the left area, only dolerite exists, in various degrees of weathering, but definitely more weathered than the dolerite of the right area (Plate 20). The RQD is between 30 per cent and 35 per cent. The joints have a spacing of 100-250mm and separation of 2-8mm. The joint walls are continuous but rough and undulating (Fig.6.12).

Fig.6.12 Stereographic projection of the discontinuity planes (—) and the water flow direction (— —).

sedimentary rock on which erosion had started, and that endangered the foundations of the wall. The dip direction of the joints that dominate on the shale is with the water flow direction. Four joint sets strike obliquely to the water direction and one set is perpendicular and dips at 90° . The directions of the joint sets of the sedimentary rock on the right apron are similar to the joint directions of the underlying dolerites. However, the separation of the joints is tighter, the spacing is greater and the filling material between the rough joint walls is harder. Sliding of the shale blocks took place along subhorizontal planes and failure along lines of intersection also occurred. In the left area, dolerite is moderately jointed, some of the joints are discontinuous and most of them are undulating. More of the joints on the dolerite of this apron are open than on the dolerite of the right area. Erosion is estimated at about 1,50m on the right apron and mainly scoured is the sedimentary rock, while on the left side scour is about 1m deep.

As temporary protection measure, gunite was applied to the eroded area below the right hand spillway. This performed well during subsequent floods. More permanent measures in the form of thick reinforced concrete slab with rock bolts, on both sides of the spillway, were constructed during 1989.

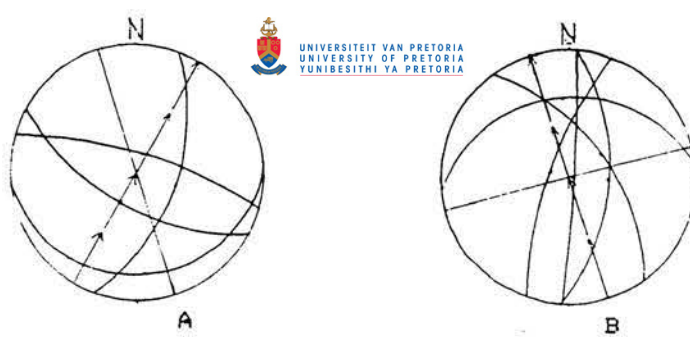
The rocks are heavily jointed by continuous, as well as many discontinuous, undulating, rough, usually some millimetres open and closely spaced joints (Fig.6.18). The rock mass is intersected by 20-30 joints/ m^3 . Stress relief joints developed along the downstream valley, on both flanks, strike perpendicular to the dam wall axis and dip towards the river along both flanks. This results in a dome-shaped appearance of the exposed rock surfaces (Plate 25). The felsites display in places a flow banding which dips downstream. The rock mass is generally slightly weathered, but intensively weathered along the discontinuity planes. Weathering takes place around a rock block to form spheroidal corestones (Plate 26). The joint planes are in nearly all cases stained with a brownish or reddish brown colour which proves that water has seeped through them. Along a discontinuity plane, striking perpendicular to the dam wall on the left side of the plunge pool, a zone of moderately weathered rock of 500mm thickness occurs. Pyrite sheets, veinlets of sulphides or fluorite, fluospar and quartz veins, even zeolite veins are often present (Kent, 1953).

Fig.6.18 Stereographic projection of the discontinuity planes (—) and the water flow direction (— —).

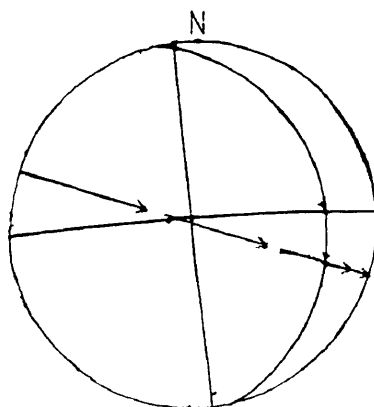
Fig.6.20 Stereographic projection of the discontinuity planes (—) and the water flow direction (— —).

The flood event was less than the 1st per cent of the maximum spillway capacity. Scour of the downstream bedrock to a depth of approximately 3m, it has been estimated (Plate 28). Removal of many blocks, some of them of large size and change a smooth, inclined area of brown sandy topsoil (George et al., 1981) to an uneven, rough surface with loose boulders of various sizes and closely spaced jointing. The close spacing and the open joint walls reduce the cohesiveness of the rock mass and increased the probability of movement. The intense jointing is a negative factor and the direction of the joints according to the direction of the water flow direction is not favourable. Two of the joints are striking perpendicular to the water flow direction, one almost at 90 degrees dip angle and the other at about 20^o, dipping with the water flow direction. In addition, the third vertical joint set is nearly parallel to the water flow, so that cubical rock blocks unfavourable for stability can be formed. The downstream slope of the bedrock is approximately 15 degrees, and sliding along the subhorizontal joint set is possible.

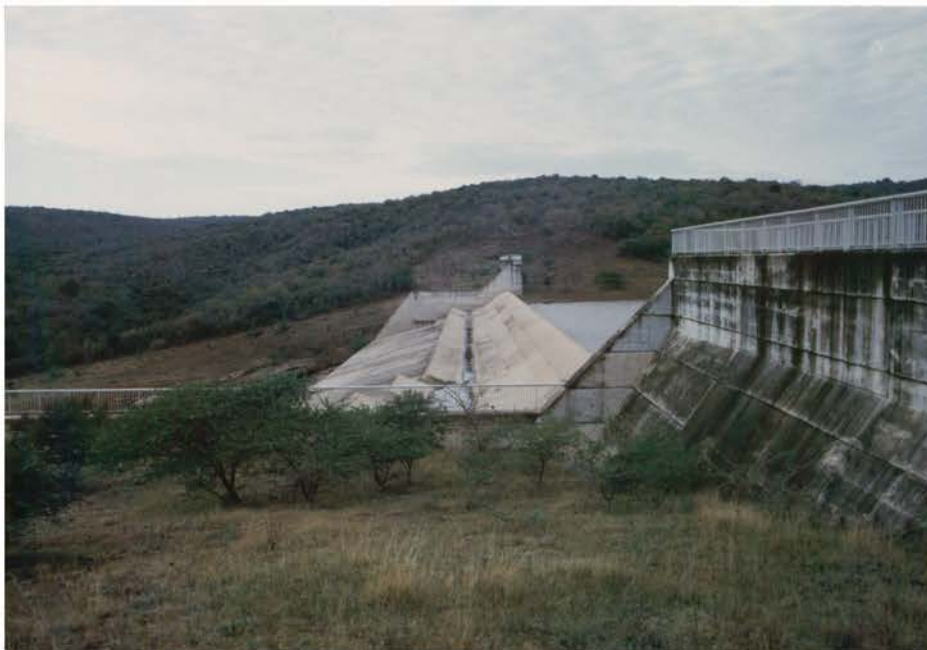
Plate 27 Goedertrou Dam - Side-channel spillway with flip bucket, apron and cut-off wall (Van Schalkwyk).

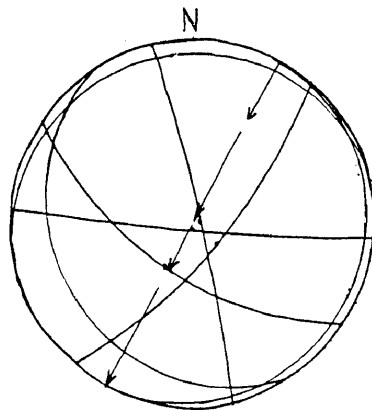
Fig.6.23 Stereographic projection of the discontinuity planes (—) and the water flow direction (— —).

In spite of the presence of more than three joint sets in the rock mass, they do not induce poor rock quality and the erosion has reached only 0,25m depth. The joints are undulating and not always continuous, so that there are not many removable rock blocks. Also, the joint walls are mostly tightly closed and rough, and thus capable of resisting movement.

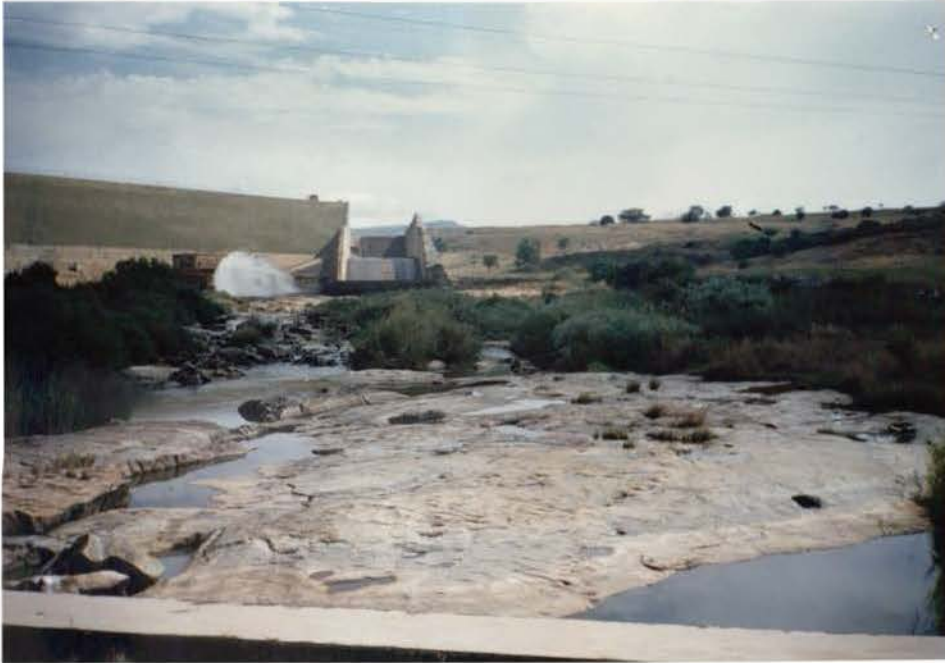
Plate 29 Vygeboom Dam - Partially lined, side-channel spillway with flip bucket.

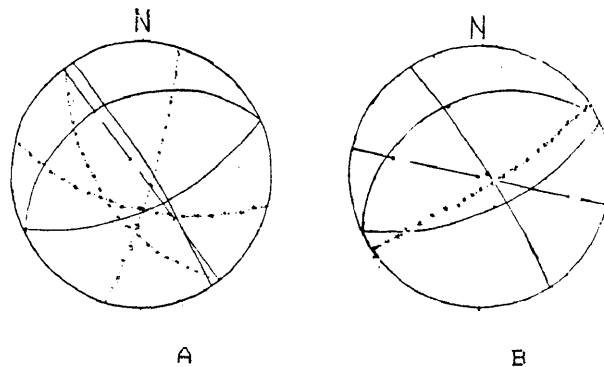
material between some quartzitic beds is about 60mm thick and appears approximately every 250mm (Plate 32). The surface of the joints is slightly rough, with the exception of the weathered subhorizontal joints where it becomes smooth (Fig.6.25).

Fig.6.25 Stereographic projection of the major (—) and the secondary (...) discontinuity planes, and the water flow direction (— —).

A-Projection of discontinuities and water flow downstream of the bottom flip bucket.
