CRACKING OF THE ASPHALT SURFACING OF THE LONGEST SUSPENSION STEEL BRIDGE IN CHINA

WANG XIAO, CHEN XIAN-HUA, CHENG GANG and HUANG WEI

Transportation School of Southeast University.
No. 2, Si Pai Lou Street, Nanjing, China, 210098.

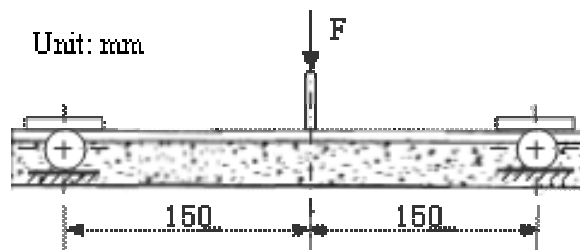
Figure 4. Fatigue test on composite beam.

The flexural fatigue test was conducted to determine the fatigue resistance and dissipated energy of the mastic asphalt, as shown in Figure 4. The composite beam is composed of a 12-mm steel deck and 50 mm of mastic asphalt, with an intermediate rubberised asphalt membrane, which was sampled in the rehabilitation project. Two samples were tested at room temperature. A 10 Hz sinusoidal load with an amplitude of 6 kN was selected to simulate an axle load of 130 kN passing over the bridge deck. The average fatigue life is 1.5 million, with a dynamic deflection of 0.25 mm before failure.

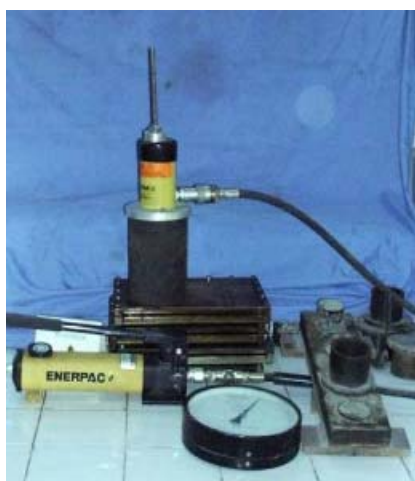
Figure 5. 'Pull-out' test equipment and samples.

The ‘pull-out’ test was conducted at room temperature (see Figure 5). The loading rate was about 200 N/s. Eccentricity should be avoided. Seven cores were drilled and tested. The bonding strength between the mastic asphalt and the steel deck plate was 1.01 MPa, with a maximum of 1.56 MPa and a minimum of 0.71 MPa.

The adhesive strength between mastic asphalt and a steel deck plate is 0.71 – 1.28 MPa. The strength decreases with increasing temperature or with the penetration of water into the bottom of the wearing course through cracks. The theoretical shear stress between mastic asphalt and a deck plate under the most adverse conditions is up to 0.68 MPa (Huang Wei, 2003). Insufficient adhesion therefore accelerated the destruction of the mastic asphalt surfacing in the west outside lane.

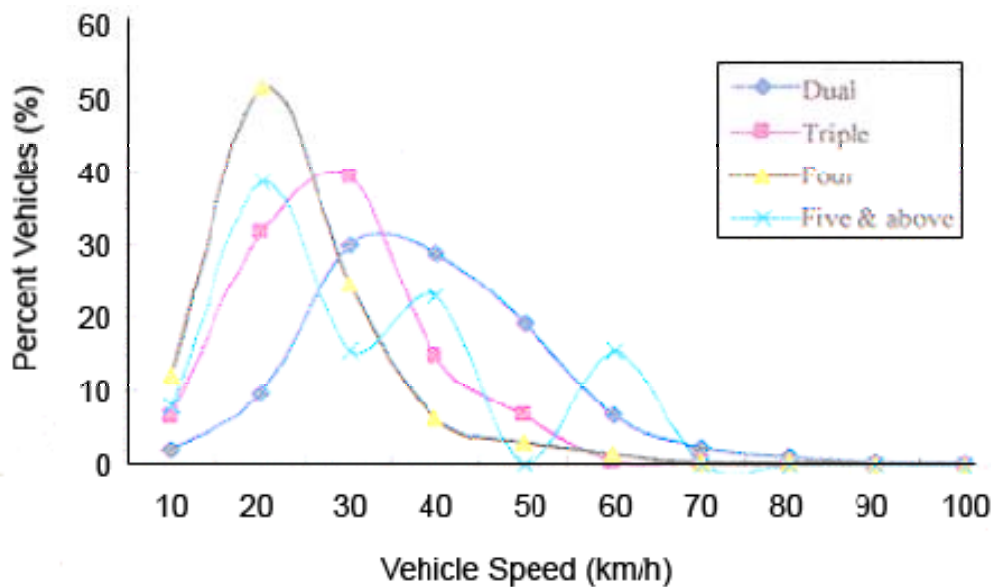
Figure 6. Speed of trucks travelling in the inside lane to Jiangyin.

The speeds of the trucks travelling in the southbound inside lane were measured with a radar speed detector on 20 February 2001, as shown in Figure 6. Trucks travelling at a speed lower than 40 km/h made up 70% of the total of 127 trucks.

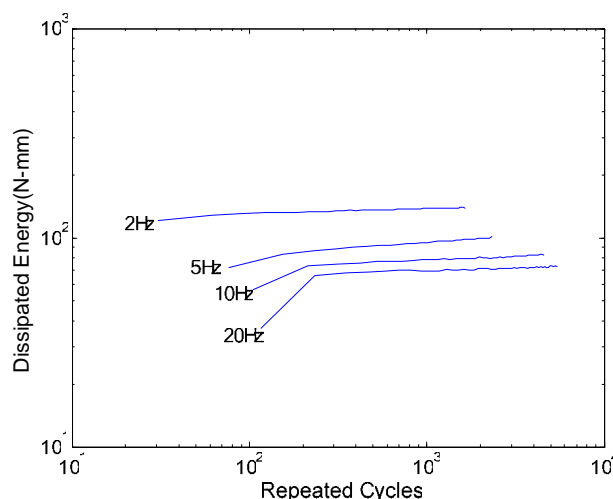
Figure 7. Dissipated energy of composite beam at different frequencies.

Laboratory tests have revealed that mastic asphalt is susceptible to temperature and loading speed. The creep rate increases quickly with temperature (Zhang Lei, 2004). The energy dissipated per cycle decreases with higher loading frequency, as shown in Figure 7. High dissipated energy per cycle means severe damage to materials. Slow-moving vehicles therefore have some adverse effects on the permanent deformation and fatigue resistance of mastic asphalt.
