APPENDIX D

PHOTOGRAPHIC RECORD OF HEAVY VEHICLE SIMULATOR (HVS) TESTS
ON PAVEMENTS WITH LIGHTLY CEMENTITIOUS LAYERS

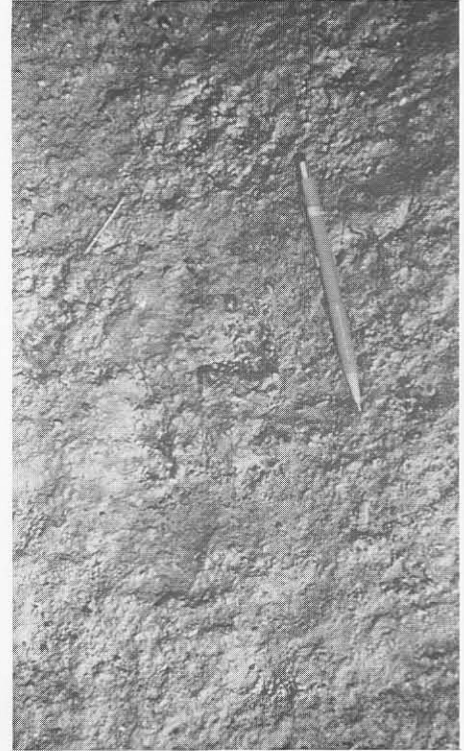
(b) Surface of the precracked cemented base after application of the prime coat.

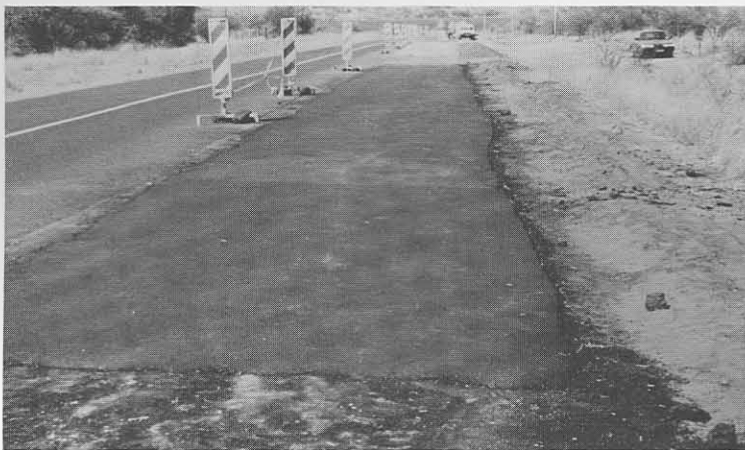
(c) Final surface of the 35 mm asphalt premix section (40 m in length).
