## Chapter 3.0

### Underground monitoring of roof and support behaviour

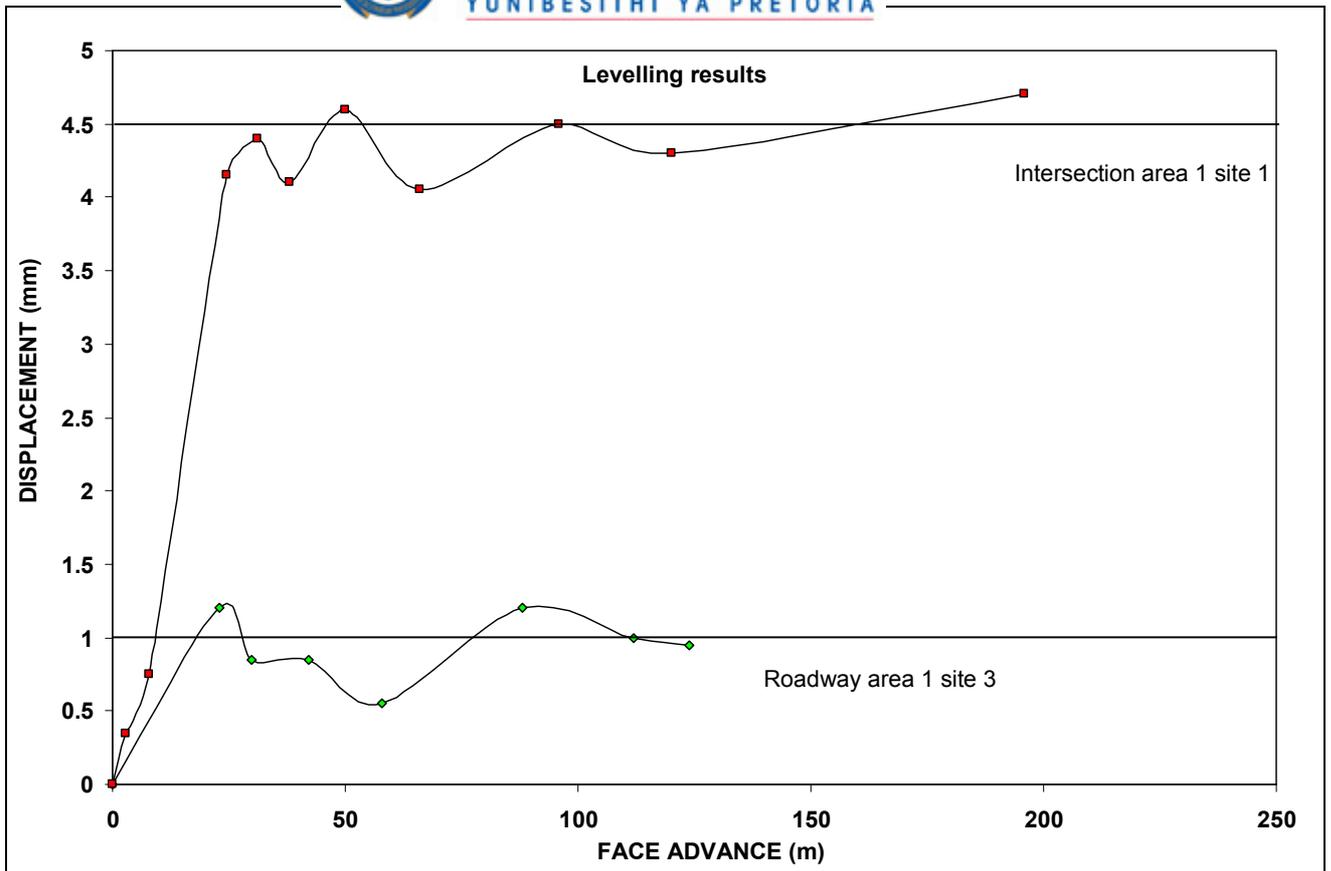
**Figure 3-11 Colliery 'B' comparison between roadway and intersection roof skin displacement**

The mining of the splits to form an intersection allowed the roof displacements to reach larger magnitudes than in the roadways. After completion of the mining cycle, the roadways and the intersections both stabilised very quickly. This is illustrated in Figure 3-11 where a comparison between the roof skin displacements, derived from the backup levelling results, at the intersection at area 1 site 1 and the roadway at area 1 site 3 are presented. The displacements of the bottom anchor near the collar of the hole in the intersection at area 1 site 1 are presented in Figure 3-12. Figure 3-13 shows the velocity profile of the same anchor. Stability was reached shortly after the splits were holed through at the 25 m face advance. The final reading was taken approximately 50 days after the initial indication that the roof had stabilised.

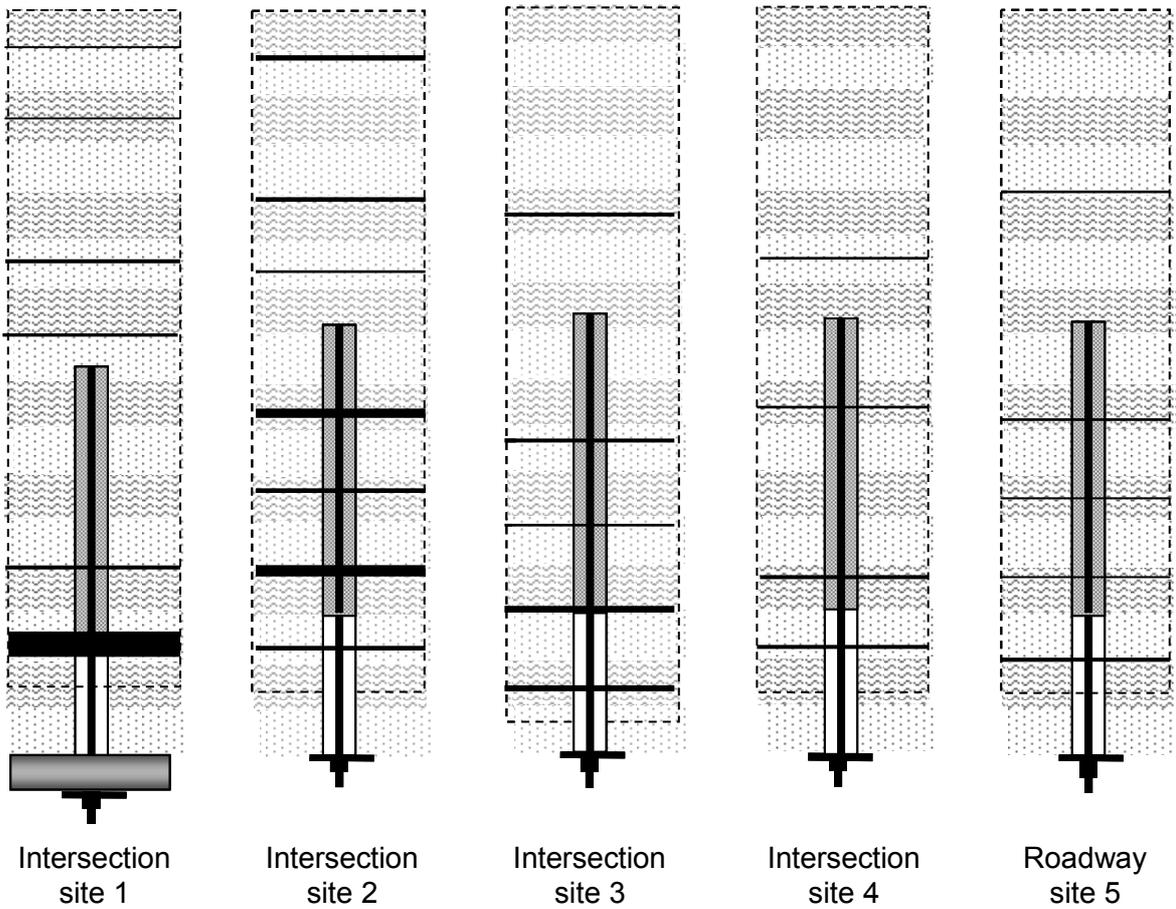
Figure 3-29 Colliery 'D' area 2 site 5 (roadway approaching dyke)

Site 5 of area 2 (Figure 3-29) was in a roadway approaching a dyke. The road width was reduced to approximately 5.0 m, which resulted in the roof bolts being closer together in the rows. Although there appears to be small displacements up to the 2.0 m elevation, the majority of the displacements were within the initial 1.2 m of roof strata and were 2.5 mm in total. Although slightly higher in value, the levelling results agreed fairly closely with the bottom sonic probe anchor.

The displacements extended to about 0.4 m above the bolt horizon.

In area 2 at site 5 (Figure 3-29) in a continuous miner section, the conditions were different in so far as the face was advanced 5.0 m to expose a dyke where it remained static over a two day period. It was then advanced through the dyke to the 11 m position and again remained stationary for three days until the final set of readings were taken. At the 5.0 m position, both the sonic probe and levelling recorded an increase in displacement of approximately 0.8 mm over the two day period. At the 11 m face position, over a three day period, no additional displacements were recorded.

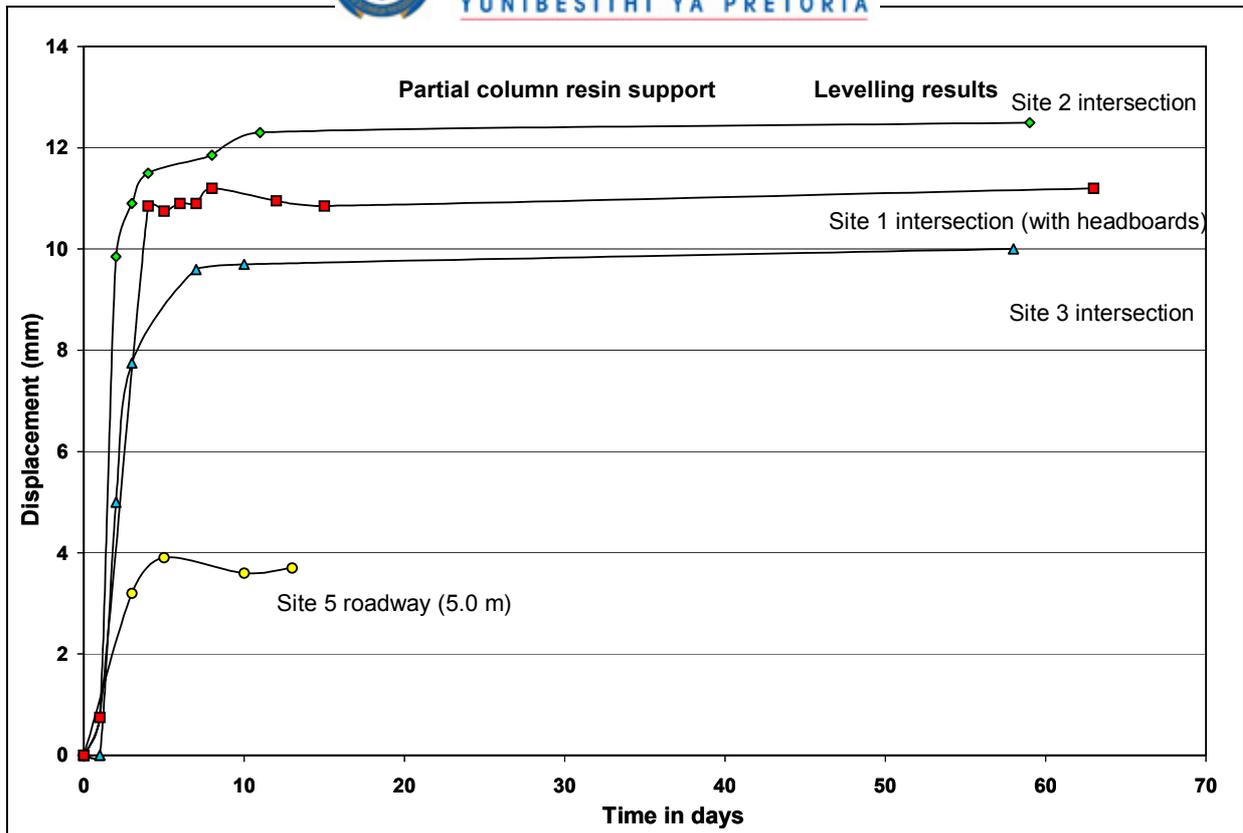
**Figure 3-31 Colliery 'D' area 2 comparison between roadway and intersection roof skin displacement**

The total relaxation within the initial 1.8 m of roof strata, as recorded by the levelling results at four of the five sites, have been plotted together and are presented in Figure 3-31. The overall relaxation at sites 1 and 2 were approximately 10 and 20 per cent higher than the site 3 values.

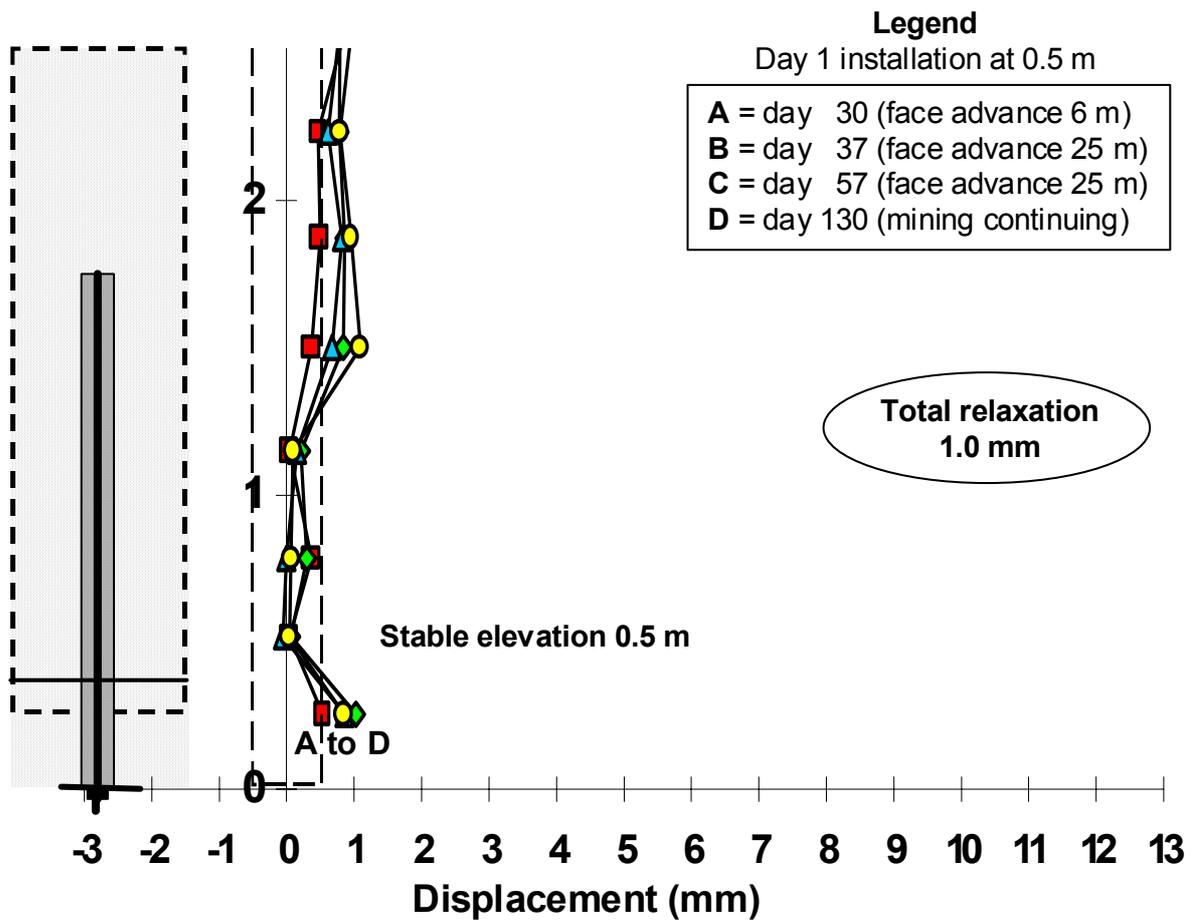
Figure 3-36 Colliery 'E' site 1 (gate road)

Overall, very little if any displacement was recorded as the roof remained stable throughout the mining process. The only site to record what appeared to be a real displacement was site 1, Figure 3-36, where a total relaxation of approximately 1.0 mm occurred within 0.3 m of the roof skin. The results from the other four sites are presented in Figure 3-37, Figure 3-38, Figure 3-39 and Figure 3-40.

<b>Coalfield</b> :Highveld	<b>Seam</b> 2 seam	<b>Position</b> Shortwall gate road
<b>Roof</b> : Laminated sandstone		
<b>Support</b> :1.8 m x 16 mm full column resin bolts four in a row (1.0 m apart) across the roadway, 1.5 m between rows.		
<b>Layout</b> : <b>Depth</b> 50 m	<b>Roadway</b> 6.5 m	<b>Pillars</b> chain pillars 50 m centres
<b>Mining</b> : Continuous miner	<b>Mining height</b> 3.0 m	
Very small displacements were recorded

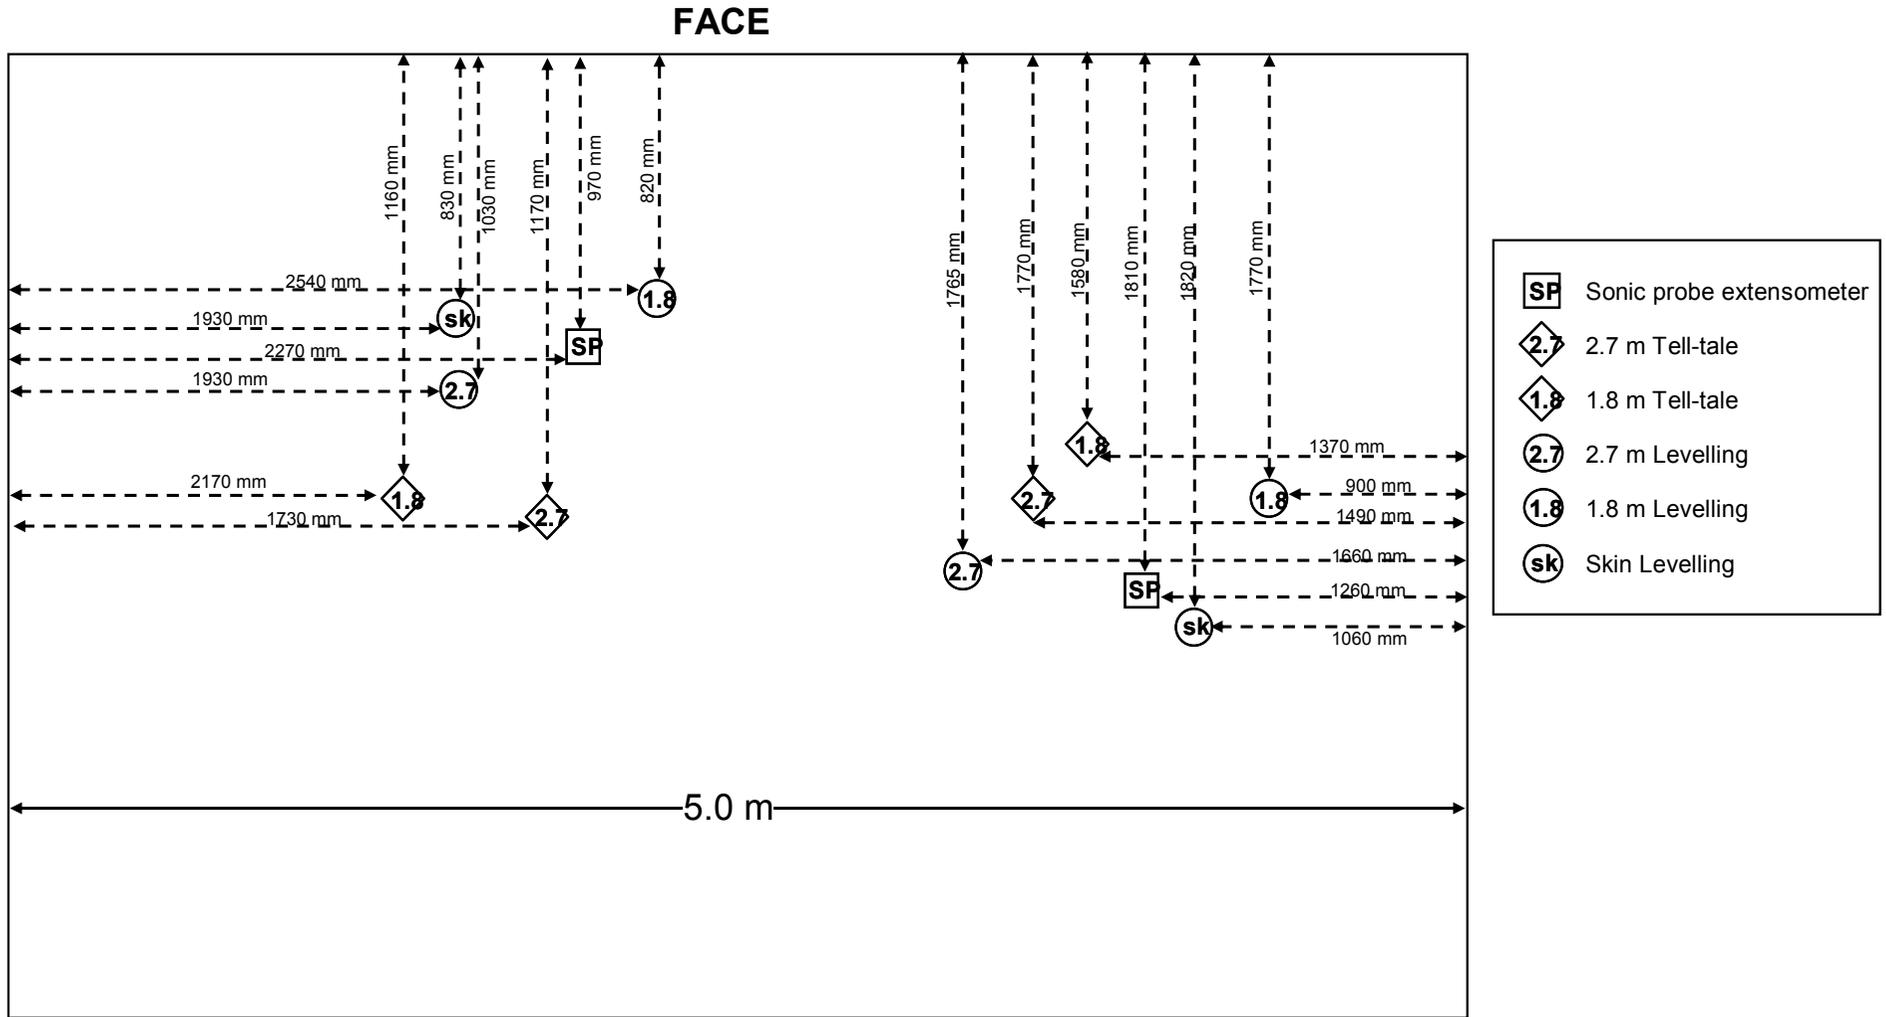
**Figure 3-43 Instrumentation layout**

The cubby was 5.1 m wide and 8.0 m long. Two sets of instrumentation were installed in the roof approximately 1.0 m from the face. Each set consisted of a 7.3 m deep sonic probe extensometer and three fixed levelling points anchored at 2.7 m, 1.8 m and close to the roof skin. Two tell-tales were also installed at each position to monitor the strata between the roof skin and the 1.8 m and 2.7 m elevations. The instrumentation layout is shown in Figure 3-43. One set of instrumentation was positioned on the centreline of the 5.1 m wide original excavation. The other approximately 1.0 m from the right hand sidewall so that it would in time be closer to the final centreline of the widened roadway. Prior to the start of the experiment, the final roadway width was unknown. The roof and sidewall conditions could only be assessed during the widening operation and a decision taken when to stop.

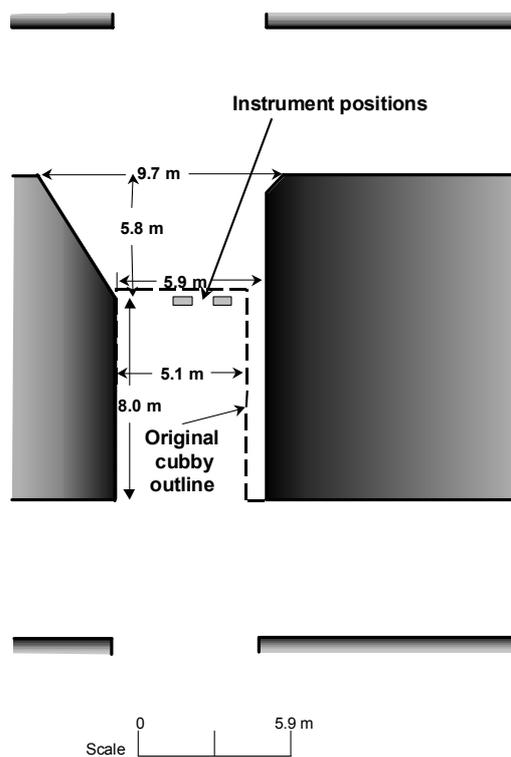
**Figure 3-44** Roadway and adjacent intersections prior to widening

The outline and dimensions of the original cubby, as well as those of the subsequent development in the immediate area, are indicated in Figure 3-44. Included are the positions of the two sets of instrumentation.

Taking the surrounding pillars as the boundaries, the span of the final excavation was 12 m x 25 m. Even if the snook is considered as being an effective support element and boundary, the minimum dimensions are reduced to 12 m x 19 m. The monitoring was limited to the supported 40 per cent of the final roadway width. The opposite side of the widened roadway was unsupported and in all probability would have experienced larger differential displacements. Nevertheless the roof remained intact without even any minor falls being noted.

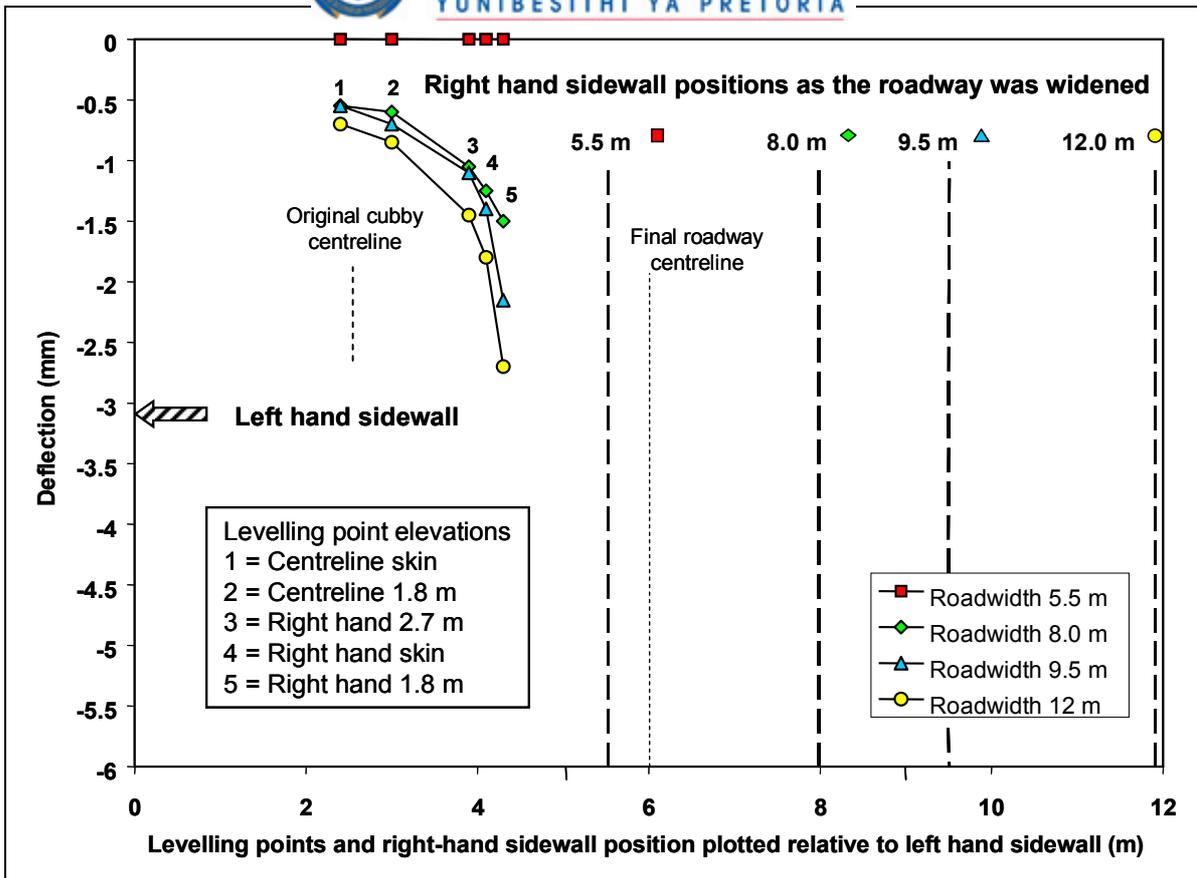
Figure 3-46 Increase in roof deflection with widening of roadway

The roof deflection recorded during the widening phase is presented in Figure 3-46. On the horizontal scale the left hand sidewall is fixed at zero, while the position of the right hand sidewall is indicated for each set of readings taken. The positions of the five levelling points are also plotted relative to the left hand sidewall. In this dynamic situation it was difficult to determine if any differential displacements, such as bed separation, were occurring. The change in shape and increase in displacement values towards the mobile centreline of the roadway occurred in the anticipated sequence in all three deflection profiles. Although not conclusive, this suggests that during this period, the 2.7 m thick roof beam being monitored remained intact.

A point worth noting, which is apparent in Figure 3-46, Figure 3-47 and Figure 3-48, is the behaviour of the 1.8 m centreline levelling point. It appears to have undergone less overall displacement than the 2.7 m point, which is anchored higher in the roof strata. This is a true reflection of the situation, which is as a result of the widening of the roadway, the 2.7 m point ended up closer to the centreline of the widened roadway. The roof deflection over the larger span influenced the 2.7 m point to a higher degree than the 1.8 m point closer to the sidewall. This was also the case with the skin anchor situated even closer to the sidewall, up until day two, when it also still recorded less deflection than the 2.7 m point.

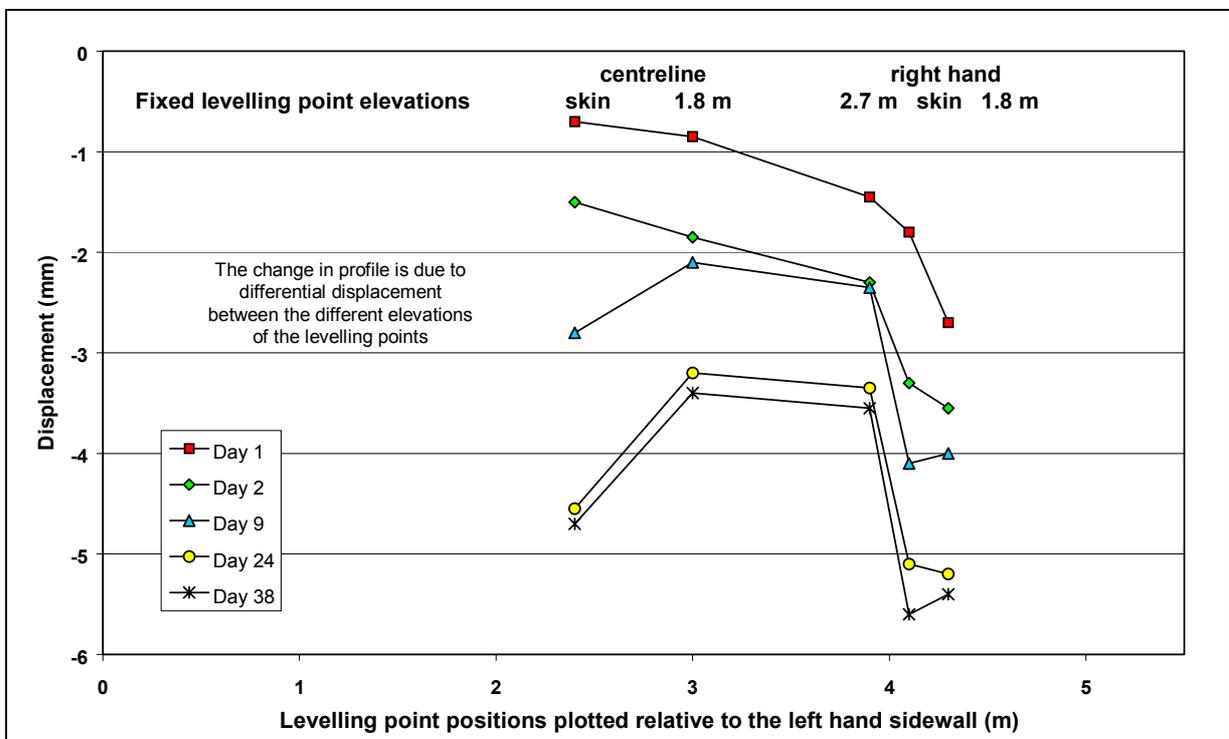
Figure 3-47 Roof behaviour of the 12 m widened roadway with time

Figure 3-47 covers the time period from day one, when the first set of readings were taken in the road once the width had been opened to 12 m, up until the final reading on day 38. The horizontal axis indicates the position of the measuring stations relative to the left hand static sidewall. In this graph two different mechanisms can be seen. The 2.7 m levelling point, being

the deepest in the roof, traditionally gives the best indication of the overall roof deflection and is the least likely to be influenced by the unravelling effects of delamination, which usually starts close to the roof skin. The deflection of this point can be seen to increase with time. The change in shape of the five point levelling profile indicates that differential displacements were also occurring in the roof beam during this time period. These can be seen more clearly in Figure 3-48. In this Figure, the relative displacement of both the 1.8 m and skin anchor points were plotted using the 2.7 m levelling point as a static reference. The separation between the skin and 1.8 m elevation on the right hand side had started within 14 hours of the roadway reaching the 12 m width. The same comparison at the centreline showed no evidence of differential displacement at this time. This could either be as a result of an opening, once initiated, migrating towards the edge of the roadway or that the displacements were localized and not interconnected. By day nine the displacements at both instrumentation positions were well defined and tended to stabilize from day 24 onwards. The maximum differential displacements values recorded were 1.0 mm at the right hand position and 2.0 mm at the centreline. The fact that the greater value occurred closer to the sidewall suggests that these displacements may have been more localized than continuous across the roof beam.
