UNIVERSITEIT VAN PRETORIA  
UNIVERSITY OF PRETORIA  
YUNIBESITHI YA PRETORIA

A P P E N D I X A

PHOTOGRAPHIC RECORD OF HVS TESTS

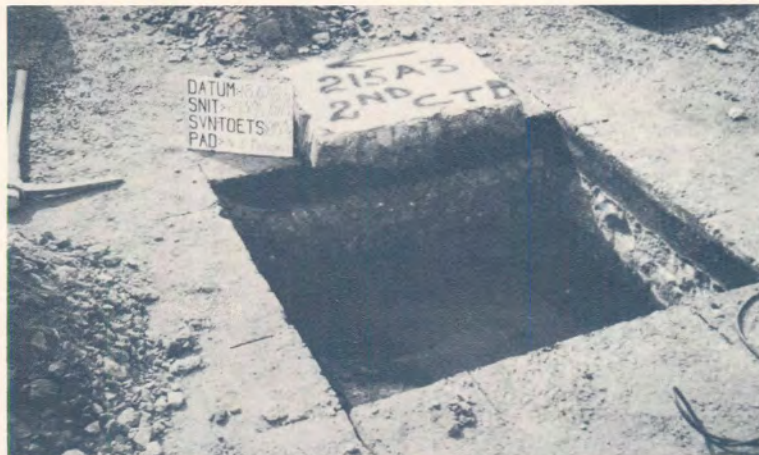
(b) Successful recovery of a solid block of stabilized material from the lower stabilized subbase layer. Note smooth interfaces between the layers.

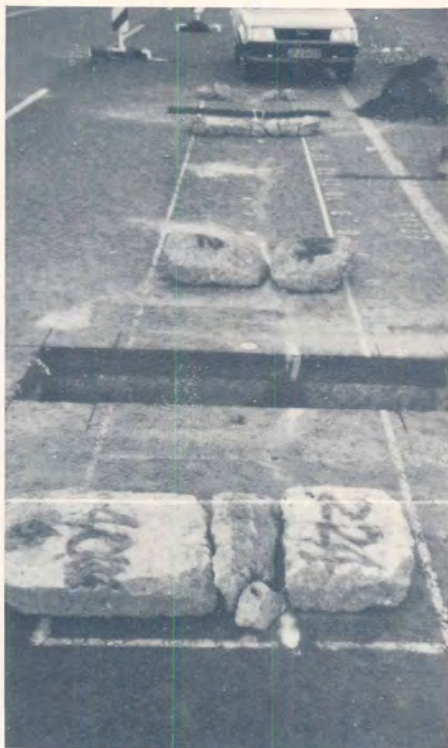
(c) General view of recovered subbase layers on SECTION 2.

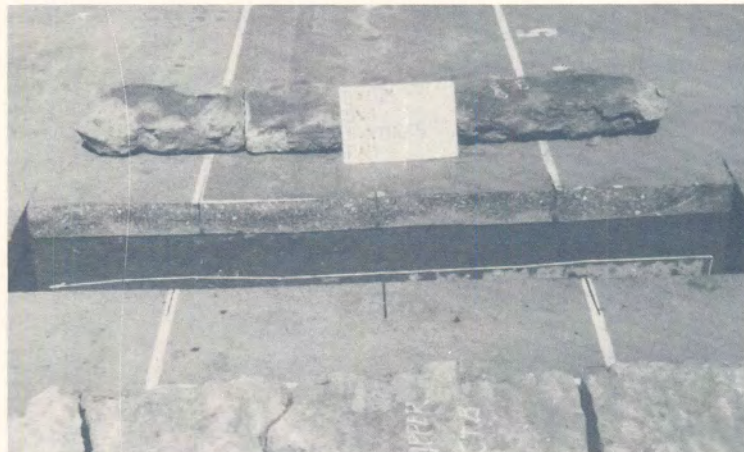
(b) Cross profile on Section 2 after the dry state. No deformation recorded on road surface.

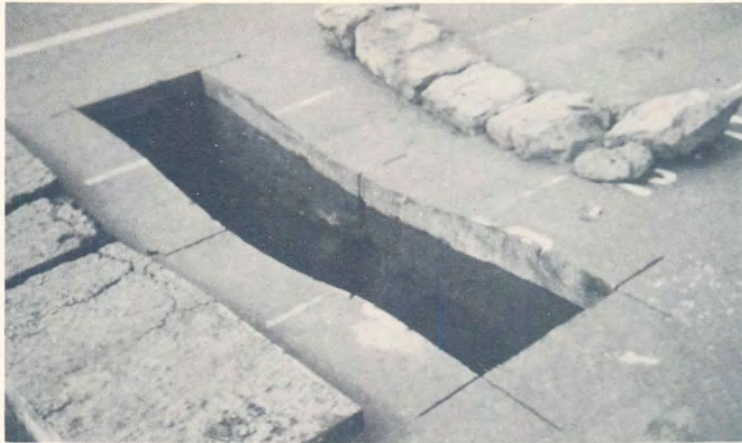
(a) Cross profile after EPWP on Section 2. Note the thinner subbase inside the trafficked area.

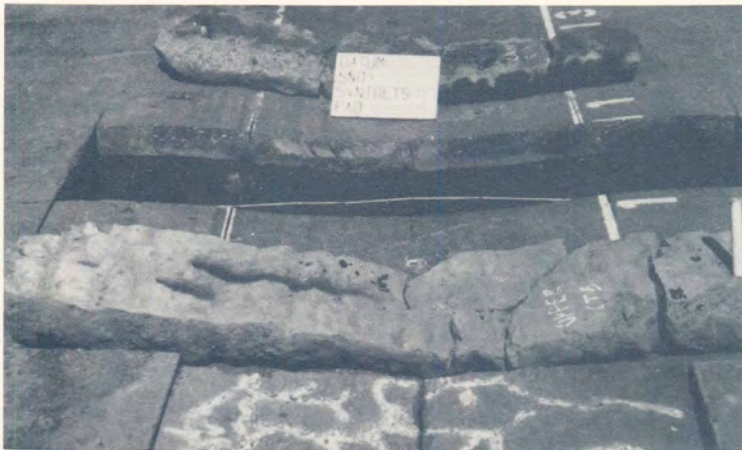
(b) Recovered upper subbase material from Section 2. Note the thinner subbase inside the trafficked area.
