**FAILURE ANALYSIS OF ULTRA-HIGH MOLECULAR WEIGHT
POLYETHYLENE ACETABULAR CUPS**

NICOLAAS DANIEL LOMBARD BURGER

DOCTOR PHILOSOPHIAE (PhD)

DECEMBER 2005

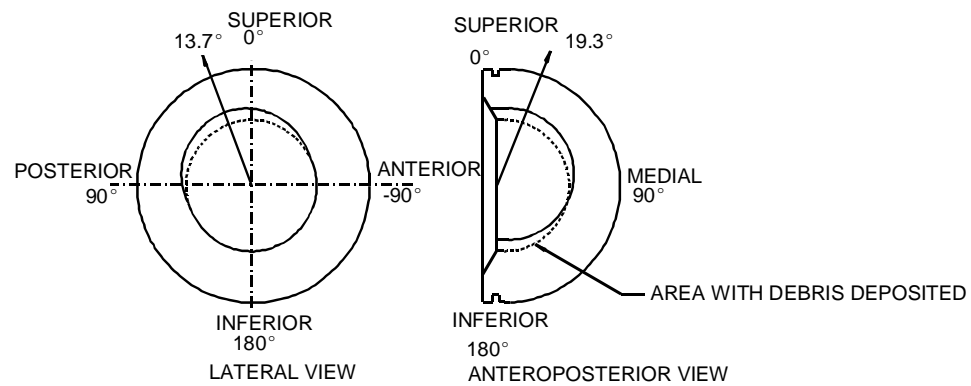
Figure 2.20: Position of maximum wear in cups according to Sychterz et al. (1996)

From Figure 2.20, it can be seen that the wear in the lateral view was orientated at 13.7 ° away from the most posterior point of the face towards the posterior side. From the anteroposterior view of the liner, this vector was orientated at a mean of 19.3° away from the face of the liner towards the apex.

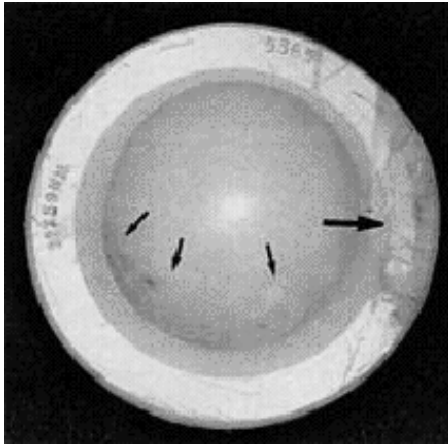
The most common types of damage reported by Jasty et al. (1997) were polishing of the running surface (see Figure 2.21), fine scratches (55 μm or less in width), see Figure 2.21, flaking (delamination of the surface), pitting, cracking, coarse abrasive wear (scratches 100 μm or more in width), embedded particles of metal or cement and dislocation. Additional findings by Jasty et al. (1997) are shown in Figures 2.21 to 2.24.

Figure 2.21: Photograph of a polyethylene acetabular component (Jasty et al., (1997) retrieved during a revision that was performed because of osteolysis six years post-operatively. There is an eccentric pattern of wear. The superior worn area is highly polished and is separated from the inferior, less worn area by a ridge (small arrows). Note the evidence of impingement anteriorly (a large arrow). Discolouration and flaking are seen in the less worn area

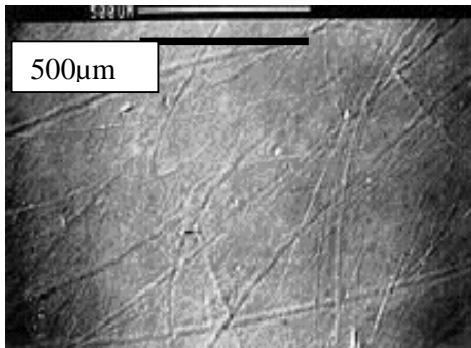
Figure 2.22: Scanning electron micrograph showing the highly worn area with numerous multidirectional fine scratches in a well-fixed acetabular component that was retrieved at autopsy ten years after implantation (original magnification, x 79.5)

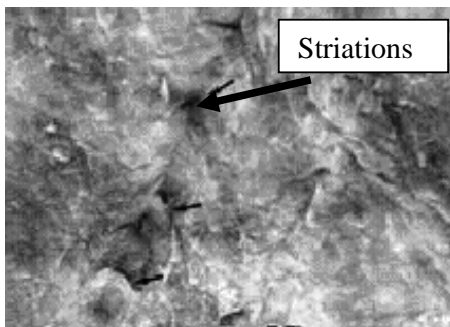
Figure 2.23: Scanning electron micrograph showing striations (arrows) perpendicular to the direction of the scratches, indicating tearing of the material during abrasive wear (original magnification, x 3900)

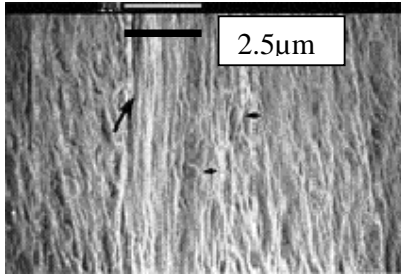
Figure 2.24: High-power scanning electron micrographs of a component retrieved six years after an arthroplasty. Reorganisation of the material has occurred during the wear process

In Figure 2.24 the scratch that formed much earlier is still visible. Within the scratch, the polyethylene is drawn into fine fibrils oriented parallel to the scratch (a large arrow). Scratches are not visible in adjacent areas, but fine fibrils, one micrometer or less in diameter, are present over the entire area. These fibrils are the major source of sub-micrometer wear particles. There are tears in the fibres in some areas and curled fibres (small arrows) (original magnification, x 10 400).

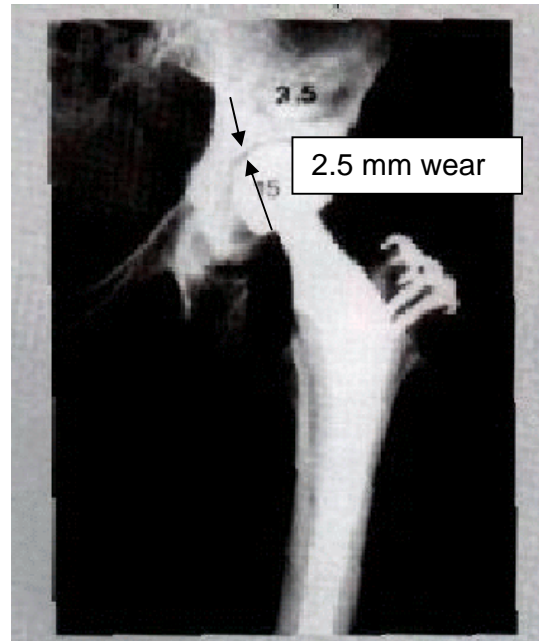
The results of the Grobbelaar et al. (1999) study are as follows: In 86 of these patients, no wear could be measured and the rest of the wear varied between 0.7 and 1.5 mm. In Figure 2.25, an example of an X-ray is shown of the worst case in this follow-up. The total wear is given as 2.5 mm. No engineering explanation is given to explain the wear mechanism. Again the problem remains that, owing to magnification of the X-ray, it is very difficult to measure on X-rays.

Figure 2.25: X-ray that shows 2.5 mm wear in cup as indicated by arrows as an eccentricity. No scale was shown in the reference but 30 mm femoral head serve as scale (Grobbelaar et al., 1999).

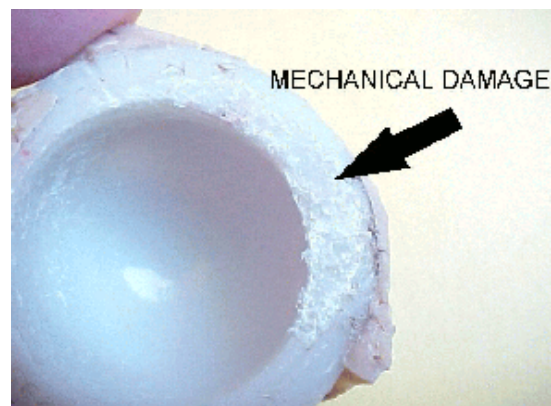
Mechanical damage, predominantly caused by impingement, is normally the result of an acetabular cup not properly aligned in vivo, whether during implantation or during rotation after aseptic loosening. The mechanical damage is normally a result of the neck of the femoral stem making contact with the rim of the acetabular component. Impingement can also occur after excessive wear when the neck of the femoral component is making contact with the acetabular component. Impingement normally results in pieces of material (UHMWPE or cement) being ripped from the edge of the cup as seen in Figure 4.1. A schematic presentation of the defect is shown in Figure 4.2

Figure 4.1: Mechanical damage on rim of cup

An initial assessment of the problem is that the pieces of material forcefully removed by the neck of the femoral component will cause large floating particles and possible loosening of the cup due to impact loading. If rotation of the cup with resulting impingement is a result of aseptic loosening, impingement will cause further rotation and discomfort to the patient.

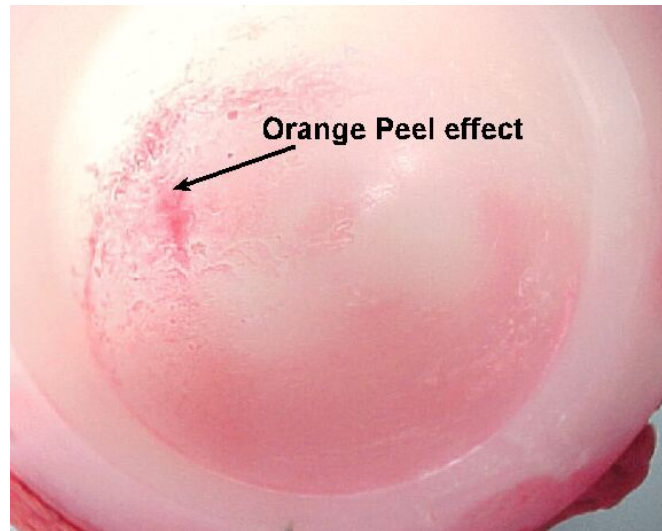
When the acetabular cups are investigated by means of a magnifying glass, areas of plastic flow are visible. These areas can have different appearances. The first is the orange peel effect. The term “*orange peel*” is used to describe the surface texture and should not be related to the surface roughening encountered in forming products from metal stock that has a coarse grain size as is commonly referred to in metallurgy and in injection moulding of plastics (Gold Technology, 1990; Engineering Materials Handbook, 1987; <http://www.principalmetals.com/glossary/odoc.htm>). This area normally occurs just outside the area of high contact stress on the bearing surface. Visually, it seems as if “molten” material or material sufficiently softened to be extruded was expelled from the area of high contact stress and transferred to an area where the contact stress is less intense. A typical defect is shown in Figure 4.5 with a schematic presentation of the defect shown in Figure 4.6.

Figure 4.5: Cup treated with dye penetrant showing “orange peel” effect indicating plastic flow of material

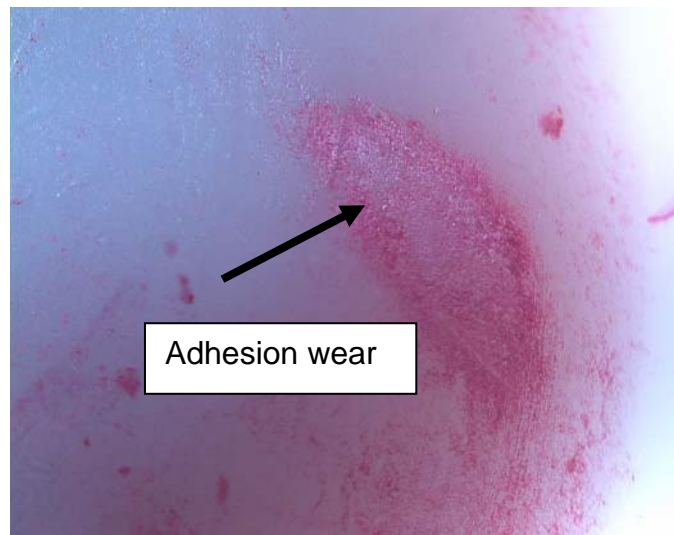
and subsequent movement causes the asperities of the softer surface to be torn out, rather than breaking the bond between the asperities, the process is called *adhesion wear*, typically the areas present as rough patches and are seen in the high contact stress areas where lubrication is the poorest. An example of an acetabular cup with signs of adhesion wear is shown in Figure 4.8 and a schematic presentation of the defect is shown in Figure 4.9.

Figure 4.8: Adhesion wear on inside made visible with dye penetrant treatment

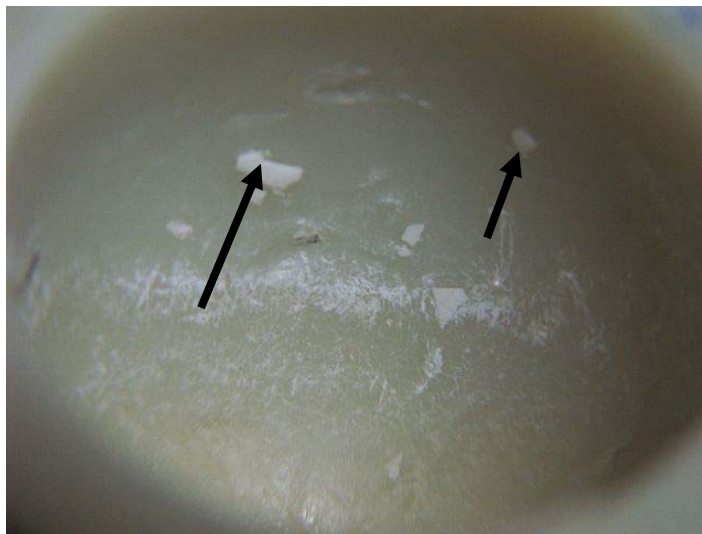
During the examination of some of the acetabular cups, wear particles were found embedded in the base material. Although wear products from the base material are also embedded in the base material, the most common particle found embedded was poly methacrylate (PMMA) cement used for the fixation of the implant as well as UHMWPE wear particles. An acetabular cup with PMMA particles embedded is shown in Figure 4.10.

Figure 4.10: Acetabular cup with embedded PMMA particles

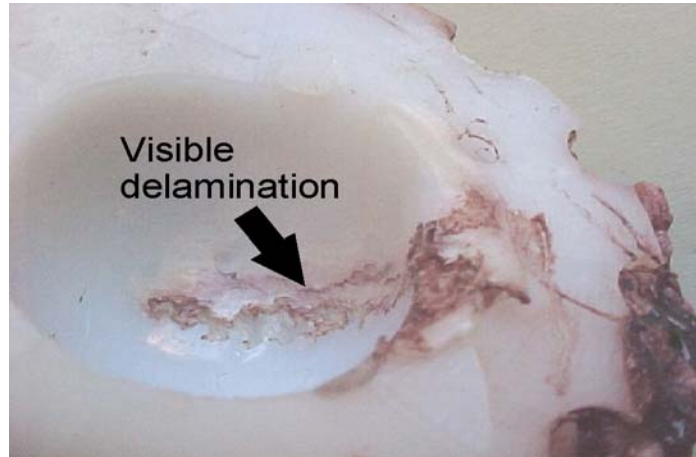
Flaking (delamination) can be defined as areas where pieces of material separate from the base material. This defect presents either as craters or areas of delamination. A cup with serious delamination is shown in Figure 4.11. This type of defect, although not common, is normally associated with a defect within the material and occurs in the high stress or contact stress areas.

Figure 4.11: Acetabular cup with serious delamination visible.

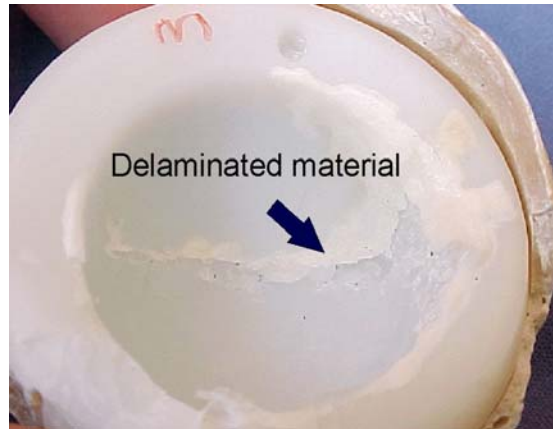
All the retrieved cups showed signs of excessive wear and/or creep. In four cases, there were catastrophic failures. For an example of these catastrophic failures, see Figure 5.1. In the second cup, something was wrong with the material (Figure 5.2), as the material started delaminating within a year after implantation. These details are discussed later.

Figure 5.2: A cup with delamination

The cups were treated with dye penetrant to make the defects more visible. The cup, shown in Figure 5.2, failed after only one year in-vivo. When inspected, using a magnifying glass, it appeared that the material was defective and that it had delaminated as can be seen in Figure 5.2. A possible explanation for this delamination is that during the manufacturing process a harder layer on the surface had formed, similar to case hardening in steel. This can be a result of incorrect cooling, incorrect cutting speed or a blunt cutting tool. When the acetabular cup is in service, contact stresses are generated at a distance below the surface (Boresi & Sidebottom, 1985). Repetitive loading may then result in fatigue failure at the depth below the surface where the contact stresses are maximised, causing the top layer of material to delaminate.

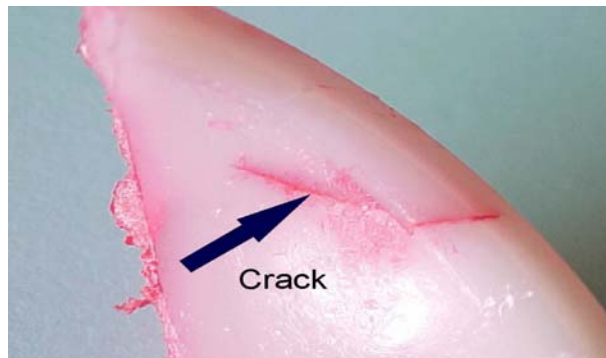
As mentioned in paragraph 5.2, four of the retrieved cups showed catastrophic failures. The first cup had fractured and it also showed some signs of cracking in other areas. It appears that the fatal crack started from a crater caused by material being extruded from the base material in the main adhesion wear area (See Figures 5.6 and 5.7).

Figure 5.7: Cracking in fractured cup

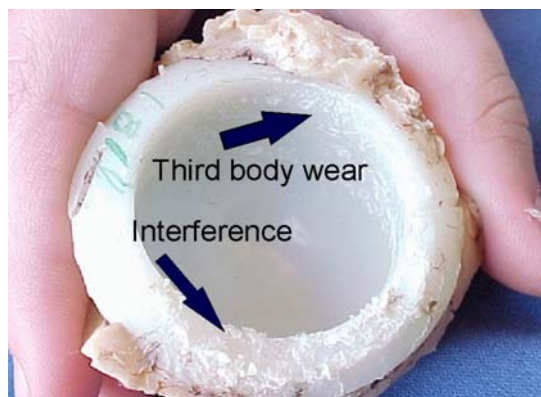
Apart from the wear/creep and the catastrophic failures, a number of other types of failure were identified in the retrieved acetabular components. The first is interference between the acetabular cup and the neck of the femoral component as shown in Figure 5.8. This was caused by misalignment in-vivo. This misalignment may be a result of problems during surgery or, more often, the impingement damage is secondary to a cup loosened due to osteolysis with the resulting movement of the cup causing misalignment. The result is that the neck of the femoral component interferes with the acetabular cup removing pieces of material (UHMWPE and PMMA cement). This debris can find its way into the bearing area where it can cause third-body wear, as discussed earlier. The larger pieces of UHMWPE removed from the rim of the cup, can also cause further osteolysis.

Figure 5.8: A cup with evidence of interference and subsequent damage

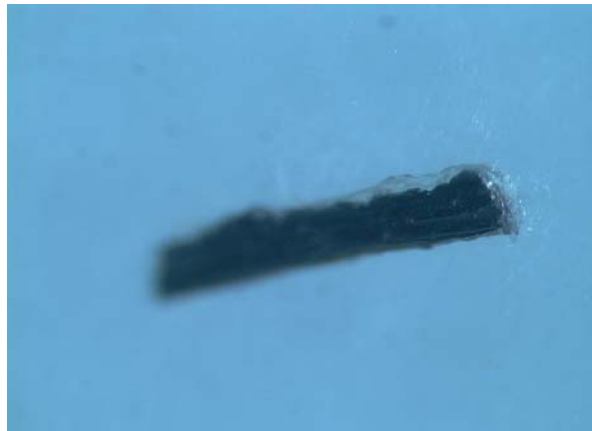
Foreign particles can find their way onto the bearing surface area. In one of the cups, a steel chip or shaving was trapped on the bearing surface and subsequently pressed into the softer polyethylene by the zirconium femoral head as shown in Figure 5.9. The origin of the steel particle is not known, but it can only be from the surgical tools because the femoral head was not manufactured from steel but zirconium and the femoral stem was manufactured from titanium. The piece of steel was embedded in the cup and did not cause the failure. Defects originating from surgical procedures will not be investigated further in this study.

Figure 5.9: Piece of steel embedded in polyethylene (magnification x 40)

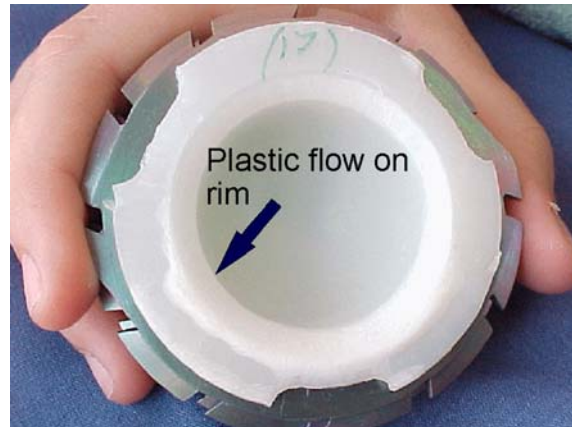
Another defect detected visually was an acetabular cup with severe plastic flow visible round the rim of the cup together with cracks running radially from the area of plastic flow. This is shown in Figures 5.10 and 5.11. The cause of this plastic flow is discussed later. In Figure 5.11, a vernier is held against the “flowed” material to indicate the extent of flow that had taken place.

Figure 5.10: Plastic flow on the rim of cup

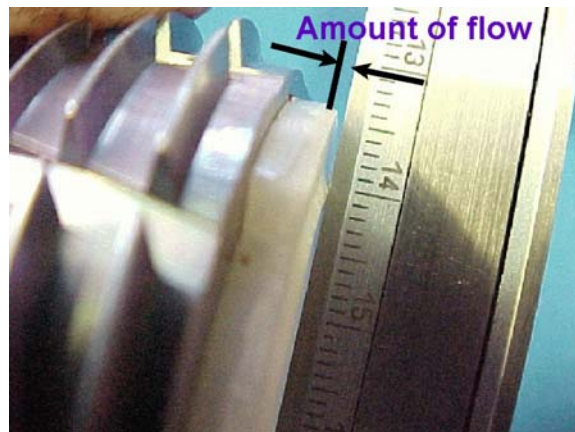
Figure 5.11: Amount of plastic flow

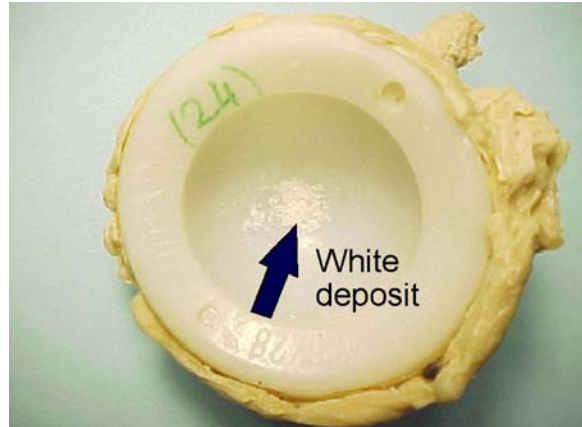
In virtually all of the cups, a whitish deposit was found inside the cup on the bearing area. Owing to the transparent nature of this deposit, it was very difficult to photograph. However, in one of the cups, the deposit was so thick that it was possible to collect and study it using an electron microscope. The deposit was found to be sodium chloride, which was probably deposited after washing the wound and the retrieved component in theatre during revision surgery. (The result of the electron microscope investigation is attached in Annexure B.) This deposit has no influence on the failure analysis of this investigation and will be ignored. Figure 5.12 shows the acetabular cup with the white deposit collected. Also visible in this cup is a slight brown discolouration towards the rim of the cup. The brown discolouration was also

investigated further using an electron microscope. In paragraph 5.6 it will be shown that this is not a discolouration but a deposit on the inside of the cups.

Figure 5.12: White deposits on inside of cup and brown discolouring

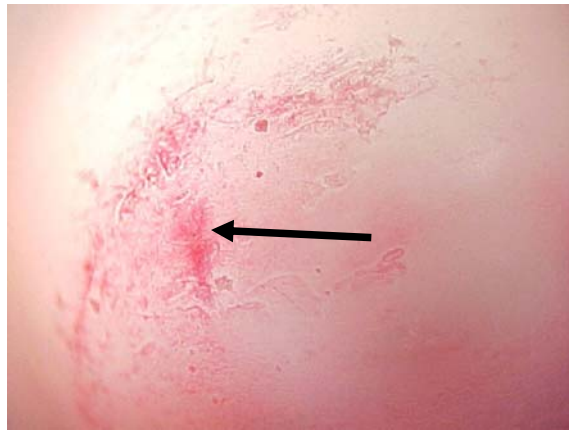
By making use of this technique, all the visual observations made in paragraph 5.2 were confirmed. The material extruded from the bearing contact surface as well as debris removed from the bearing surface during operation can be seen in Figure 5.13.

Figure 5.13: Deposited debris, resulting flow pattern and adhesion wear

Another feature of the plastic flow that became evident during the dye penetrant tests was that although the running surface looked polished, debris was deposited over the total bearing area. This deposited debris is visible in Figure 5.13. This led to the conclusion that the bearing surface is in actual fact not smooth but “pockmarked” due to debris deposited and then flattened and pressed into the bearing surface. The deposited wear debris is not evenly spread over the bearing surface as can be seen in Figures 5.13 and 5.15. Areas with higher concentrations of wear debris are found. These areas are investigated using a stereoscope, as discussed later.

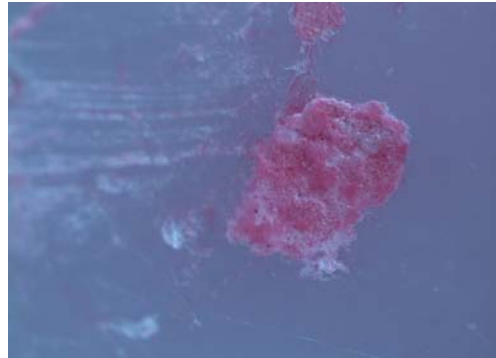
Figure 5.20: Magnification(x 20) of defect after treatment with dye penetrant

The cracks seen in Figure 5.6 are now clearly visible in Figure 5.18. It is believed that the final fracture occurred after the cracks that had propagated from these defects (Figure 5.21) had extended beyond the critical crack length for this material. Also visible in Figure 5.19 are indications of the orange peel effect, as discussed earlier. Visible in Figure 5.21, is material that was extruded or forced out leaving the crater as indicated by the arrow.

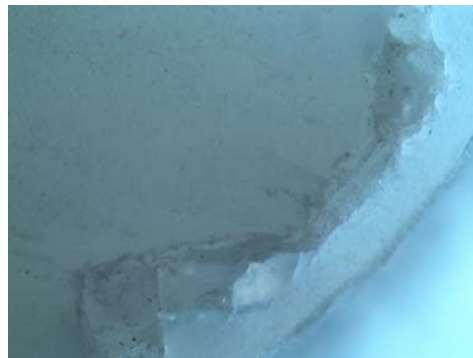
Figure 5.23: Magnification (x 20) of defect on rim of cup

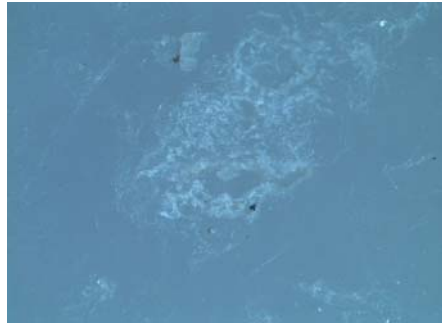
Figure 5.26: Magnification (x 20). The photograph shows softened/extruded debris with what looks like craters in between. Note the irregular shape of the deposit after being flattened by the ball.

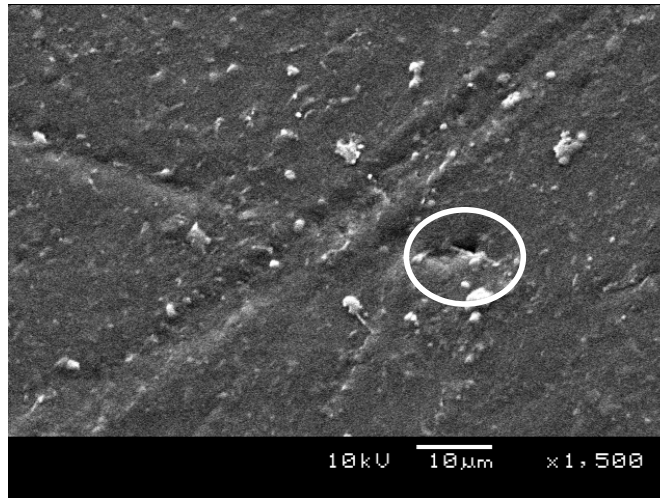
These particles ripped from the base material, result in abrasion wear as can be seen in Figures 5.38 and 5.39.

Figure 5.38: Surface of acetabular cup with scratches due to third-body wear (magnification x 1 500)

To ensure that the scratches, as can be seen in Figure 5.38, were not a result of PMMA cement entering the bearing area, an electron microscope study with back scatter analysis was performed. In doing this analysis, the base material (UHMWPE) is compared with the particle lodged in the base material (encircled in Figure 5.38) at the end of the scratch to see if the particle is the same or if the

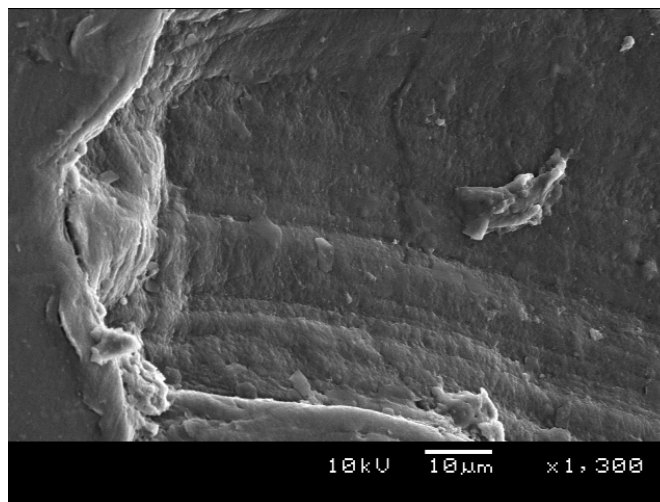
Figure 5.39: Abrasion wear on acetabular cup (magnification x 1 300)

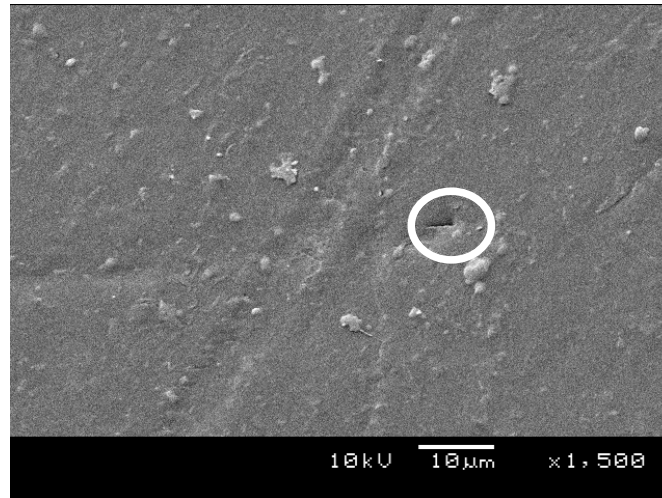
Figure 5.40: Back scatter analysis on wear particle lodged at end of abrasion wear in acetabular cup (magnification x 1 500)

From the back scatter analysis, as presented in Figure 5.40, in conjunction with a stereoscope investigation it can be concluded that the particle responsible for the abrasion wear as shown in Figures 5.38 and 5.39 was indeed an UHMWPE particle that was dislodged from the bearing area as foreign particles are now showing up in the abrasion area. In the area encircled in Figure 5.40, a cavity is also exposed penetrating into the acetabular cup. This type of cavity can create a stress raiser which can lead to early fracture of the acetabular cup.

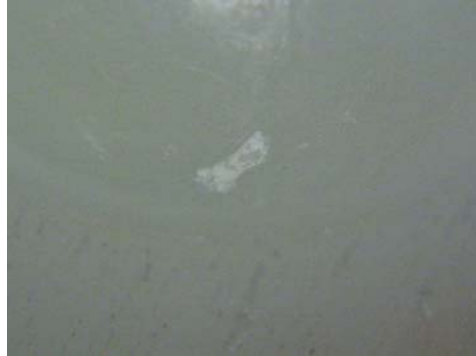
A further analysis was done making use of the electron microscope. In Figure 5.41 an acetabular cup is shown with defects similar to the adhesion wear defects shown in Figures 5.28 and 5.29. The aim of this analysis was to gain a better understanding of the detail inside these adhesion wear areas.

Figure 5.41: Adhesion wear area in acetabular cup

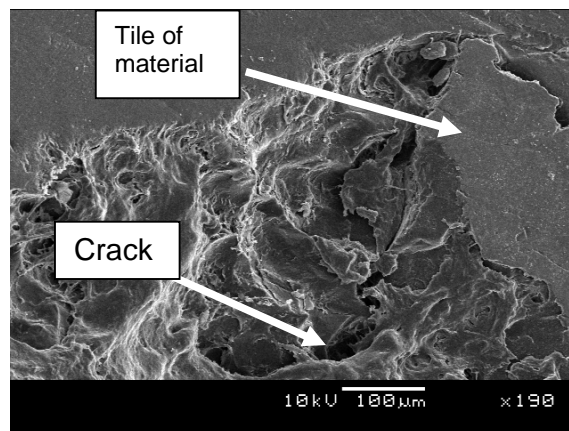
Figure 5.45: Adhesion wear under higher magnification (magnification x 190)

In the top right-hand corner of adhesion wear defect as presented in Figure 5.45 again it is clear that the top surface of the bearing area has been ripped off by adhering to the femoral head exposing the deeper part of the UHMWPE. It

would appear that the area was exposed by ripped-off tiles of UHMWPE. A tile at the verge of being dislodged is shown in Figure 5.45. Also visible in Figure 5.45 is the start of a deep crack propagating into the base of the acetabular cup. This crack will likewise create a stress raiser that may lead to early fracture of the acetabular cup.

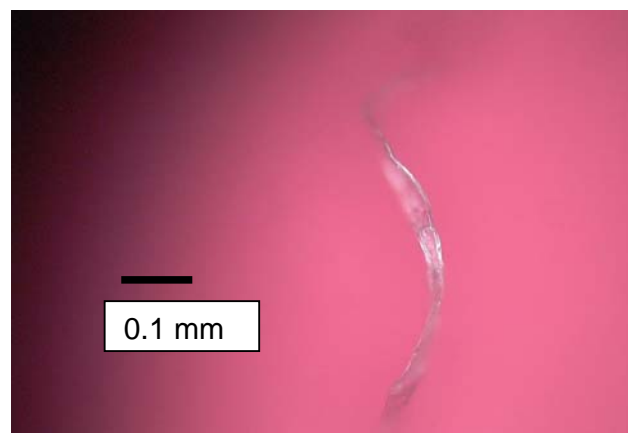
Figure 5.52: Retrieved particle (magnification x 100)

The extruded whisker shown in Figure 5.52 is almost 0.6 mm long. The full whisker is not shown in the picture as it curves up and down on the filter paper and is therefore difficult to get in focus.

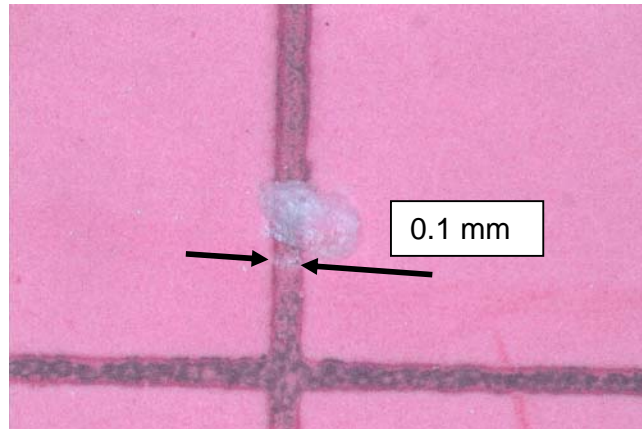
The microscope revealed particles with extruded edges, namely particles that became sufficiently plastic to allow extrusion of fibre-like particles from the base material under the prevailing pressure. The retrieved particles are shown in Figures 5.51 to 5.54.

Figure 5.53: Retrieved particle (magnification x 40)

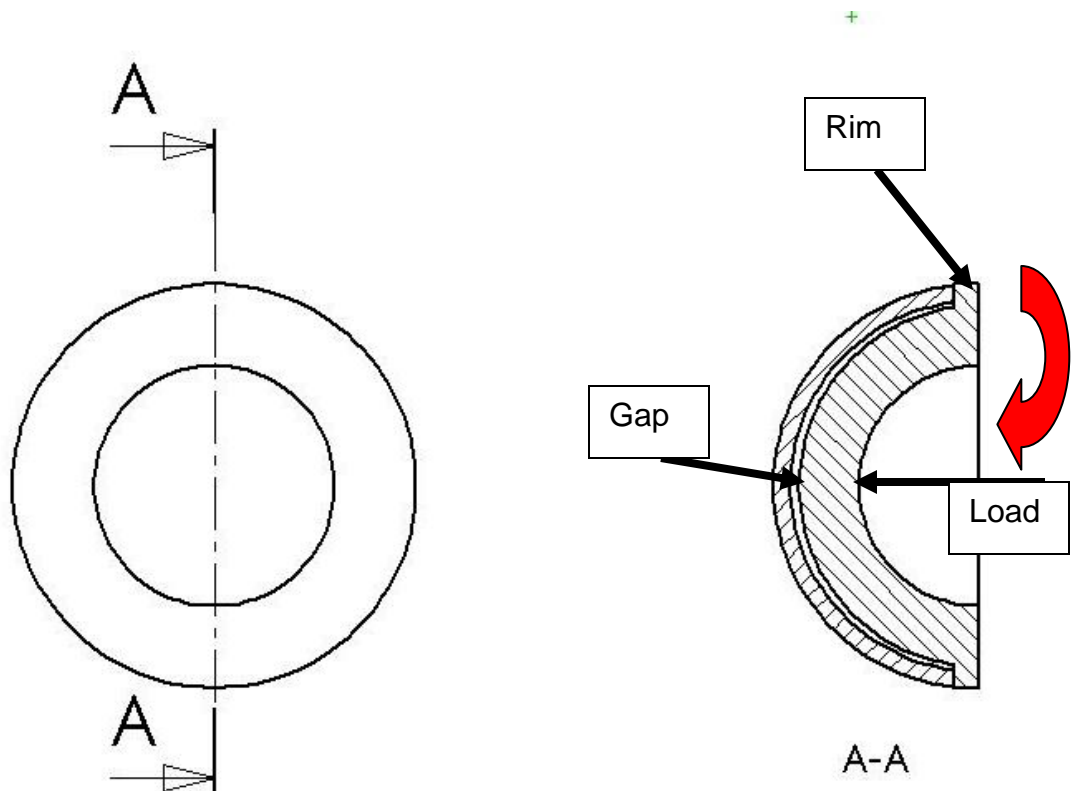
This failure of cracks and accompanying delamination on the rim of the cup were only seen in metal back cups and also only in the metal back cups from one specific manufacturer. On closer inspection, it was noted that the UHMWPE liner does not fit snugly into the metal backing allowing the resultant forces in the hip joint to be transmitted into the pelvis via the rim of the UHMWPE liner only. This principle is schematically shown in Figure 6.3.

Figure 6.3: Schematic layout of UHMWPE liner not fitting snugly into metal backing

As can be seen from Figure 6.3, there is a small gap between the UHMWPE liner and the metal backing. The load coming into the bearing area will now deform the cup resulting in a bending moment with the corresponding bending stress in the rim of the cup. As the patient is walking, this load will vary according to the load profiles defined in Chapter

2 (Paul, 1976; Bergmann et al., 1993; ISO 14242-1, 2002), resulting in a dynamic load input into the rim of the UHMWPE that can lead to the fatigue failure that is manifested in the form of cracks and the delamination of the rim interface.

From the data presented, it can be accepted that this failure is due to an error either during the design or during the manufacturing process of the metal backing or the UHMWPE liner. As this defect is not a result of the wear mechanism active in-vivo, this defect will not be investigated further.

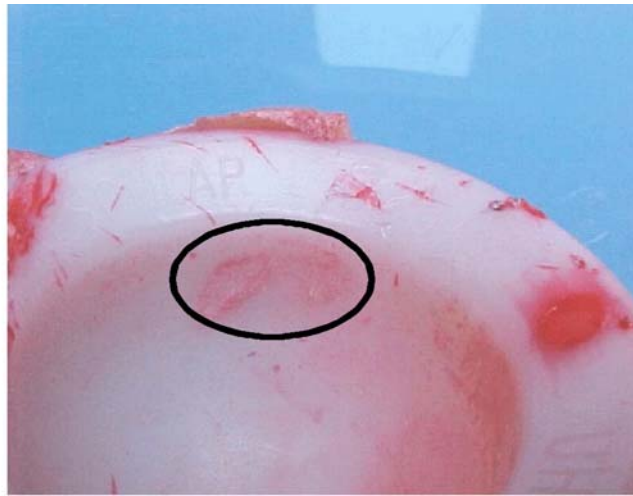
In the observations done in this chapter, areas of adhesion wear were identified. These areas were first identified during the visual examination of the retrieved components as shown in Figure 6.22. When the components were treated with dye penetrant spray, these affected areas became clearly visible, as shown in Figure 6.23. The areas were characterised by a typical butterfly shape as described by Wang et al. (1997), where the surface of the bearing area seemed to be broken up. In some of the cups, the machining marks are also still visible under higher magnification, as shown in Figure 6.24. The edges of these areas are very rough and this is indicative of the temperature under which the removal of the material took place.

Figure 6.23: Butterfly wear pattern on inside of acetabular cup

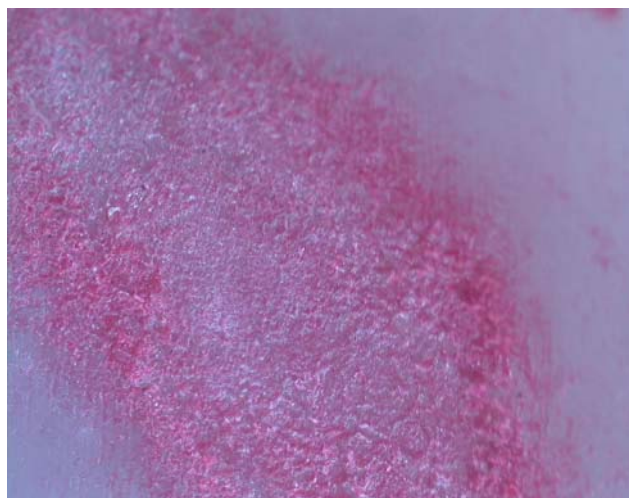
Figure 6.24: Area with adhesion wear (magnification x 40)

The area with adhesion wear, as indicated in Figure 6.21, was then further investigated making use of the electron microscope. From the data obtained from the electron microscope, as presented in Chapter 5, it is evident that in this area adhesion of the material to the femoral head took place. The surface of the bearing was subsequently ripped, exposing the deeper part of the base material as is shown in Figure 6.25.

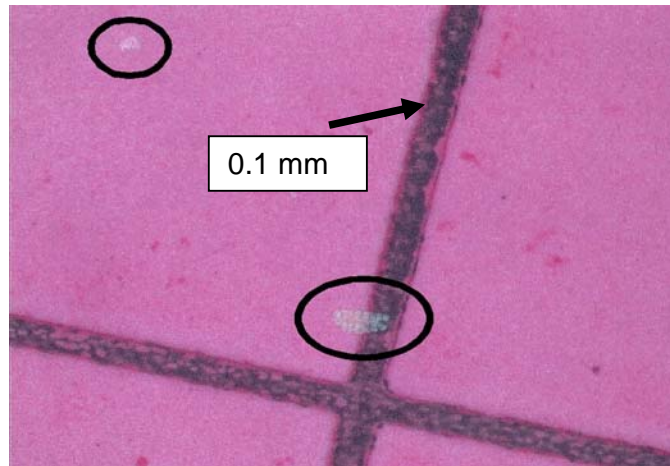
Temperatures of up to 65°C were measured in the bottom of the cup within 15 minutes of operation where after the temperature stabilised at 65°C. The lubricating fluid in the chamber was kept at a constant temperature of 37.5°C. As described, the first sample was taken after only 250 000 cycles and the lubricating fluid was filtered through a 0.45µm filter. The same technique, as described in Chapter 5, was used, in other words colouring of the filter paper enabled the wear particles to become visible against the coloured filter paper and allowed them to be studied under a microscope. In Figure 7.12, two wear particles can be seen at 40 times magnification.

Figure 7.12: Wear particles on filter material (magnification x 40)

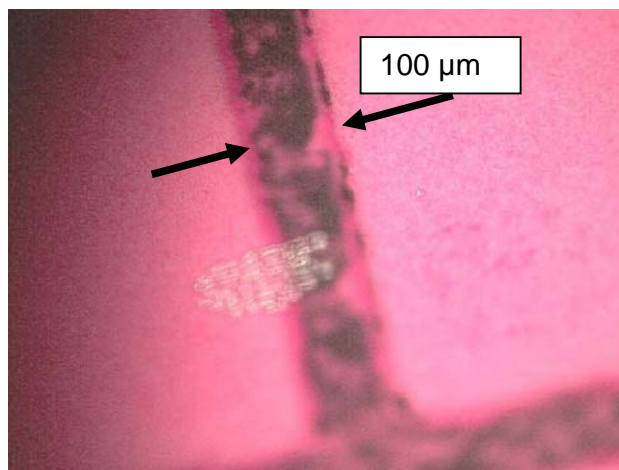
In Figure 7.13, the larger particle is shown under a magnification of 100 times. From this photograph (see the enclosed CD for better clarity), the extruded edges are clearly visible. The shape of the wear particle indicates that the temperature at localised spots rises sufficiently to allow the particle to be transferred or to be extruded. The same particle but under 900 x magnification is shown in Figure 7.14.

Figure 7.13: Wear particle retrieved from simulator (magnification x 100)

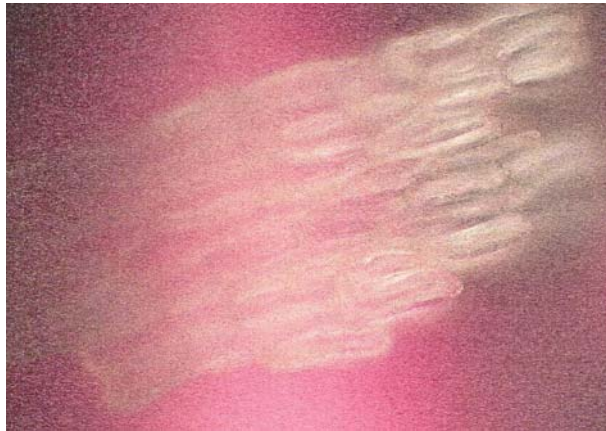
Figure 7.14: Retrieved wear particle from simulator (magnification x 900)

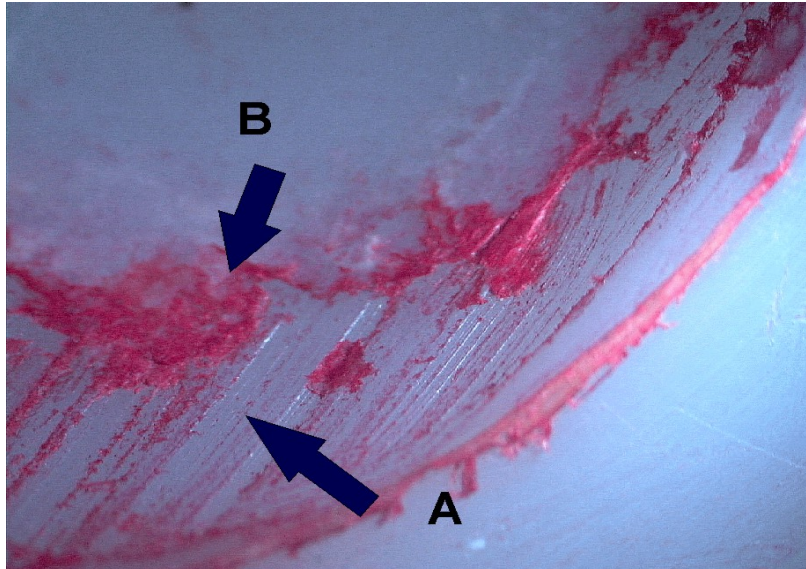
Failure occurred after about 10 minutes, at 90 Hz, when strands of plastic were forced out from the bearing surface in the acetabular cup. The

Figure 7.15: Wear surface on the inside of the cup (magnification x 10)

- a. An area is visible where it appears as if the material was torn out of the base material, leaving what looks like scratch marks. (See A in Figure 7.15 and enlarged in Figure 7.16 also marked by an A)
- b. On the edge of the high-wear area, extrusions are visible. This is marked with a B in Figure 7.15 and enlarged in Figure 7.16.

The test without any lubrication failure of the acetabular cups, as shown in Figures 7.15 and 7.16, happened so quickly that no temperature readings were possible.

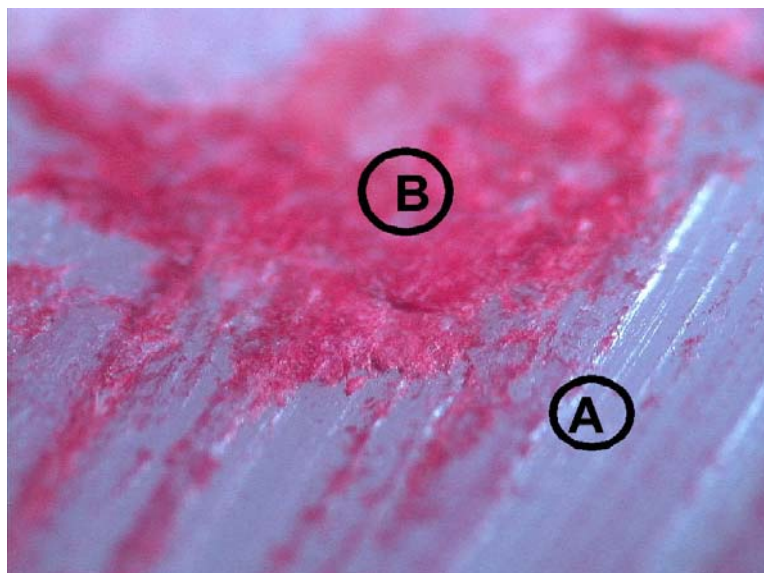
Figure 7.16: Wear on inside of a cup (magnification x 20)

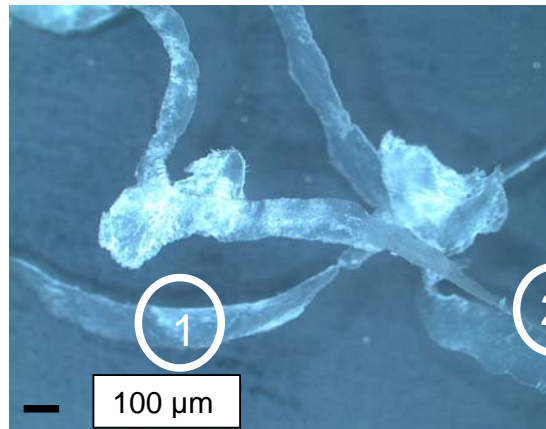
Figure 7.17: Wear debris retrieved from an acetabular cup on simulator (magnification x 20)

- c. If one looks closely at the retrieved wear debris, Figures 7.17, 7.18 and 7.19, signs of waviness on the edges are visible, suggesting formation at an elevated temperature. The extruded whiskers, as described in paragraph 5.8.2, are also visible.

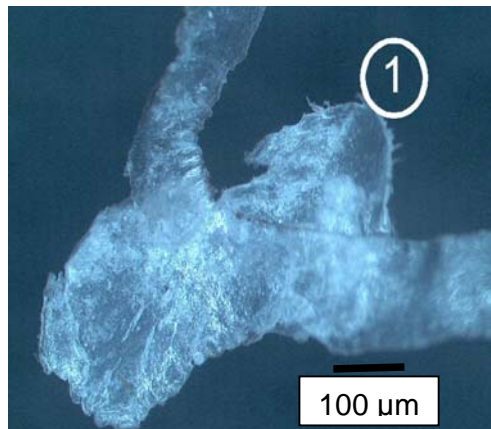
Figure 7.18: Wear debris retrieved from an unlubricated acetabular cup in a hip simulator (magnification x 40)

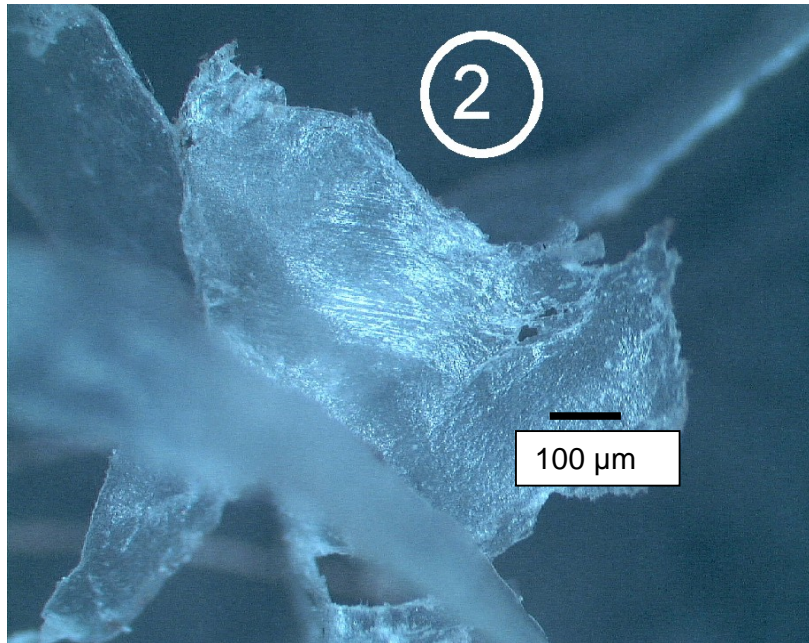
Figure 7.19: Wear debris retrieved from an unlubricated acetabular cup in a hip simulator (magnification x 40)

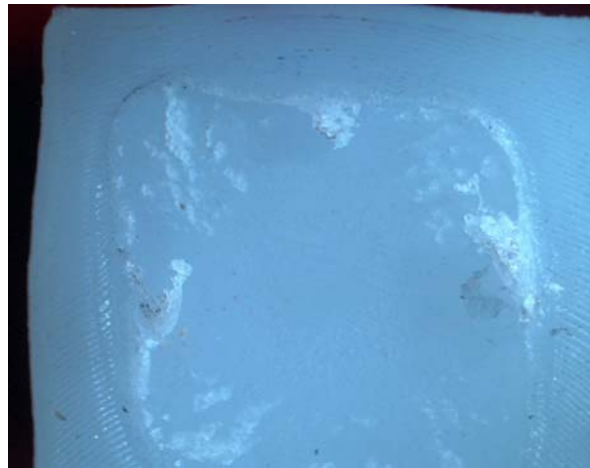
A temperature of 105°C was measured on the surface of the UHMWPE test piece at the onset of debris formation. The resulting damage on the UHMWPE test piece can be seen in Figures 7.21 and 7.22.

Figure 7.21: Area of damage on a test piece

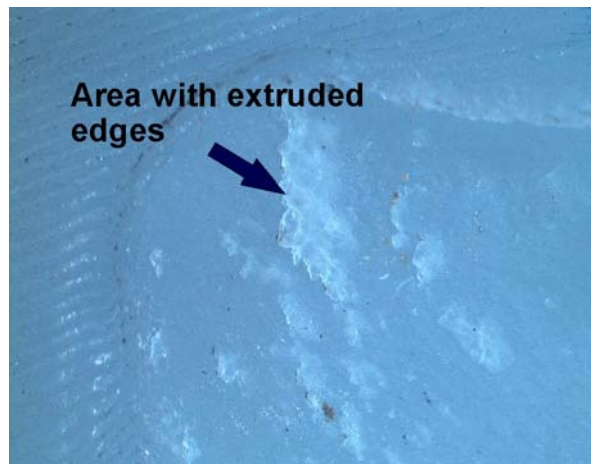
Figure 7.22: Surface damage on UHMWPE test piece (magnification x 20)

visible, as well as whiskers of material that were extruded under the prevailing heat and pressure. Also visible in these test results is the plastic flow of the material as described in Chapters 5 and 6. The plastic flow on the test piece can be seen in Figure 7.22.

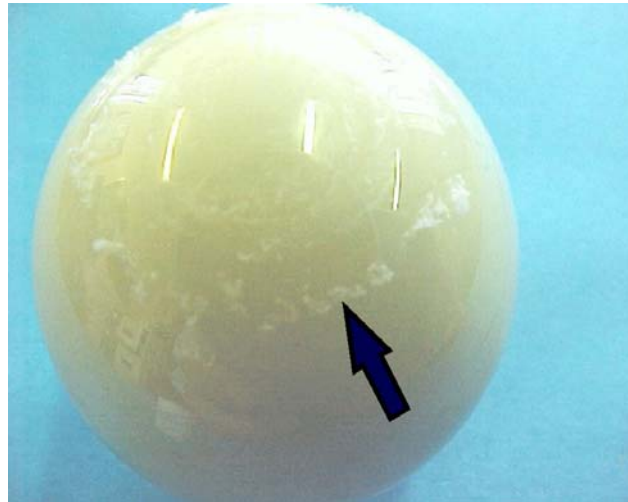
In Figure 7.23, the wear debris adhering to the ceramic femoral ball is also visible. The extruded edges, as presented earlier, are also visible on the debris that had formed during the test.

Figure 7.23: Wear debris adhering to femoral ball — indicated with an arrow

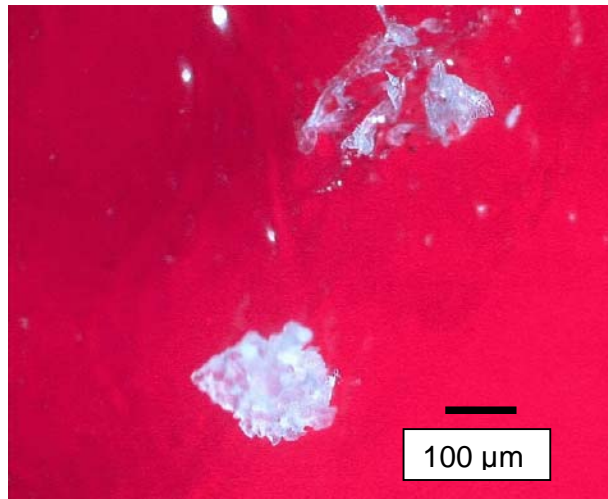
Figure 7.24: Wear debris generated by frictional heat at a measured temperature of 105°C (magnification x 40)

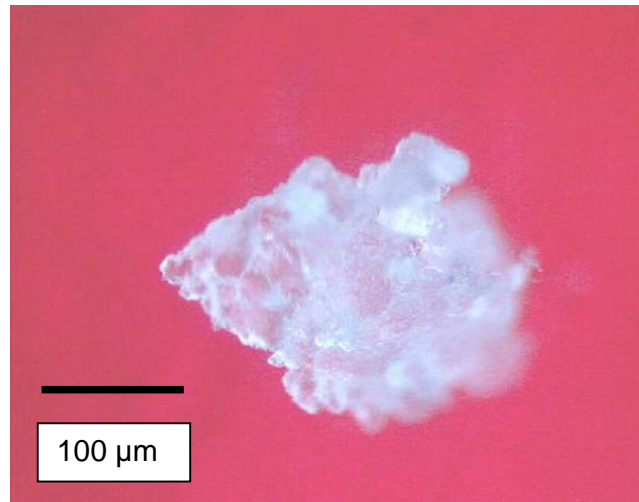
Figure 7.25: Wear particle at higher magnification (magnification x 100)

The particle shows evidence that it heated up sufficiently to adhere to the ceramic femoral head and to be ripped from the base material.

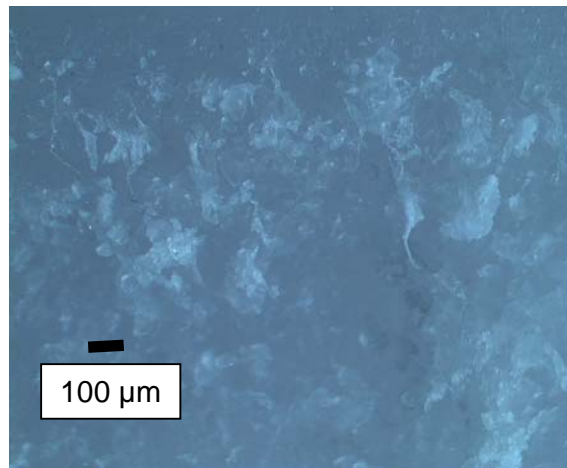
At 100°C, the surface of the test piece again showed evidence of the femoral head adhering to the UHMWPE and then ripping out and extruding particles from the base material. This phenomenon was not expected at 90°C or lower in this short duration test, as the temperatures measured during the frictional heating test were above 100°C. (See Figures 7.27 and 7.28 for the damage on the UHMWPE surface and Figure 7.29 showing the wear particles adhering to the femoral ball.)

Figure 7.27: Surface of a test piece after damage by preheated femoral head (magnification x 10)

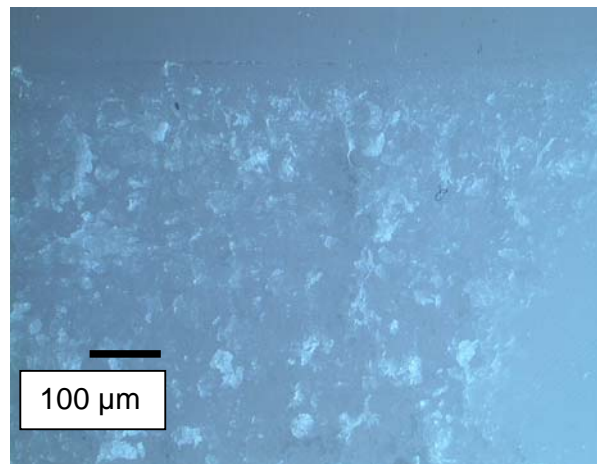
Figure 7.28: Damage surface of UHMWPE test piece (magnification x 20)

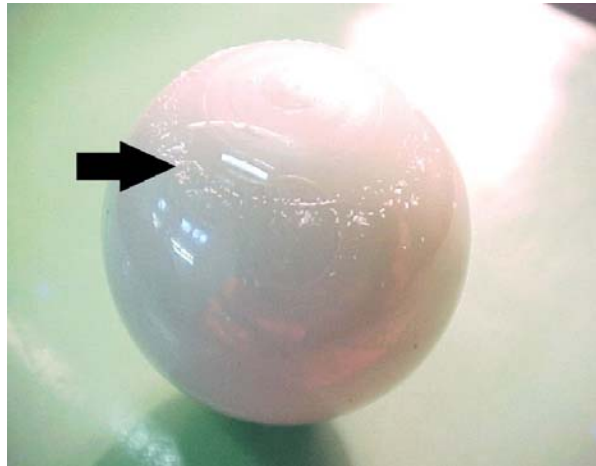
Figure 7.29: Wear particles adhering to femoral ball — indicated with an arrow

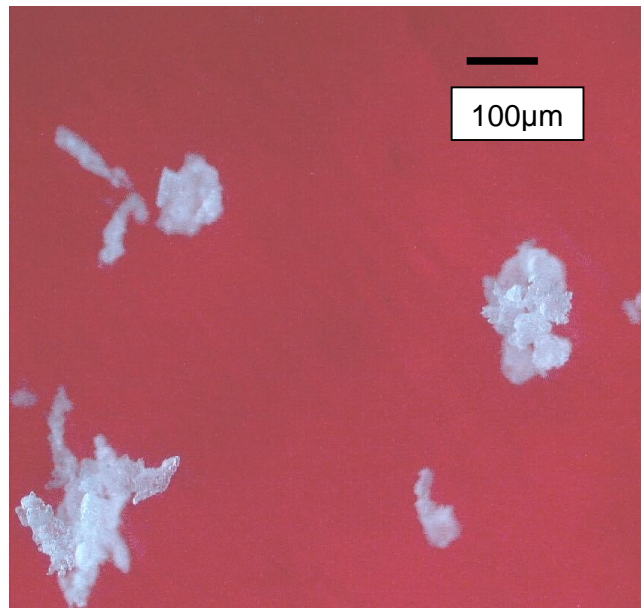
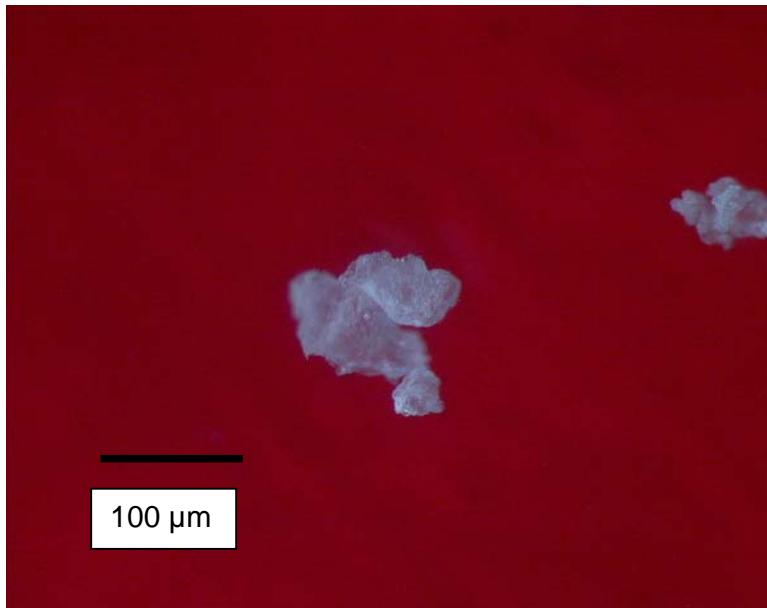
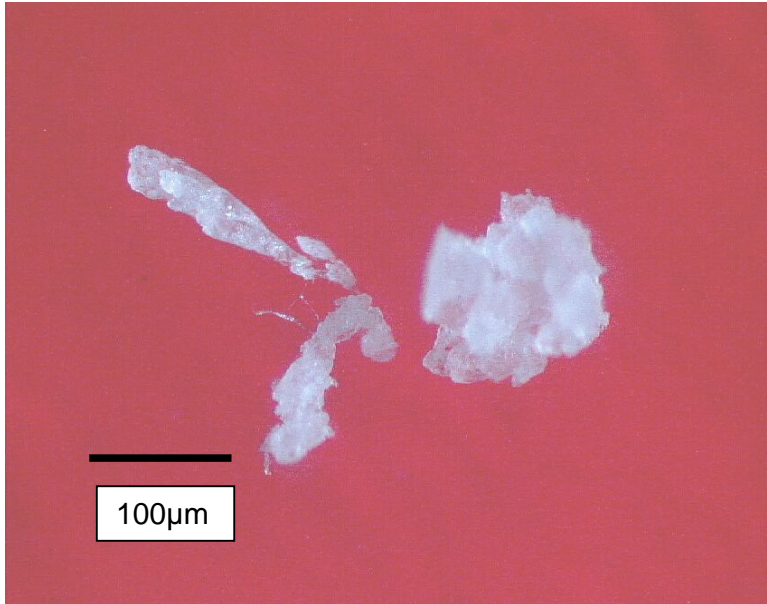
Figure 7.30: Retrieved wear debris from preheated ball test. Ball temperature 100°C (magnification x 20)

Figure 7.31: Wear particles retrieved from externally heated femoral head at temperature of 100°C (magnification x 40)

Figure 7.32: Wear particles retrieved from externally heated femoral head at a temperature of 100°C (magnification x 40)

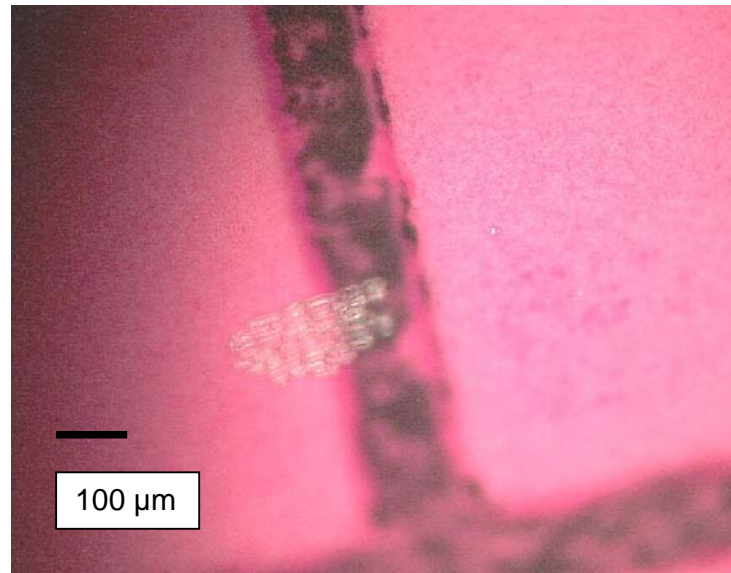
Figure 7.35: Wear debris retrieved from simulator (magnification x 100)

If the wear debris in Figure 7.35 is compared with wear debris retrieved from the scar tissue, as shown in Figure 7.36, as well as the particle still attached to the acetabular cup as shown in Figure 7.37, a similarity in shape and size between the different debris is visible.

All the debris retrieved from simulator and tissue, showed signs of the bumpy surface where the particles were ripped from the base material after adhering to the femoral head. This failure is only possible if the localised temperature in the acetabular cup is high enough for the material to be sufficiently softened to enable the adhesion of the UHMWPE to the femoral head with the consequent ripping of the material from the base material. The temperatures measured during the current study showed
