**FAILURE ANALYSIS OF ULTRA-HIGH MOLECULAR WEIGHT
POLYETHYLENE ACETABULAR CUPS**

NICOLAAS DANIEL LOMBARD BURGER

DOCTOR PHILOSOPHIAE (PhD)

DECEMBER 2005

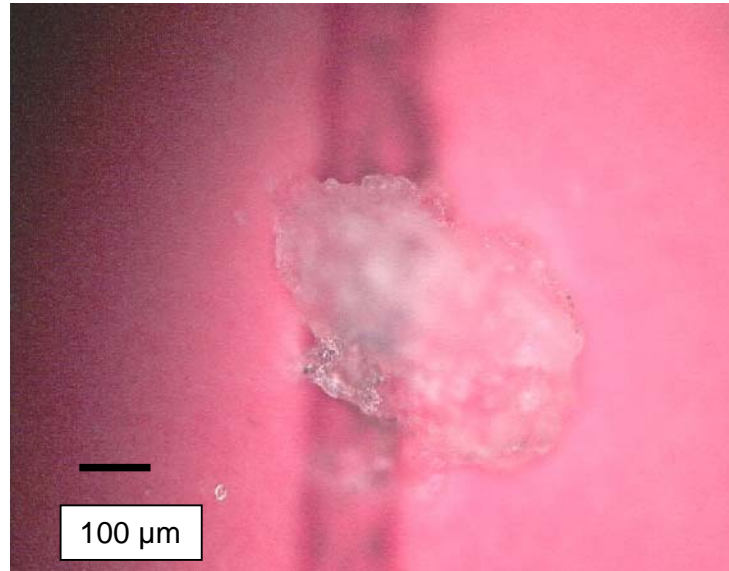
If the wear debris in Figure 7.35 is compared with wear debris retrieved from the scar tissue, as shown in Figure 7.36, as well as the particle still attached to the acetabular cup as shown in Figure 7.37, a similarity in shape and size between the different debris is visible.

Figure 7.36: UHMWPE wear debris retrieved from scar tissue (magnification x 100)

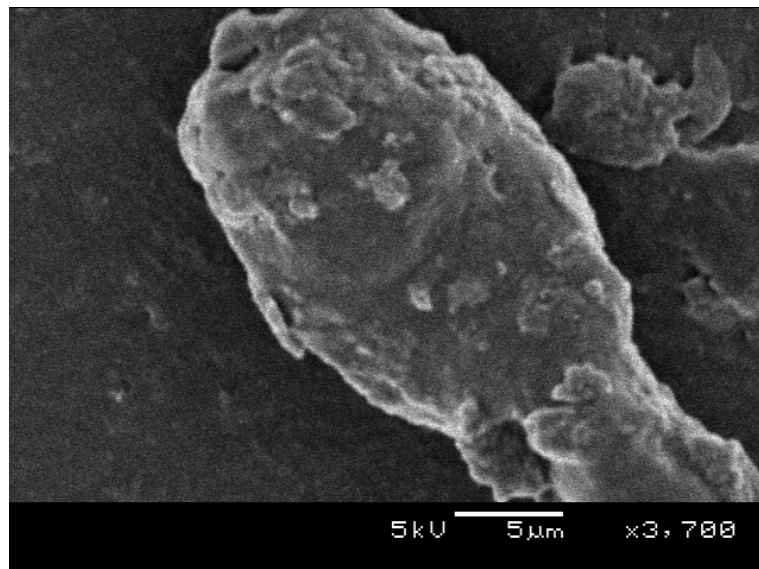
Figure 7.37: UHMWPE wear particle still attached to base material (magnification x 3 700)

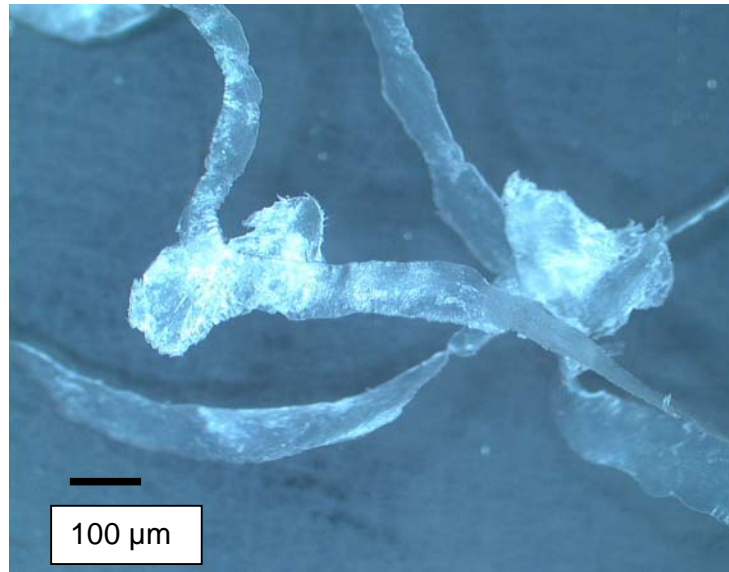
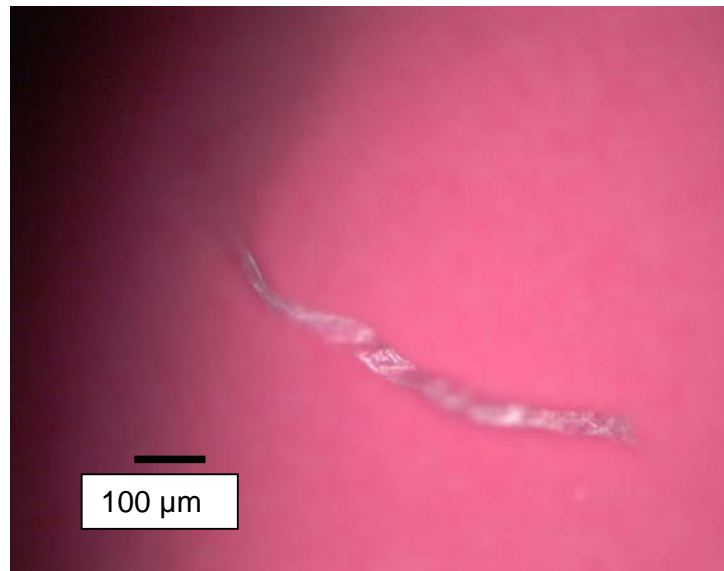
Figure 7.38: UHMWPE wear debris retrieved from simulator running without lubrication (magnification x 20)

Figure 7.39: UHMWPE wear debris retrieved from scar tissue (magnification x 100)

If the debris in Figures 7.38 and 7.39 is compared again the similarities are clear, although the debris retrieved from the simulator is much bigger. (See paragraph 7.4.)

All of the retrieved debris showed signs of extruded edges. It is proof that the extruded edges are indicative of overheating on the interface between the ceramic femoral head and the UHMWPE acetabular cups. The indication in both the wear debris retrieved from the scar tissue and the debris generated in the simulator is that the material was heated sufficiently to be softened to such an extent that the material was extruded under the prevailing pressure.

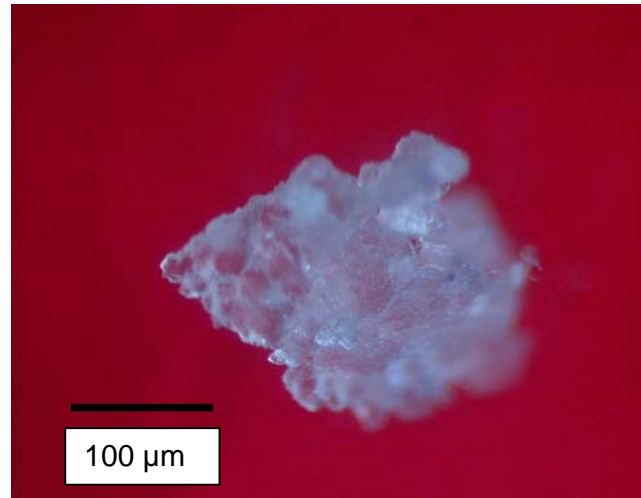
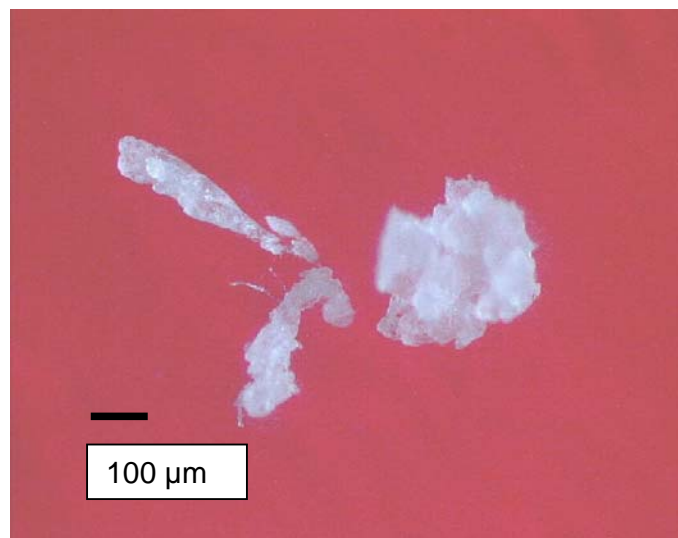
The wear debris generated during both of these tests was fairly similar, as can be seen in Figures 7.40 and 7.41. In both tests, the temperature generated and the preheated temperature required to form the type of wear debris as shown were in excess of 90°C. The similarity between the wear debris generated and the debris retrieved from the scar tissue is also remarkable. A particle retrieved from the scar tissue is shown in Figure 7.42. Both pieces of material ripped from the base material after adhering to the femoral head are

Figure 7.40: UHMWPE wear particle generated by means of frictional heating (magnification x 100)

Figure 7.41: UHMWPE wear debris generated by preheating the femoral head (magnification x 40)

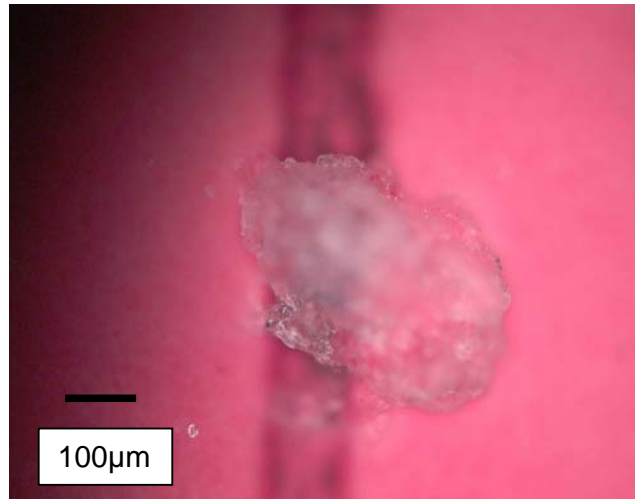
visible, as well as whiskers of material that were extruded under the prevailing heat and pressure. Also visible in these test results is the plastic flow of the material as described in Chapters 5 and 6. The plastic flow on the test piece can be seen in Figure 7.22.

Figure 7.42: UHMWPE wear debris retrieved from scar tissue (magnification x 100)

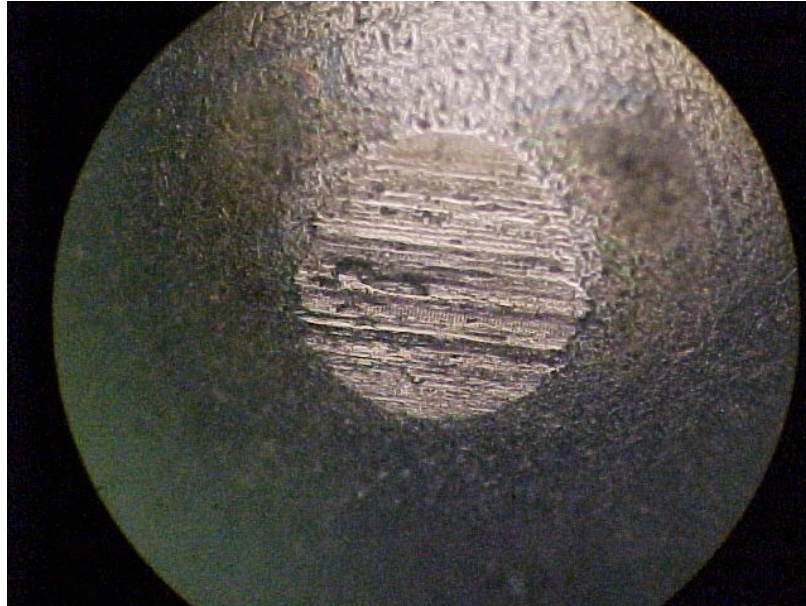
Figure 8.8: Wear scar on moving specimen (ball)

A typical wear scar size on the ball for a load at failure of 550N is 0.65 mm in the direction of sliding motion and 0.7 mm across the direction of the sliding motion.

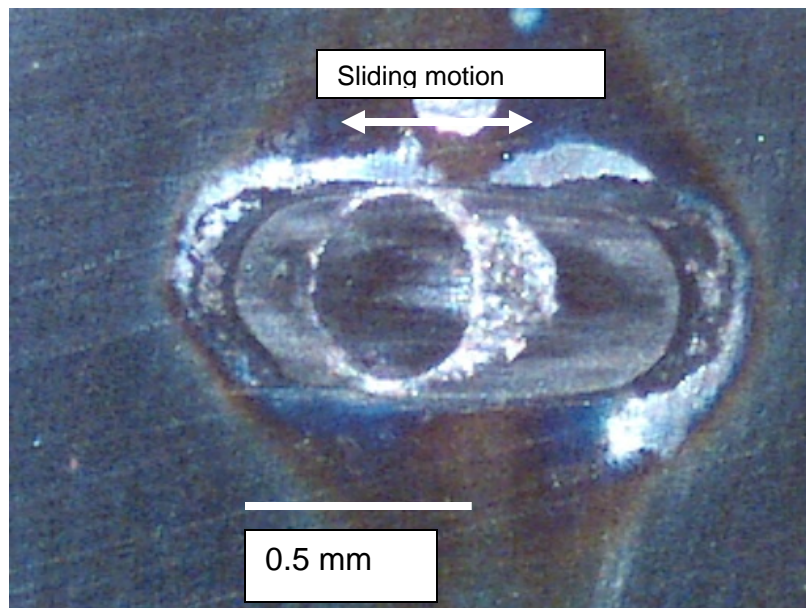
Figure 8.9: Wear scar on fixed specimen (disk) (magnification x 60)

From Figure 8.9, the visible imprint from the ball as it was cold welded to the surface and then, when disassembled, tore away. The size of the wear scar is a function of the load at which the lubricant failed.

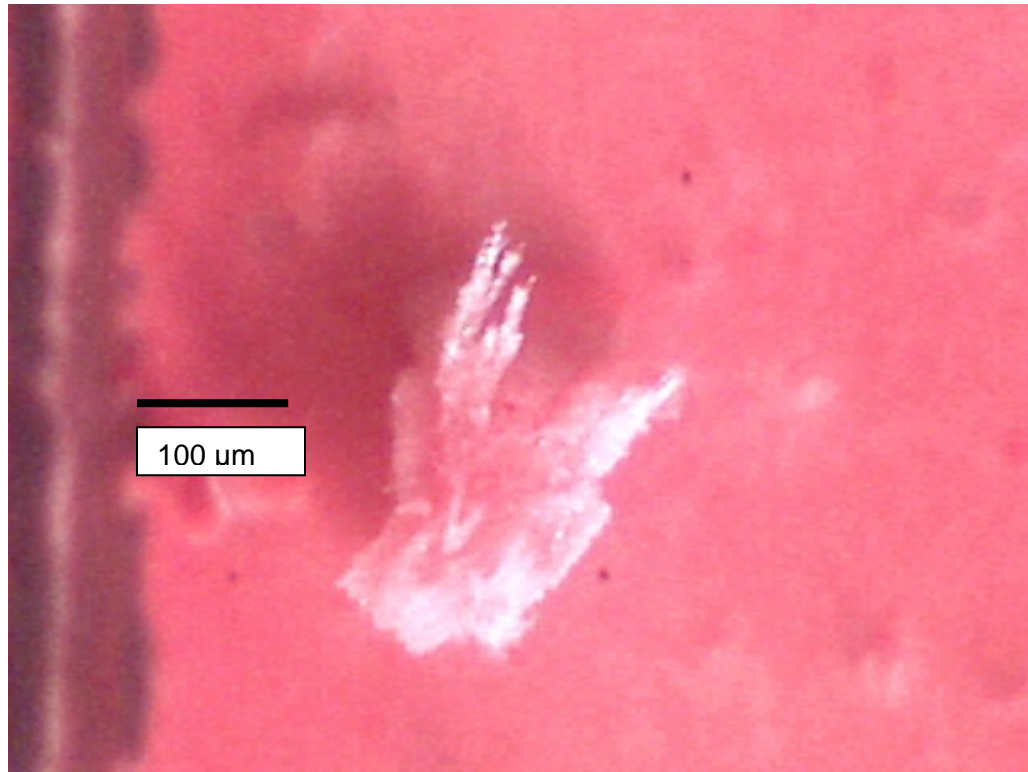
The wear debris retrieved from the scar tissue as presented in Figures 8.12 and 8.13, as well as in Chapters 5 and 6 was also consistent of wear debris generated in a bearing where there was inadequate lubrication.

Figure 8.13: Wear debris retrieved from patient no. 5 (magnification x 200)

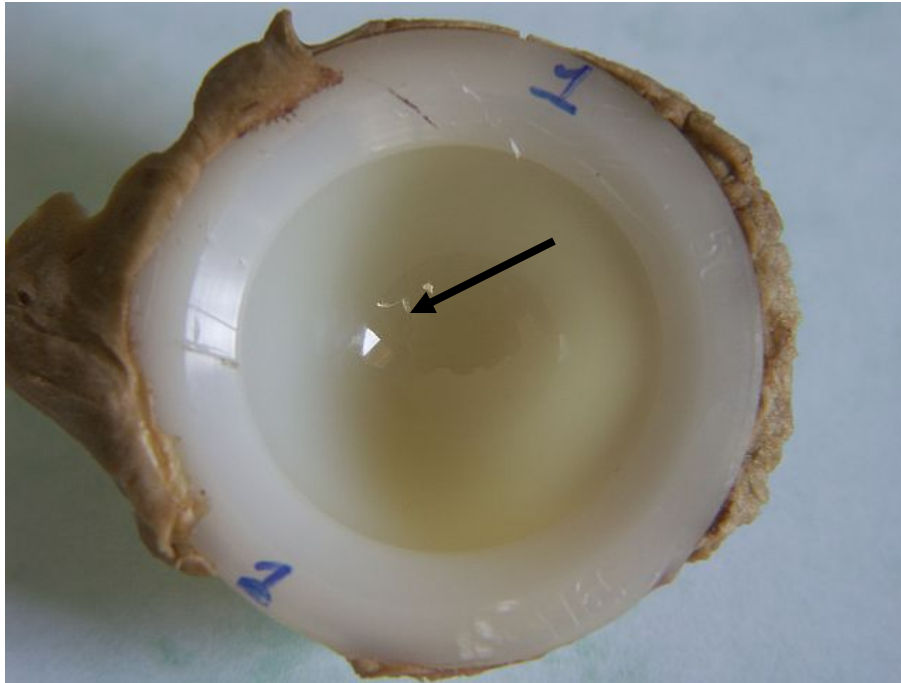
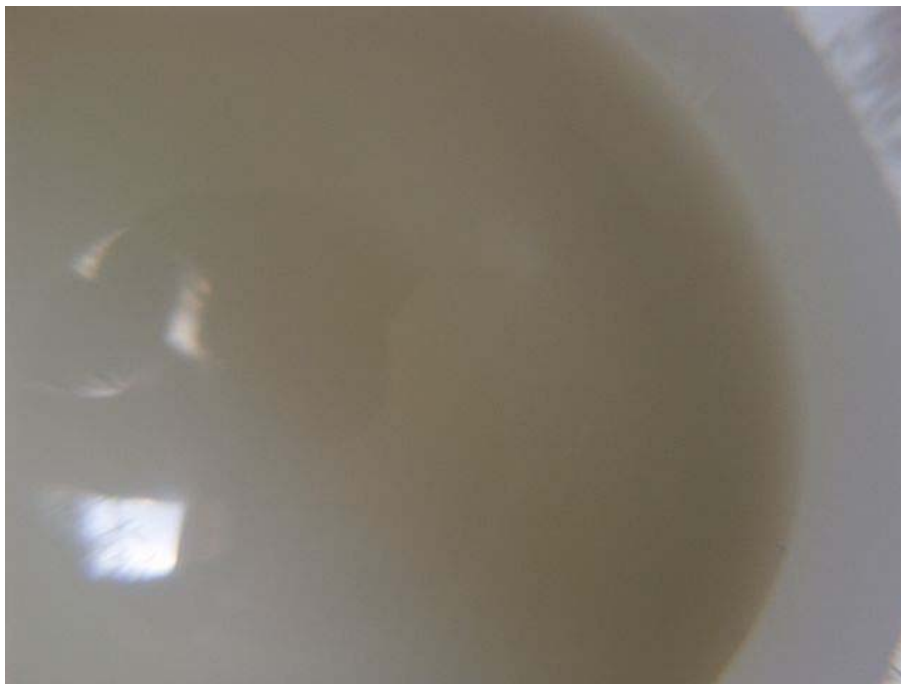
Patient 1

1	Femoral head size	32 mm
2	Type of head	Alumina
3	Cup type	UHMWPE - Osteal
4	Crosslink	No
5	Amount of linear wear	± 1.1 mm
6	Duration in vivo	13 years and 7 months
7	Size of wear debris from pathologist	10 – 30 µm
8	Visible discoloration	Yes (Figure 1)
9	Metal backing	No
10	Thickness of poly	9 mm
11	Mechanical damage	No
12	Cracks in material	No
13	Plastic flow	No
14	Scratches	No (visually)
15	Adhesion wear	Yes
16	Wear particles embedded in base material	No
17	Flaking	No

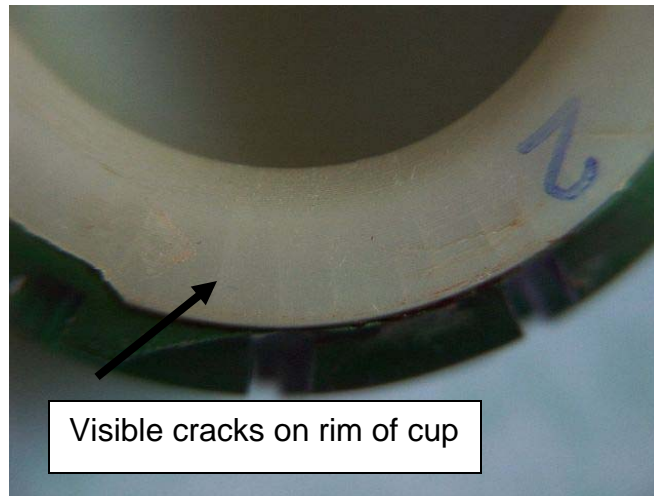
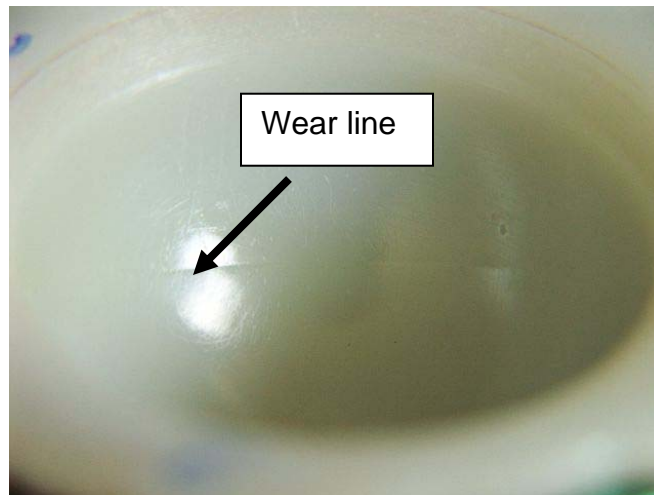
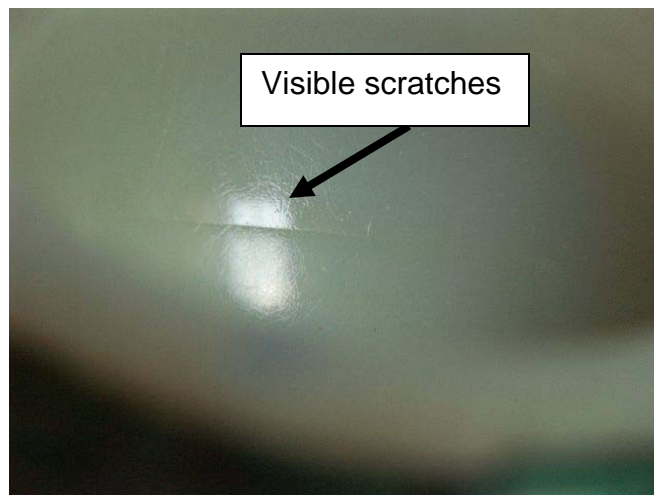
Patient 2

1	Femoral head size	32 mm
2	Type of head	Alumina
3	Cup type	UHMWPE - Osteal
4	Crosslink	No
5	Amount of linear wear	\pm 0.8 mm
6	Duration in vivo	17 years
7	Size of wear debris from pathologist	20 – 110 μ m, avg. 40 μ m
8	Visible discoloration	Yes (Figure 1)
9	Metal backing	No
10	Thickness of poly	\pm 7 mm
11	Mechanical damage	Yes
12	Cracks in material	Yes
13	Plastic flow	No
14	Scratches	Yes
15	Adhesion wear	No
16	Wear particles embedded in base material	No
17	Flaking	No

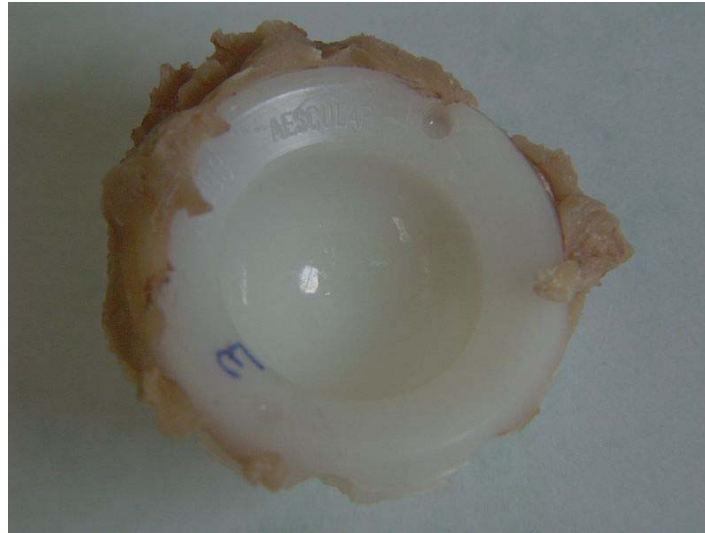
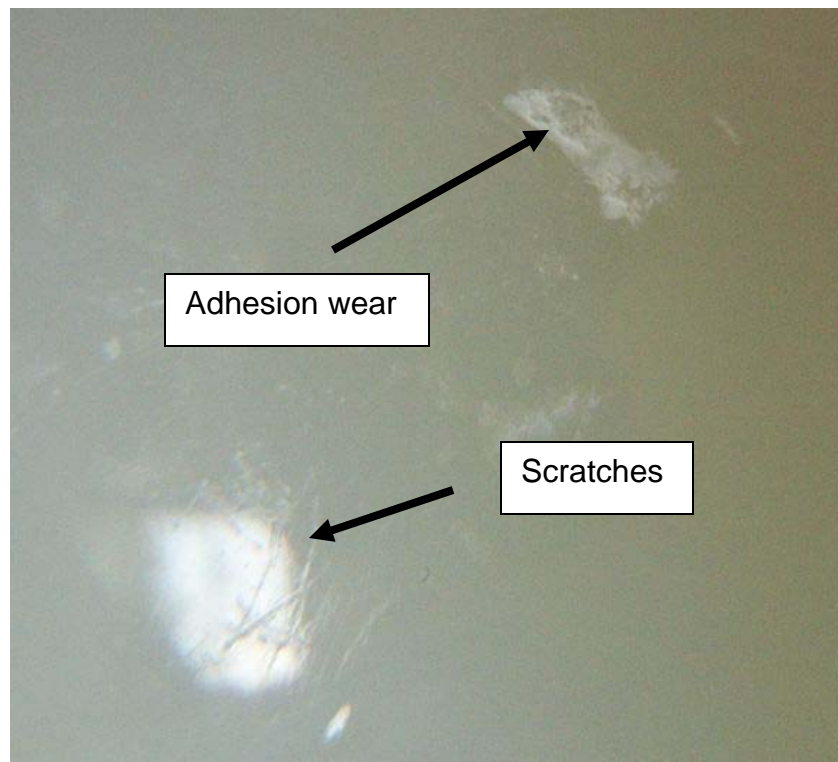
Patient 3

1	Femoral head size	26 mm
2	Type of head	Alumina
3	Cup type	UHMWPE - Aesculab
4	Crosslink	No
5	Amount of linear wear	± 0.4 mm
6	Duration in vivo	6 years
7	Size of wear debris from pathologist	10 – 50 µm
8	Visible discoloration	Yes (Figure 6)
9	Metal backing	No
10	Thickness of poly	9 mm
11	Mechanical damage	No
12	Cracks in material	No
13	Plastic flow	No
14	Scratches	Yes
15	Adhesion wear	Yes
16	Wear particles embedded in base material	Yes
17	Flaking	No

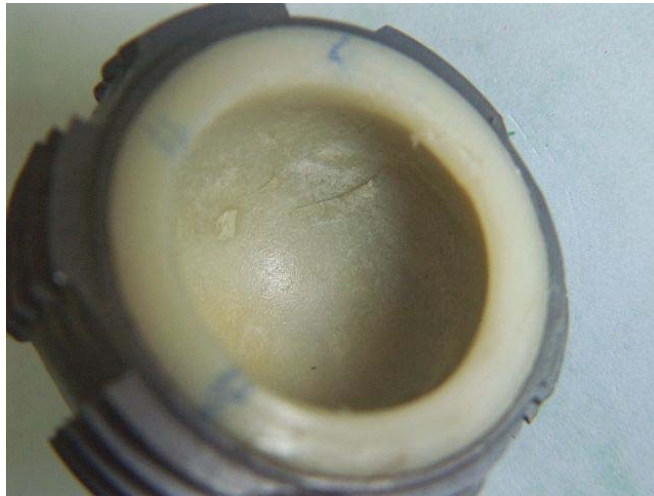
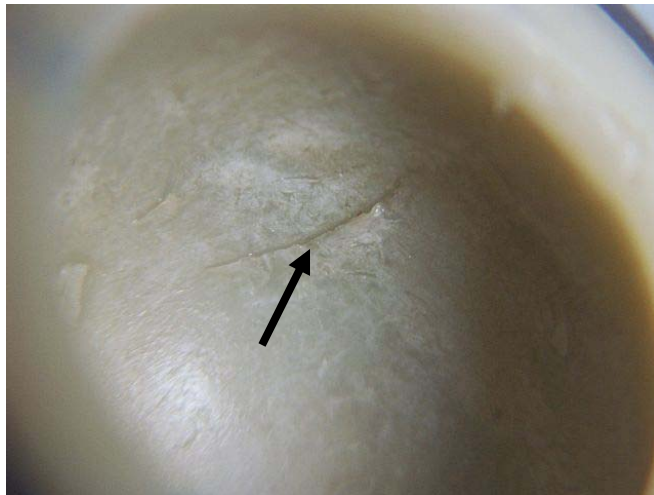
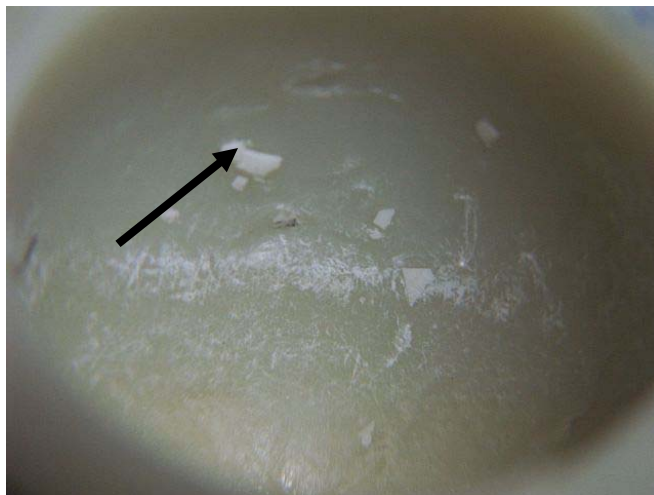
Patient 4

1	Femoral head size	32 mm
2	Type of head	Alumina
3	Cup type	UHMWPE – ARD
4	Crosslink	No
5	Amount of linear wear	± 4.5 mm
6	Duration in vivo	12 years
7	Size of wear debris from pathologist	10 – 90 µm
8	Visible discoloration	No
9	Metal backing	Yes
10	Thickness of poly	± 5 mm
11	Mechanical damage	Yes
12	Cracks in material	Yes
13	Plastic flow	No
14	Scratches	Yes
15	Adhesion wear	Yes
16	Wear particles embedded in base material	Yes
17	Flaking	No

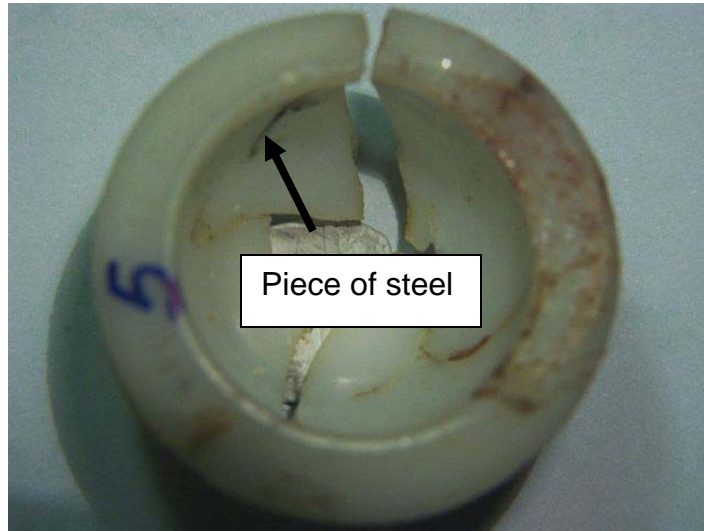
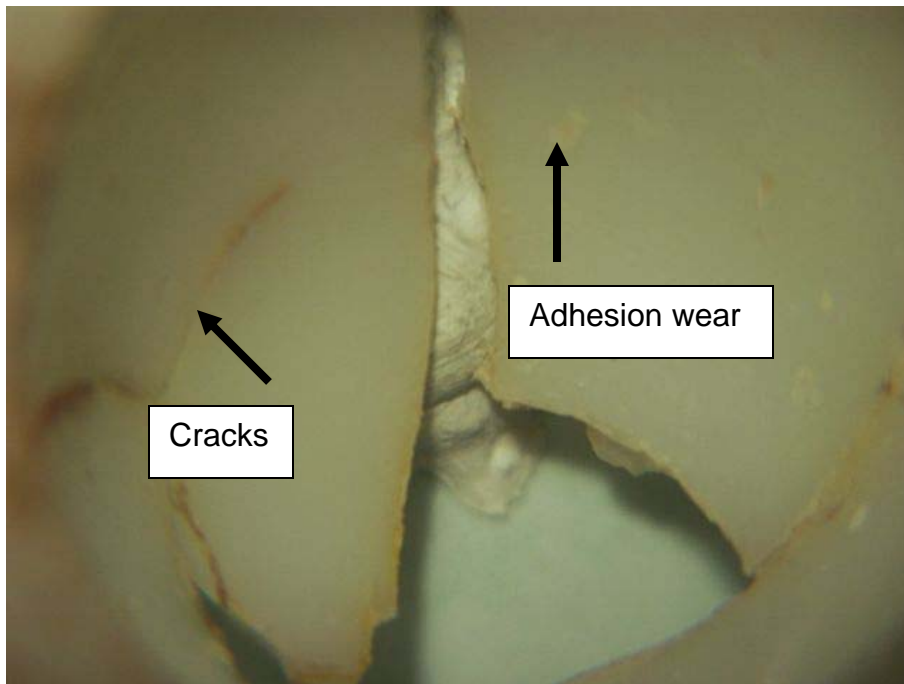
Patient 5

1	Femoral head size	32 mm
2	Type of head	Stainless
3	Cup type	UHMWPE – ARD
4	Crosslink	No
5	Amount of linear wear	± 5 mm
6	Duration in vivo	9 years and 5 months
7	Size of wear debris from pathologist	100 – 800 µm, avg. 600 µm
8	Visible discoloration	No
9	Metal backing	No
10	Thickness of poly	7 mm
11	Mechanical damage	Yes
12	Cracks in material	Yes
13	Plastic flow	No
14	Scratches	Yes
15	Adhesion wear	Yes
16	Wear particles embedded in base material	Yes
17	Flaking	No

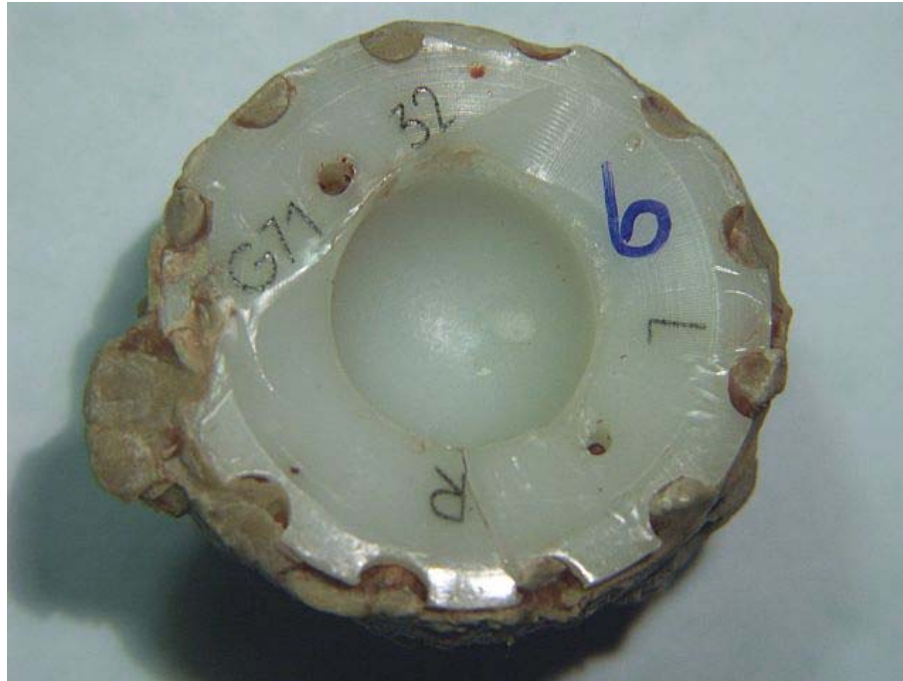
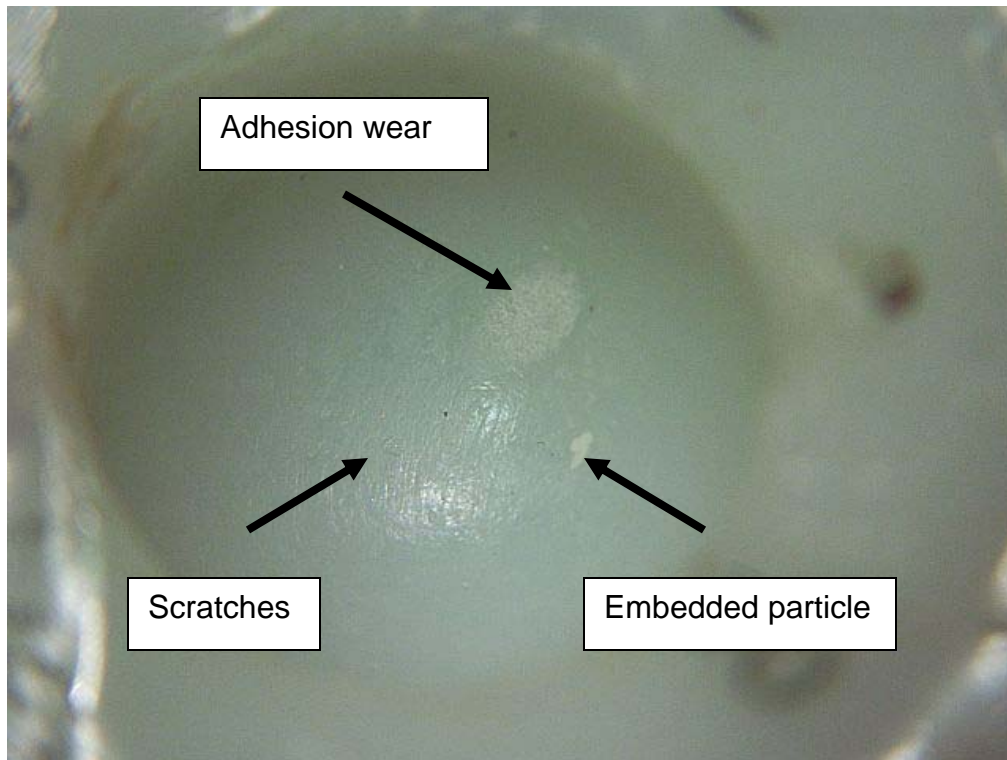
Patient 6

1	Femoral head size	22 mm
2	Type of head	Stainless
3	Cup type	UHMWPE – Charnley
4	Crosslink	No
5	Amount of linear wear	± 3 mm
6	Duration in vivo	8 years
7	Size of wear debris from pathologist	60 – 140 µm
8	Visible discoloration	No
9	Metal backing	No
10	Thickness of poly	14 mm
11	Mechanical damage	No
12	Cracks in material	No
13	Plastic flow	No
14	Scratches	Yes (figure 14)
15	Adhesion wear	Yes (figure 14)
16	Wear particles embedded in base material	Yes (figure 14)
17	Flaking	No

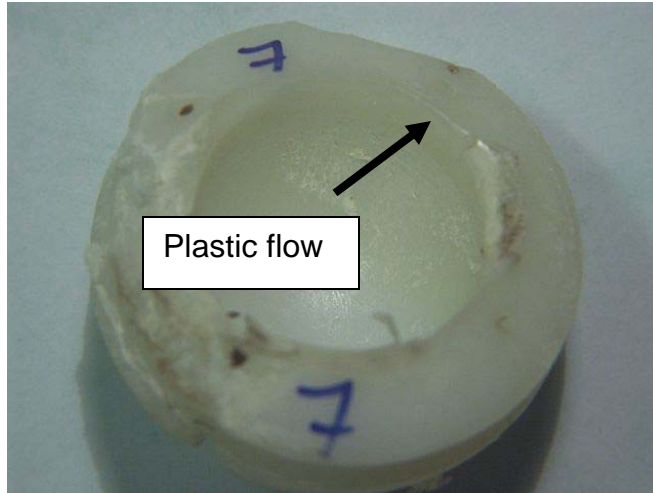
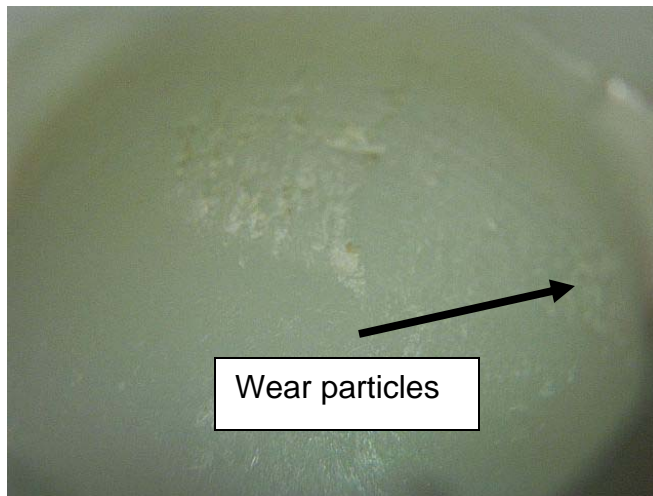
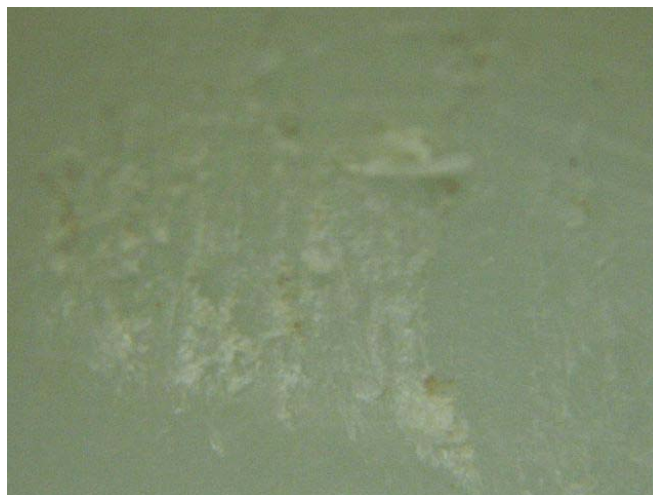
Patient 7

1	Femoral head size	30 mm
2	Type of head	Stainless steel
3	Cup type	UHMWPE – ARD
4	Crosslink	No
5	Amount of linear wear	± 5 mm
6	Duration in vivo	23 years and 5 months
7	Size of wear debris from pathologist	20 – 180 µm
8	Visible discoloration	No
9	Metal backing	No
10	Thickness of poly	9 mm
11	Mechanical damage	Yes
12	Cracks in material	No
13	Plastic flow	Yes (figure 15)
14	Scratches	Yes (figure 16 & 17)
15	Adhesion wear	Yes (figure 16 & 17)
16	Wear particles embedded in base material	Yes (figure 16)
17	Flaking	No

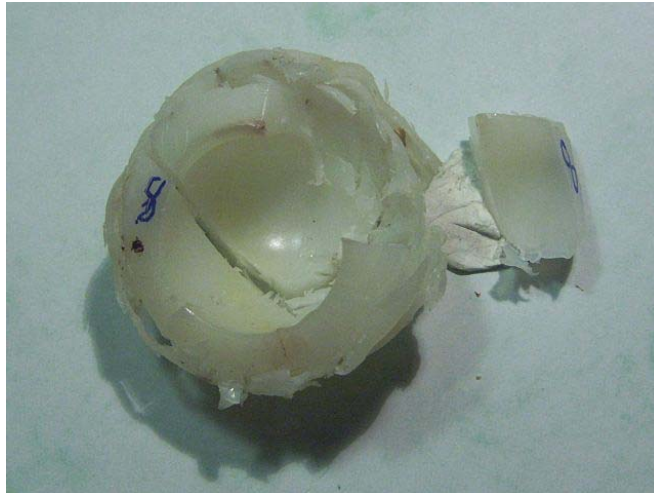
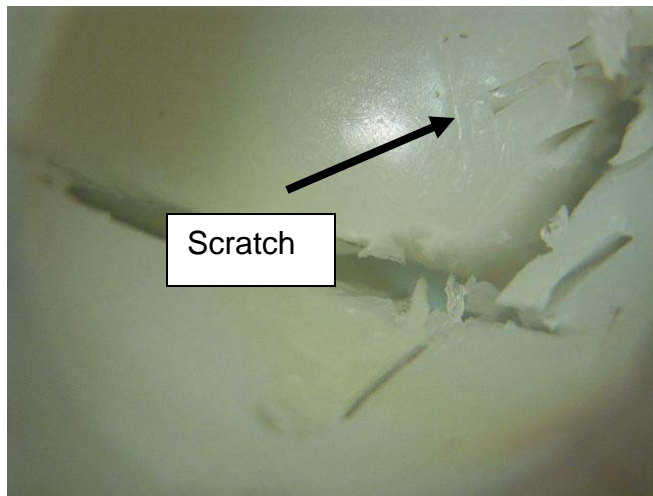
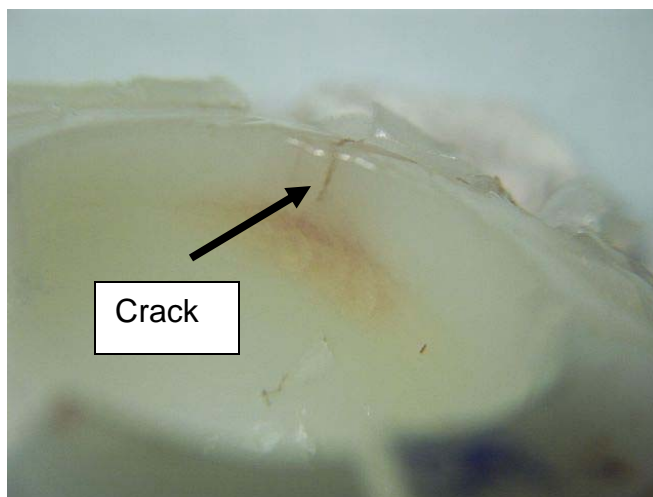
Patient 8

1	Femoral head size	30 mm
2	Type of head	Stainless steel
3	Cup type	UHMWPE – ARD
4	Crosslink	No
5	Amount of linear wear	± 5 mm
6	Duration in vivo	16 years and 4 months
7	Size of wear debris from pathologist	Not known
8	Visible discoloration	Yes (Figure 18)
9	Metal backing	No
10	Thickness of poly	9 mm
11	Mechanical damage	Yes
12	Cracks in material	Yes
13	Plastic flow	Yes
14	Scratches	Yes
15	Adhesion wear	Yes
16	Wear particles embedded in base material	Yes
17	Flaking	No

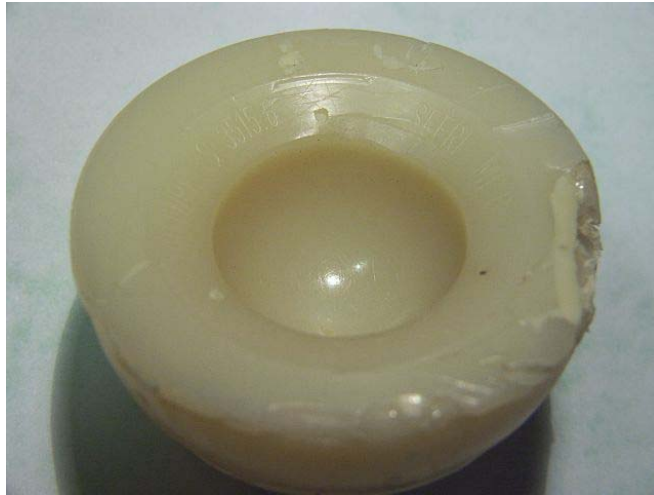
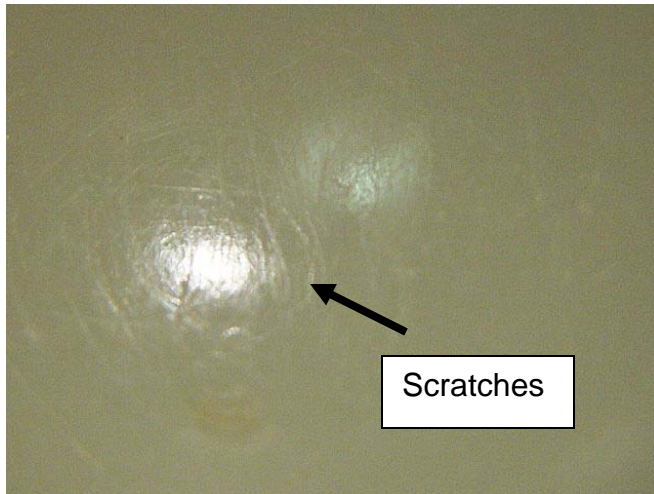
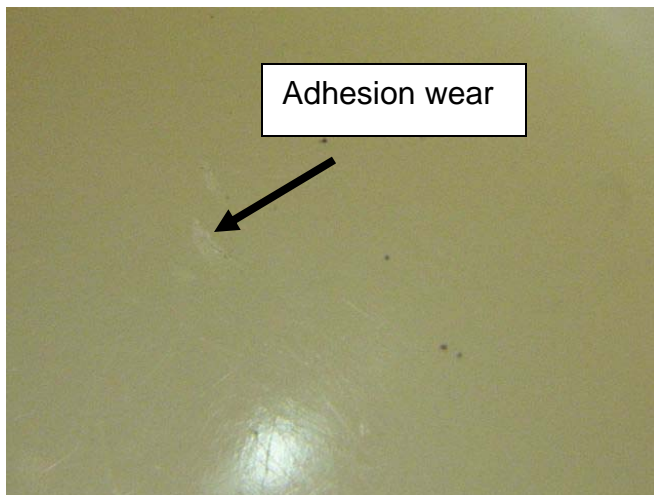
Patient 9

1	Femoral head size	32 mm
2	Type of head	Zirconium
3	Cup type	UHMWPE – Aesculab
4	Crosslink	Yes
5	Amount of linear wear	± 0 mm
6	Duration in vivo	3 years and 9 months
7	Size of wear debris from pathologist	Not available
8	Visible discoloration	No
9	Metal backing	Yes
10	Thickness of poly	19 mm
11	Mechanical damage	No
12	Cracks in material	No
13	Plastic flow	No
14	Scratches	Yes (figure 22)
15	Adhesion wear	Yes
16	Wear particles embedded in base material	No
17	Flaking	No

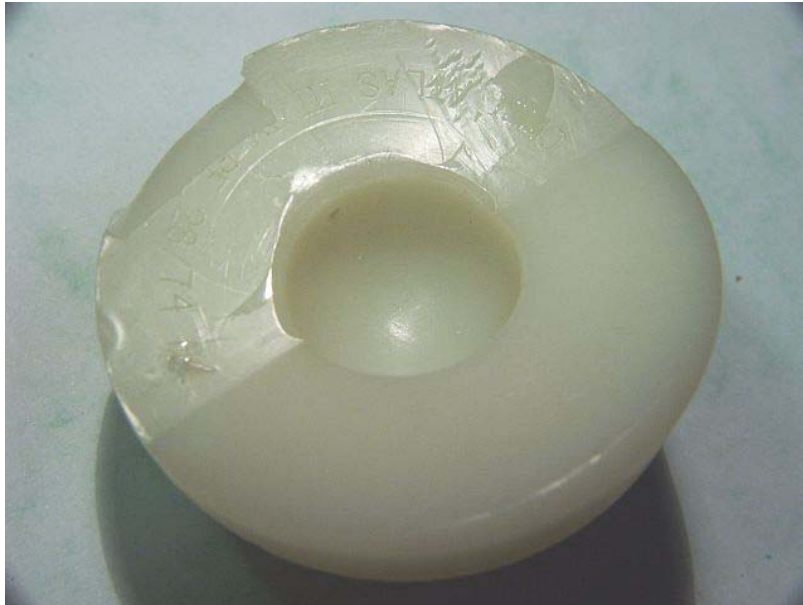
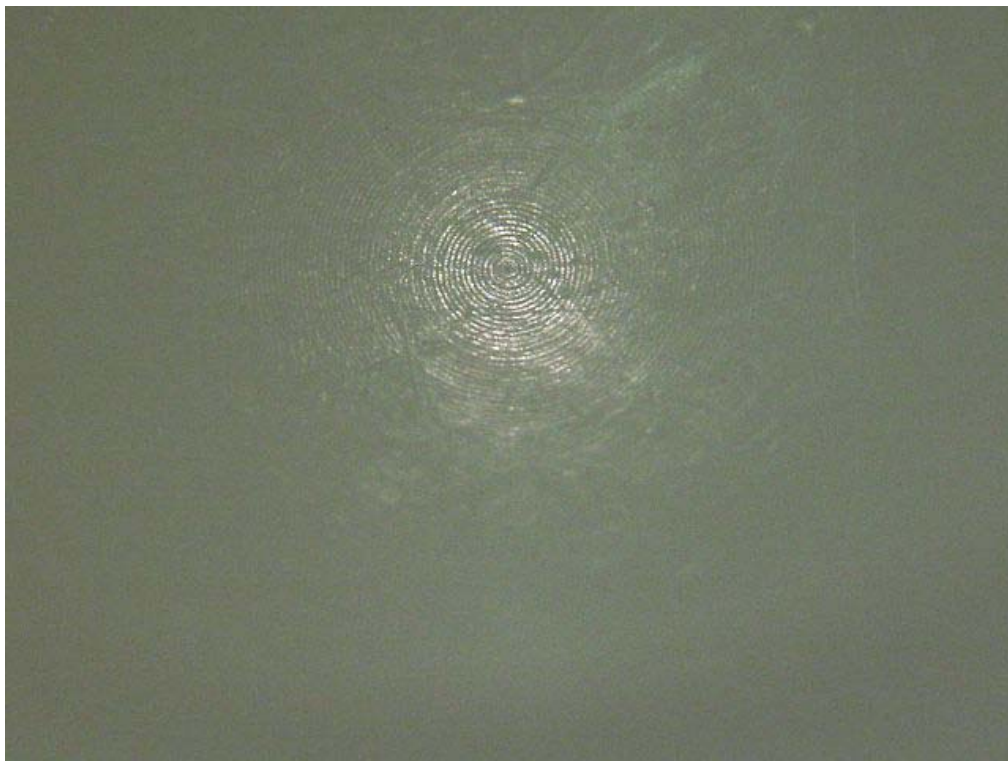
Patient 10

1	Femoral head size	28 mm
2	Type of head	Alumina
3	Cup type	UHMWPE – Aesculab
4	Crosslink	Yes
5	Amount of linear wear	\pm 0 mm
6	Duration in vivo	7 Months
7	Size of wear debris from pathologist	Not available
8	Visible discoloration	No
9	Metal backing	Yes
10	Thickness of poly	23 mm
11	Mechanical damage	No
12	Cracks in material	No
13	Plastic flow	No
14	Scratches	No
15	Adhesion wear	No
16	Wear particles embedded in base material	No
17	Flaking	No

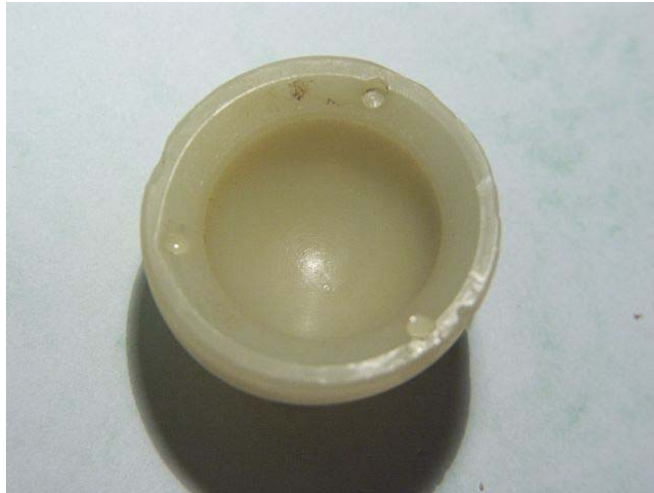
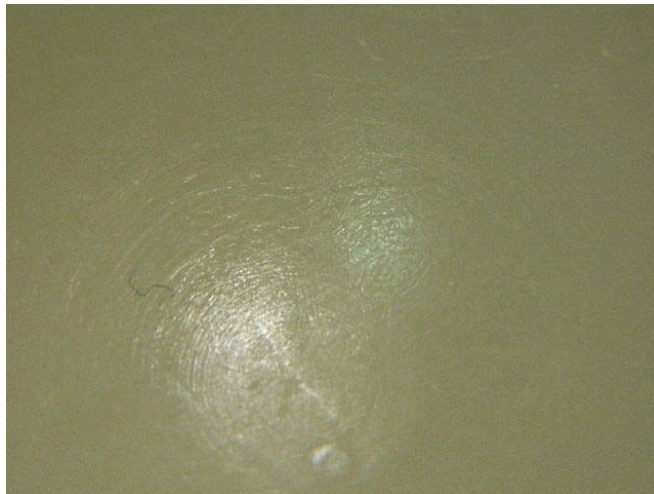
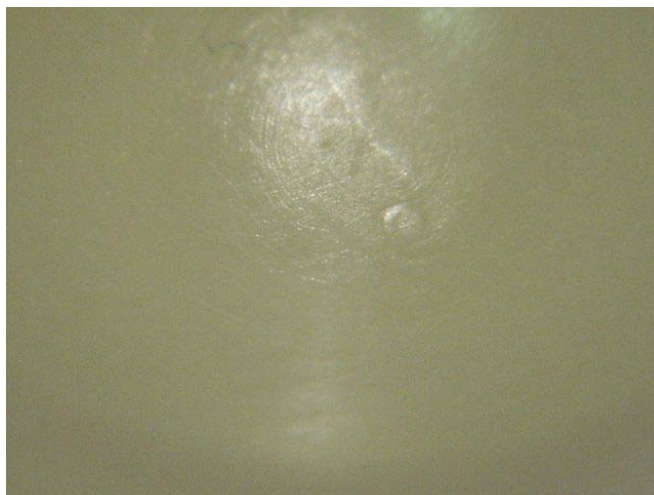
Patient 11

1	Femoral head size	28 mm
2	Type of head	Zirconium
3	Cup type	UHMWPE – Aesculab
4	Crosslink	Yes
5	Amount of linear wear	\pm 0 mm
6	Duration in vivo	14 months
7	Size of wear debris from pathologist	10 – 40 μ m
8	Visible discoloration	No
9	Metal backing	Yes
10	Thickness of poly	9 mm
11	Mechanical damage	No
12	Cracks in material	No
13	Plastic flow	No
14	Scratches	Yes
15	Adhesion wear	No
16	Wear particles embedded in base material	Yes
17	Flaking	No

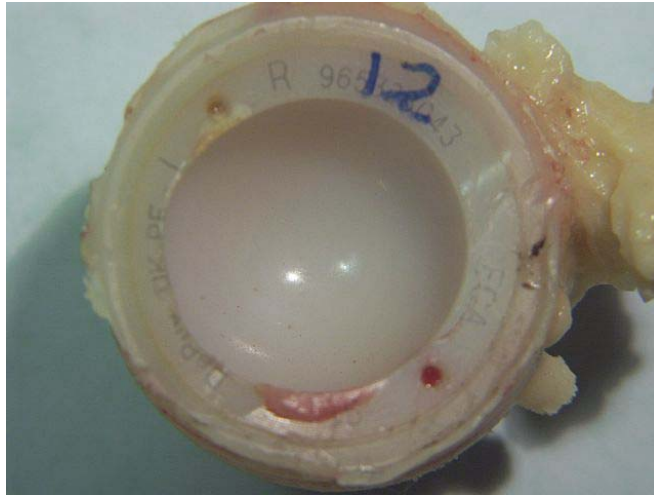
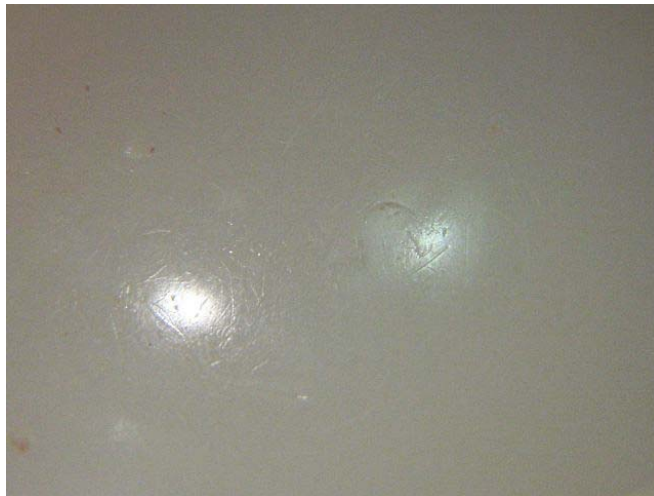
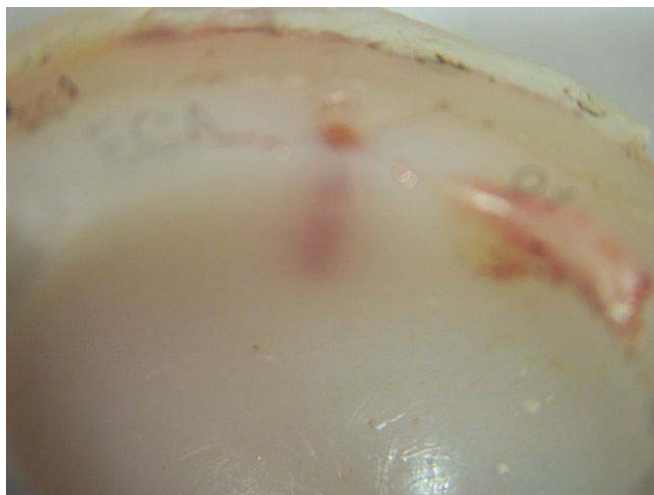
Patient 12

1	Femoral head size	28 mm
2	Type of head	Zirconium
3	Cup type	UHMWPE – de puy
4	Crosslink	No
5	Amount of linear wear	± 3.5 mm
6	Duration in vivo	10 years
7	Size of wear debris from pathologist	20 – 80 µm
8	Visible discoloration	Yes
9	Metal backing	No
10	Thickness of poly	9 mm
11	Mechanical damage	Yes
12	Cracks in material	Yes
13	Plastic flow	Yes
14	Scratches	Yes
15	Adhesion wear	Yes
16	Wear particles embedded in base material	No
17	Flaking	No

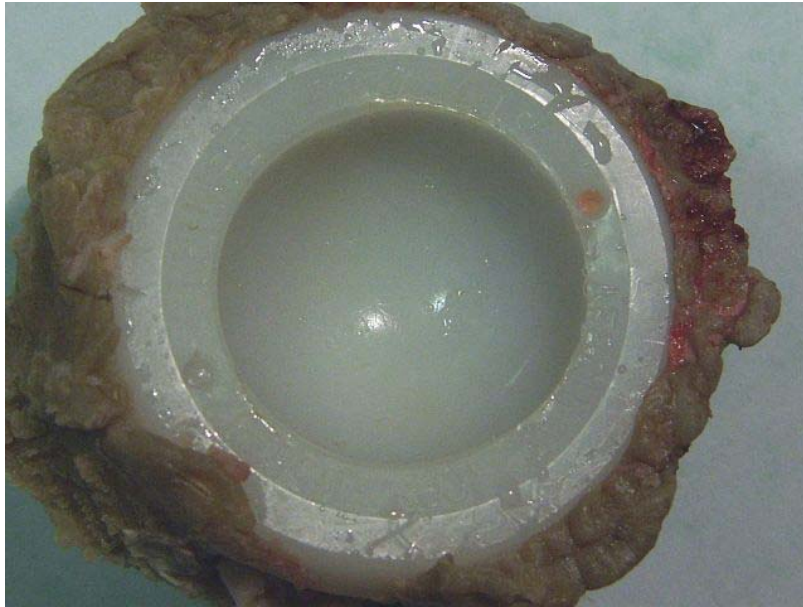
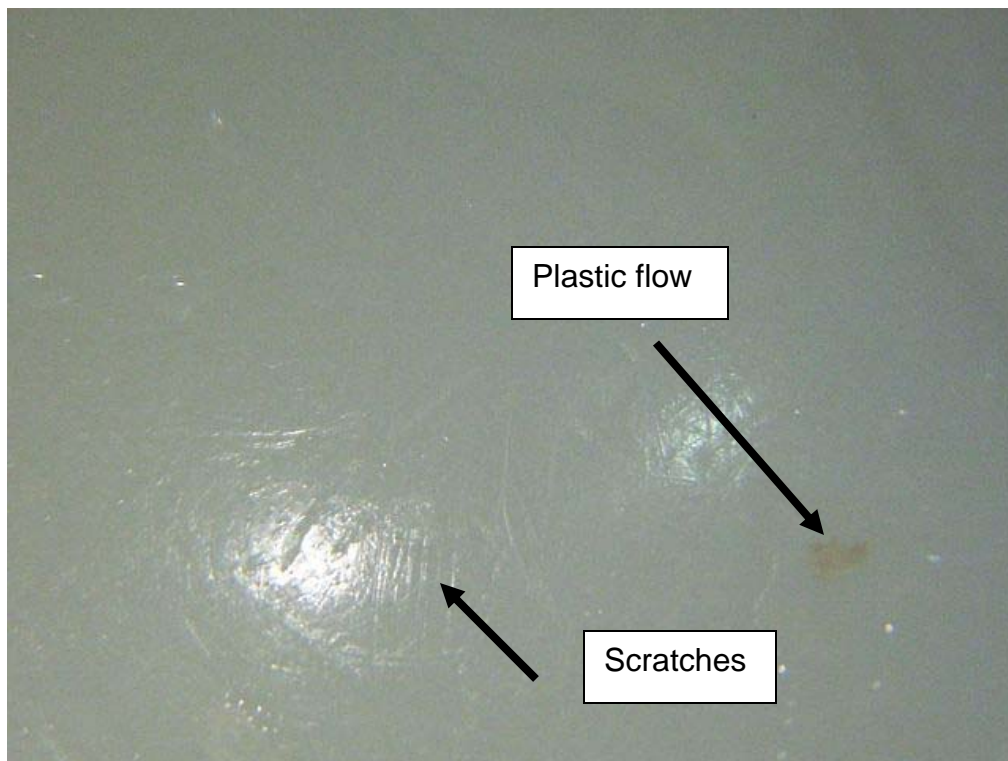
Patient 13

1	Femoral head size	32 mm
2	Type of head	Zirconium
3	Cup type	UHMWPE – Aesculab
4	Crosslink	No
5	Amount of linear wear	± 3.5 mm
6	Duration in vivo	9 years and 3 months
7	Size of wear debris from pathologist	20 – 100 µm, avg. 60 µm
8	Visible discoloration	No
9	Metal backing	No
10	Thickness of poly	12 mm
11	Mechanical damage	No
12	Cracks in material	No
13	Plastic flow	Yes
14	Scratches	Yes
15	Adhesion wear	Yes
16	Wear particles embedded in base material	Yes
17	Flaking	No

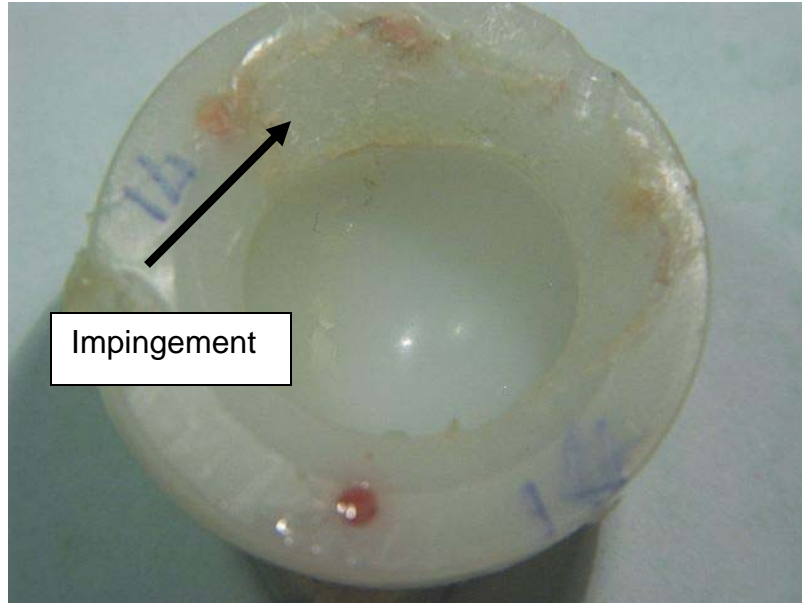
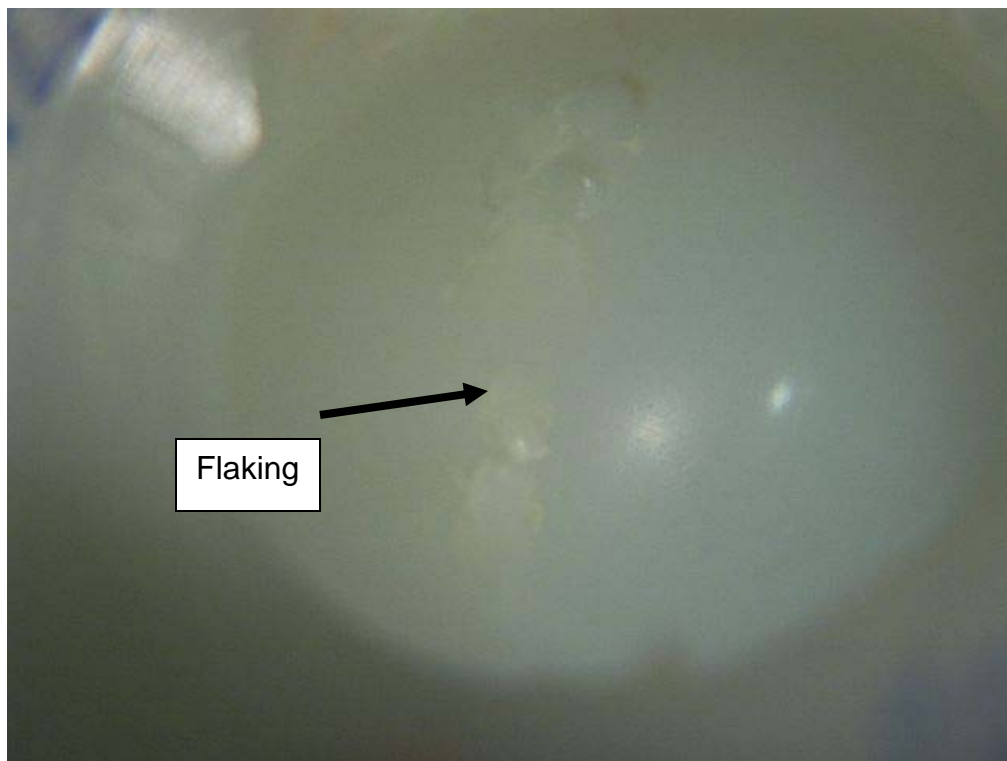
Patient 14

1	Femoral head size	22 mm
2	Type of head	Zirconium
3	Cup type	UHMWPE – Aesculab
4	Crosslink	No
5	Amount of linear wear	± 5 mm
6	Duration in vivo	7 years
7	Size of wear debris from pathologist	Not available
8	Visible discoloration	Yes (Figure 34)
9	Metal backing	Yes
10	Thickness of poly	11 mm
11	Mechanical damage	Yes (serious impingement – see figure 34)
12	Cracks in material	Yes
13	Plastic flow	No
14	Scratches	Yes
15	Adhesion wear	Yes
16	Wear particles embedded in base material	Yes
17	Flaking	Yes
