**FAILURE ANALYSIS OF ULTRA-HIGH MOLECULAR WEIGHT
POLYETHYLENE ACETABULAR CUPS**

NICOLAAS DANIEL LOMBARD BURGER

DOCTOR PHILOSOPHIAE (PhD)

DECEMBER 2005

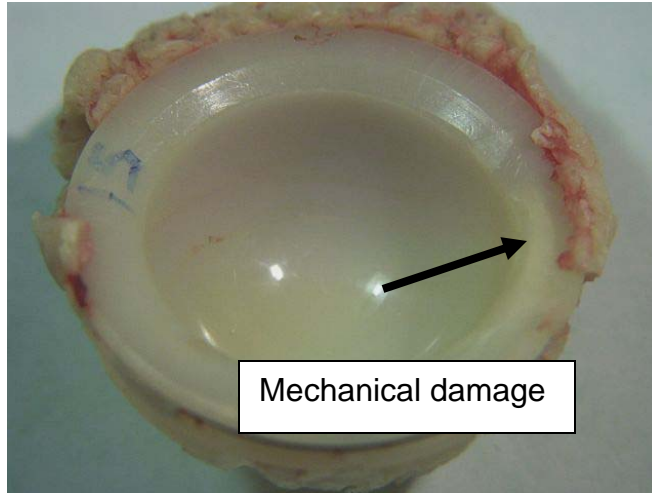
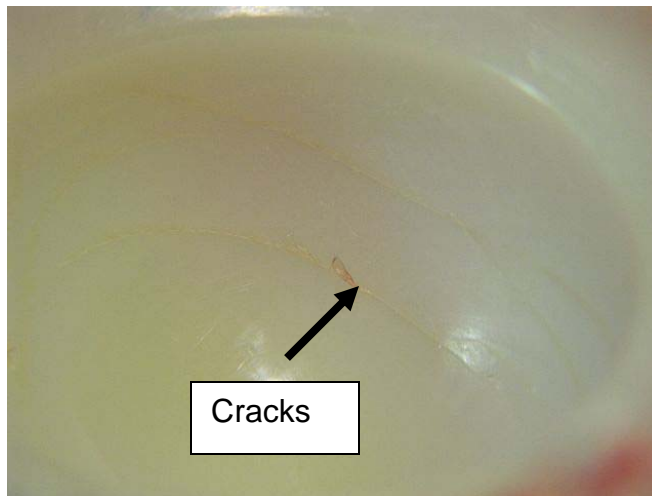
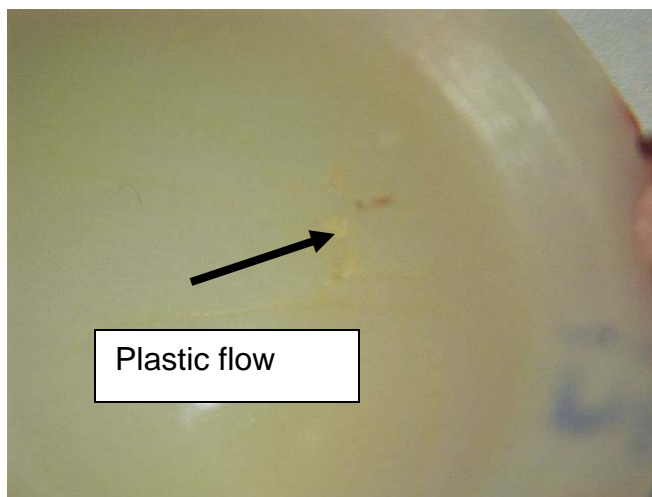
Patient 15

1	Femoral head size	32 mm
2	Type of head	Alumina
3	Cup type	UHMWPE – Aesculab
4	Crosslink	No
5	Amount of linear wear	± 0.2 mm
6	Duration in vivo	15 years
7	Size of wear debris from pathologist	20 – 140 µm, avg. 80 µm
8	Visible discoloration	Yes (Figure 36)
9	Metal backing	No
10	Thickness of poly	7 mm
11	Mechanical damage	Yes (figure 36)
12	Cracks in material	Yes
13	Plastic flow	No
14	Scratches	Yes
15	Adhesion wear	Yes
16	Wear particles embedded in base material	Yes
17	Flaking	No

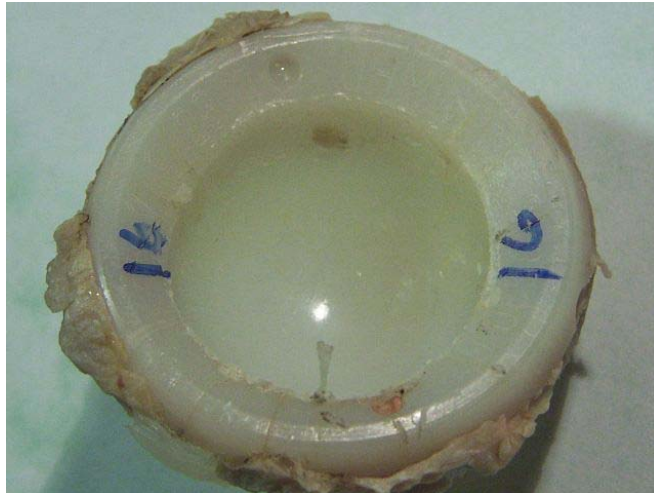
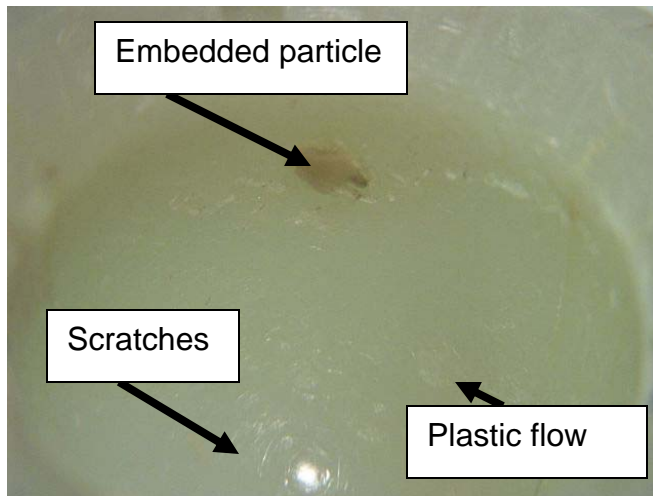
Patient 16

1	Femoral head size	28 mm
2	Type of head	Zirconium
3	Cup type	UHMWPE – Aesculab
4	Crosslink	No
5	Amount of linear wear	± 3.5 mm
6	Duration in vivo	10 years
7	Size of wear debris from pathologist	20 – 350 µm
8	Visible discoloration	Yes (Figure 39)
9	Metal backing	No
10	Thickness of poly	11 mm
11	Mechanical damage	Yes (figure 39)
12	Cracks in material	No
13	Plastic flow	Yes
14	Scratches	Yes
15	Adhesion wear	Yes
16	Wear particles embedded in base material	Yes
17	Flaking	No

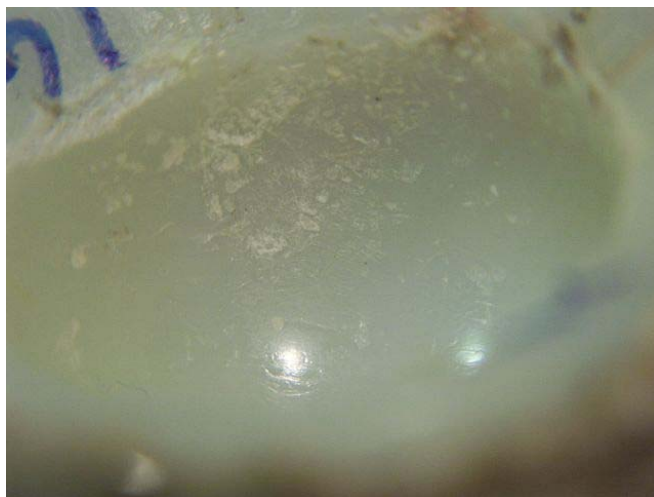
Figure A41

Cup analysis: Patient 16

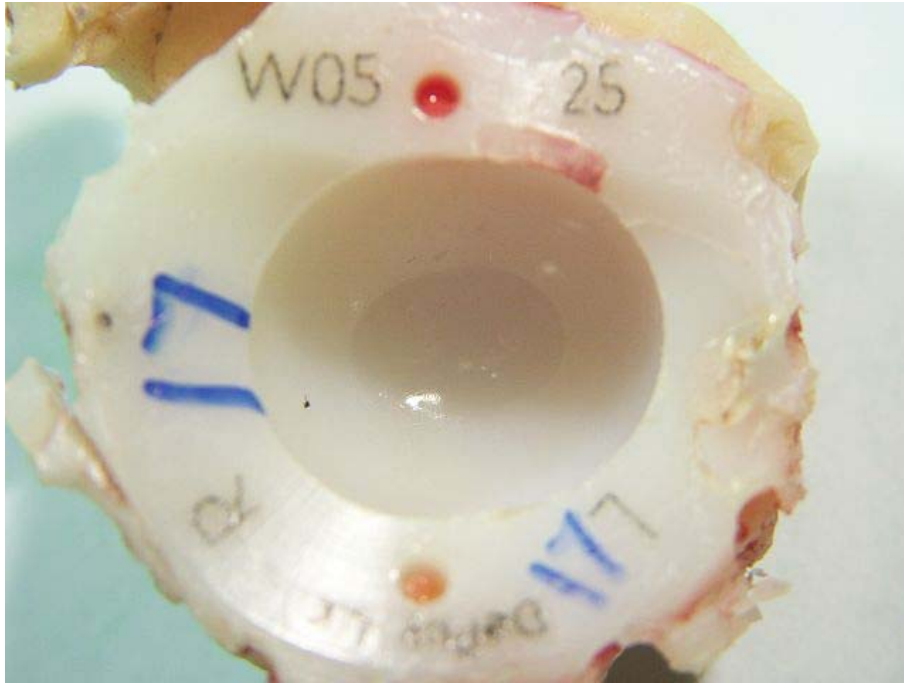
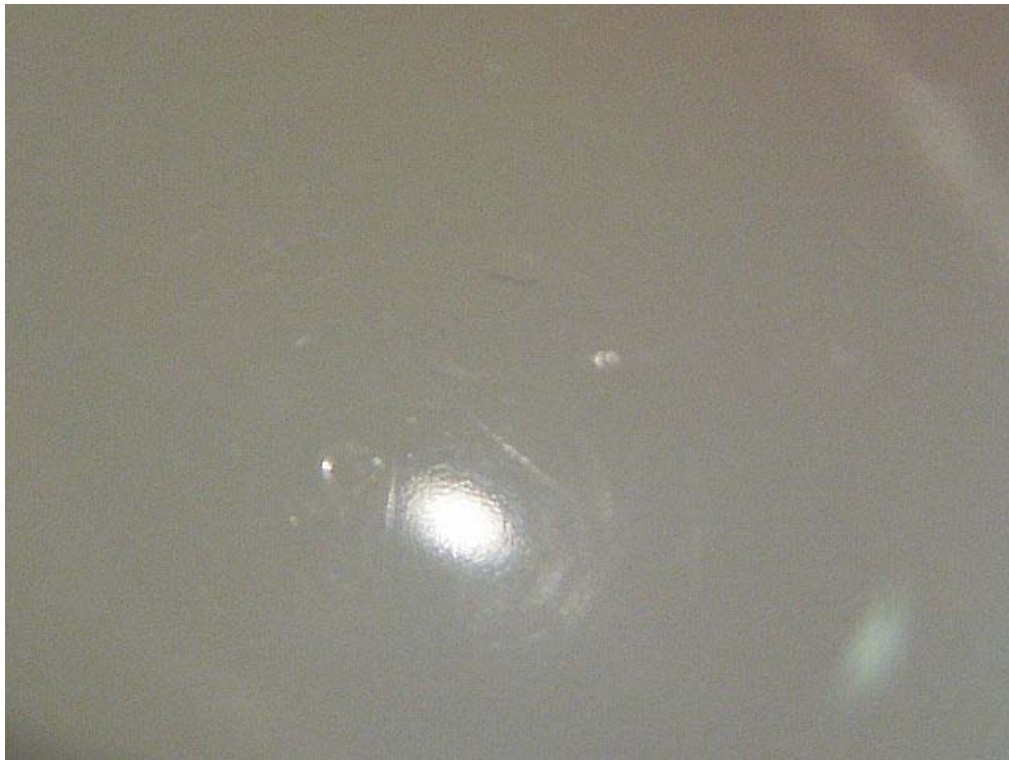
Cup analysis: Patient 17

1	Femoral head size	22 mm
2	Type of head	Stainless Steel
3	Cup type	UHMWPE – Charnley, de Puy
4	Crosslink	No
5	Amount of linear wear	± 6 mm
6	Duration in vivo	10 years and 6 months
7	Size of wear debris from pathologist	Not available
8	Visible discoloration	Yes (Figure 42)
9	Metal backing	No
10	Thickness of poly	13 mm
11	Mechanical damage	No
12	Cracks in material	No
13	Plastic flow	No
14	Scratches	Yes
15	Adhesion wear	No
16	Wear particles embedded in base material	No
17	Flaking	No

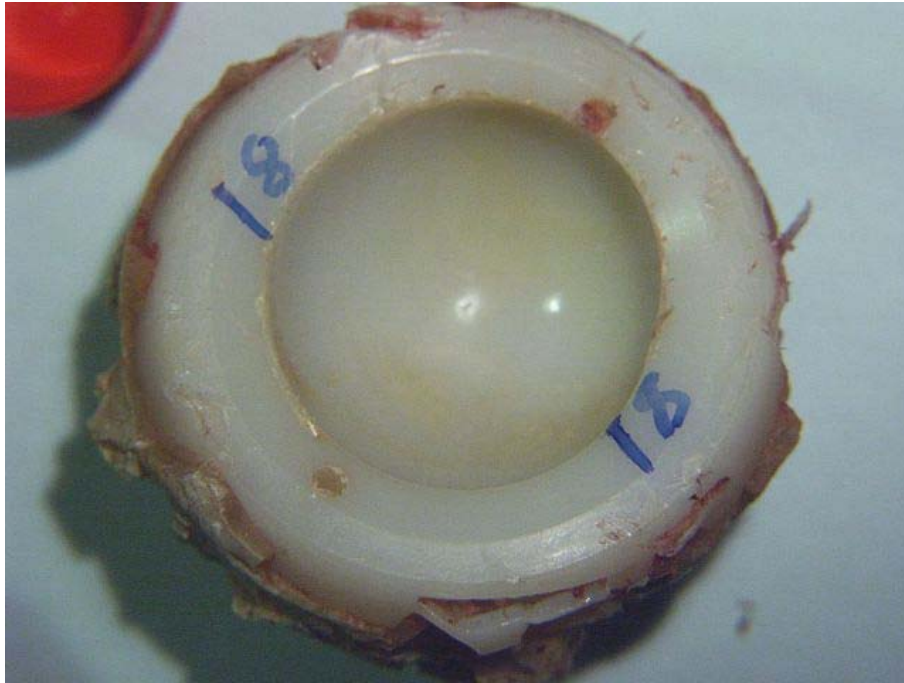
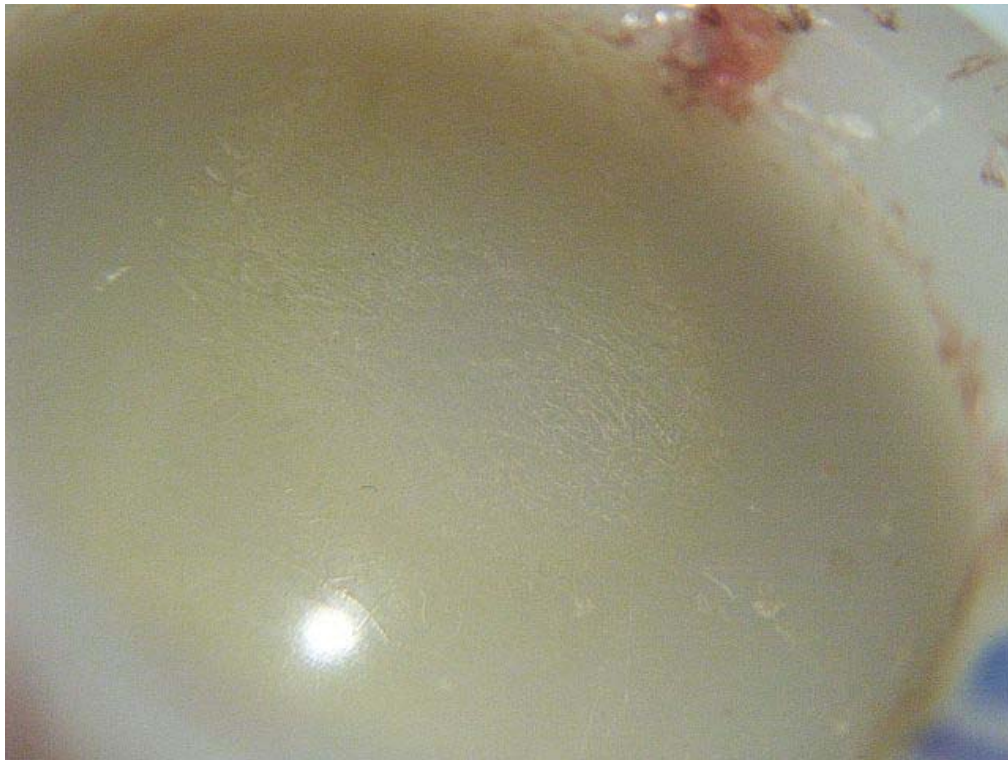
Cup analysis: Patient 18

1	Femoral head size	32 mm
2	Type of head	Alumina
3	Cup type	UHMWPE - Aesculab
4	Crosslink	No
5	Amount of linear wear	± 5 mm
6	Duration in vivo	6 years and 6 months
7	Size of wear debris from pathologist	Not available
8	Visible discoloration	Yes
9	Metal backing	No
10	Thickness of poly	12 mm
11	Mechanical damage	Yes
12	Cracks in material	No
13	Plastic flow	No
14	Scratches	Yes
15	Adhesion wear	Yes
16	Wear particles embedded in base material	Yes
17	Flaking	No

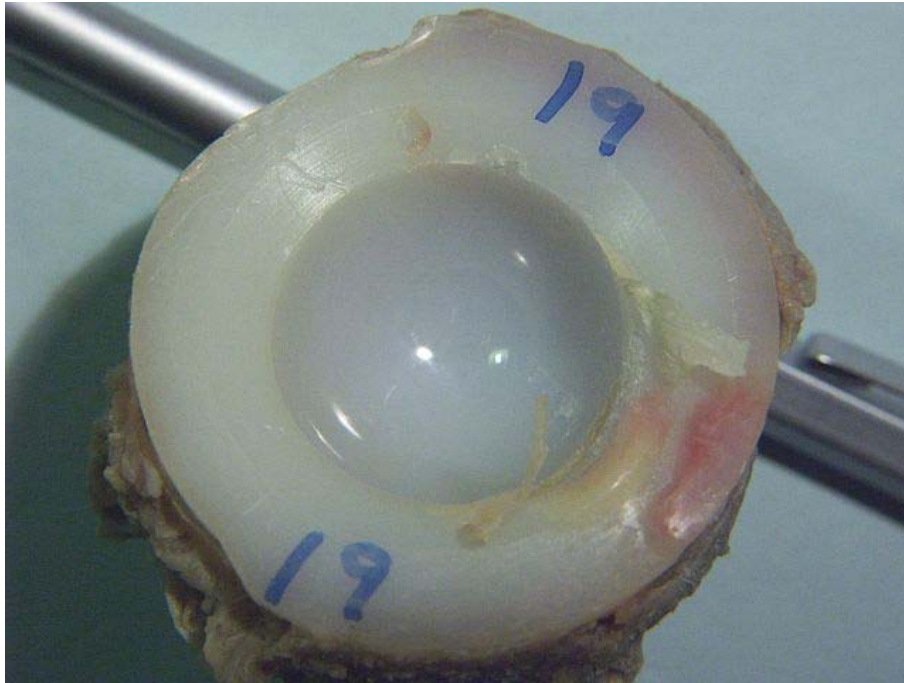
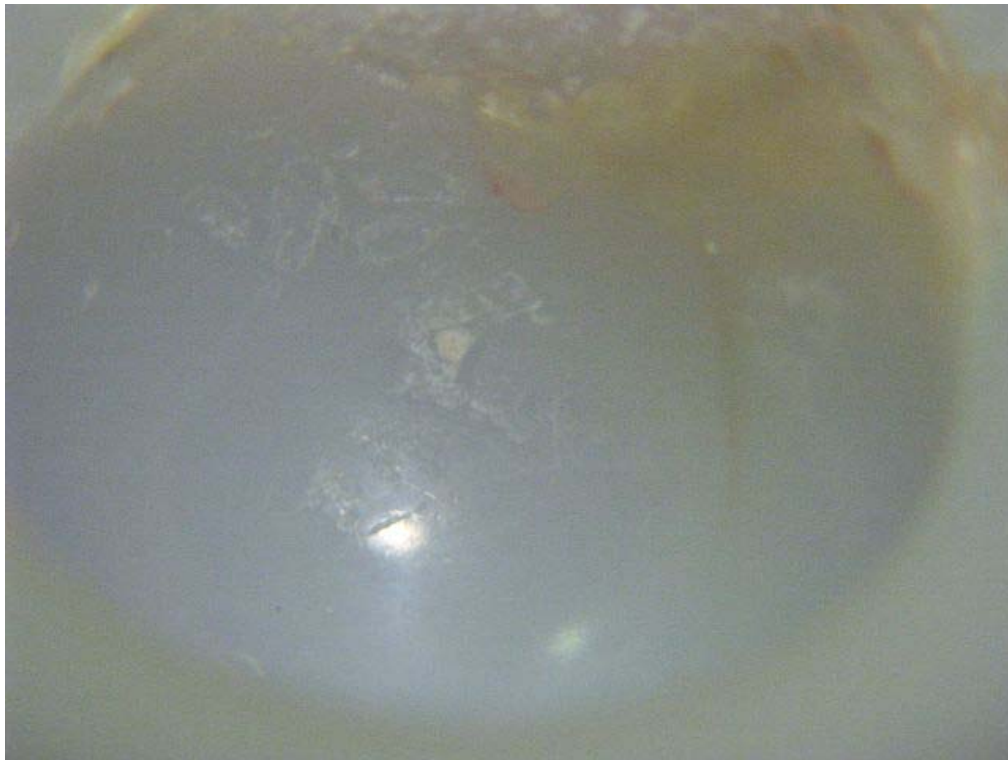
Cup analysis: Patient 19

1	Femoral head size	28 mm
2	Type of head	Alumina
3	Cup type	UHMWPE - BARC
4	Crosslink	No
5	Amount of linear wear	± 2 mm
6	Duration in vivo	15 years and 6 months
7	Size of wear debris from pathologist	Not available
8	Visible discoloration	Yes
9	Metal backing	No
10	Thickness of poly	10 mm
11	Mechanical damage	Yes
12	Cracks in material	Yes
13	Plastic flow	Yes
14	Scratches	Yes
15	Adhesion wear	Yes
16	Wear particles embedded in base material	Yes
17	Flaking	Yes

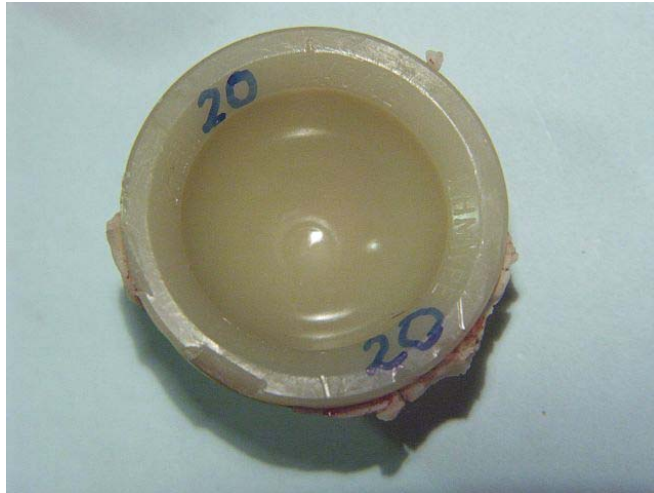
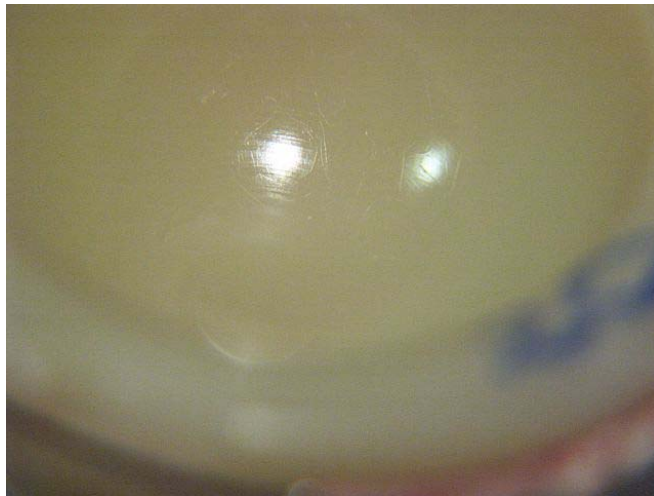
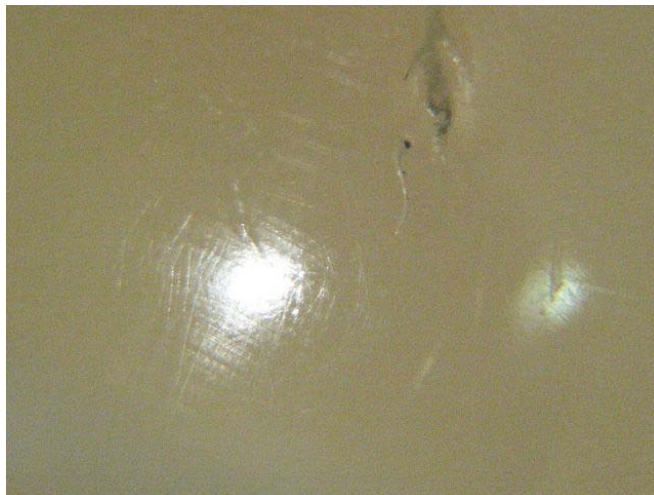
Cup analysis: Patient 20

1	Femoral head size	32 mm
2	Type of head	Zirconium
3	Cup type	UHMWPE - Aesculab
4	Crosslink	Yes
5	Amount of linear wear	± 0 mm
6	Duration in vivo	2 years and 4 months
7	Size of wear debris from pathologist	Not available
8	Visible discoloration	No
9	Metal backing	No
10	Thickness of poly	7 mm
11	Mechanical damage	No
12	Cracks in material	No
13	Plastic flow	No
14	Scratches	Yes
15	Adhesion wear	Yes
16	Wear particles embedded in base material	No
17	Flaking	No

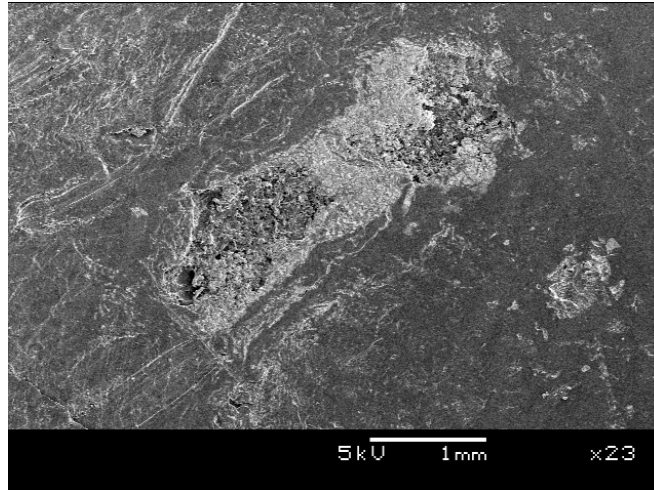
Figure E1: Adhesion wear

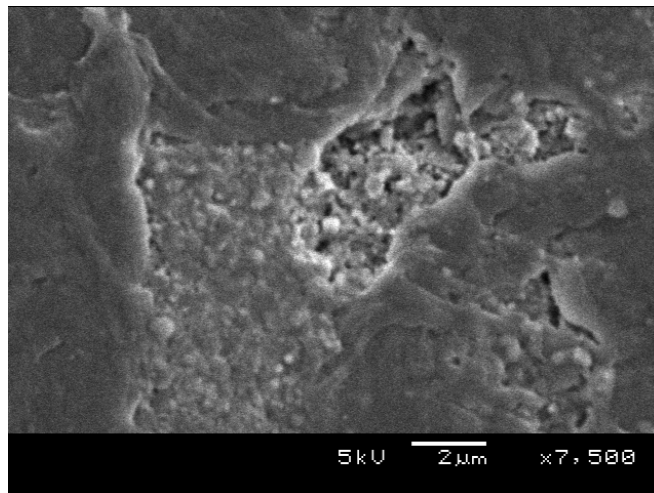
Figure E2: Adhesion wear

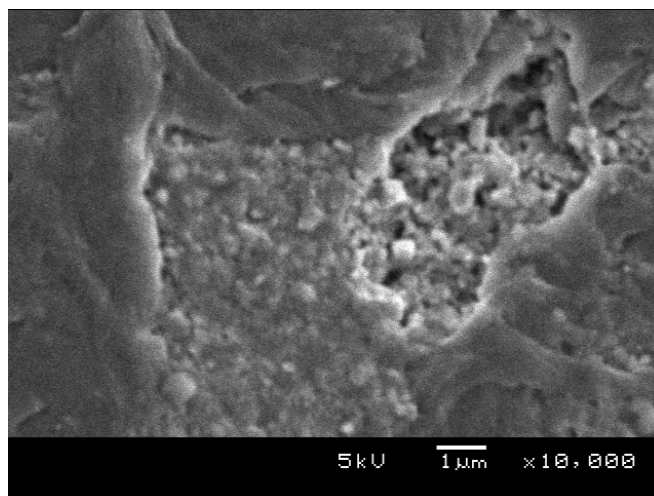
Figure E3: Adhesion wear

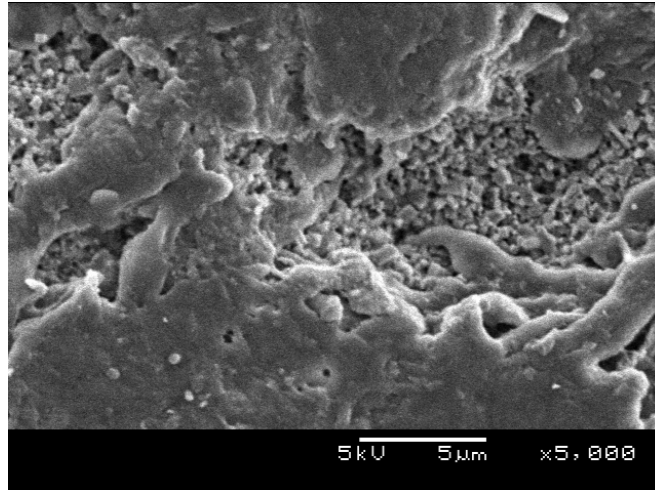
Figure E4: Adhesion wear

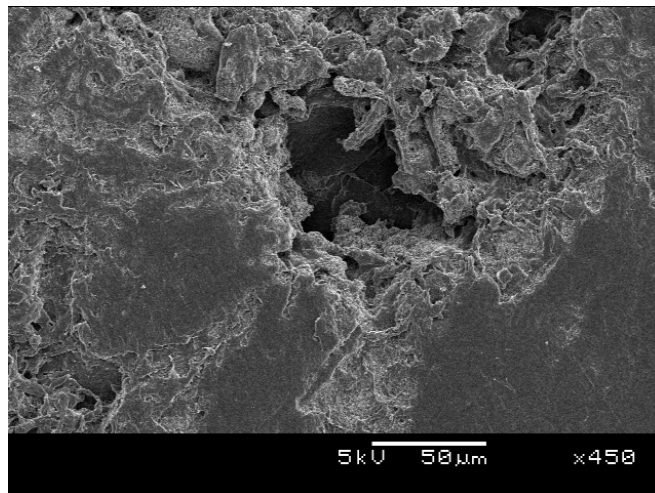
Figure E5: Crater after adhesion wear

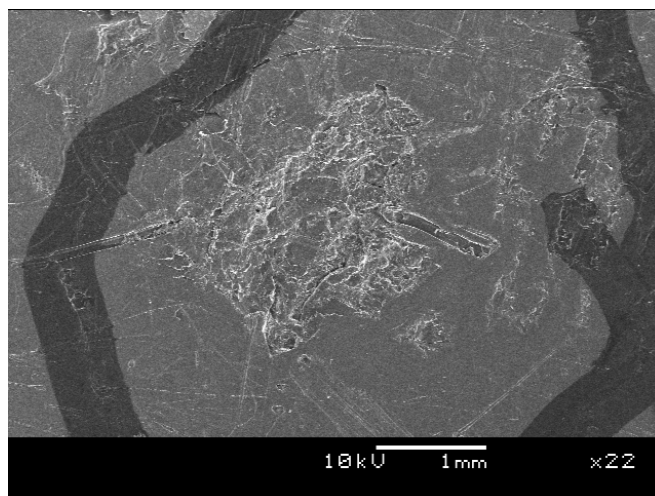
Figure E6: Patch with adhesion wear

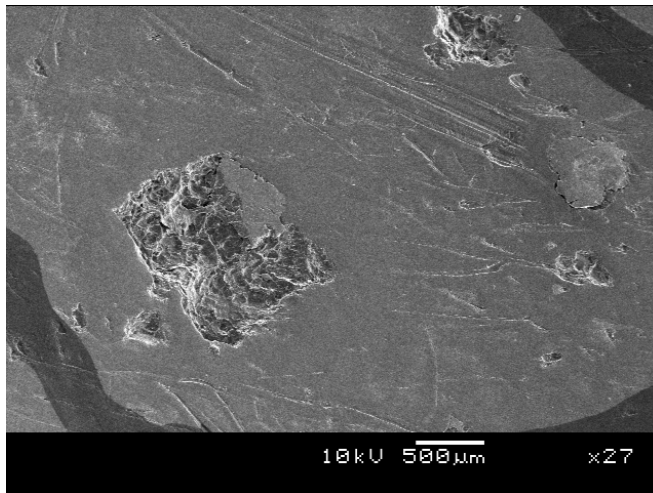
Figure E7: Patch with adhesion wear

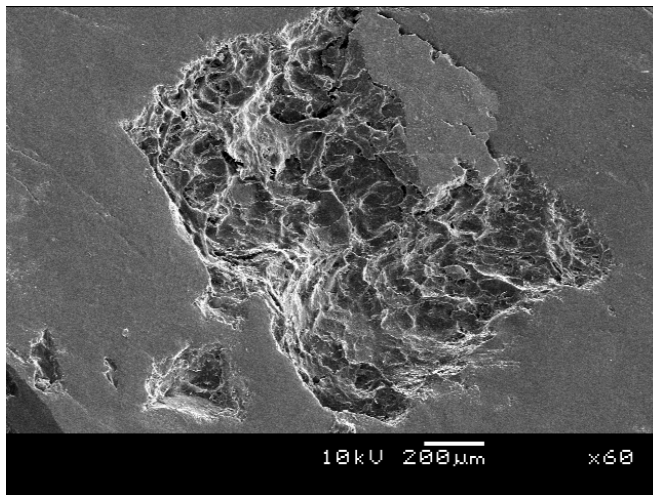
Figure E8: Patch with adhesion wear

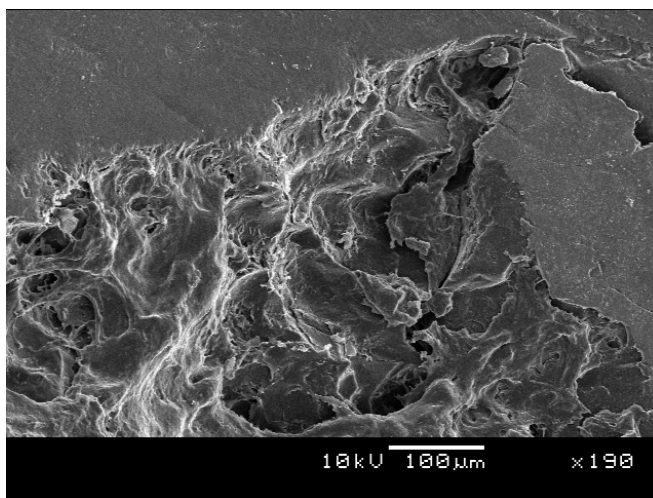
Figure E9: Patch with adhesion wear

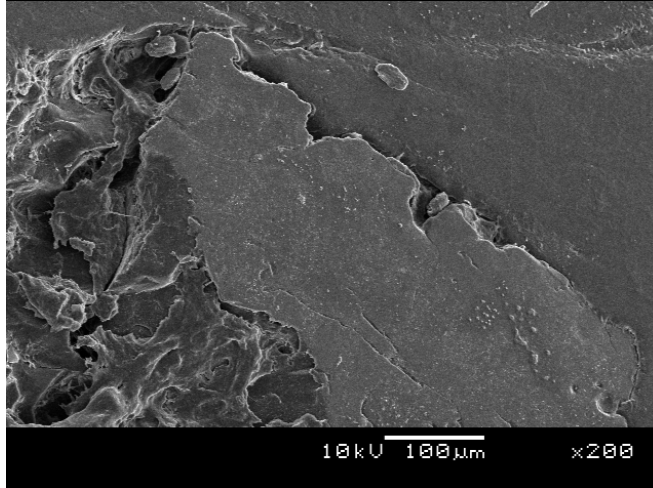
Figure E10: Remaining flake after adhesion wear

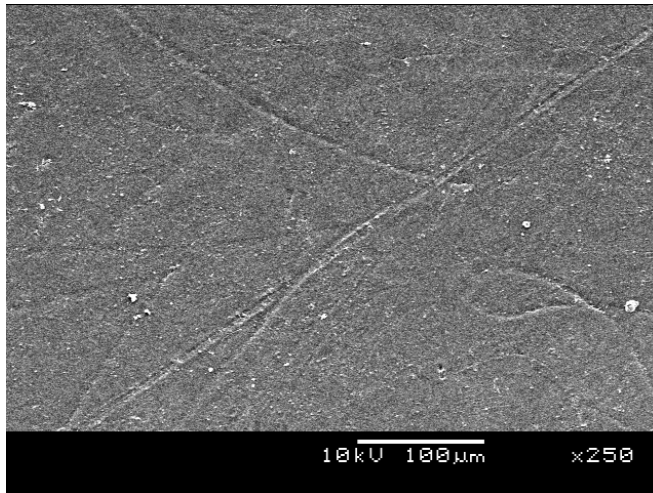
Figure E11: Scratches on bearing surfaces

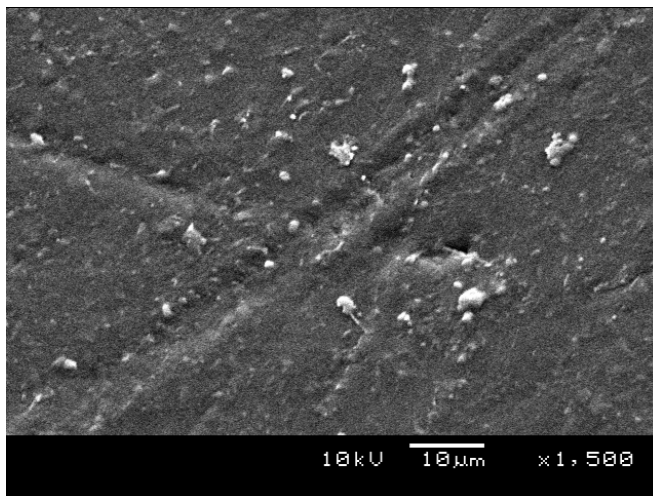
Figure E12: Scratches on bearing surfaces

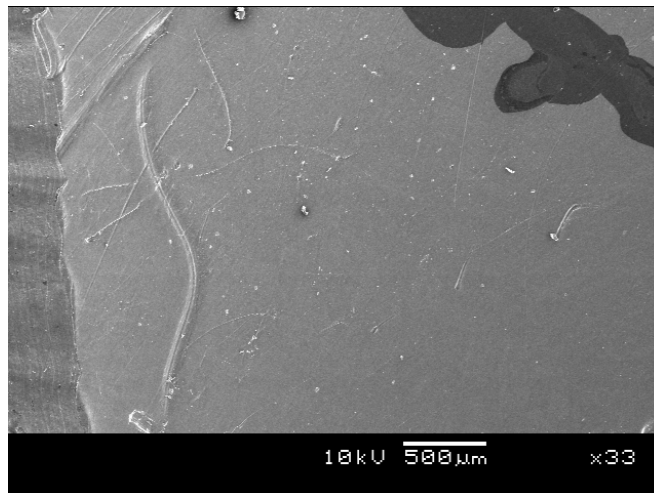
Figure E14: Scratches on bearing surfaces

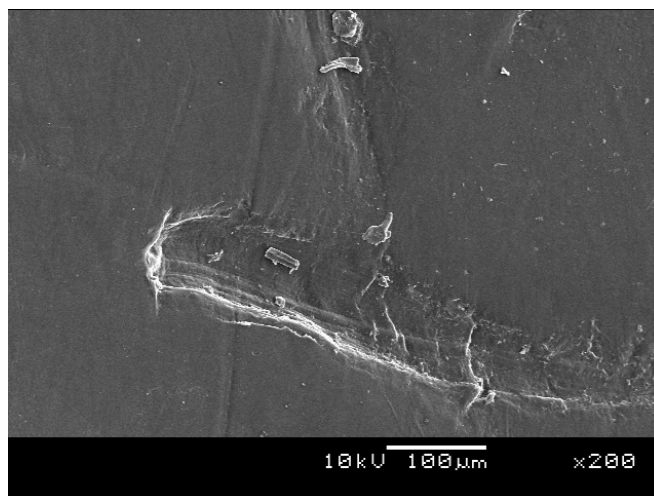
Figure E15: Scratches on bearing surfaces

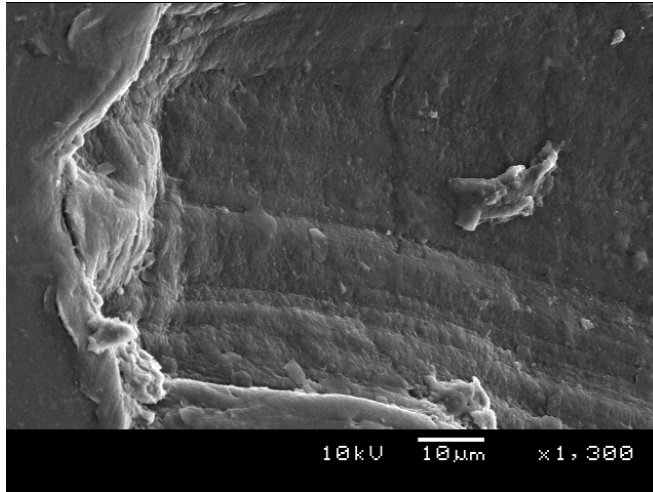
Figure E16: Ploughing mark

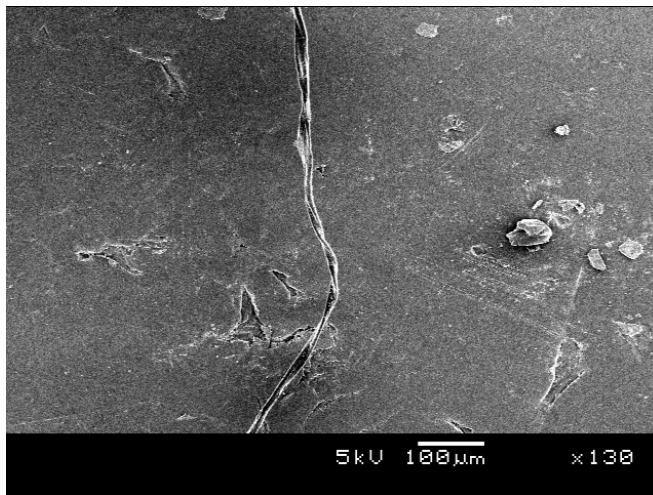
Figure E17: Scratch on bearing surface

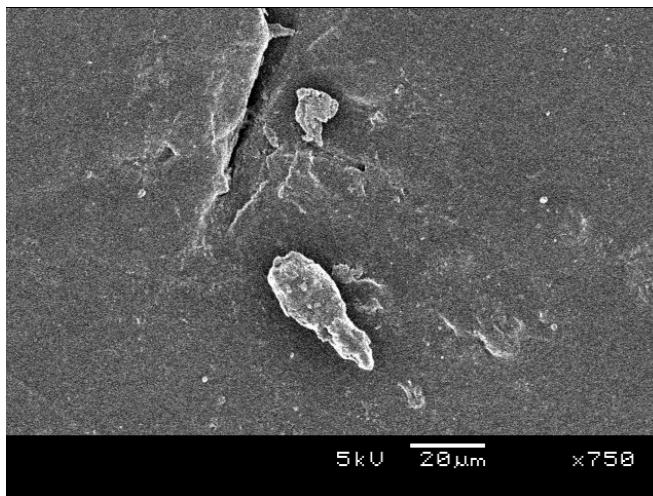
Figure E18: Wear particle

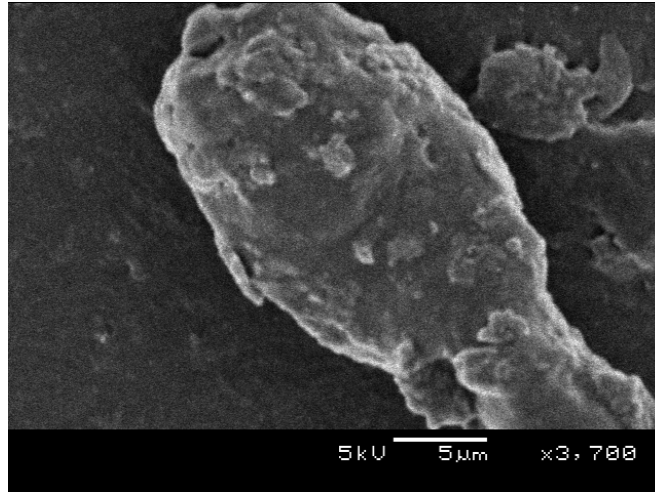
Figure E19: Wear particle

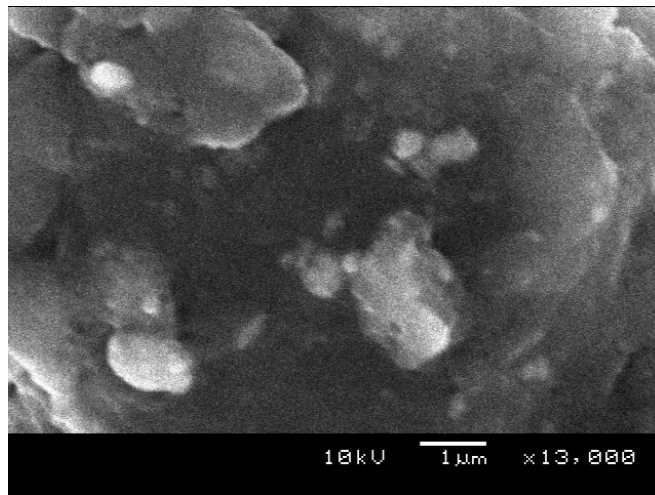
Figure E20: Wear particle

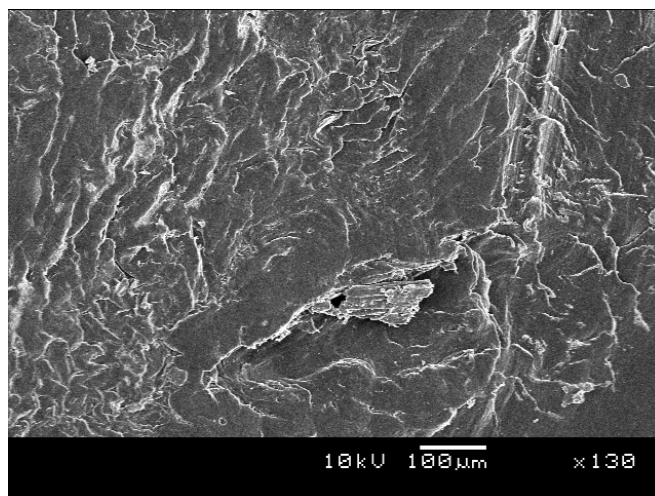
Figure E21: Plastic flow

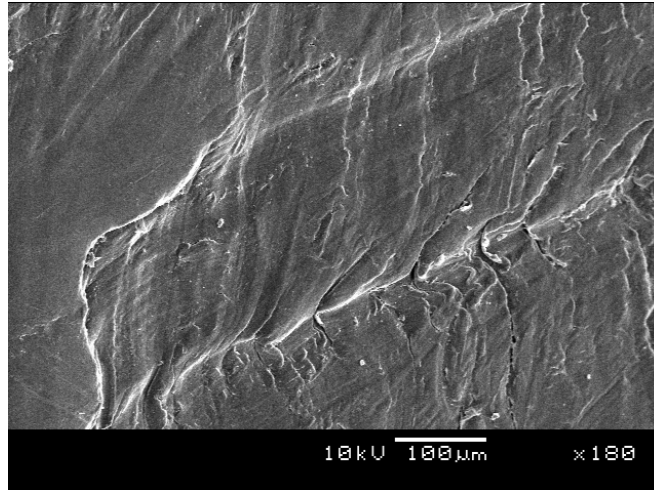
Figure E22: Plastic flow

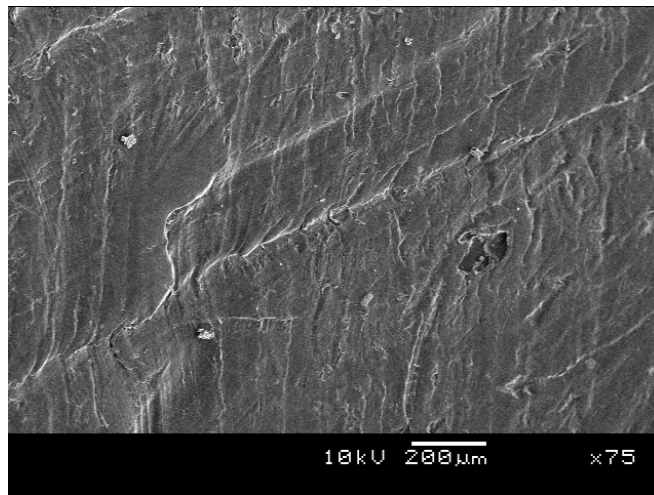
Figure E23: Plastic flow

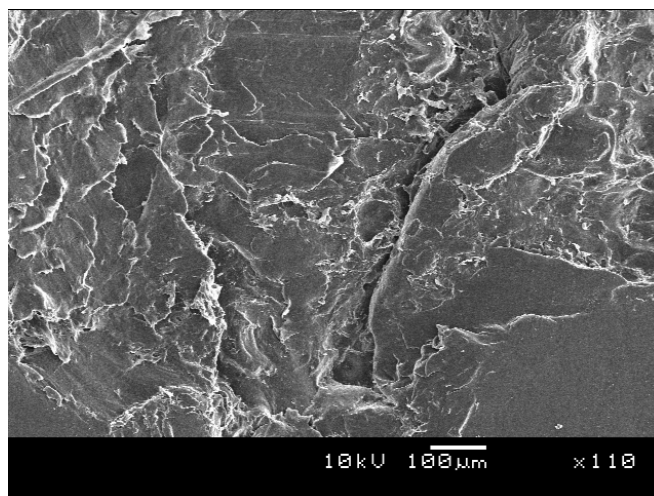
Figure E24: Crack after adhesion wear
