Metals from K2 and Mapungubwe: A technological study of early second millennium material culture, with an emphasis on conservation

A thesis submitted in partial fulfilment of the requirements for
the degree

DPhil Archaeology

February 2013

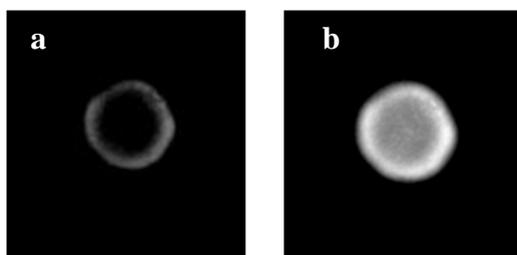
By adjusting contrast and brightness (ImageJ open source analytical software) the corrosion region in the slice can be contrasted and identified more clearly to improve accuracy. In (Fig.2.2) we have such a scenario for the shaft region of a real object (the spatula also shown in (Appendix A. Table SI1)). Using the software tools it becomes possible to isolate the corroded region as shown in (Fig. 2.2a). The area of the corroded part as well as the total object area can then be sensitively determined. The exact units are irrelevant as we are only interested in the dimensionless ratio as defined by equation (2.3).

Figure 2.2. Slice perpendicular to the spatula (SI1) shaft axis with adjusted contrast to show: (a) the corrosion ring alone; and (b) the metal core in grey and corrosion in white.

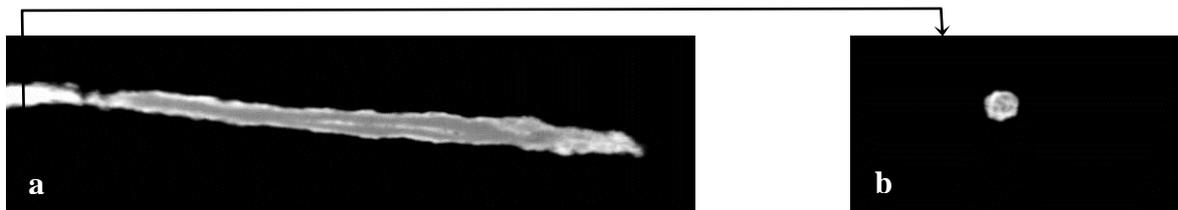
Neutron tomography shows that this iron rod has a crumbly metal core (Fig.3.2). The sharp point has a lamellar structure with no traces of metal. At the thick point of the rod the metal core has a fractured structure. A deep crack, filled with corrosion products, is seen along the entire length of the object. Based on frontal slices, 64% of the object consists of corrosion products. The original surface is damaged. A summary of the neutron tomography result of the object was given in Appendix D. Table: 3.1.

Figure 3.2. Neutron tomograms of KI6. a) Sagittal slice. Longitudinal crack spread among the object. b) Axial slice. Cracular structure of metal core with penetration of corrosion products can be observed.

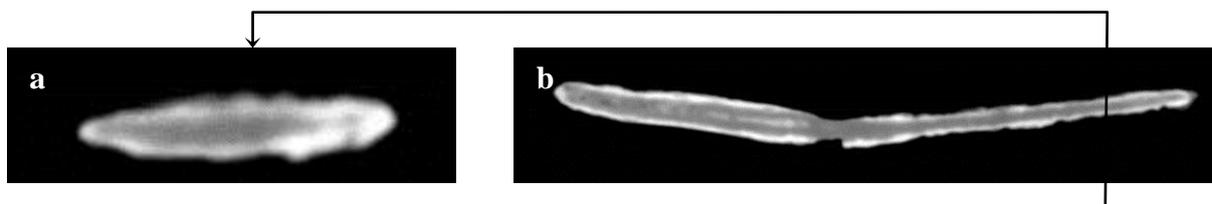
Neutron tomography shows that this spoon-like artefact has a continuous metal core, although the edges of the blade in some parts are structurally weak. At the edges of the blade corrosion has decreased the thickness of the metal to the extent that, in some places, no metal has remained. (Fig.3.5a). Investigative cleaning is needed to establish whether the original surface has remained in these areas. A crack which is filled with corrosion products can be observed in the shaft (Fig.3.5b). Based on axial slices, 66% of the object consists of corrosion products. A Summary of the neutron tomography result of the object was given in Appendix D. Table: 3.1.

Figure 3.5. Neutron tomograms of MI3. a) Axial slice. Demolishing of metal at the edge of blade is observed. b) Sagittal slice of the object. Longitudinal crack among the shaft is revealed.

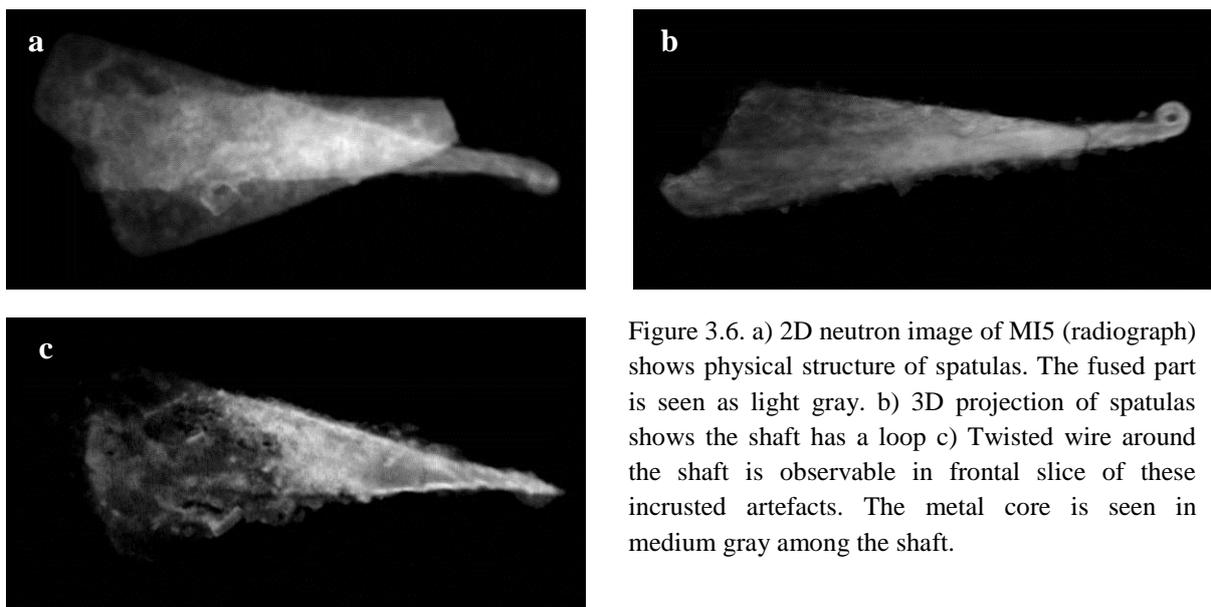
The remaining shaft has a delicate loop at one end (Fig.3.6b). A thin wire is twisted along the length forming a screw-like feature (Fig.3.6b, c). The thinness of the wire indicates it was not manufactured by simple hammering although the corroded structure of it prevents revealing the exact method of manufacture. This technique of manufacture is similar to another spatula (SI1) which was found in the same chronological layer at Southern Terrace.

The low interaction of neutrons with unconsolidated soil allowed the structures inside the crusted clump to be studied in detail, revealing the structure of the corroded artefacts. Only a small amount of metal core has remained in the shaft, while within the blades no remnant of metal is detected (Fig.3.6c). A reliable estimation of the corrosion percentage was unsuccessful in this case due to a large variation in thickness, particularly in the joint part. A summary of the neutron tomography result of the object was given in Appendix D. Table: 3.1.

Figure 3.6. a) 2D neutron image of M15 (radiograph) shows physical structure of spatulas. The fused part is seen as light gray. b) 3D projection of spatulas shows the shaft has a loop c) Twisted wire around the shaft is observable in frontal slice of these encrusted artefacts. The metal core is seen in medium gray among the shaft.

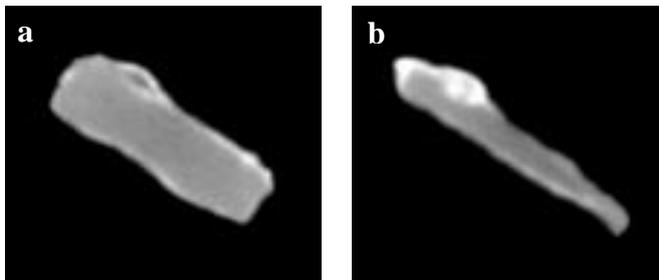
Neutron tomography shows that this adze has a robust continuous metal core. A thin layer of corrosion covers the surface of the object. A few flakes which are surrounded by corrosion are observed on the surface. In parts of the blade the corrosion penetrated the metal core and damaged the original surface thereby volume expansion of the corrosion products. (Fig.3.10). Based on axial slices, 37% of the object was corroded. A summary of the neutron tomography result of the object was given in Appendix D. Table: 3.1.

Figure 3.10. Neutron tomograms of KI3. Axial slices. a) Corrosion produced flakes on the surface of the object. b) Penetration of corrosion in the metal core caused defects on the original surface.

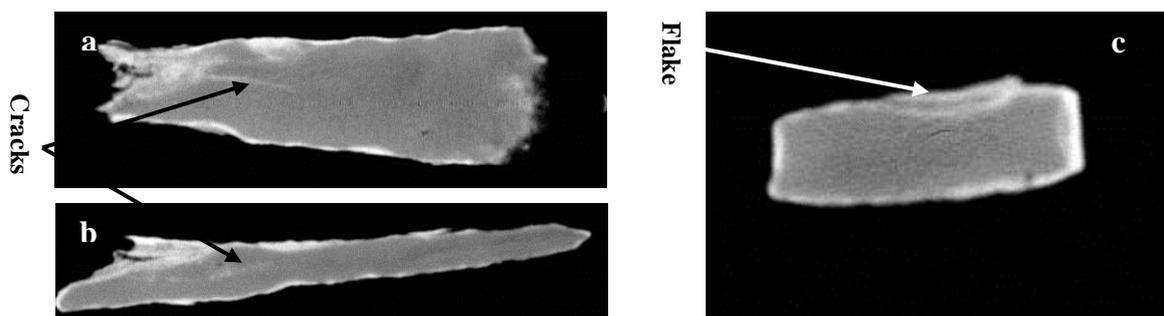
The sagittal and frontal slices of the neutron tomogram show the adze has a continuous and robust metal core from tip toward the shank. Corrosion is present as a thin layer on the surface of the whole object. The blade shank has a lamellar structure resulting from severe corrosion in this area. The lamellas are severely corroded and only a small section of metal connects them to the rest of the metal core. Narrow cracks which have been filled with corrosion products are seen close to and along this structure. Expansion of these products may induce more pressures in these zones. Consequently, after a while, the lamellar structure would extend further toward the inside (Fig.3.11a, b). Approximately 31% of the object contains corrosion products. On the surface, flakes that contain metal core are mostly surrounded by corrosion and have no connection to the rest of the object (Fig.3.11c). Presence of flakes and laminations on the surface will reduce the chance to have an even surface after treatment. Fortunately the number of flakes is low. A summary of the neutron tomography result of the object was given in Appendix D. Table: 3.1.

Figure 3.11. Neutron tomogram slices of KI4. a) Sagittal slice b) Frontal slice c) Axial slice.

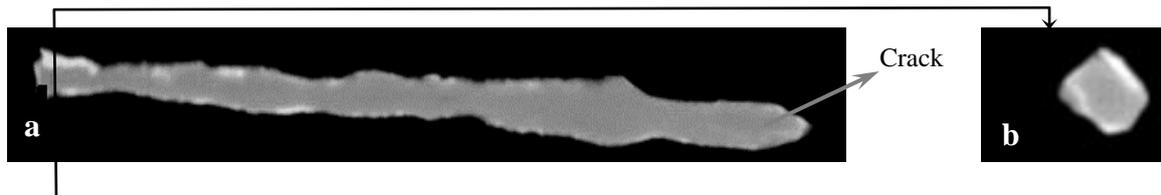
Neutron tomography result shows that this iron chisel has a continuous robust metal core. A short crack, filled by corrosion products, is seen within the tapered point of the sample (white line) (Fig.3.13a). A damaged part is also seen at the end of the shaft which is more obvious in the axial slices (Fig.3.13b). Here a flake of metal is completely surrounded by corrosion products. In the case of treatment of the object in chemical solution, this part may be removed and results in damaging of the object. Except in this case, corrosion is only observed on the surface of the object and did not penetrate deep inside. Based on axial slices, 15% of the object contains corrosion products. A summary of the neutron tomography result of the object was given in Appendix D. Table: 3.1.

Figure 3.13. Neutron tomogram of KI5. a) Frontal slice. Small crack is seen along the sharp point. b) Axial slice of end point of shaft at the position of the line, shows presence of a flake.

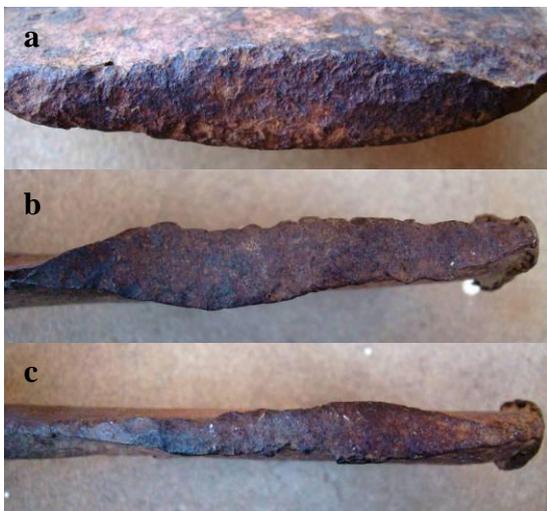
MI2 has a rectangular blade with a long semi-rectangular cross section handle which tapers toward the end (Appendix A. Table: MI2). The manufacture evidence on the surface of the hoe shows that it is incomplete. The surface of the blade was raised along the edges (burr) due to the hammering. The burrs became more obvious because the edges were forged in opposite directions. This formed a thick flat surface on these parts (Fig.3.15a, b, c). It appears that this stage was a preliminary step in several successive stages of narrowing the edges to produce a steep facet. In the next step the manufacturer would suppress the burrs by continuing forging of the blade's surface but these have remained intact.

Figure 3.15. a) Thick flat surface on front edge of the hoe (MI2). b.c) Flat surface on the side edges

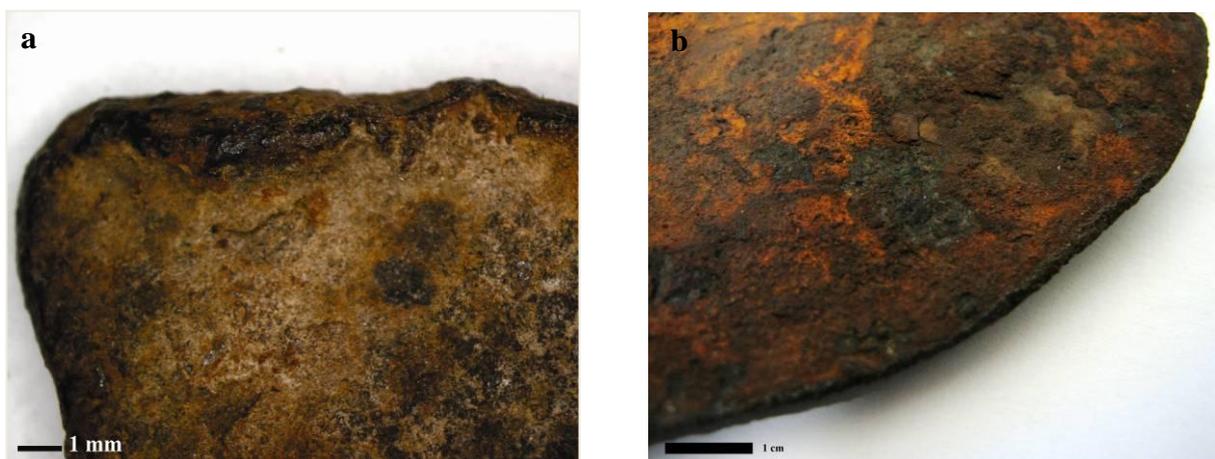
MI7, MI9 and MI10 are more similar in their typology (Appendix A. Tables: MI7, MI9, MI10). Their blades are almost scapula-shaped and joined to the handle at an obtuse angle. They, however, are different in size. The blade tips of these hoes were completely sharpened. The signs of creasing (burr) on the edges of the MI7 and MI9 blades are due to forging (Fig.3.17a, b). These are clear to the naked eye, while the heavily corroded structure of MI10 obscured all traces of manufacture on the surface.

Figure 3.17. a) Creasing marks on the blade edge of MI7. These marks are seen continuously along the edge b) Creasing marks on the blade of MI9. The creases here are more delicate than MI7 and are not continuous.

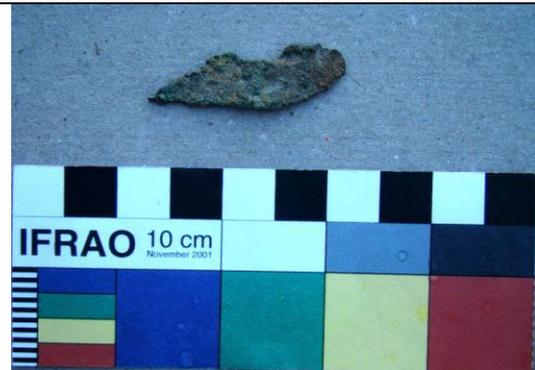
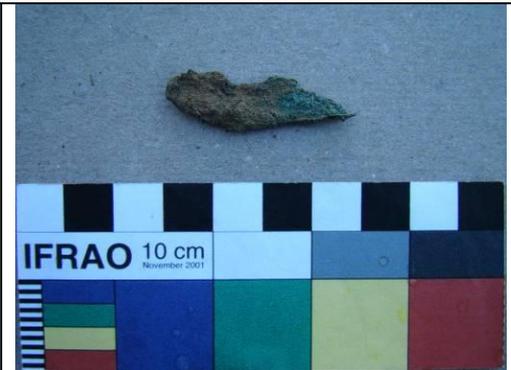
Table: KC4

Accession No. –		Acquisition source Excavation 15/7/1936	
Site: K2	Square: B.2 S.8 -2 nd strip	Layer: 7'.18'.2'	Box No. Miller stuff
Metal type: Copper	Estimate value: Research		Current object use: in storage
Physical description: A copper plate with a non-geometric shape and an uneven surface.			
Measurement and dimensions			
Weight: 1.9 g	Width:	Diameter:	
Length: 36.93 mm	Height:	Thickness: 1.47 mm	
Condition and damage: Moderately corroded with light and dark green corrosion products. Soil contamination is observable on its surface.			
Facilities, report of location			
Type of support, frame and package: It is in a small plastic bag in a large cardboard box in the museum storage facility.			
Environment control: -			
Photographic documentation

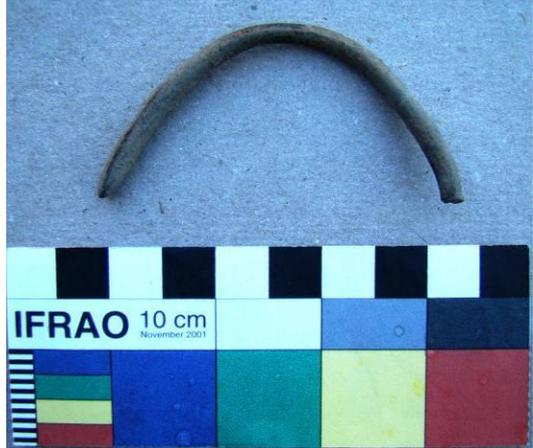
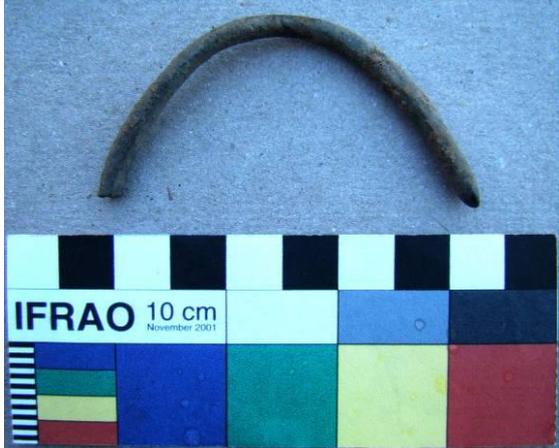
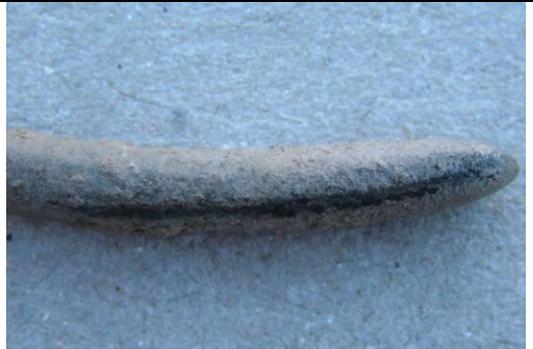
Table: KC5

Accession No. –		Acquisition source: Excavation 23/6/1936	
Site: K2	Square: B.2 S.9	Layer: 11'.26'.1'	Box No. Miller stuff
Metal type: Copper	Estimate value: Research		Current object use: in storage
Physical description: It is a bent round wire. One of its ends was tapered and the another end was cut straight probably by sampling.			
Measurement and dimensions			
Weight: 12.2 g	Width:	Inside diameter: 65.31 mm	
Length: 36.93 mm	Height:	Thickness: 4.49 mm	
Condition and damage: Moderately corroded with a dark brown corrosion and soil contamination on its surface.			
Facilities, report of location			
Type of support, frame and package: It is placed in small plastic bag in large box in museum storage.			
Environment control: -			
Photographic documentation

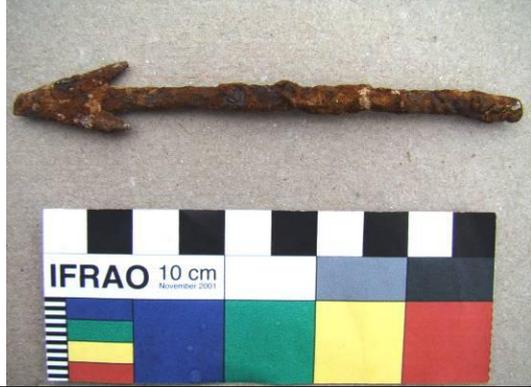
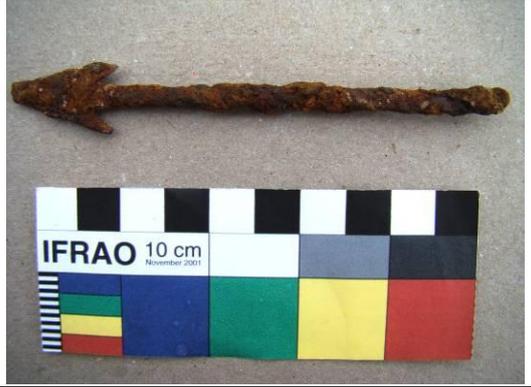
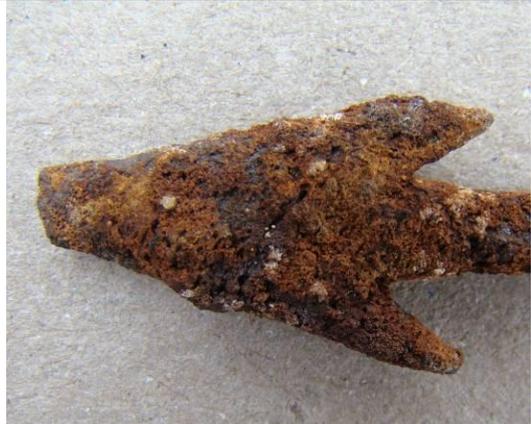
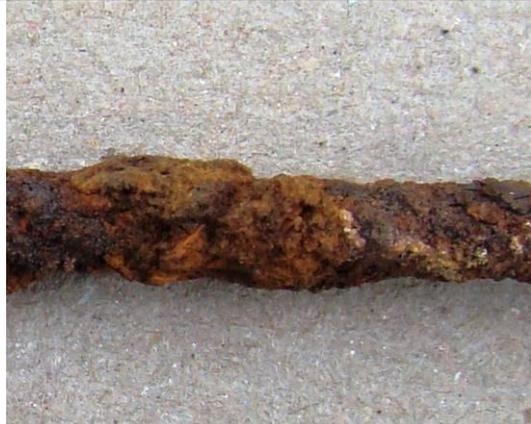
Table: MII

Accession No. C/711		Acquisition source: excavated	
Site: Map Hill	Square: -	Layer: -	Box No. C80
Metal type: Iron	Estimate value: exhibition, cultural		Current object use: in storage
Physical description: An iron arrowhead with a barbed triangular shape and a long shaft with a circular cross section.			
Measurement and dimensions			
Weight: 8.6g	Width:	Diameter:	
Length: 107.90mm	Height:	Thickness: Shaft: ~4.80 mm Blade: 2.77mm	
Condition and damage: Heavily corroded with soil and calcareous deposits on the surface.			
Facilities, report of location			
Type of support, frame and package: It has been mounted in a dense polyethylene foam and kept in a cardboard box in the museum storage area.			
Environment control: -			
Photographic documentation

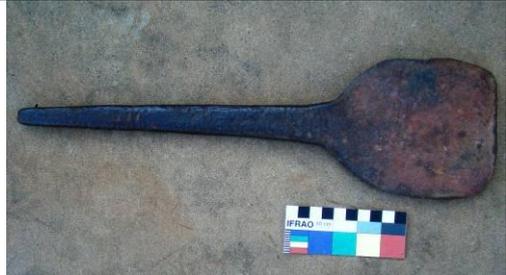
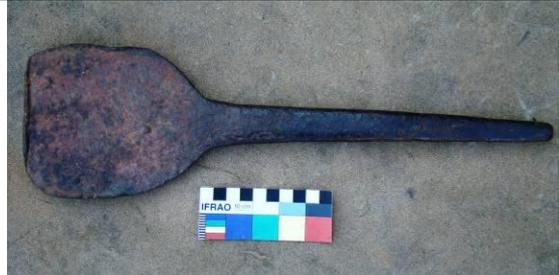
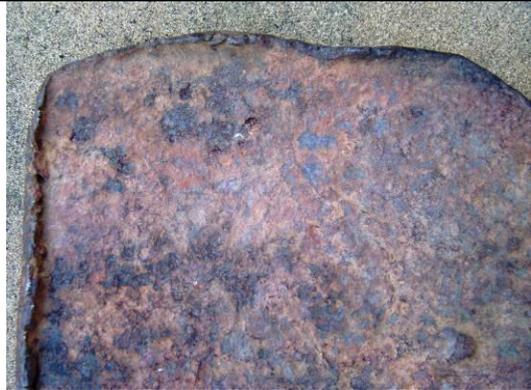
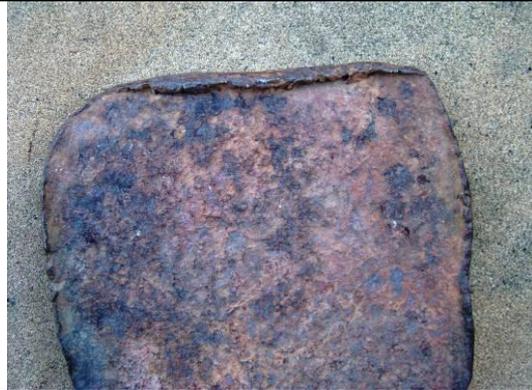
Table: MI2

Accession No. C/2326		Acquisition source: 1939	
Site: Map Hill	Square: -	Layer: -	Box No. C109
Metal type: Iron	Estimate value: exhibition		Current object use: in storage
Physical description: An iron hoe with a square blade and a long shaft. The shaft is tapered toward its end and has a rectangular cross section. The blade does not have a narrow edge. The edges of the blade have broad flat surfaces. It seems it has an incomplete manufacture.			
Measurement and dimensions			
Weight: 1435.5g	Width:	diameter:	
Length: 380 mm	Height:	Thickness: Handle: 10.99-14.68 mm Blade: 16.93- 3.81mm	
Condition and damage: Low corroded.			
Facilities, report of location			
Type of support, frame and package: It has been mounted in a dense polyethylene foam. The foam is in a cardboard box. It is kept in the museum storage facility.			
Environment control: -			
Photographic documentation

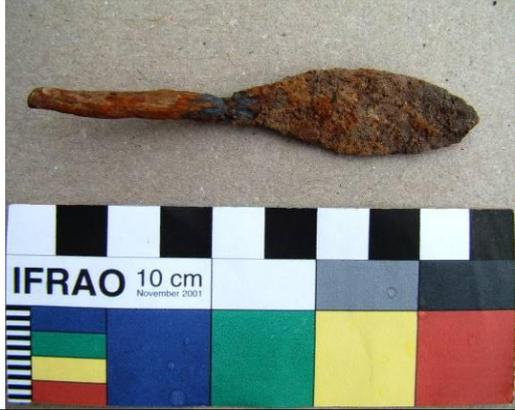
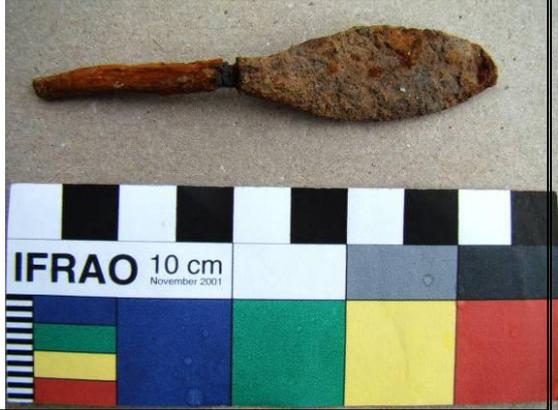
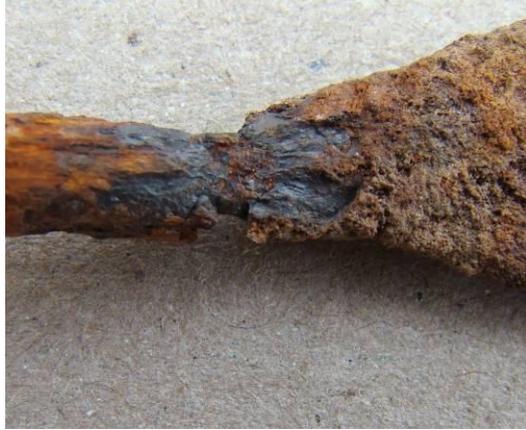
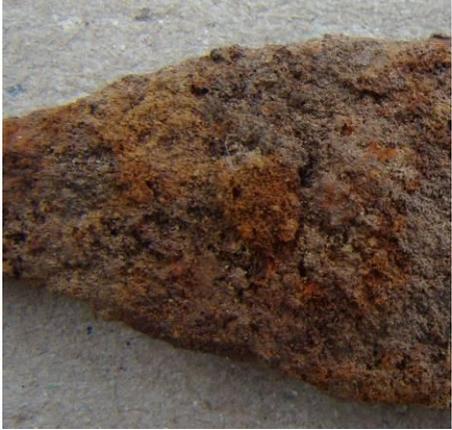
Table: MI3

Accession No. MAP/03/244		Acquisition source: Excavated	
Site: Map Hill (northern dump)	Square: -	Layer: -	Box No. MNP/044
Metal type: Iron	Estimate value: exhibition, cultural		Current object use: in storage
Physical description: A spoon like iron object. It has a circular cross section shaft.			
Measurement and dimensions			
Weight: 8.3 g	Width:	Diameter:	
Length: 81.58 mm	Height:	Thickness: handle: 4.76mm blade: 2.94 mm	
Condition and damage: Heavily corroded. Its shaft was bent in the conjunction with the blade and the corrosion was exfoliated in this part. Soil and calcareous deposits are observable on the surface.			
Facilities, report of location			
Type of support, frame and package: It is kept in a sealed plastic bag in a cardboard box in the storage area.			
Environment control: -			
Photographic documentation

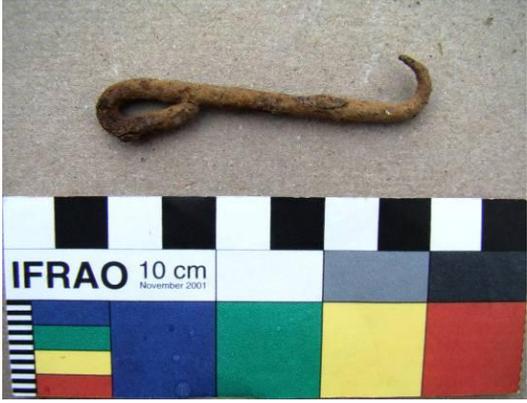
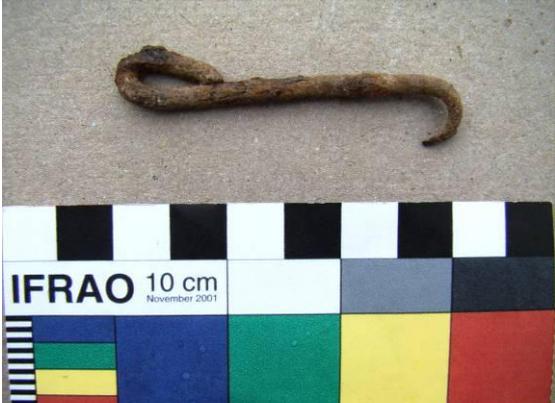
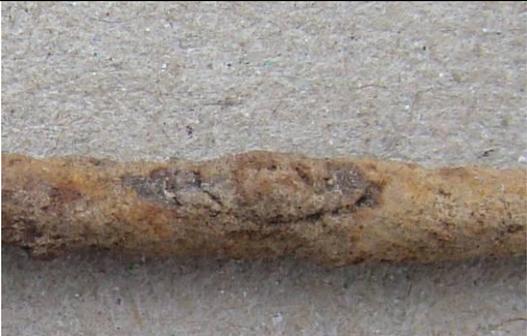
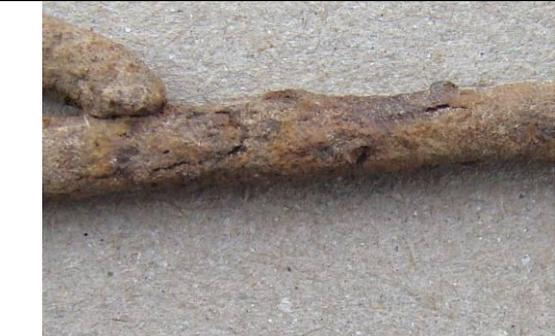
Table: MI4

Accession No. MAP/03/424		Acquisition source: Excavated in northern Dump	
Site: MAP Hill	Square: -	Layer: -	Box No. MNP/044
Metal type: Iron	Estimate value: exhibition, cultural		Current object use: in storage
Physical description: An iron Hook. It made of a round wire which was bent to form a hook with a sharp point at one end. The other end of wire was bent to form a loop.			
Measurement and dimensions			
Weight: 4.6g	Width:	Diameter:	
Length: 58.91 mm	Height:	Thickness: 3.54 mm	
Condition and damage: Moderately corroded with flaking. Entrapped soil particles are observable in corrosion on the surface.			
Facilities, report of location			
Type of support, frame and package: It has been placed in a plastic bag in a cardboard box in the storage facility.			
Environment control: -			
Photographic documentation

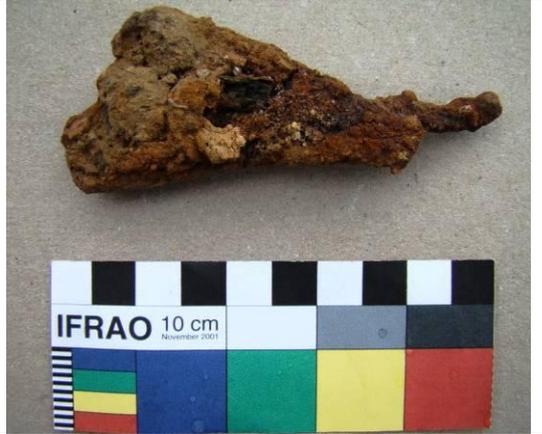
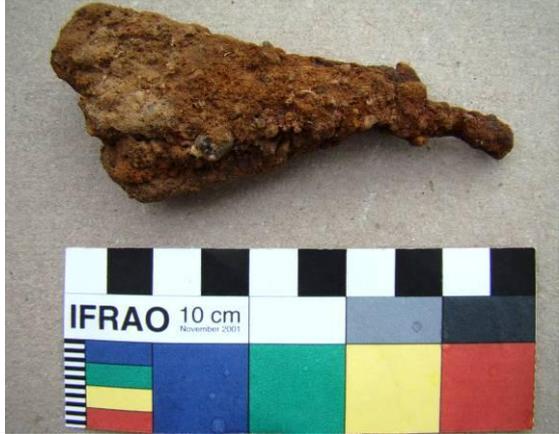
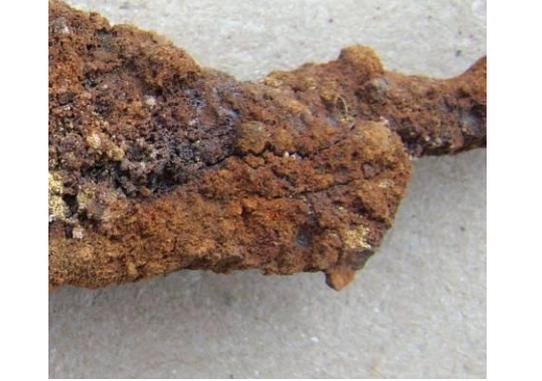
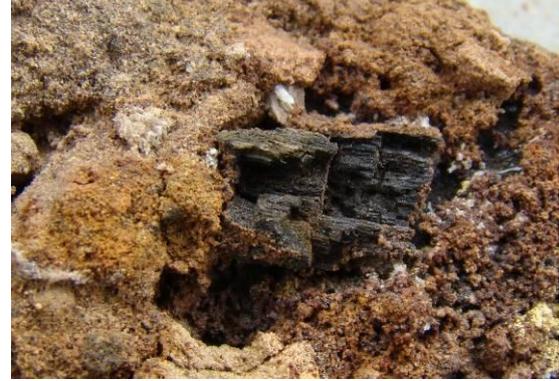
Table: MI5

Accession No. –		Acquisition source: Excavated (1973)	
Site: MAP Hill	Square: MK1/ B3	Layer: L11	Box No. Miller stuff
Metal type: Iron	Estimate value: research, cultural		Current object use: in storage
Physical description: Two iron spatulas that were fused together and completely covered with soil deposits.			
Measurement and dimensions			
Weight: 33.7 g	Width:	Inside diameter:	
Length: 91.50 mm	Height:	Thickness:	
Condition and damage: One of the adzes has a shaft missing and the other one has a missing part in the blade.			
Facilities, report of location			
Type of support, frame and package: It is kept in a plastic bag in a cardboard box in the museum storage area.			
Environment control: -			
Photographic documentation

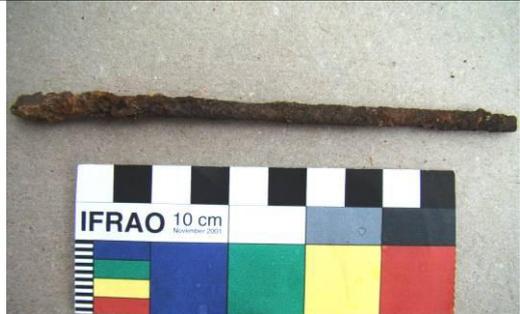
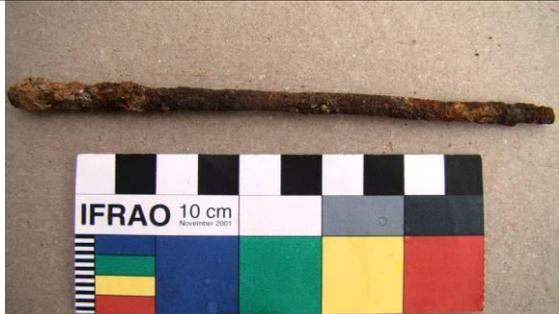
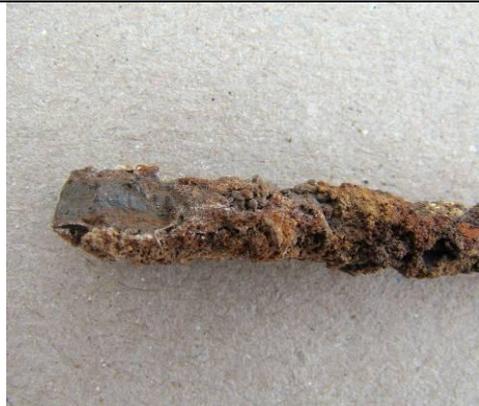
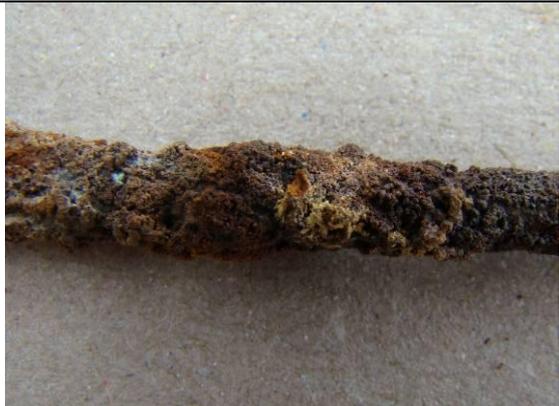
Table: MI6

Accession No. –		Acquisition source Excavated by Gardner (1940)	
Site: Map Hill	Square: B.5 S.5	Layer: 9'.3'.11'	Box No. Miller Stuff
Metal type: Iron	Estimate value: exhibition, cultural		Current object use: storage
Physical description: An iron point (rod). It is gradually become narrower from one end to another.			
Measurement and dimensions			
Weight: 9.6 g	Width:	Diameter:	
Length: 130.28 mm	Height:	Thickness: 8.26- 4.12mm	
Condition and damage: Heavily corroded with soil and calcareous deposits on the surface. Corrosion flaked in some parts.			
Facilities, report of location			
Type of support, frame and package: It is kept in a plastic bag in a cardboard box in the museum storage area.			
Environment control:-			
Photographic documentation

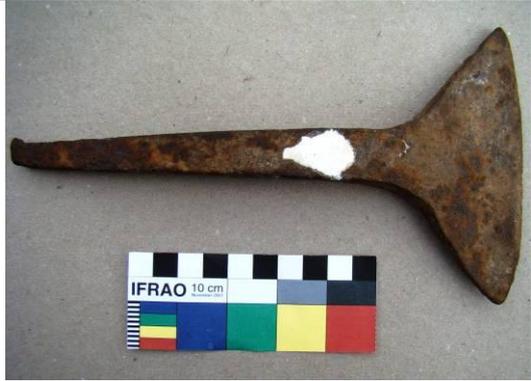
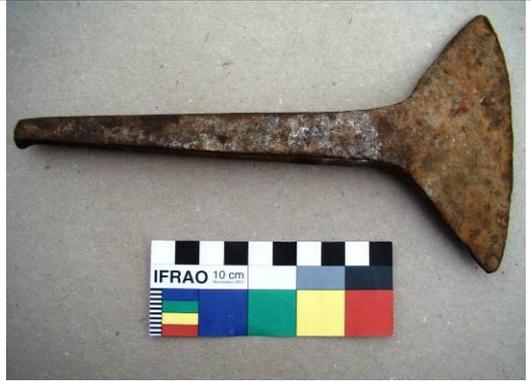
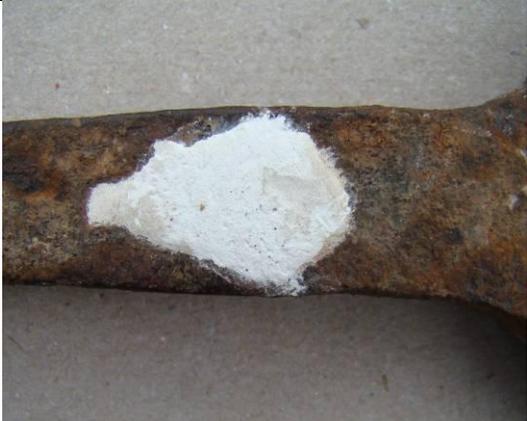
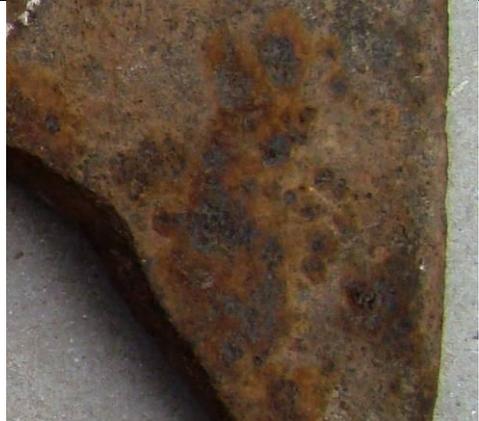
Table: MI7

Accession No. C/965		Acquisition source: 1935	
Site: Shashe-Limpopo (rock shelter)	Square: -	Layer: -	Box No. C80
Metal type: Iron	Estimate value: -		Current object use: in storage
Physical description: An iron hoe. Its handle becomes thicker in the conjunction with the blade. Its blade gradually becomes thinner towards the edge.			
Measurement and dimensions			
Weight: 406.5 g	Width:	Diameter:	
Length: 198.08 mm	Height:	Thickness: Handle: 8.93-17.40 mm Blade: 10.55- 4.95 mm	
Condition and damage: Low corroded. On the shaft it has a gap which was filled with plaster. The plaster has contaminated the surface.			
Facilities, report of location			
Type of support, frame and package: It has been mounted in a dense polyethylene foam. The foam has been placed in a cardboard box in the museum storage area.			
Environment control: -			
Photographic documentation

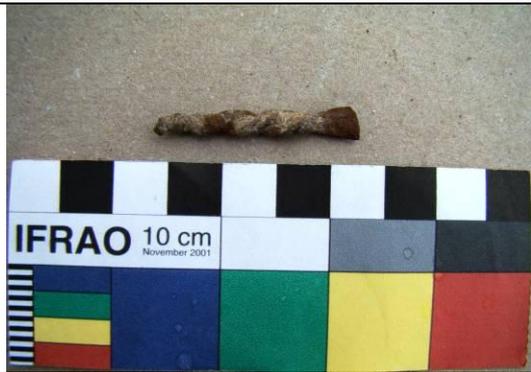
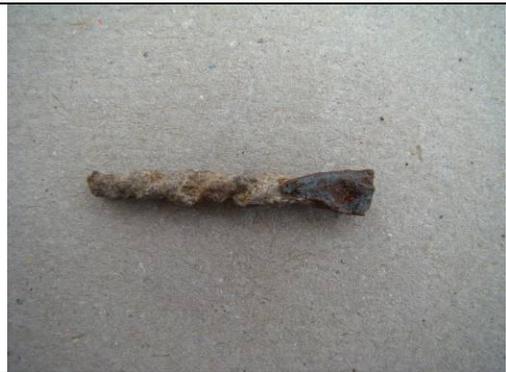
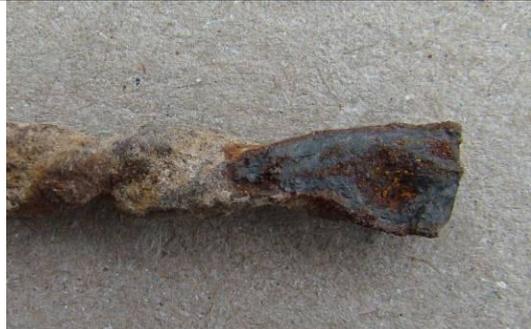
Table: MI8

Accession No. MAP/03/425		Acquisition source Excavated	
Site: MAP Hill	Square: -	Layer: -	Box No. MNP/044
Metal type: Iron	Estimate value: Cultural , research		Current object use: in storage
Physical description: A piece of block-twisted strip.			
Measurement and dimensions			
Weight: 2 g	Width: 6.25 mm	Diameter:	
Length: 36.15 mm	Height:	Thickness: 1.76 mm	
Condition and damage: It has a corroded surface. Soil particles and calcareous deposits are observable on the surface. In one end it was broken.			
Facilities, report of location			
Type of support, frame and package: It is kept in a plastic bag in a cardboard box in the museum storage area.			
Environment control: -			
Photographic documentation

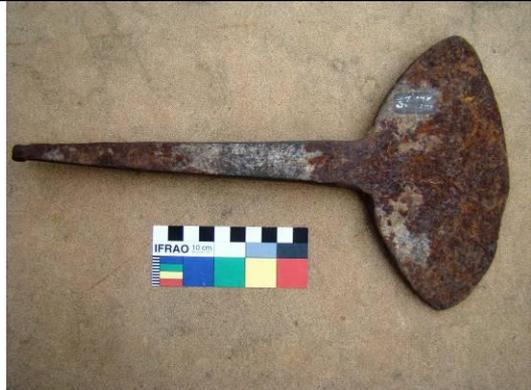
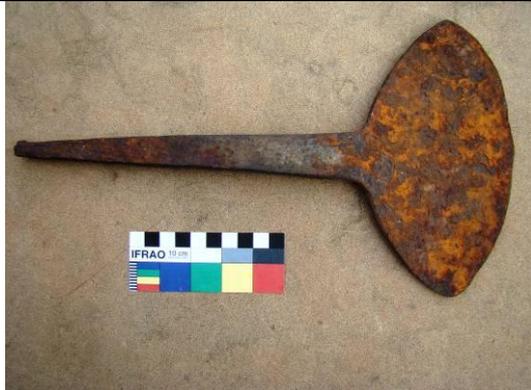
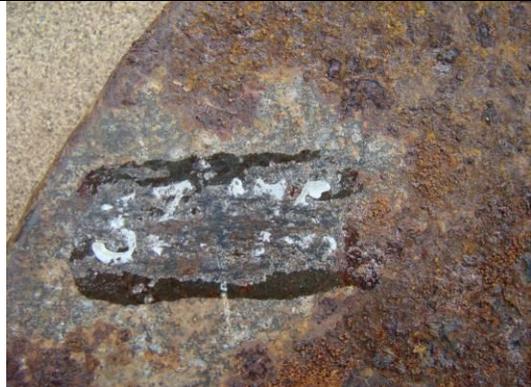
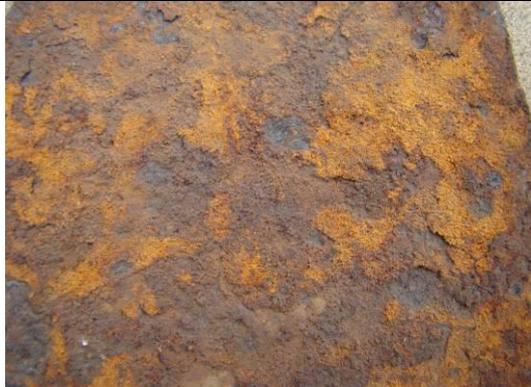
Table: MI9

Accession No. C/960		Acquisition source: Excavated (1933)	
Site: Shashe-Limpopo Rock Shelter	Square: -	Layer: -	Box No. C81
Metal type: Iron	Estimate value: exhibition, cultural		Current object use: in exhibition
Physical description: An iron hoe with a scapula shape blade and a long shaft. The blade has a narrow edge. The shaft has a rectangular cross section which tapers toward the end.			
Measurement and dimensions			
Weight: 850g	Width: Blade 11.73-2.26 mm Handle 14.80- 7.87 mm	Diameter:	
Length: 310 mm	Height:	Thickness:	
Condition and damage: Moderately corroded. One of the surfaces of the blade has dark brown corrosion products and on the other surface loose light orange corrosion products are observable. The latter surface was in a direct contact with the base board of the showcase.			
Facilities, report of location			
Type of support, frame and package: It is kept in a display box at Mapungubwe museum. Environment control: -

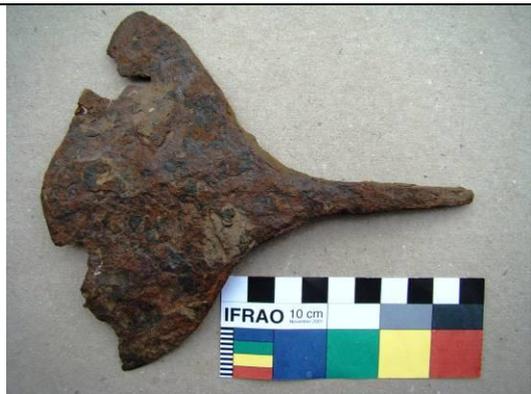
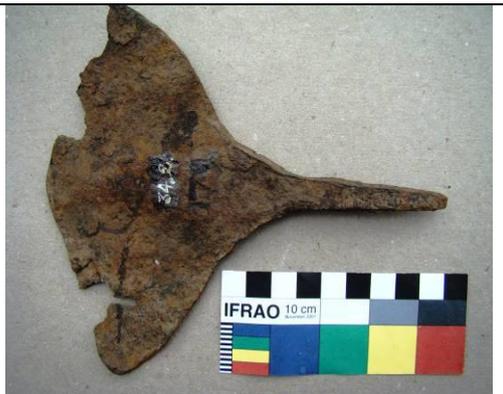
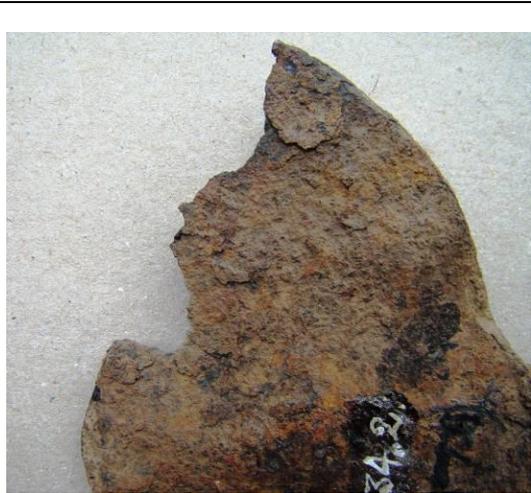
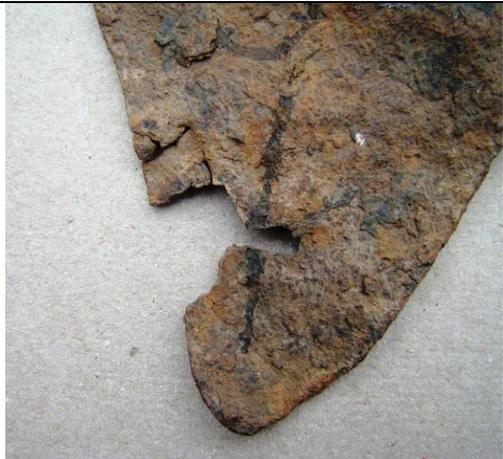
Table: MI10

Accession No. C/490		Acquisition source: excavated (1933)	
Site: Map Hill	Square: JS4	Layer: -	Box No. C89
Metal type: Iron	Estimate value: exhibition cultural		Current object use: in storage
Physical description: An iron hoe with a short handle which is tapered towards the end. The blade thickness gradually decreases towards the edge.			
Measurement and dimensions			
Weight: 192 g	Width:	Diameter:	
Length: 154.42 mm	Height:	Thickness: Handle: 6.76 – 9.78 Blade: 7.03 - ~1.47 mm	
Condition and damage: Heavily corroded. The iron hoe has two missing parts in the blade. Corrosion layers were exfoliated in some places.			
Facilities, report of location			
Type of support, frame and package: It has been mounted in a dense polyethylene foam. The foam has been placed in a cardboard box in the museum storage area.			
Environment control: -			
Photographic documentation

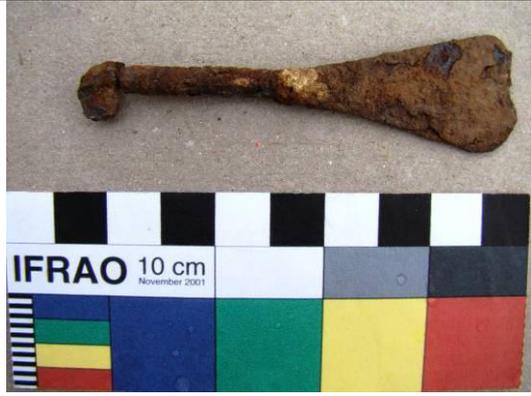
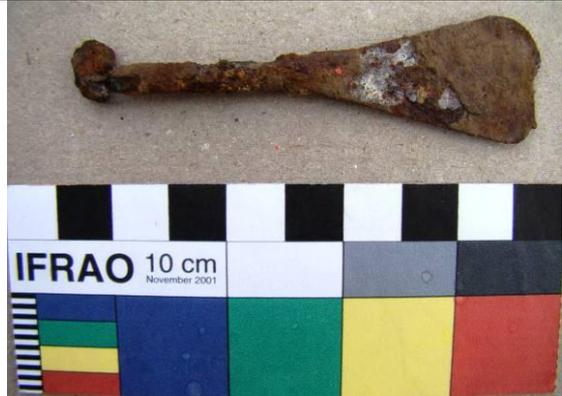
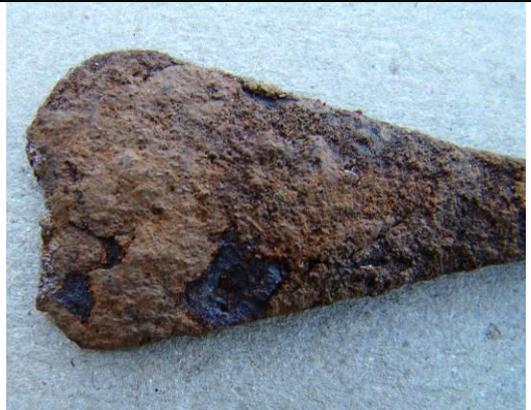
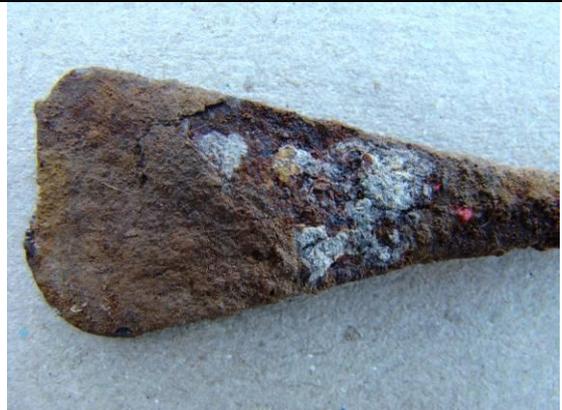
Table: SI1

Old Field /analysis ref No. 6) 02.01		Acquisition source: Excavated (1971)	
Site: MST	Excavation: K8	Layer: l(iii)	Box No. 214 (MRF)
Metal type: Iron	Estimate value: exhibition, cultural		Current object use: in storage
Physical description: A sweat scraper with a screw feature on the shaft. The shaft has a loop. The blade has a triangular shape.			
Measurement and dimensions			
Weight: 7.1g	Width:	Inside diameter:	
Length: 69.48 mm	Height:	Thickness: Blade: 1.33mm Shaft: 5.29mm	
Condition and damage: Heavily corroded with calcareous and soil deposits in corrosion on the surface. Corrosion products in some places flaked and the loop of the shaft was cut off.			
Facilities, report of location			
Type of support, frame and package: It is in a small glass container with a plastic lid in the MRF storage facility.			
Environment control: -			
Photographic documentation

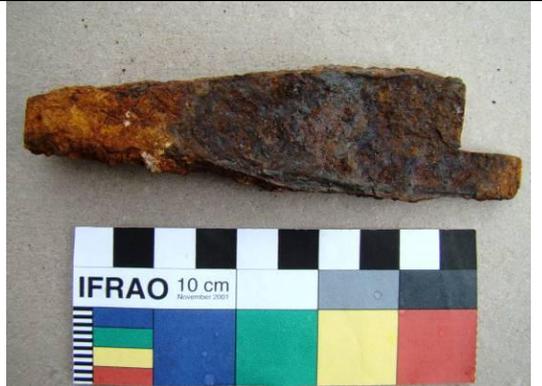
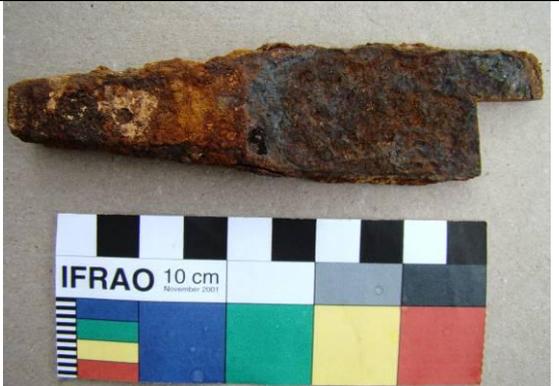
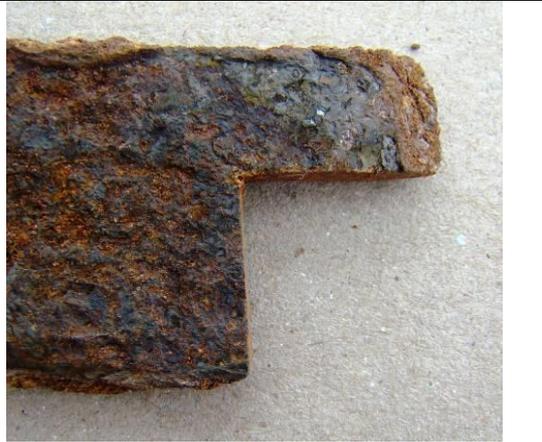
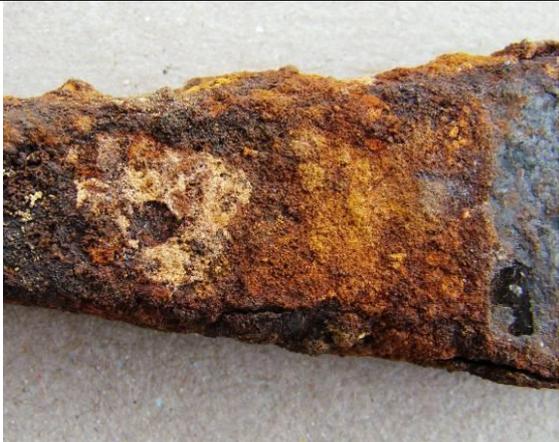
Table: SI2

Accession No. –		Acquisition source: Excavated (1971)	
Site: MST	Square: H5	Layer: 4 (i)	Box No. Miller stuff
Metal type: Iron	Estimate value: exhibition, cultural		Current object use: storage
<p>Physical description: An iron adze with a rectangular shape blade which is tapered towards the shaft. The blade thickness decreases gradually towards the tip. The shaft has a rectangular cross-section. Two big areas were removed by previous researcher from the blade and the shaft.</p>			
Measurement and dimensions			
Weight: 127.1 g	Width:	Inside diameter:	
Length: 115.92 mm	Height:	Thickness: Handle: 11.74 mm Blade: 5.17 mm	
<p>Condition and damage: Heavily corroded. The corrosion was exfoliated from the blade surface. A calcareous deposit is observable on the shaft. It has a 150*150 mm² gap in the blade. A sample was also removed from the shaft but no evidence is present to show its dimensions.</p>

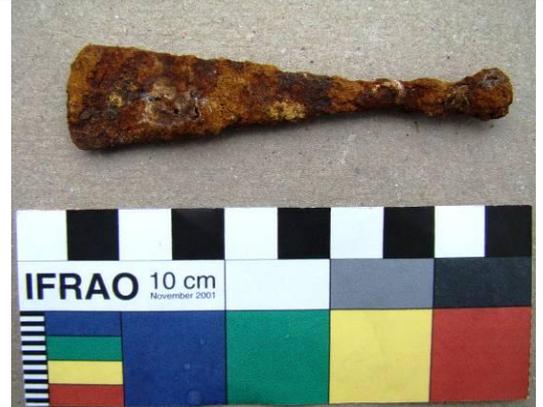
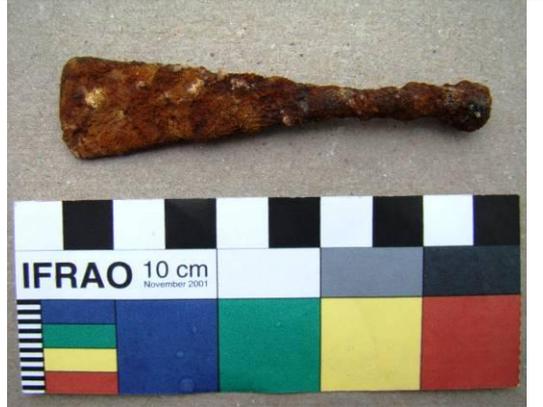
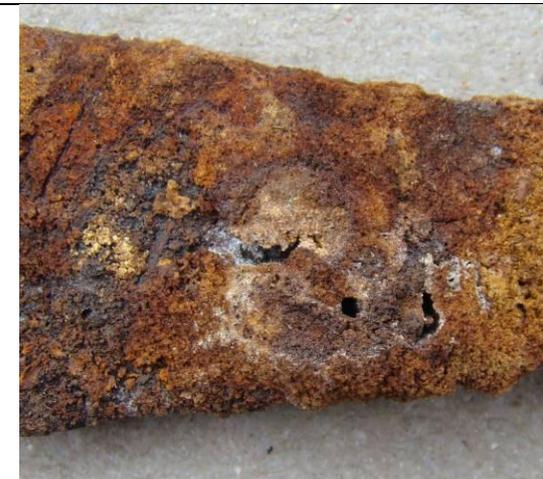
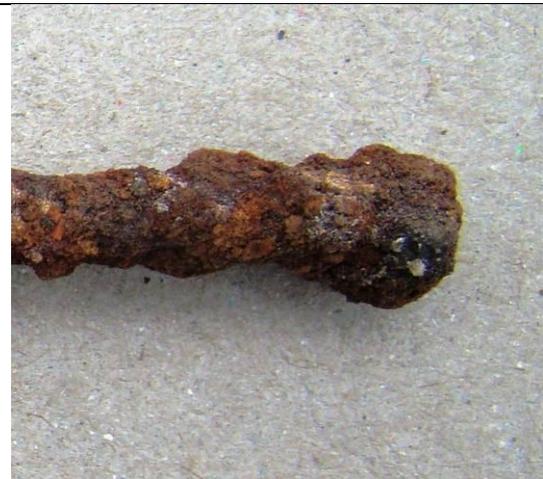
Table: SI3

Accession No. –		Acquisition source: Excavated (1971)	
Site: MST	Excavation: K8	Layer: L13 (B24)	Box No. Miller stuff
Metal type: Iron	Estimate value: exhibition, cultural		Current object use: in storage
Physical description: A spatula. It has a triangle shape blade with a shaft with a round cross section. The shaft has a sphere.			
Measurement and dimensions			
Weight: 8.3g	Width:	Diameter: Sphere 8.98 mm	
Length: 80.07 mm	Height:	Thickness: Blade 14.19-3.60 mm Handle: 5.18 mm	
Condition and damage: Heavily corroded with soil and calcareous contaminants on the surface.			
Facilities, report of location			
Type of support, frame and package: It has been placed in a small plastic bag and in a cardboard box in the museum storage area.			
Environment control: -			
Photographic documentation

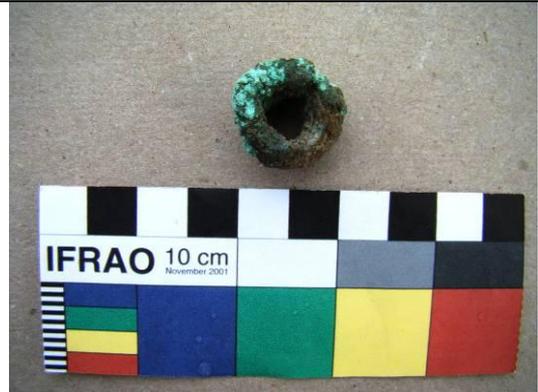
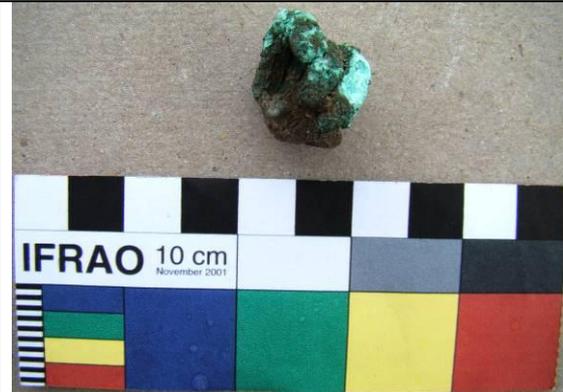
Table: MC1

Accession No. –		Acquisition source: Excavated by Gardner (1940)	
Site: MAP Hill	Square: B.5 S.5	Layer: 8'. 4'. 11'	Box No. Miller Stuff
Metal type: Copper	Estimate value: exhibition, cultural		Current object use: in storage
Physical description: A ring. It was made of a coiled wire with a circular cross section.			
Measurement and dimensions			
Weight: 10.2 g	Width:	Inside diameter:	
Length:	Height:	Thickness: 3.79 mm	
Condition and damage: Heavily corroded with light powdery and dark green corrosion products on the surface.			
Facilities, report of location			
Type of support, frame and package: It is kept in a plastic bag in a cardboard box in the museum storage area.			
Environment control: -			
Photographic documentation

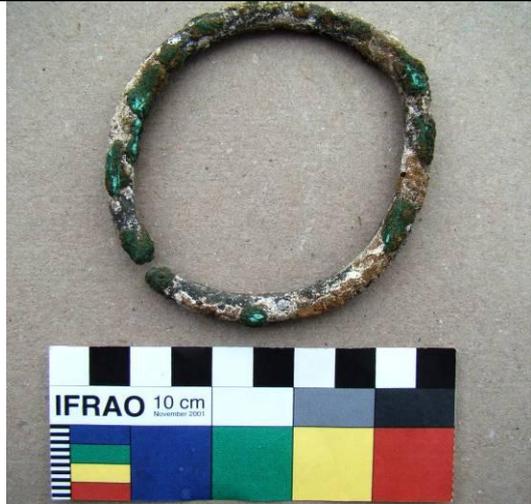
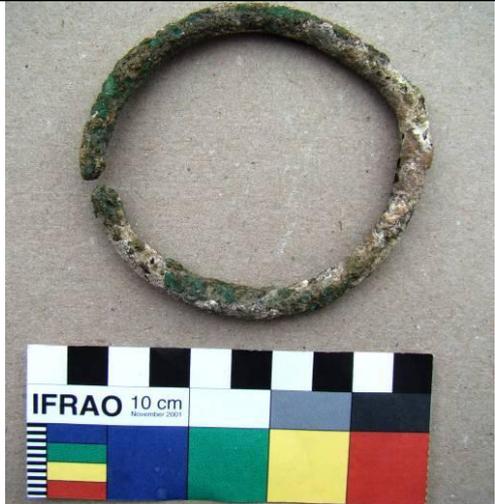
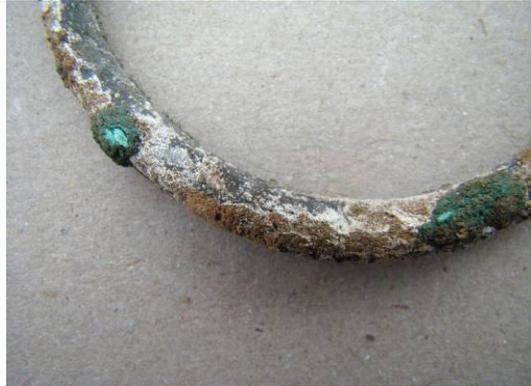
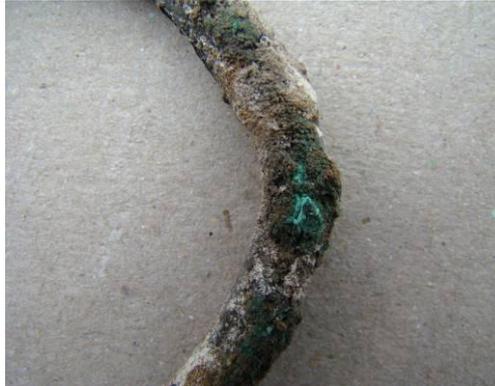
Table: MC2

Accession No. C/649		Acquisition source: Excavated by Gardner	
Site: Map Hill	Square: B.5 S.4	Layer: 45'. 15'. 5'	Box No. C89
Metal type: Copper	Estimate value: exhibition, cultural		Current object use: in storage
Physical description: A cooper bangle. It was made of a round wire with an open end.			
Measurement and dimensions			
Weight: 53.8 g	Width:	Inside diameter: 59.38 - 67.08 mm	
Length:	Height:	Thickness: 5.94- 7.60 mm	
Condition and damage: Heavily corroded with dark and light green corrosion products and white calcareous deposit on the surface. The bangle was deformed.			
Facilities, report of location			
Type of support, frame and package: It has been mounted in a dense polyethylene foam. The foam is in a cardboard box in the museum storage area.			
Environment control: -			
Photographic documentation
