Metals from K2 and Mapungubwe: A technological study of early second millennium material culture, with an emphasis on conservation

A thesis submitted in partial fulfilment of the requirements for
the degree

DPhil Archaeology

February 2013

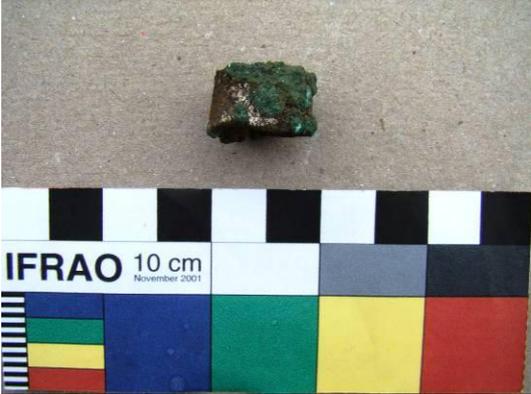
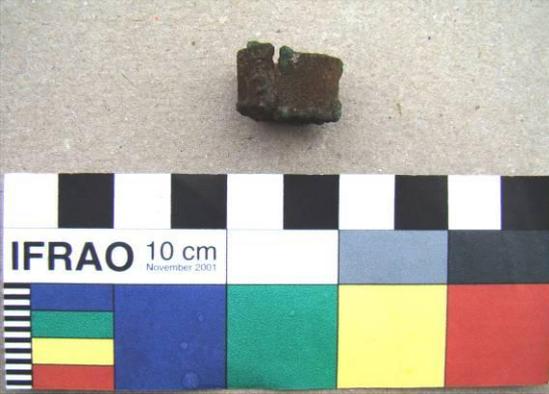
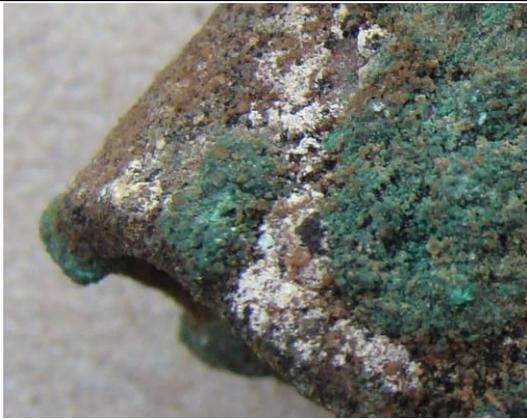
Table: MC3

Accession No. C/699		Acquisition source Excavated by Gardner (1940)	
Site: Map Hill	Square: B.5 S.4	Layer: 68'. 9'. 6'	Box No. C79
Metal type: Copper	Estimate value: exhibition, cultural		Current object use: in storage
Physical description: A copper ring. It was made of a strip of copper which bent to form a ring. The edges of the strip are not straight and have a light wavy feature. It has an open end.			
Measurement and dimensions			
Weight: 5.4 g	Width: 10.97 mm	Inside diameter: 10.39-12.32 mm	
Length:	Height:	Thickness: 1.64 mm	
Condition and damage: Moderately corroded with dark and light green corrosion products and calcareous contaminants on the surface.			
Facilities, report of location			
Type of support, frame and package: it has been mounted in a high dense polyethylene foam and covered with a polyethylene sheet in a cardboard box.			
Environment control: -			
Photographic documentation

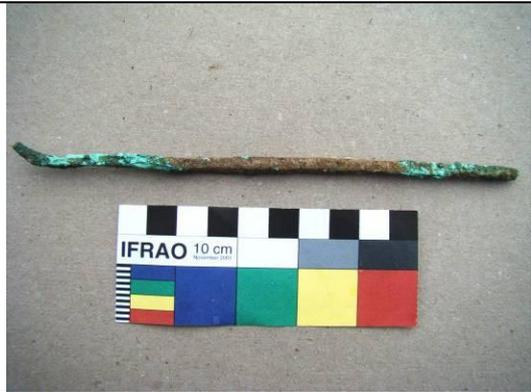
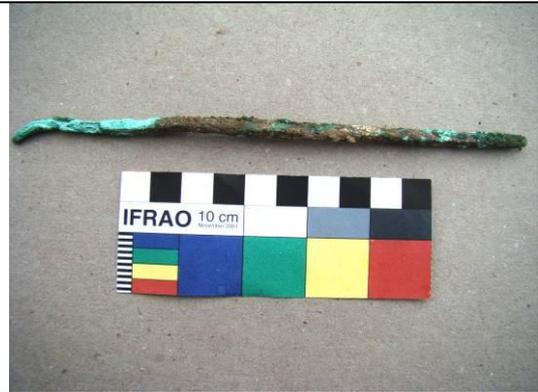
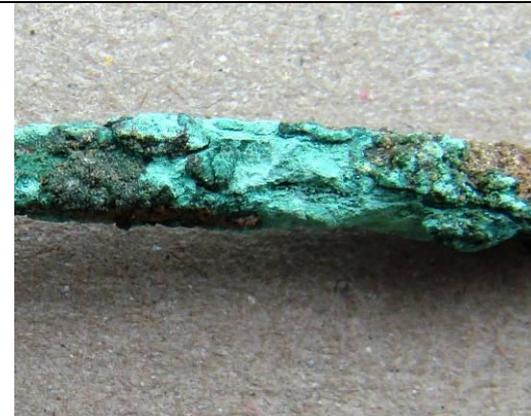
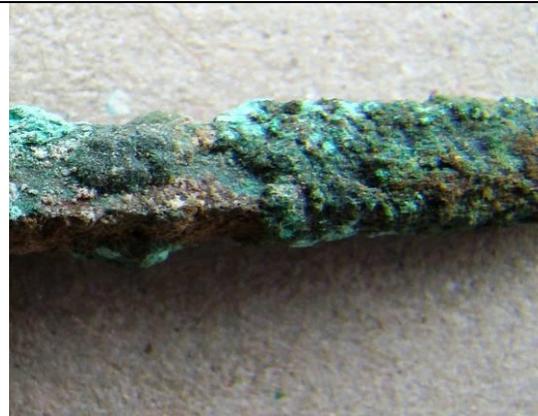
Table: MC4

Accession No. C/3942		Acquisition source: excavated	
Site: Map Hill	Square: -	Layer: -	Box No. 172a
Metal type: Copper	Estimate value: exhibition, cultural		Current object use: storage
Physical description: A copper rod with a bent end. It has rectangular cross section and become narrower in the gouge end.			
Measurement and dimensions			
Weight: 15.6 g	Width:	Diameter:	
Length: 165mm	Height:	Thickness: 2.75- 5.6mm	
Condition and damage: Heavily corroded with a light powdery green corrosion and soil contaminants on the surface. It has uneven surface.			
Facilities, report of location			
Type of support, frame and package: It has been mounted in a high dense polyethylene foam and covered with a sheet of polyethylene foam in a cardboard box.			
Environment control: -			
Photographic documentation

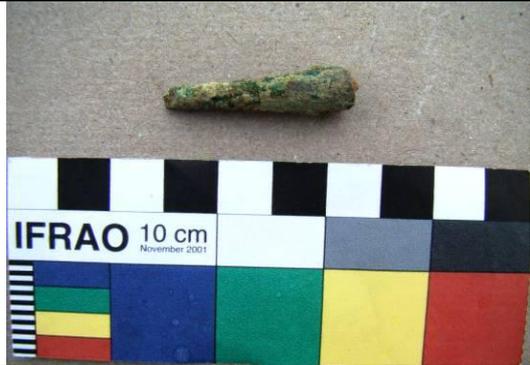
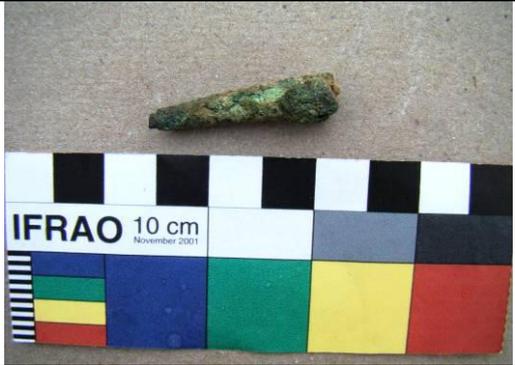
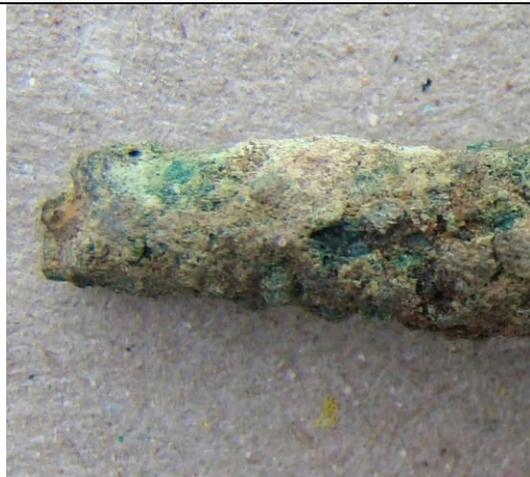
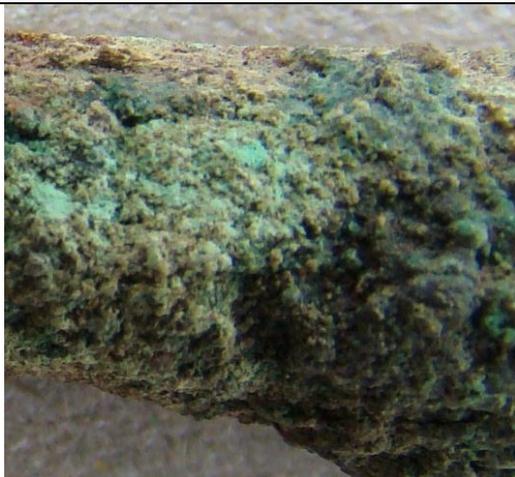
Table: MC5

Accession No. MAP/03/082		Acquisition source excavated	
Site: Map Hill	Square: Gardner west	Layer: -	Box No. MNP/019
Metal type: Copper	Estimate value: exhibition, cultural		Current object use: in storage
Physical description: A funnel shape copper object that was made by rolling a copper sheet. The seam was joined together without any welding or any other mechanical or heating method.			
Measurement and dimensions			
Weight: 2.6g	Width:	Diameter: 7.94- 4.42 mm	
Length:	Height:	Thickness: 1.93mm	
Condition and damage: Heavily corroded. It has light and dark green corrosion products on the surface. The surface is uneven. A calcareous deposit is seen on some parts of the surface.			
Facilities, report of location			
Type of support, frame and package: It is in a sealed plastic bag in a cardboard box in the storage facility.			
Environment control: -			
Photographic documentation

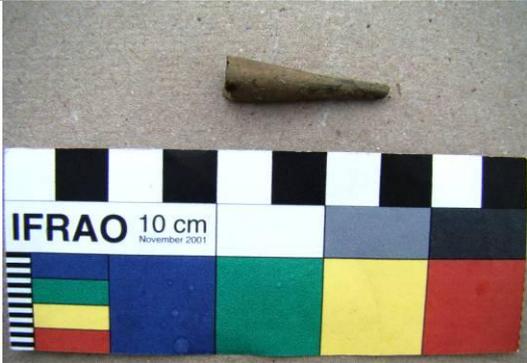
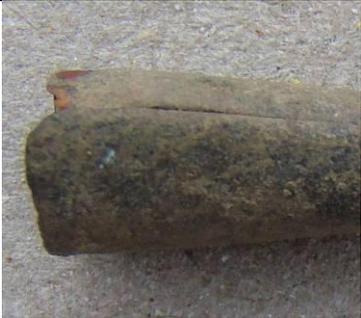
Table: MC6

Accession No. MAP/03/082		Acquisition source: excavated	
Site: Map Hill	Square: Gardner west	Layer: -	Box No. MNP/019
Metal type: Copper	Estimate value: exhibition	Cultural	Current object use: storage
Physical description: A funnel shape copper object that was made by rolling of a copper sheet. The seam was joined together without any welding or any other mechanical or heating method.			
Measurement and dimensions			
Weight: 1.9g	Width:	Diameter: 6.49– 2.84mm	
Length: 28.56mm	Height:	Wall thickness: 0.64mm	
Condition and damage: Low corroded. It has a small bend close to the funnel's open seam and in peripheral of the wide part of the funnel.			
Facilities, report of location			
Type of support, frame, and package: It is in a sealed plastic bag in a cardboard box in the storage facility.			
Environment control: -			
Photographic documentation

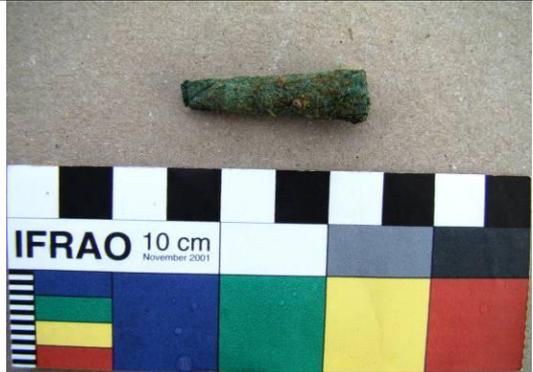
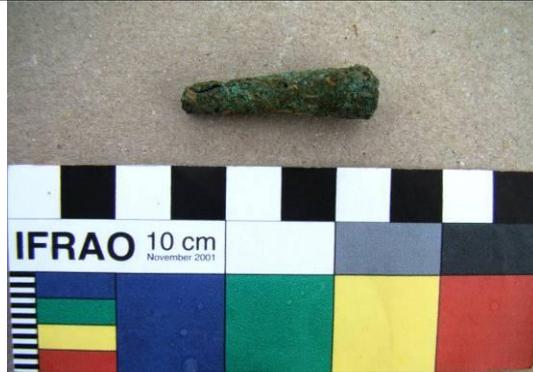
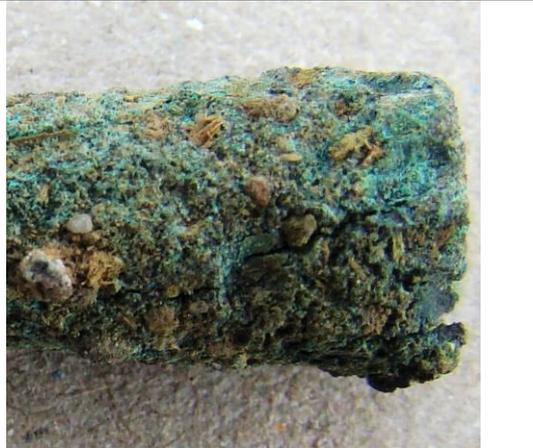
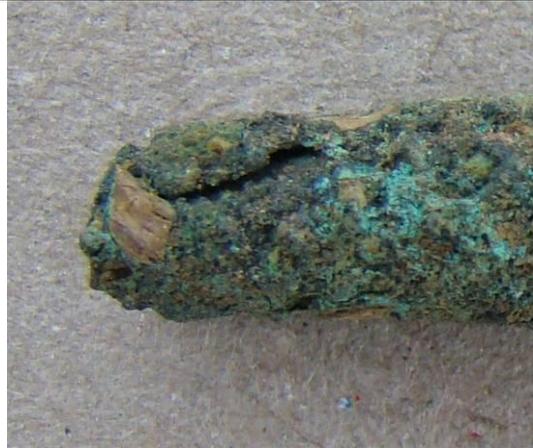
Table: MC7

Accession No. MAP/03/248		Acquisition source: Excavated	
Site: MAP Hill	Square: Northern Dump	Layer: -	Box No. MNP/044
Metal type: Copper	Estimate value: exhibition, cultural		Current object use: in storage
Physical description: A funnel shape copper object. A copper sheet was rolled to form it.			
Measurement and dimensions			
Weight: 3g	Width:	Diameter: 9.20- 5.15mm	
Length: 32.46mm	Height:	Wall thickness: 1.59 mm	
Condition and damage: Heavily corroded with fossilized fibers in light corrosion products on the surface. Corrosion layer in some places was cracked and flaked.			
Facilities, report of location			
Type of support, frame and package: It is kept in a small sealed plastic bag in a cardboard box in the storage facility.			
Environment control: -			
Photographic documentation

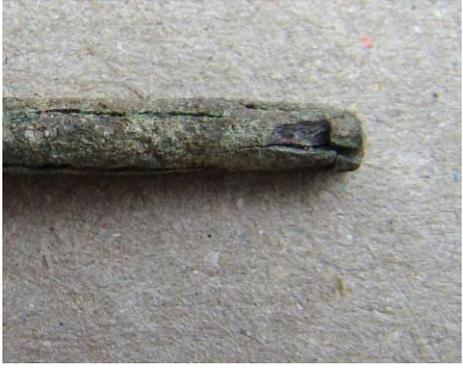
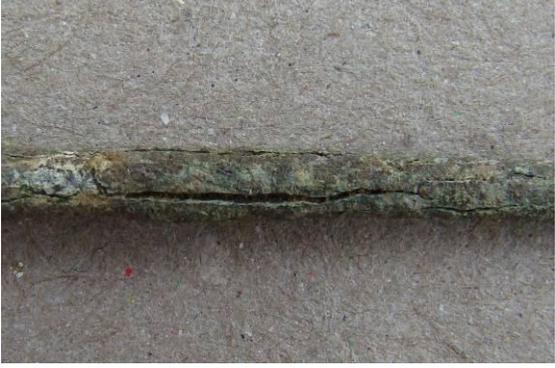
Details of the damaged parts

Accession No. MAP/03/226		Acquisition source Excavated (Northern Dump)	
Site: MAP Hill	Square: -	Layer: -	Box No. MNP/044
Metal type: Bronze	Estimate value: exhibition, cultural		Current object use: in storage
Physical description: A nail with a hemisphere head and a long shank with a round cross section. The nail shank is moderately become narrower towards the end.			
Measurement and dimensions			
Weight: 3.9g	Width:	Diameter: 2.88mm- 5.04 mm head: 8.34	
Length: 52.52mm	Height:	Thickness: 1.59 mm	
Condition and damage: Heavily corroded with a small amount of light green corrosion products on the surface. Soil contaminants and longitudinal cracks are observable on the surface.			
Facilities, report of location			
Type of support, frame and package: It is kept in a small sealed plastic bag in the storage facility.			
Environment control: -			
Photographic documentation

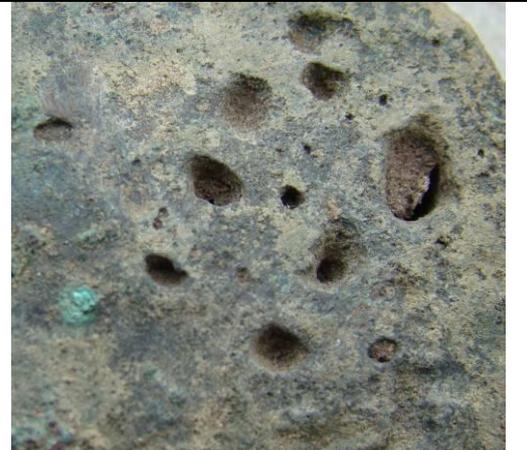
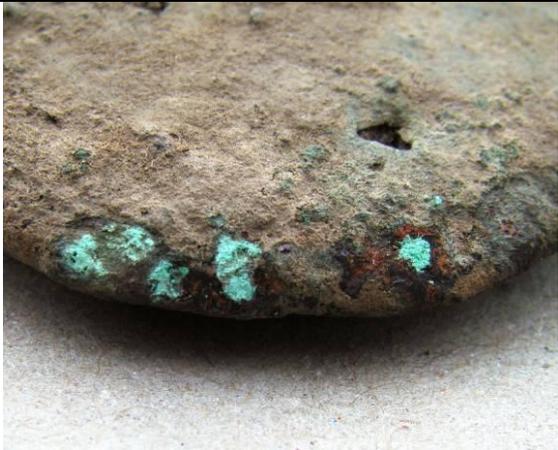
Details of the damaged parts

Accession No. -		Acquisition source: Excavated by Gardner (July 1935)	
Site: Map Hill (rock shelter)	Square: -	Layer: -	Box No. 223 (research facility)
Metal type: Copper	Estimate value: exhibition, cultural		Current object use: storage
Physical description: A copper ingot with a lentiform shape. On the mold surface, it has several voids. On the rough surface, it has a protrusion in the middle.			
Measurement and dimensions			
Weight: 132.2 g	Width:	Diameter: 54.50mm	
Length:	Height:	Thickness: Centre 15.62 Edge: ~6.90	
Condition and damage: Low corroded. Brown and light green corrosion products with soil contaminants are observable on its surfaces. It has several voids on the mold surface.			
Facilities, report of location			
Type of support, frame, and package: It is kept in a mail paper pocket in a cardboard box in Mapungubwe research facility (MRF) storage area.			
Environment control:-			
Photographic documentation

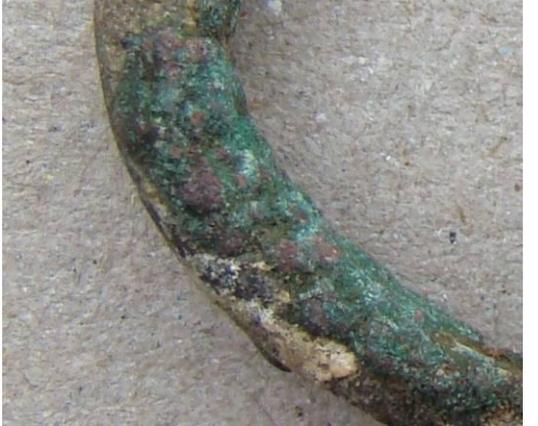
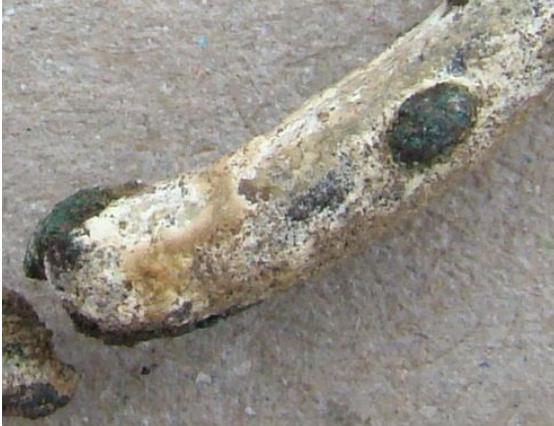
Details of the damaged parts

Accession No. C/1040		Acquisition source: Excavated by Gardner (Oct.1937)	
Site: Map Hill	Square: B.1 S.4	Layer: 5'. 47'. 4'	Box No. C79
Metal type: copper	Estimate value: exhibition, cultural		Current object use: storage
Physical description: A copper ring. It was made by bending of a round wire.			
Measurement and dimensions			
Weight: 7.7 g	Width:	Inside diameter: 19.17-24.72 mm	
Length:	Height:	Thickness: 3.34-4.40mm	
Condition and damage: Heavily corroded with dark and light green corrosion products on the surface. The surface is uneven. Calcareous deposits are also observable on the surface. The ring was deformed by pressure during its usage or burial.			
Facilities, report of location			
Type of support, frame, and package: It has been mounted in a dense polyethylene foam. The foam is in a cardboard box in the museum storage facility.			
Environment control: -			
Photographic documentation

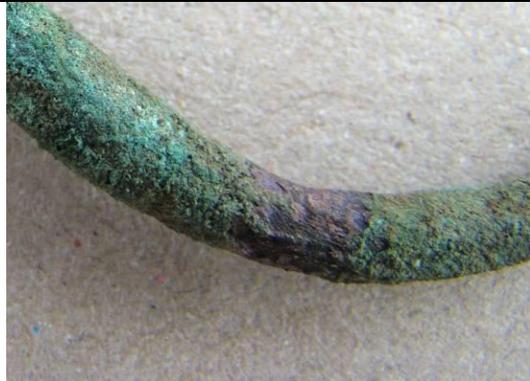
Details of the damaged parts

Accession No. C/680		Acquisition source Excavated by Gardner (1940)	
Site: Map Hill	Square: B.5 S.4	Layer: 25'. 7'. 4'	Box No. C79
Metal type: Copper	Estimate value: exhibition , Cultural		Current object use: in storage
Physical description: A copper bangle. It was made by bending of a round wire and has an open end.			
Measurement and dimensions			
Weight: 24.4 g	Width:	Inside diameter: 55.37-56.37 mm	
Length:	Height:	Thickness: 3.90-4.68mm	
Condition and damage: Moderately corroded with a dark green patina. In some parts, light green corrosion is observable on the surface. Corrosion products in some places were exfoliated. The object has a little distortion.			
Facilities, report of location			
Type of support, frame, and package: It has been mounted in a dense polyethylene foam. The foam is in a cardboard box in the museum storage area.			
Environment control:			
Photographic documentation

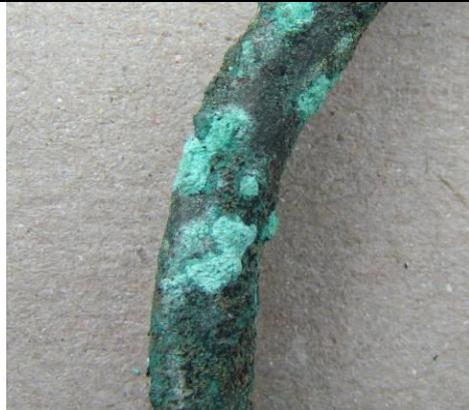
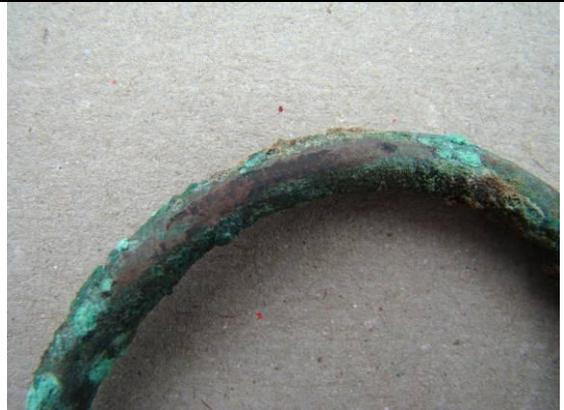
Details of the damaged parts

Accession No. C/641		Acquisition source Excavation by Gardner	
Site: Map Hill	Square: B.5 S.4	Layer: 64'. 14'. 8'	Box No. C89
Metal type: Copper	Estimate value: exhibition, cultural		Current object use: storage
Physical description: A copper bangle. It was made by bending of a round wire and has an open end.			
Measurement and dimensions			
Weight: 55 g	Width:	Inside diameter: 62.53-62.65mm	
Length:	Height:	Thickness: 6.98 mm	
Condition and damage: Moderately corroded with dark and light green corrosion products on the surface. Soil and calcareous contaminants are also observable. Corrosion was abraded from the surface in one place and along the bangle length. It has a distortion almost in the middle.			
Facilities, report of location			
Type of support, frame, and package: It has been mounted in a dense polyethylene foam in a cardboard box in the museum storage area.			
Environment control: -			
Photographic documentation

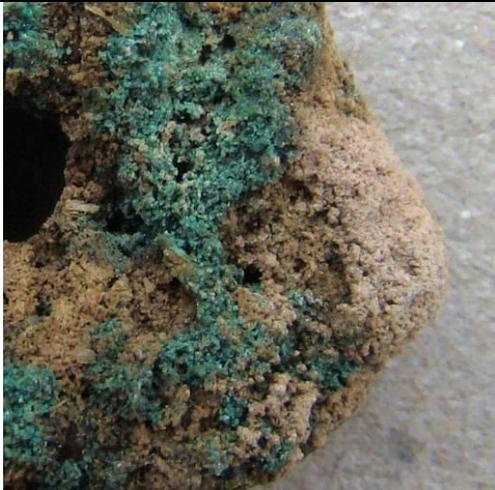
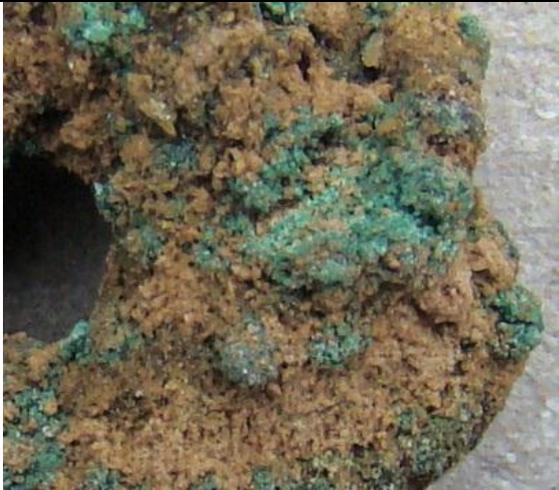
Details of the damaged parts

Accession No. –		Acquisition source Excavated (1971)	
Site: MST	Square: K8	Layer: L14	Box No. Miller stuff
Metal type: Copper	Estimate value: Research		Current object use: in storage
Physical description: A copper ring. A copper helix of several strip twisting wires was coiled to form this ring.			
Measurement and dimensions			
Weight: 4.5g	Width:	Diameter: 20.12- 21.87 mm	
Length:	Height:	Thickness:	
Condition and damage: Heavily corroded. It has dark and light green corrosion products with soil particles on the surface. This object is brittle.			
Facilities, report of location			
Type of support, frame, and package: It is kept in a small plastic bag in a cardboard box in the museum storage area.			
Environment control: -			
Photographic documentation

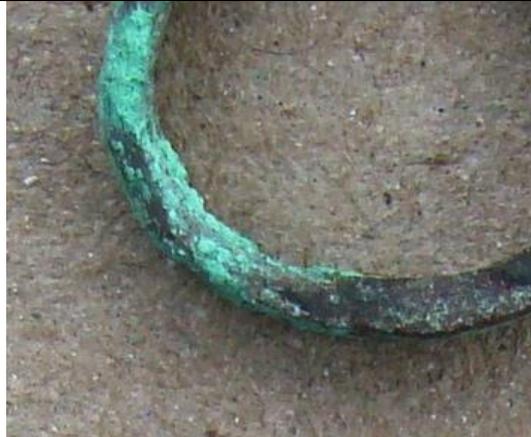
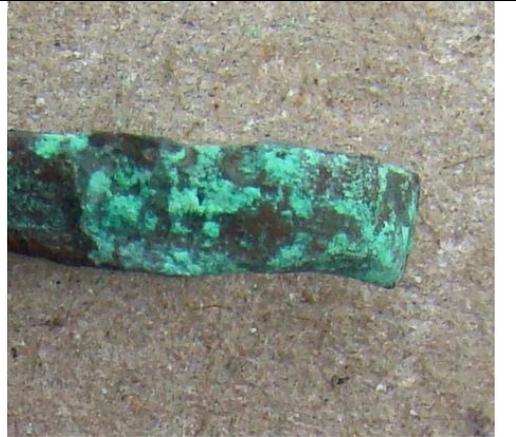
<p>Details of the damaged parts</p>

Accession No. MAP/03/026		Acquisition source Excavated	
Site: MST	Square: JS2(b)	Layer: -	Box No. MNP/001
Metal type: copper	Estimate value: Exhibition, cultural		Current object use: in storage
<p>Physical description: A copper ring with an open end. It was made of a piece of strip which has a rectangular cross section.</p>			
<p>Measurement and dimensions</p>			
Weight: 24.4 g	Width: 3.65-3.82 mm	Inside diameter: 13.79 mm	
Length:	Height:	Thickness: 1.82 mm	
<p>Condition and damage: Moderately corroded with light green and brown corrosion products. In some places the cuprite layer was mechanically removed from the surface as the result of over cleaning.</p>			
<p>Facilities report of location</p>			
<p>Type of support, frame, and package: It is kept in a small plastic bag in a cardboard box in the storage facility.</p>			
<p>Environment control: -</p>			
<p>Photographic documentation</p>

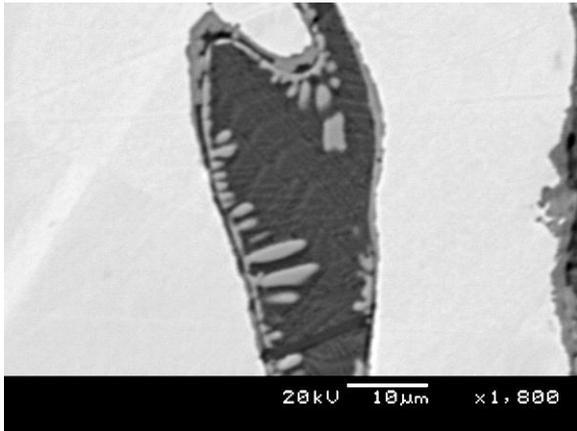
Figure 1. Polished section of iron rod (KI1) showing bloomery two-phase inclusion (KI1a) of wüstite dendrites in dark slag. (SEM-BSE)

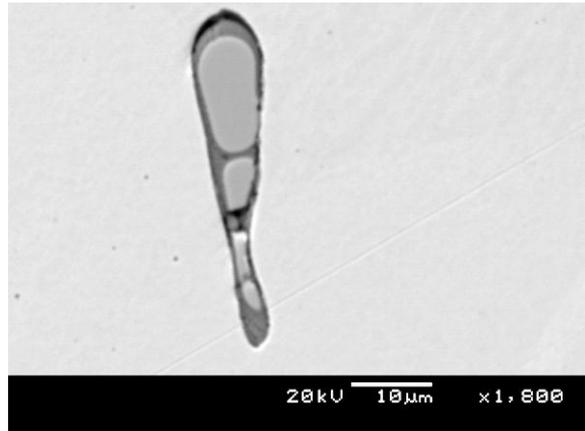
Figure 2. Polished section of iron rod (KI1) showing bloomery two-phase inclusion (KI1b) with dark-grey slag surrounding light gray wüstite globules. (SEM-BSE)

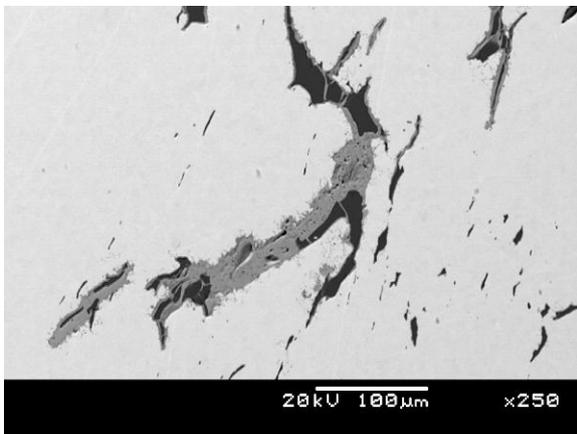
Figure 3. Polished section of iron rod (KI1) showing slag inclusion (KI1c) of light iron oxide in accompany with dark glassy phase. (SEM-BSE)

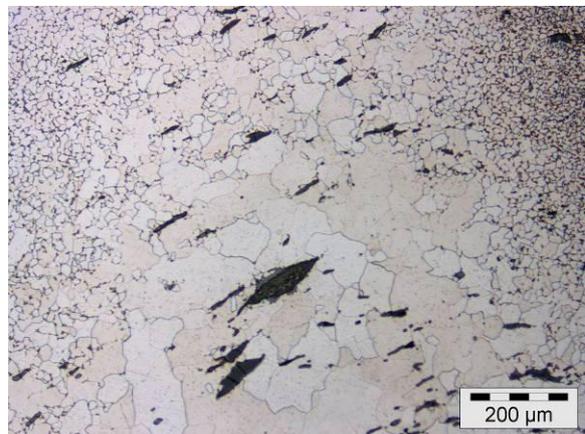
Figure 4. Etched section of iron rod (KI1) showing critical growth of ferrite grains within the metal core and close to the metal surface.

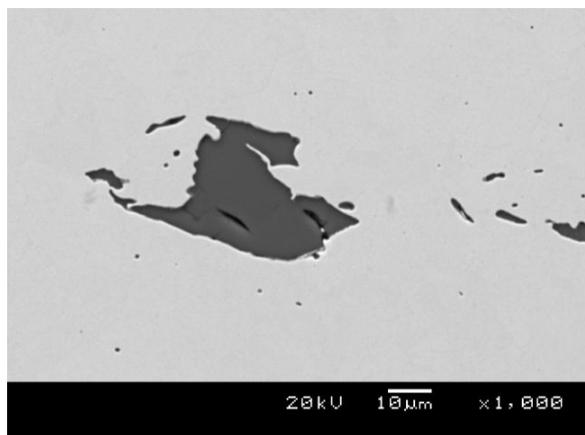
Figure 6. Glassy inclusions within remainder of metal phase in MI6. (SEM-BSE)

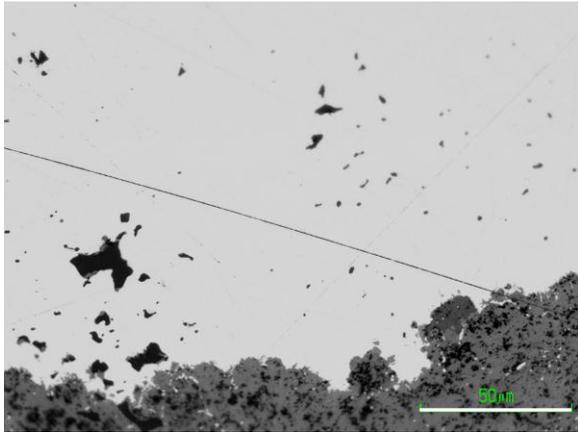
Figure 7. Micrograph of a small inclusion with lime content in peripheral of void within metallic phase in MI6. (Scale: 50µm)

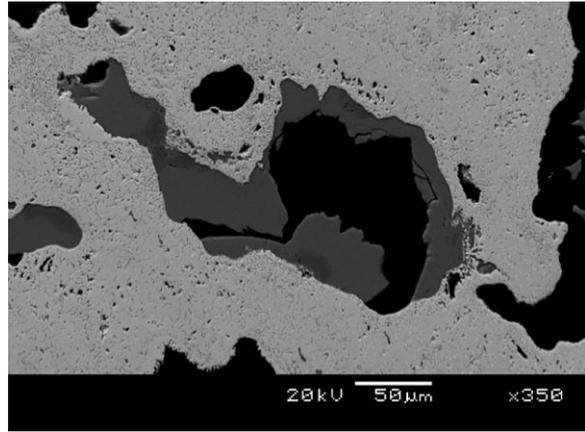
Figure 8. The inclusion with lime content in peripheral of a void within corrosion products in (MI6). (SEM-BSE)

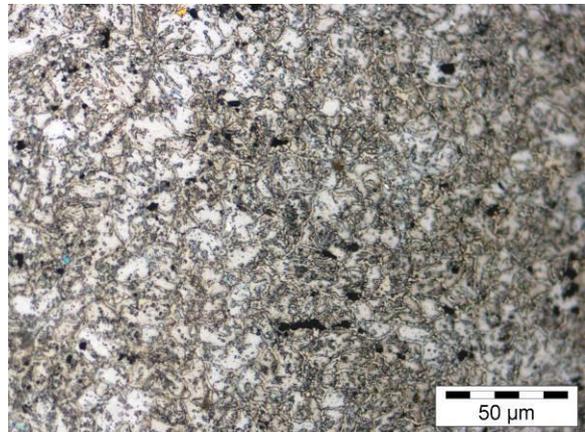
Figure 10. The etched micrograph of MI6 showing former austenite grains with grain boundaries of cementite.

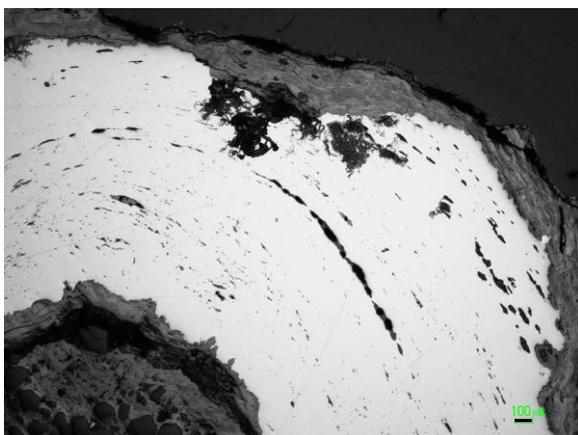
Figure 11. Polished cross section of SII showing elongated stringers of slag passing along the length of the heavily worked surfaces. (Scale: 100µm)

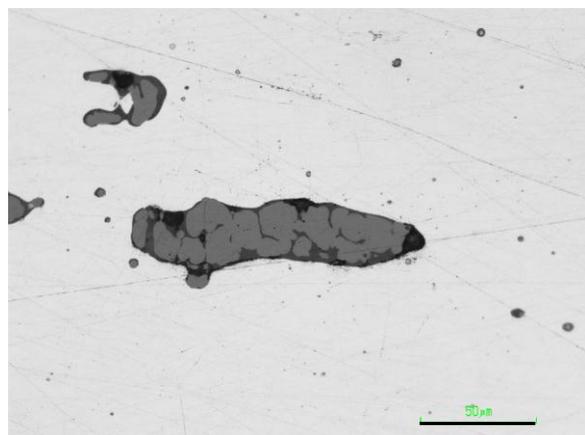
Figure 12. Micrograph of transversely section of (SII) showing dendrite of wüstite in a matrix of slag. (Scale: 50µm)

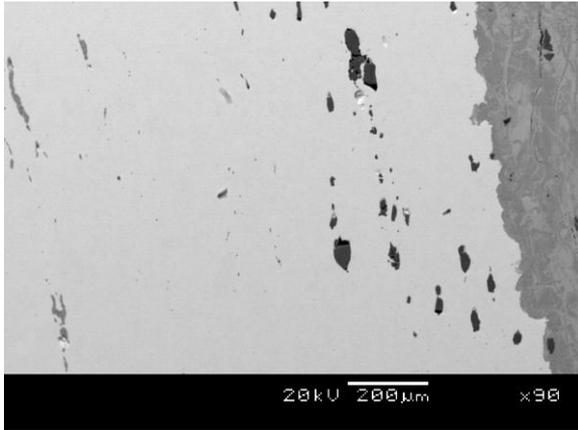
Figure 13. Polished transverse section of S11 showing elongated dark glassy slag in the right close to the corroded surface. (SEM- BSE)

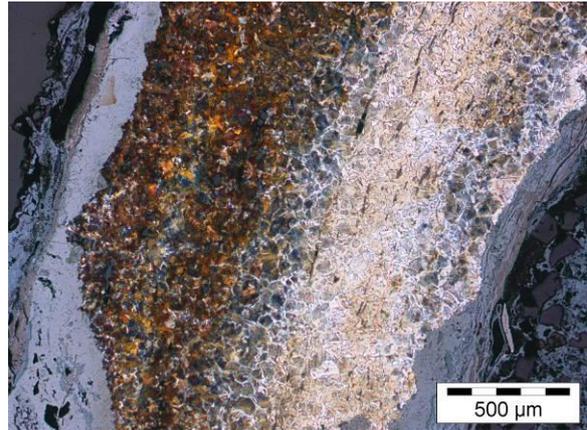
Figure 14. Etched transverse section of S11 in the shaft shows a carburized structure with a lamellar form with a gradient from peripheral high carbon content to a lower carbon content zone in the middle.

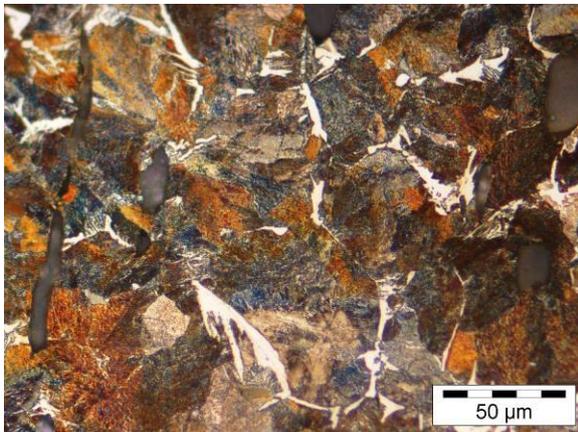
Figure 15. Etched transverse section of S11 in the shaft in the carburized zone shows laths of ferrite on former austenite grain boundaries with Widmanstätten structure.

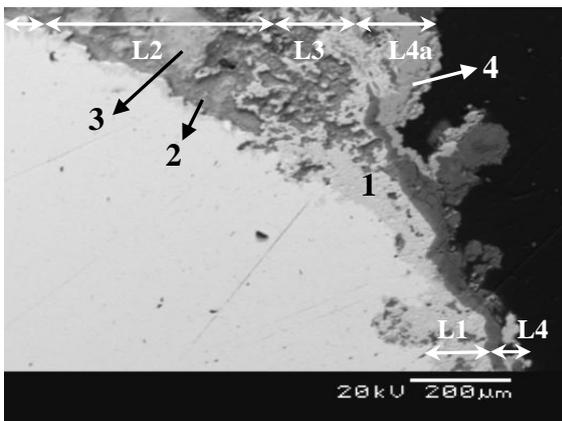
Figure 17. Microstructure of corrosion layers on KC2. Lamellar corrosion; in light grey: cuprous oxide; in medium grey: cupric compounds; in dark grey: products with high amount of silicon and oxygen.

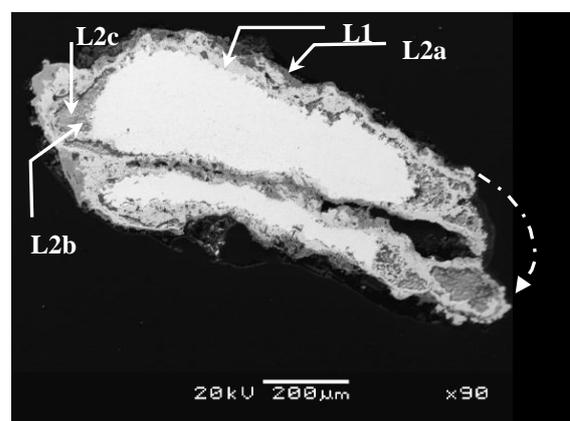
Figure 18. Microstructure of corrosion layers on KC4. Lamellar corrosion ; in light grey: cuprous oxide; in dark grey: cupric compounds; dash line shows the point and direction of folding.

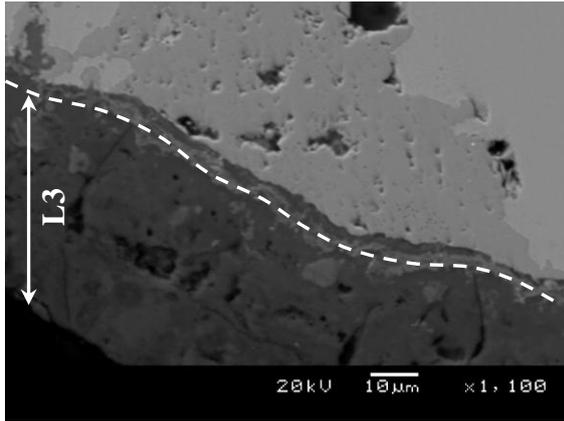
Figure 19. Microstructure of corrosion layers on KC5. Noble patina; in light grey: cuprous oxide, in dark grey: outer and external layer; dash line shows the limit of original surface.

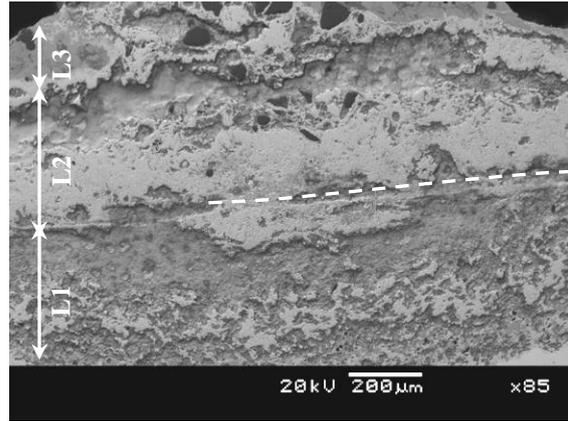
Figure 20. Microstructure of corrosion layers on MC2. In light grey: cuprous oxide; in medium grey: Cu(II) alkaline chloride compounds and nantokite; in dark grey: sand; dash line shows the limit of original surface.

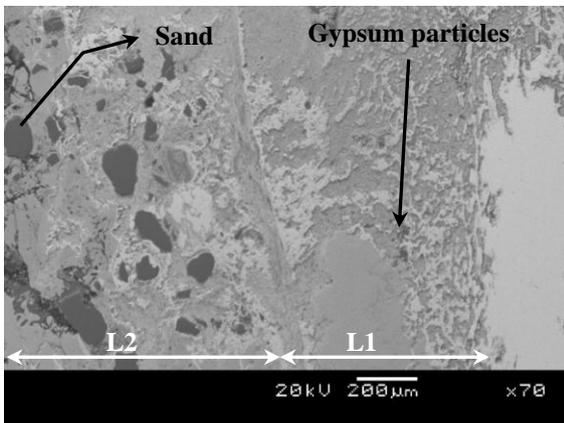
Figure 21. Microstructure of corrosion layers on MC4. In light grey: cuprous oxide; in medium grey: alkaline compounds of Cu(II); in dark grey: sand; dash line shows the limit of original surface.

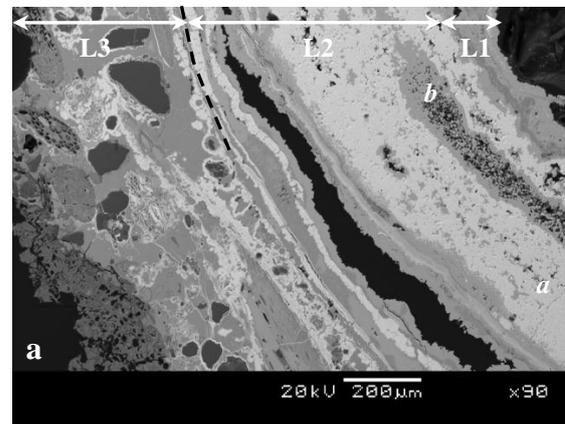
Figure 22. Microstructure of corrosion layers on MC7. Region A; broad light gray: cuprite; thin light gray close to the fissure: chalcocite; in dark gray: chloride compounds of copper.

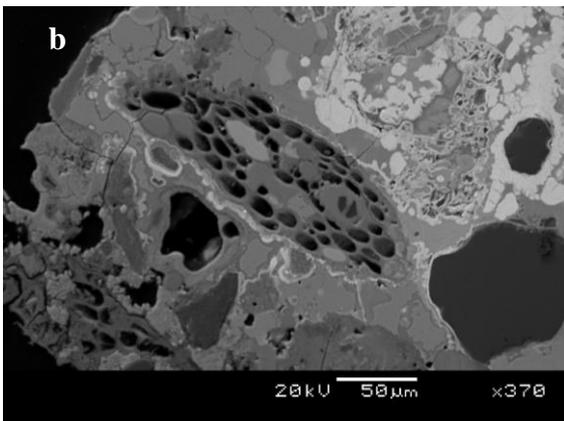
Figure 23. Microstructure of corrosion layers on MC7. Embedded sands and plant in a matrix of cupric compounds.

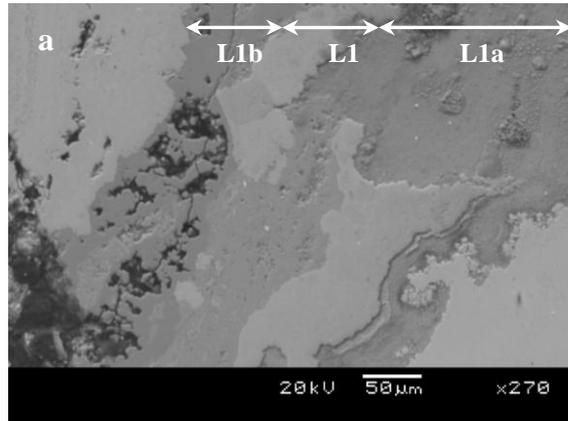
Figure 24. Microstructure of corrosion layers on MC8. L1,a and b: adjacent layer to the alloy phase.

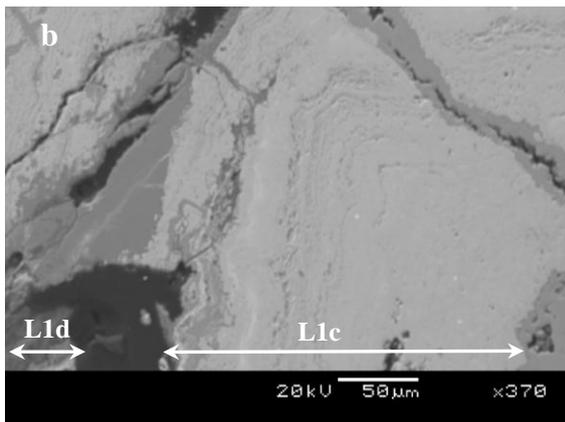
Figure 25. Microstructure of corrosion layers on MC8 with Liesegang phenomena. L1c, d: Disrupted lamellar layer at intermediate of internal outer layer. The hypothetical original surface is among this layer.

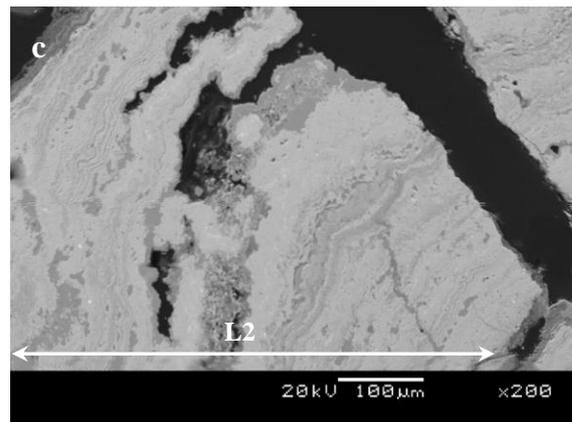
Figure 26. Microstructure of corrosion layers on MC8 with Liesegang phenomena. L2: The outer corrosion layer which formed after restarting the corrosion.

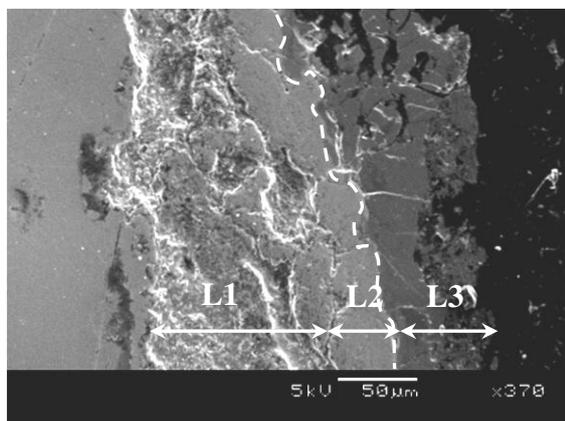
Figure 27. Microstructure of corrosion layers on MC9. A generalized corrosion; L1: internal layer; L2: intermediate layer; L3: external layer; dash line: limit of original surface.

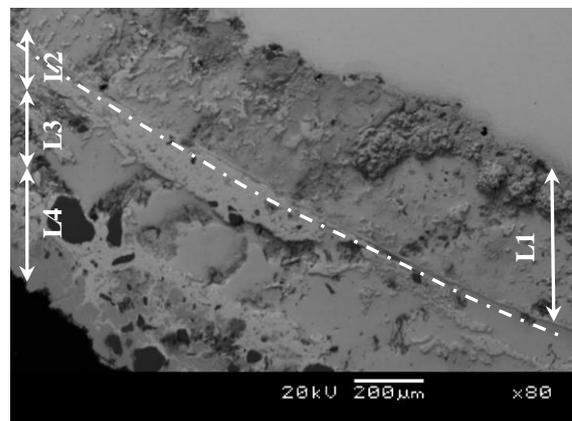
Figure 28. Microstructure of corrosion layer on MC10. A generalized corrosion; L1: internal layer; L2: disrupted cuprite layer; L3 and L4: external layer; dash line: the limit of original surface.

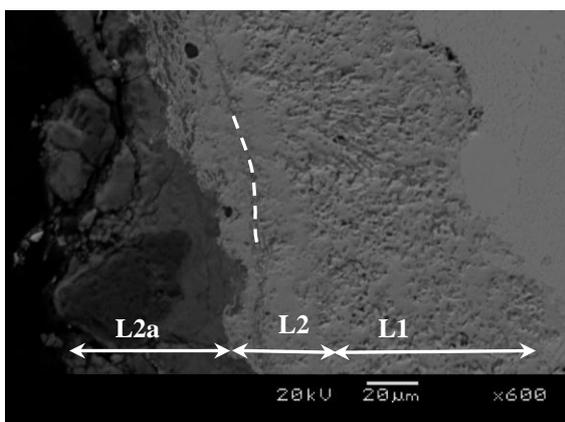
Figure 29. Microstructure of corrosion layers on MC11. A bilayer corrosion; in light grey: cuprite; in dark grey: cupric compounds in accompany with sands; dash line: the limit of original surface.

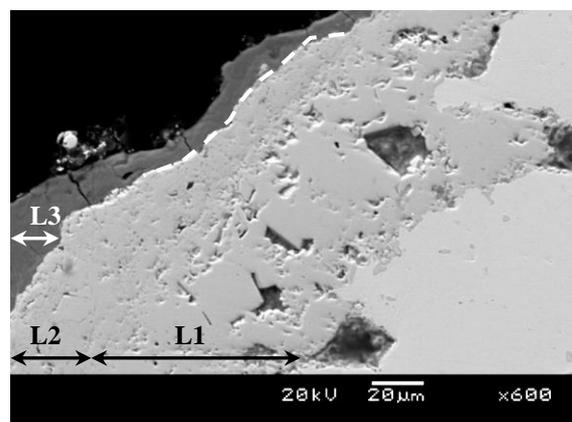
Figure 30. Microstructure of corrosion layer on MC12. Even surface; L1: internal layer; L2: outer layer; L3: external layer; dash line: the limit of original surface.

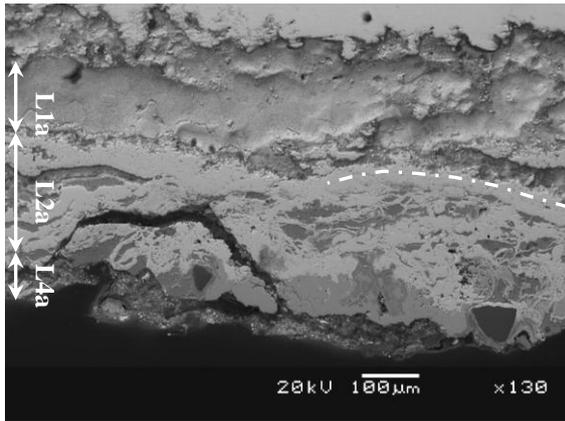
Figure 31. Microstructure of corrosion layer on MC12. Coarse surface; in light grey: cuprite; in medium grey and with a waxy texture nantokite; in dark grey copper trihydroxychloride with sand; dash line: the limit of original surface.

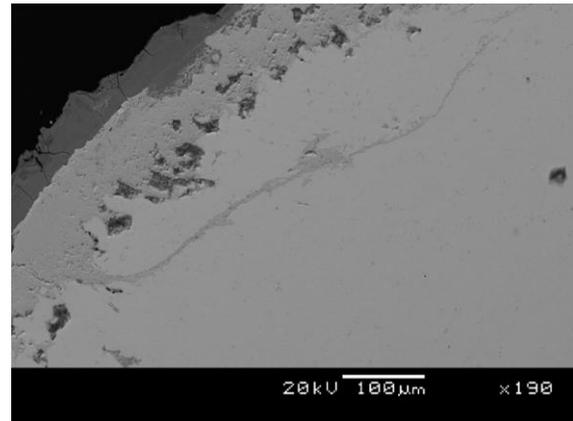
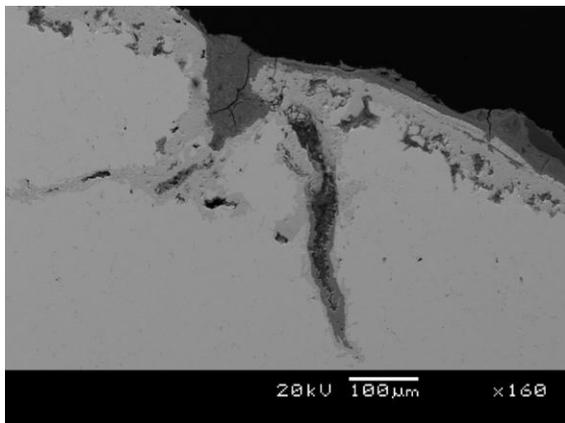
There were several oblique cracks around the cross section which was filled with corrosion products. This indicated that these cracks were quite old and were related to the method of manufacture of the bangle (Appendix C. Fig.32 and Fig.33).

Figure 32. Microstructure of corrosion layer on MC12. Penetration of corrosion along structural defect at peripheral of the sample.

Figure 33. Microstructure of corrosion layer on MC12. Penetration of corrosion along structural defect at peripheral of the sample.

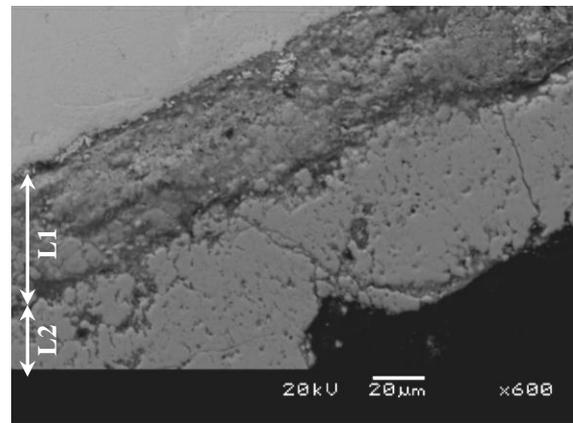
Figure 34. Microstructure of corrosion layers on SC2.

The polished transverse section of this ring showed a bilayer corrosion on the surface which is quite different to the other artefacts in this assemblage (Appendix C. Fig.34). Both layers had a composition approaching copper trihydroxychloride (Appendix D. Table 5.3: analysis SC2L1 and L2) with a different texture. The middle layer is much denser than the internal layer. No trace of a cuprite layer was detected in this sample. It shows that this layer was completely removed from some parts of the surface during the cleaning of the object in the past. It appears the present layers of corrosion were formed on the bare metal surface after the cleaning procedure. Copper Trihydroxychlorid shows the ring is still subjected to bronze disease.
