Investigating the different support methods for various geological structures encountered in hard rock mining within the Eastern Limb of the Bushveld Igneous Complex, South Africa.

Master of Science (Engineering Geology)

University of Pretoria

June 2018

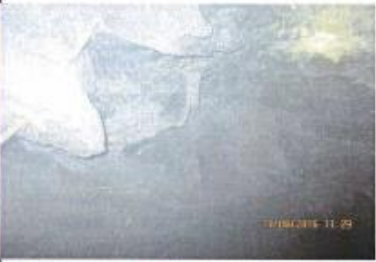
<p>Wedges and partings due to Joint nature . All bolts protruding 30cm + must be replaced.</p>

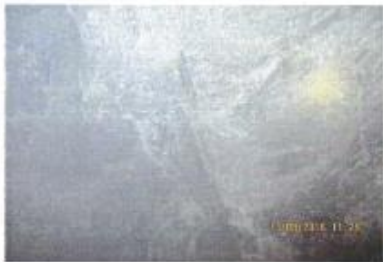
<p>Overhang and loose wedges along Up Dip Sidewall. Blast down loose wedges and overhang. Replace all damaged support.</p>
