Fracture Analysis of Compressor Impellers in Olefin Units: Numerical and Metallurgical Approach

This paper presents a failure analysis conducted in 7175 aluminum alloy compressor impellers used in olefin units which operate at 34500 rpm to compress gas in the process. Some characterizations such as chemical composition, microstructure, and hardness tests were conducted to obtain a detailed evaluation of the base alloy. Furthermore, a finite element method and a 3D point cloud data technique have used to determine critical stress points on the surface of impellers. The finite element result showed the root of blades has significant stress concentration. Moreover, the formed cyclic tension has led to a fatigue phenomenon in the root of the blade, so near this location, the local strain accumulation was visible in 3D points cloud data. The fractography results showed that the mode of crack progression and the fractured surface would change by changing the stress mode. In addition, CFD modeling for investigating the effect of flow hydrodynamics on the HP and LP compressor blades is analyzed. The results revealed that the maximum pressure of gas stream for the rotor speed of 34500 had

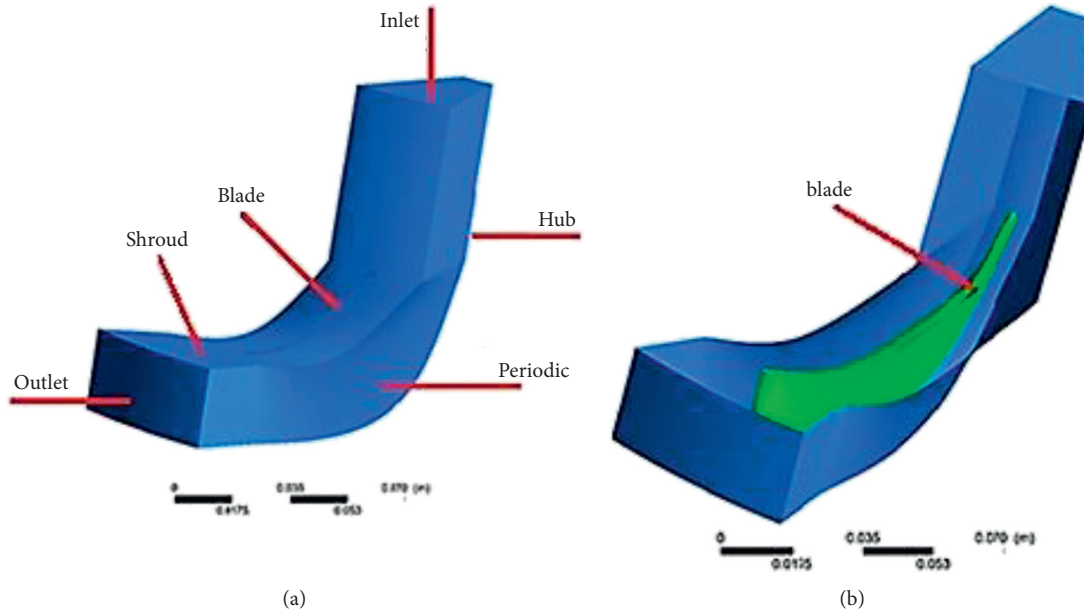
FIGURE 2: (a) Geometry of a compressor row with boundary conditions (b) Geometry of a compressor row with the blade.

2.2. Numerical Analysis. The procedure was divided into four steps for numerical simulation of the flow inside the compressor blade. In the first step, the CAD model of the mentioned blade was generated. Figure 2 and Table 3 indicate the CAD model of the blade with boundary conditions and the dimensions of the model, respectively. In the second step, the computational domain to discretize equations has been prepared that is shown in Figure 3. All the discretized equations have been solved by using a CFD code at the third step. FVM numerical approach has been employed to solve governing equations. A second-order upwind scheme was applied for discretizing the momentum equation, turbulence equation, and energy equation on the provided grid. The SIMPLE algorithm has been considered for Pressure-Velocity coupling. Also, a steady state rotating reference frame (RRF) handles the rotation of the wheel of the compressor. The final step of the modeling was post-processing of the outcomes from CFD computations which have been analyzed and compared with the experimental results to evaluate the blade fatigue. The information of both computational grids and models has been provided in Tables 3 and 4, respectively.

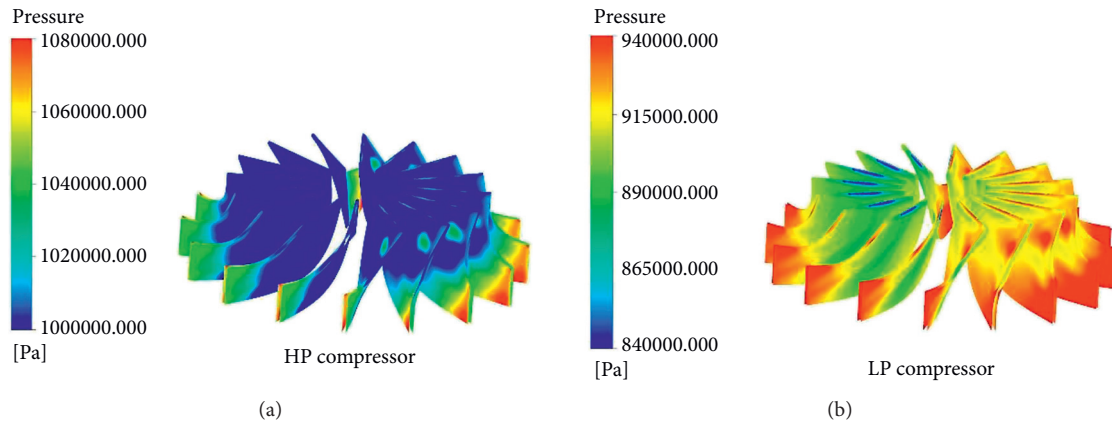
FIGURE 11: Contour of pressure for (a) HP Compressor (b) LP Compressor.

3.3. *Finite Element and Numerical Analysis.* Figure 11 shows the result of the CFD simulation for HP and LP Compressor. The results revealed that the maximum pressure of the gas stream for the rotor speed of 34500 rpm has taken place in the fractured area of the blade. The shear stress (WSS) contours are shown in Figure 12, which also indicates the maximum in the breakdown zone. The temperature gradient for HP and LP Compressor is shown in Figure 13.

In addition, fluid velocity vectors in a row of the compressor from the inlet to the outlet are shown in Figure 14. The results showed that the pressure, stress gradients on the HP blade were significantly higher than the LP compressor, providing the reason for the blade fracture in the HP compressor.

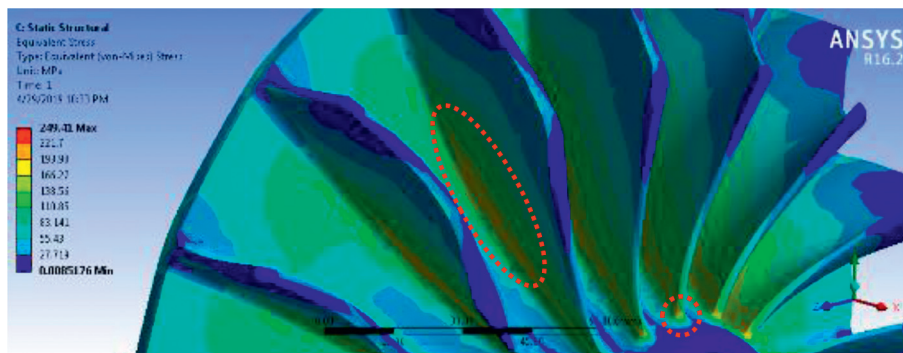
FIGURE 18: High magnification of the contour of von-mises for pressure difference of 0.1 in 34500 rpm.

Figure 15(a) illustrates that the maximum deformation is about 0.1 mm. The extracted contour of elastic strain and von-Mises stress for mentioned conditions are shown in Figures 15(b) and 15(c), respectively. The extracted contours illustrate the maximum stress has accrued in the root of the blades of the impeller. This is due to the interference of the torque due to the centrifugal force and the fluid pressure, which is maximized at this point. Moreover, Von-Mises stress has a maximum value of 231 MPa in the root of the blades of the impeller. This phenomenon is evident in Figure 16.
