CHAPTER 4

Context

This chapter provides a background study of the history of the National Zoological Gardens of South Africa, while critiquing the overall site and the current elephant enclosure according to zoo theory.

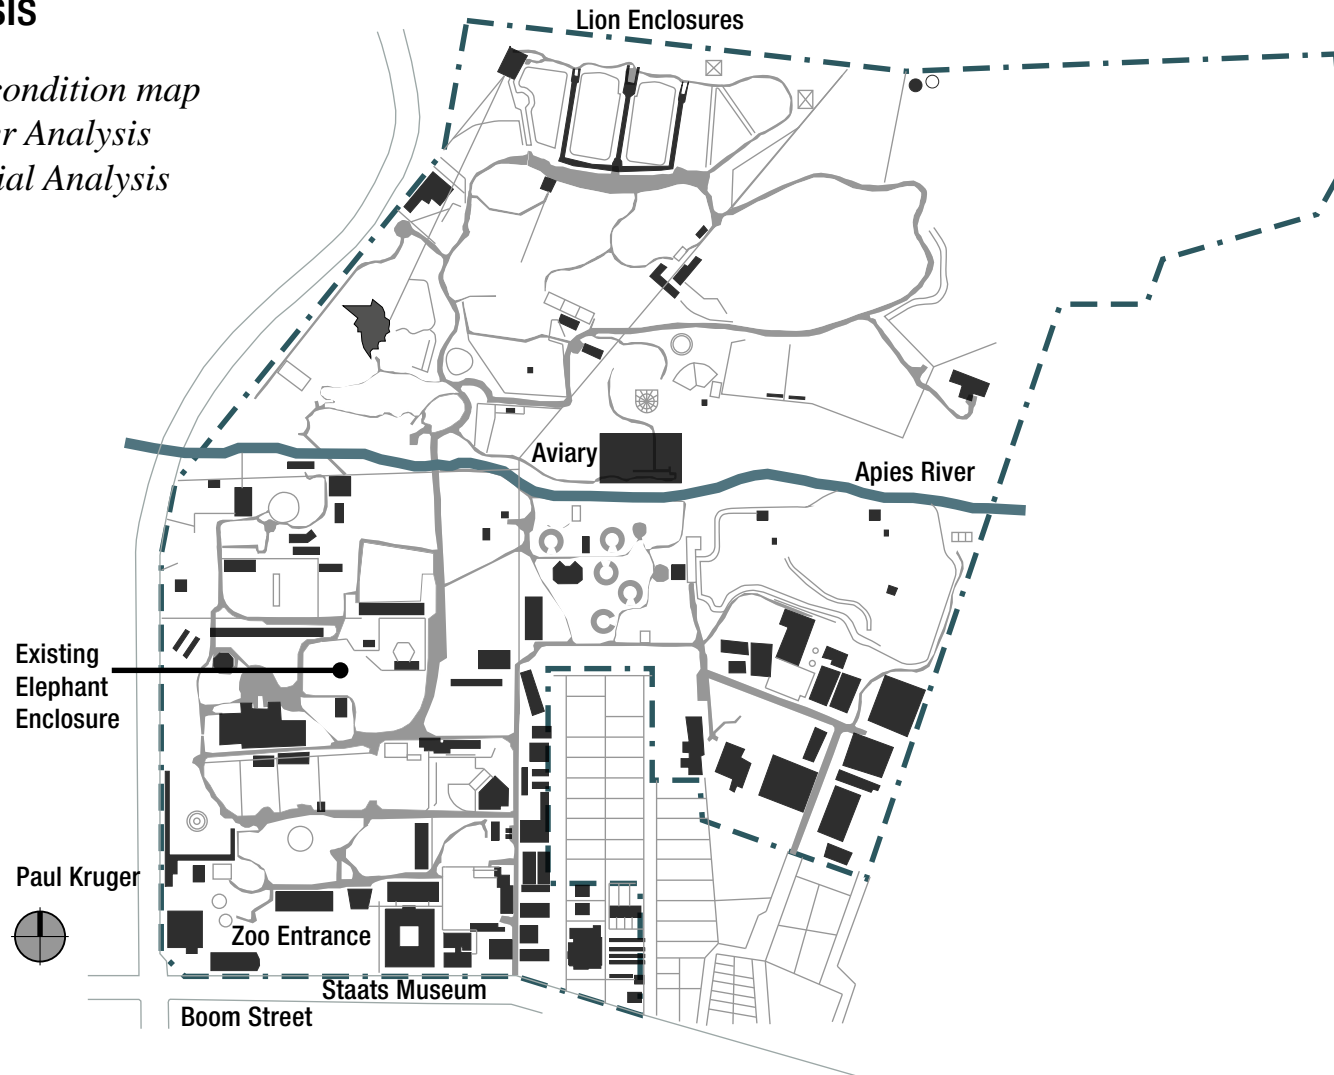
Latest Enclosure Map National Zoological Gardens

Figure 4.13 Map summaries of various ecological conditions
56

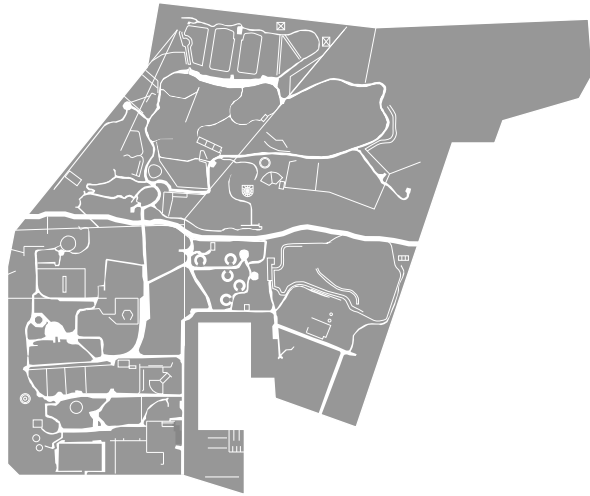
Animal Enclosures
National Zoological Gardens

Figure 4.15 Map summaries of various spatial conditions
58

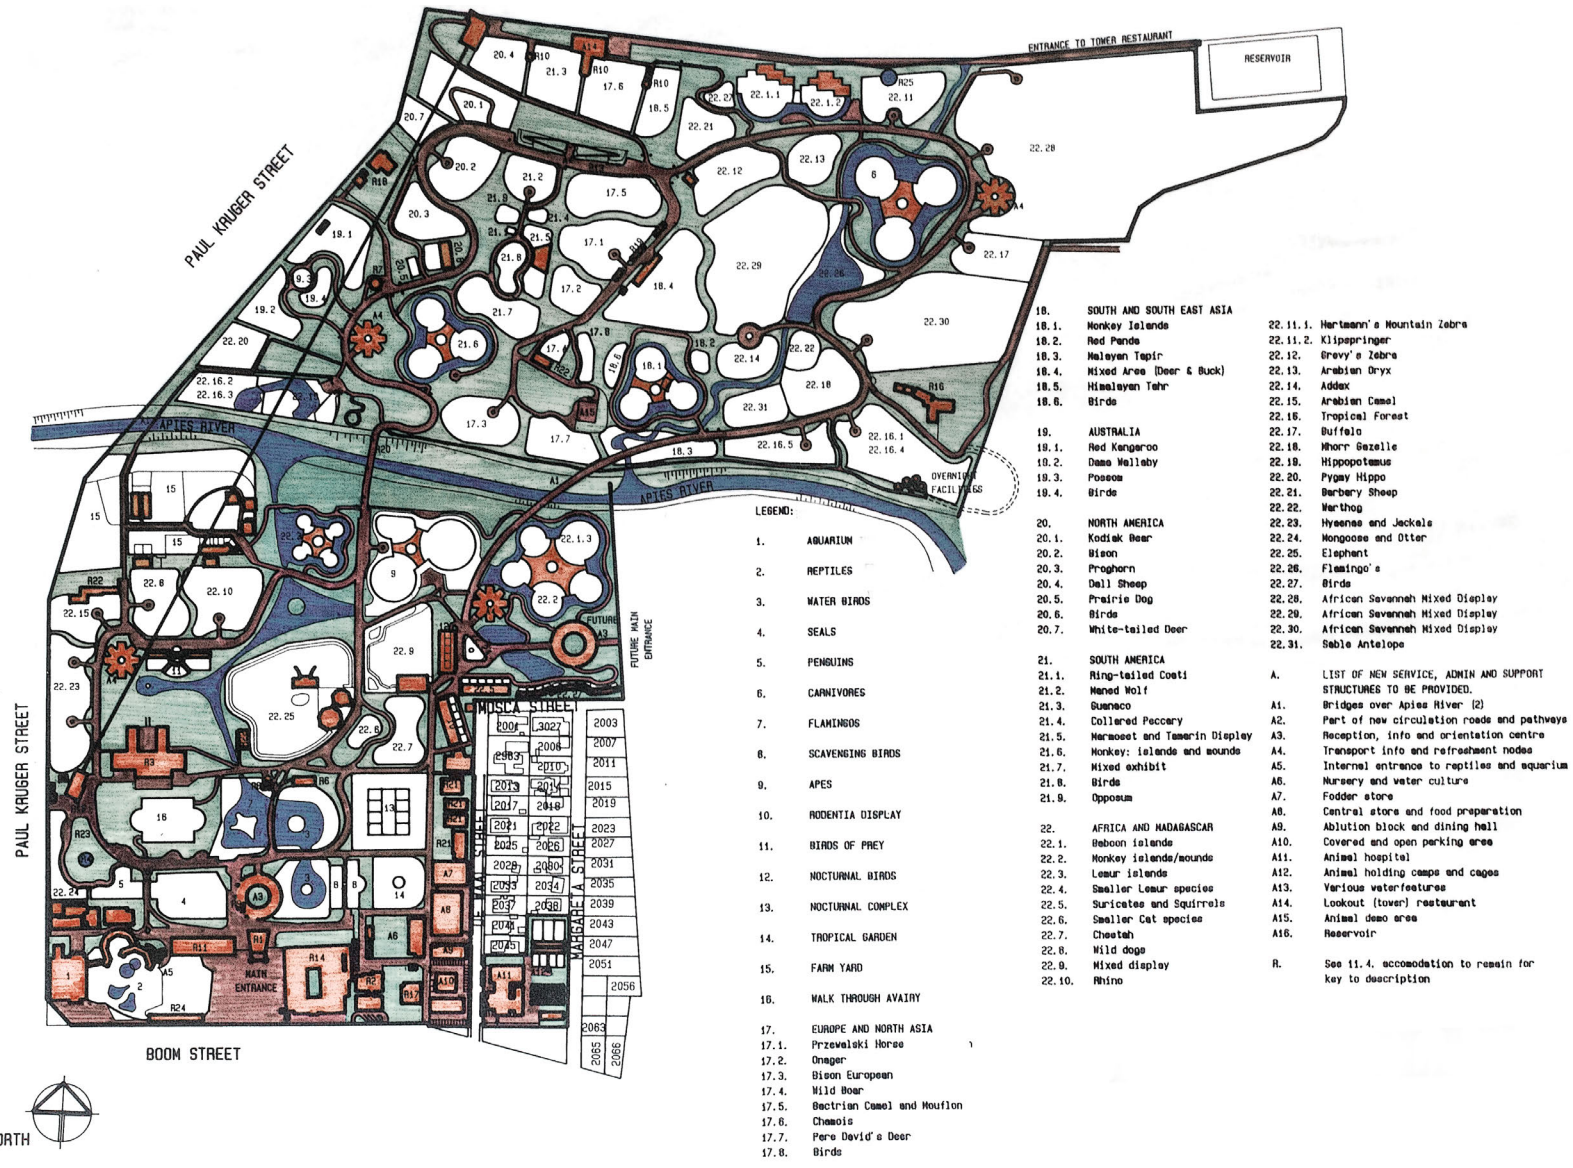
Figure 4.16 Masterplan proposal

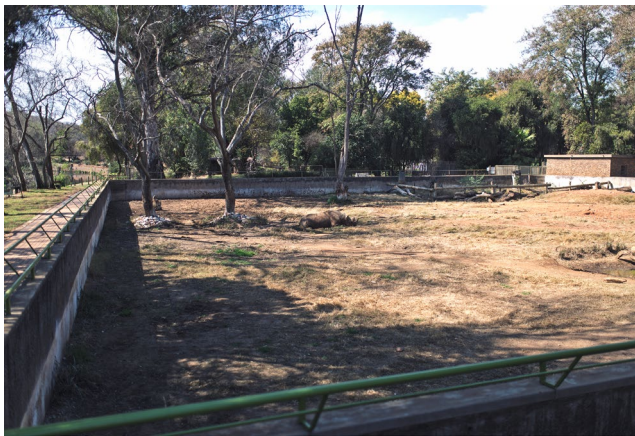
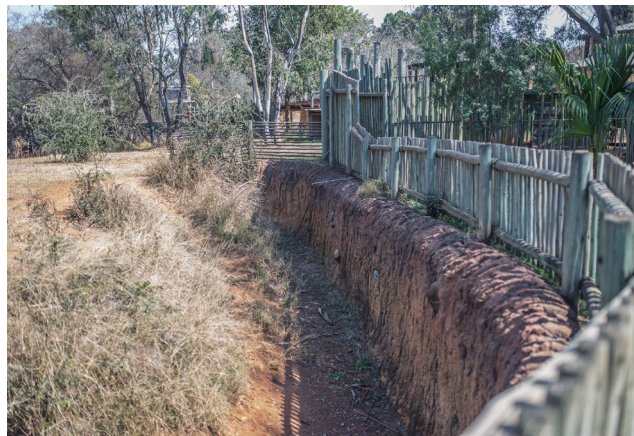
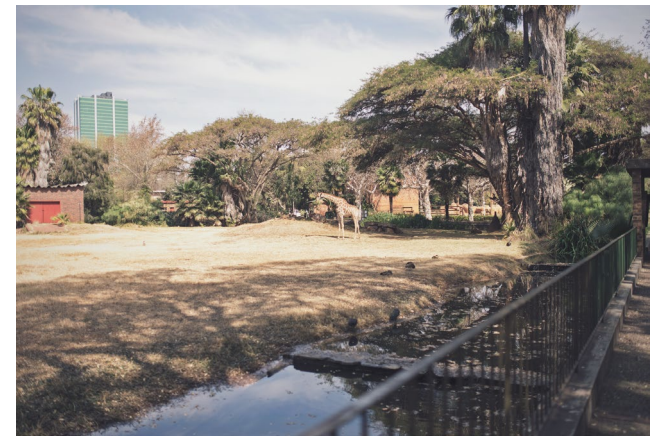
Barriers in NZG

Figure 4.17 Photographic collage of various barrier methods in the NZG (Author, 2016).

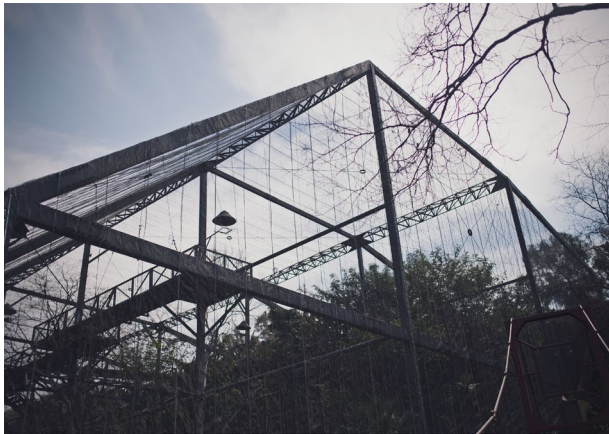
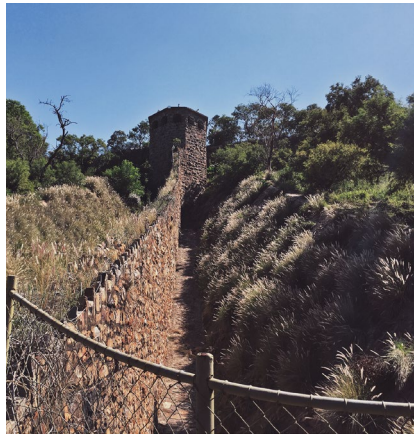
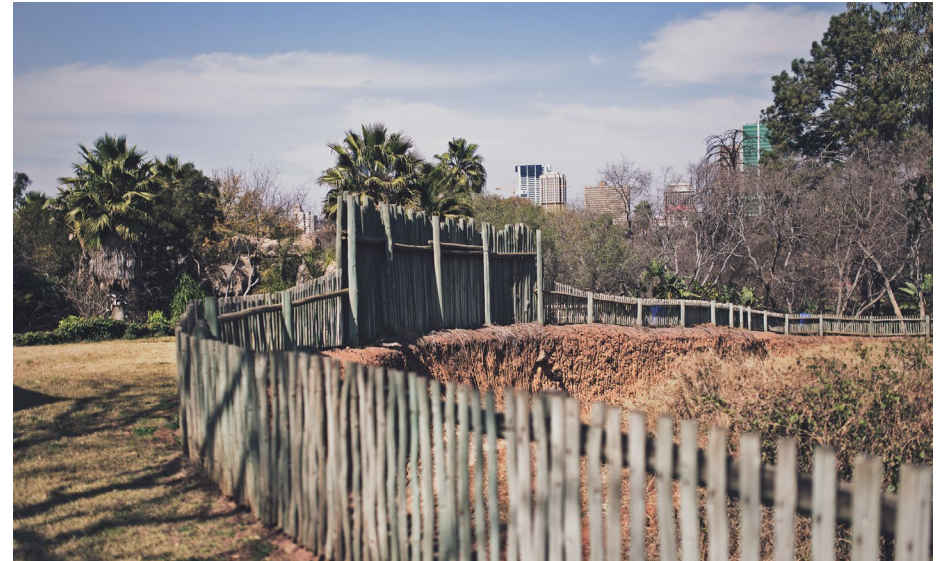
Material Palette in NZG

Figure 4.18 Photographic collage of different materials and textures found in the NZG (Author, 2016).

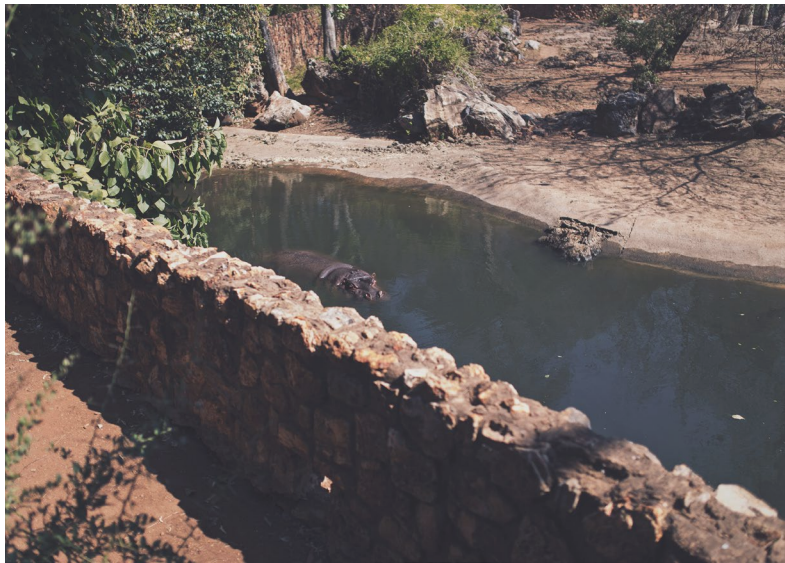
Current hippo pool

Figure 4.19 Site analysis sketch of current hippo pool to be converted for elephants (Author, 2016).

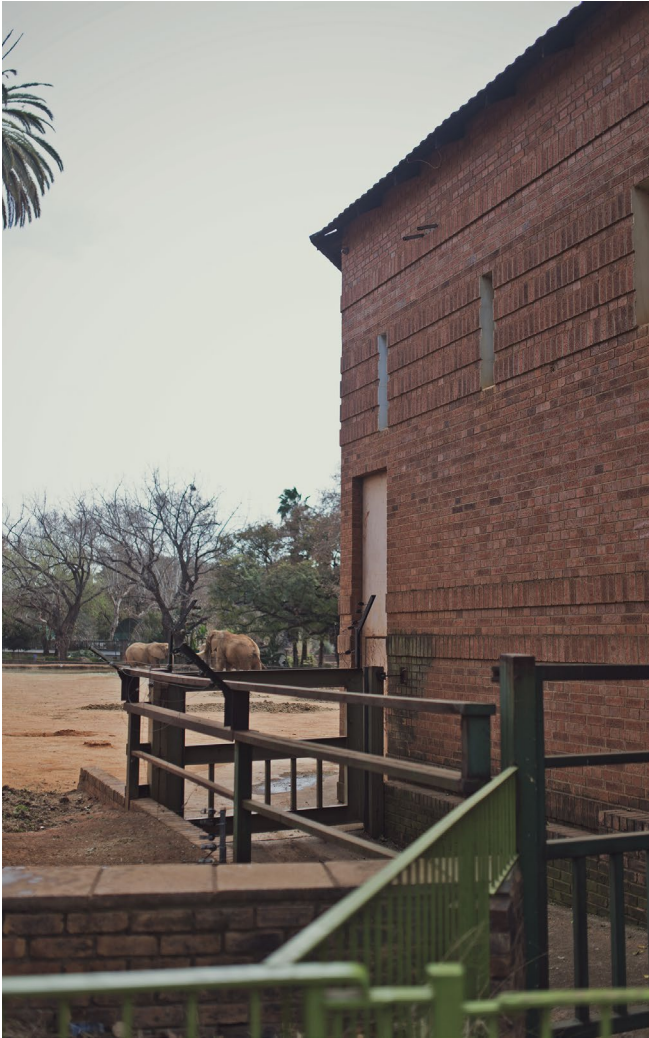
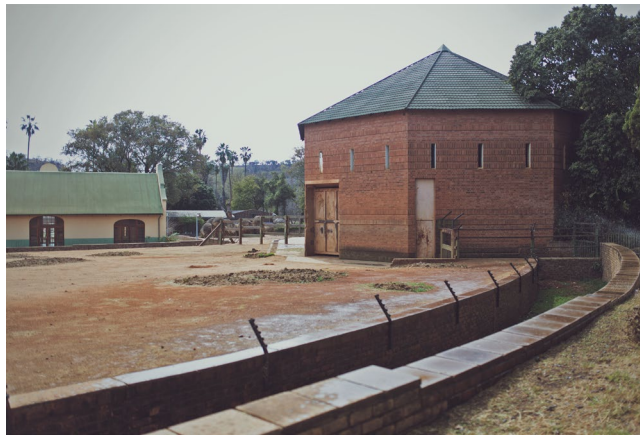
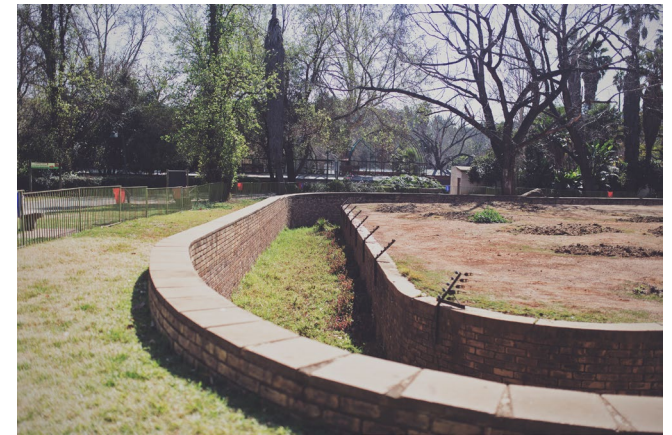
Current elephant enclosure & barriers

Figure 4.20 Photographic collage of existing elephant enclosure at the NZG (Author, 2016).

As neither mud nor loose sand or dust is provided for the elephants to coat themselves, it is intolerable that they do not have ample tree shade or artificial cover either. The only trees found in their enclosure are palm trees which do not provide any shade - despite the abundance of diverse trees found in the zoo, particularly north of the river. To add to the elephants' distress, the large doors to their night houses are closed during the day to force the elephants to remain outdoors for public viewing and amusement – despite their own needs being so blatantly ignored. The extent of the damage from the lack of natural and artificial shade protecting them from direct sunlight, is evident in the severity of their poor skin health.

Unsafe Barriers

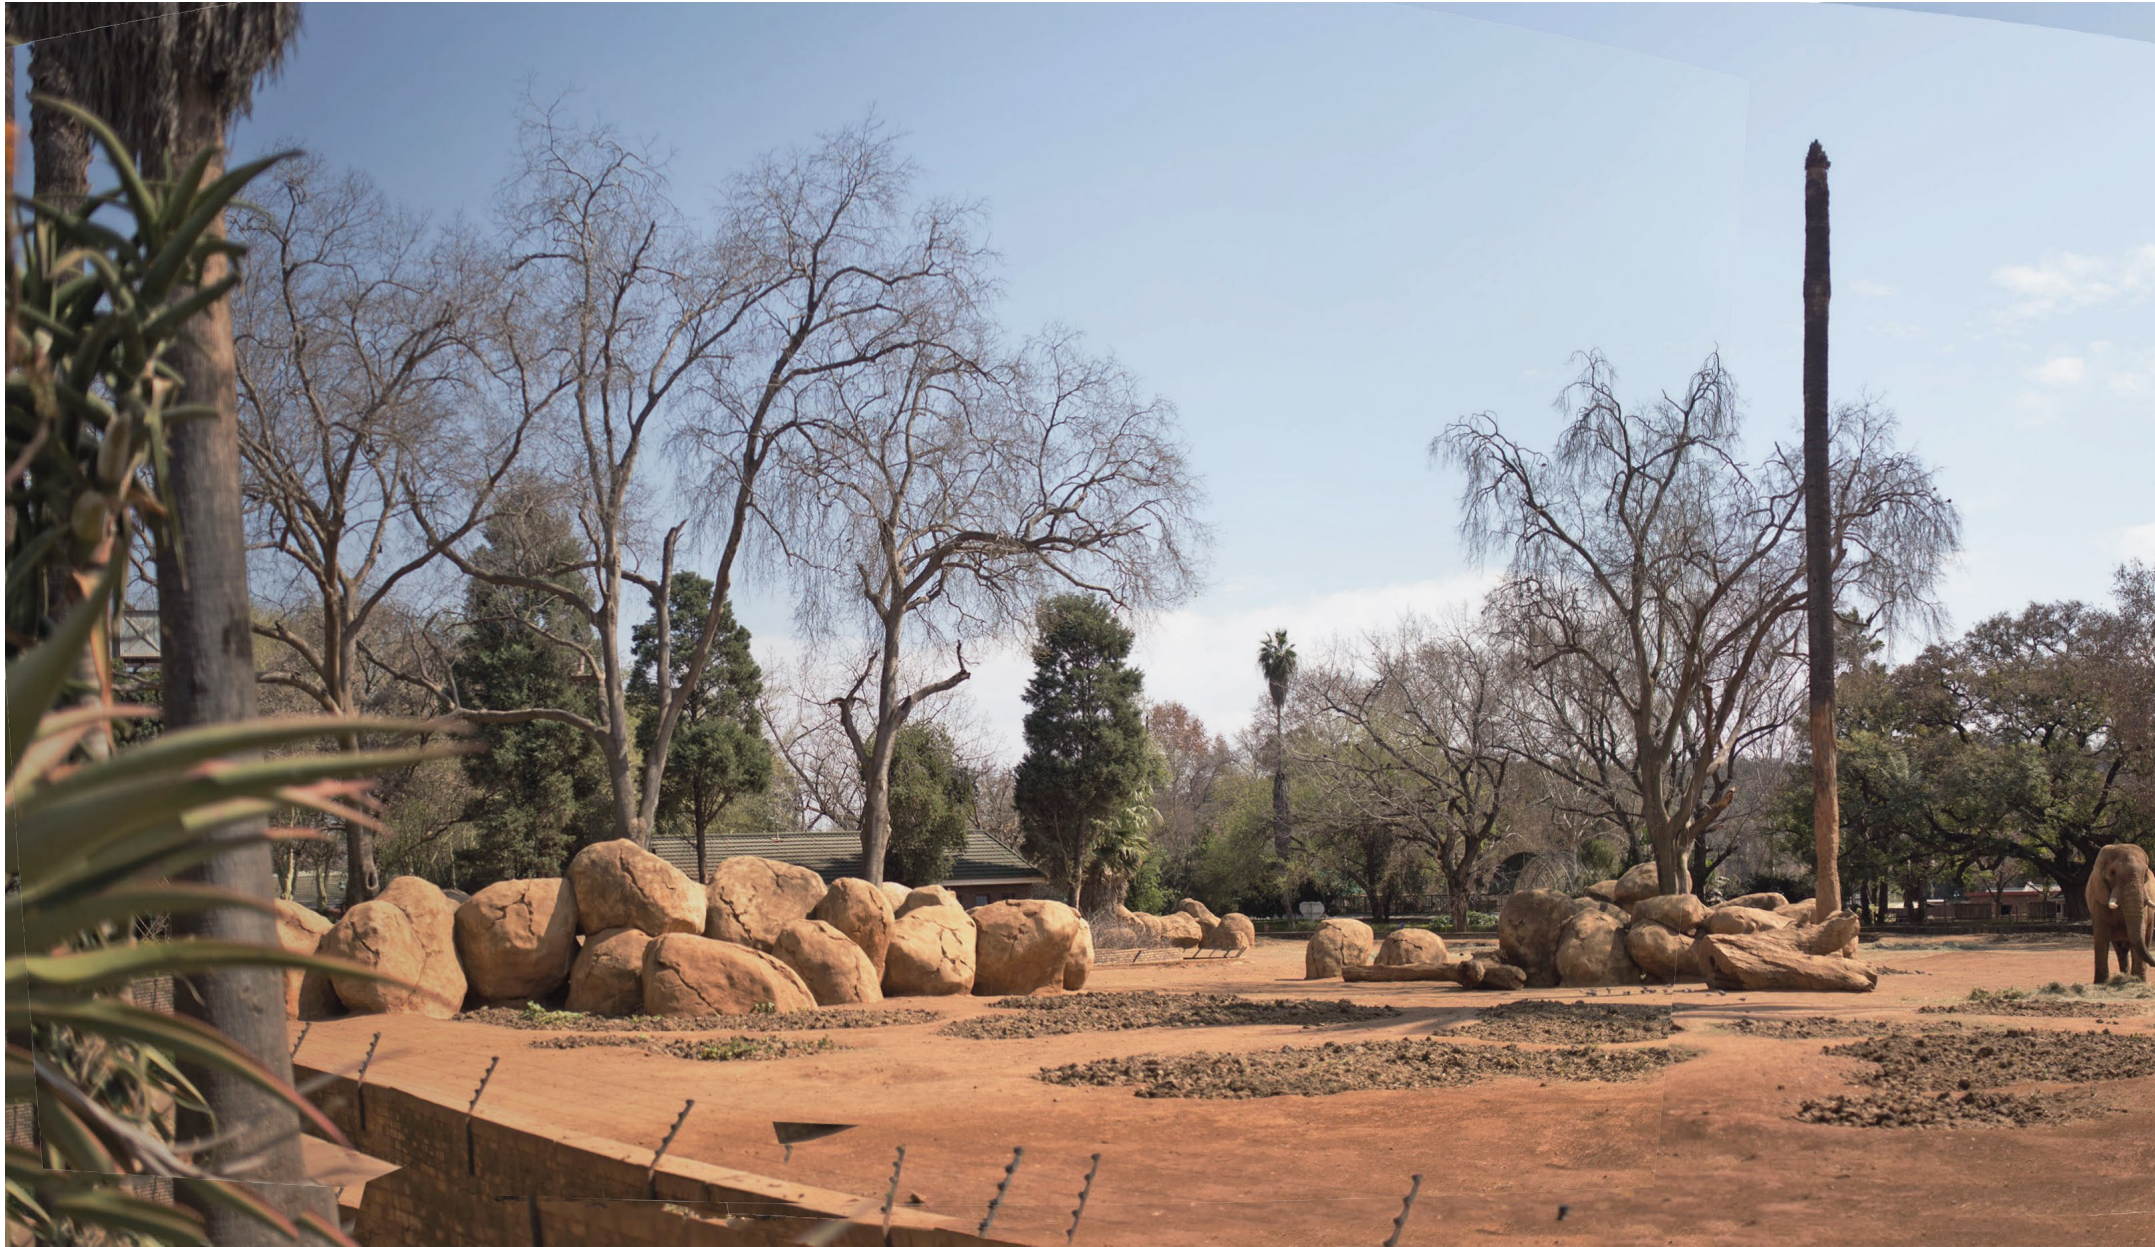
Figure 4.21 Panorama of the existing elephant enclosure

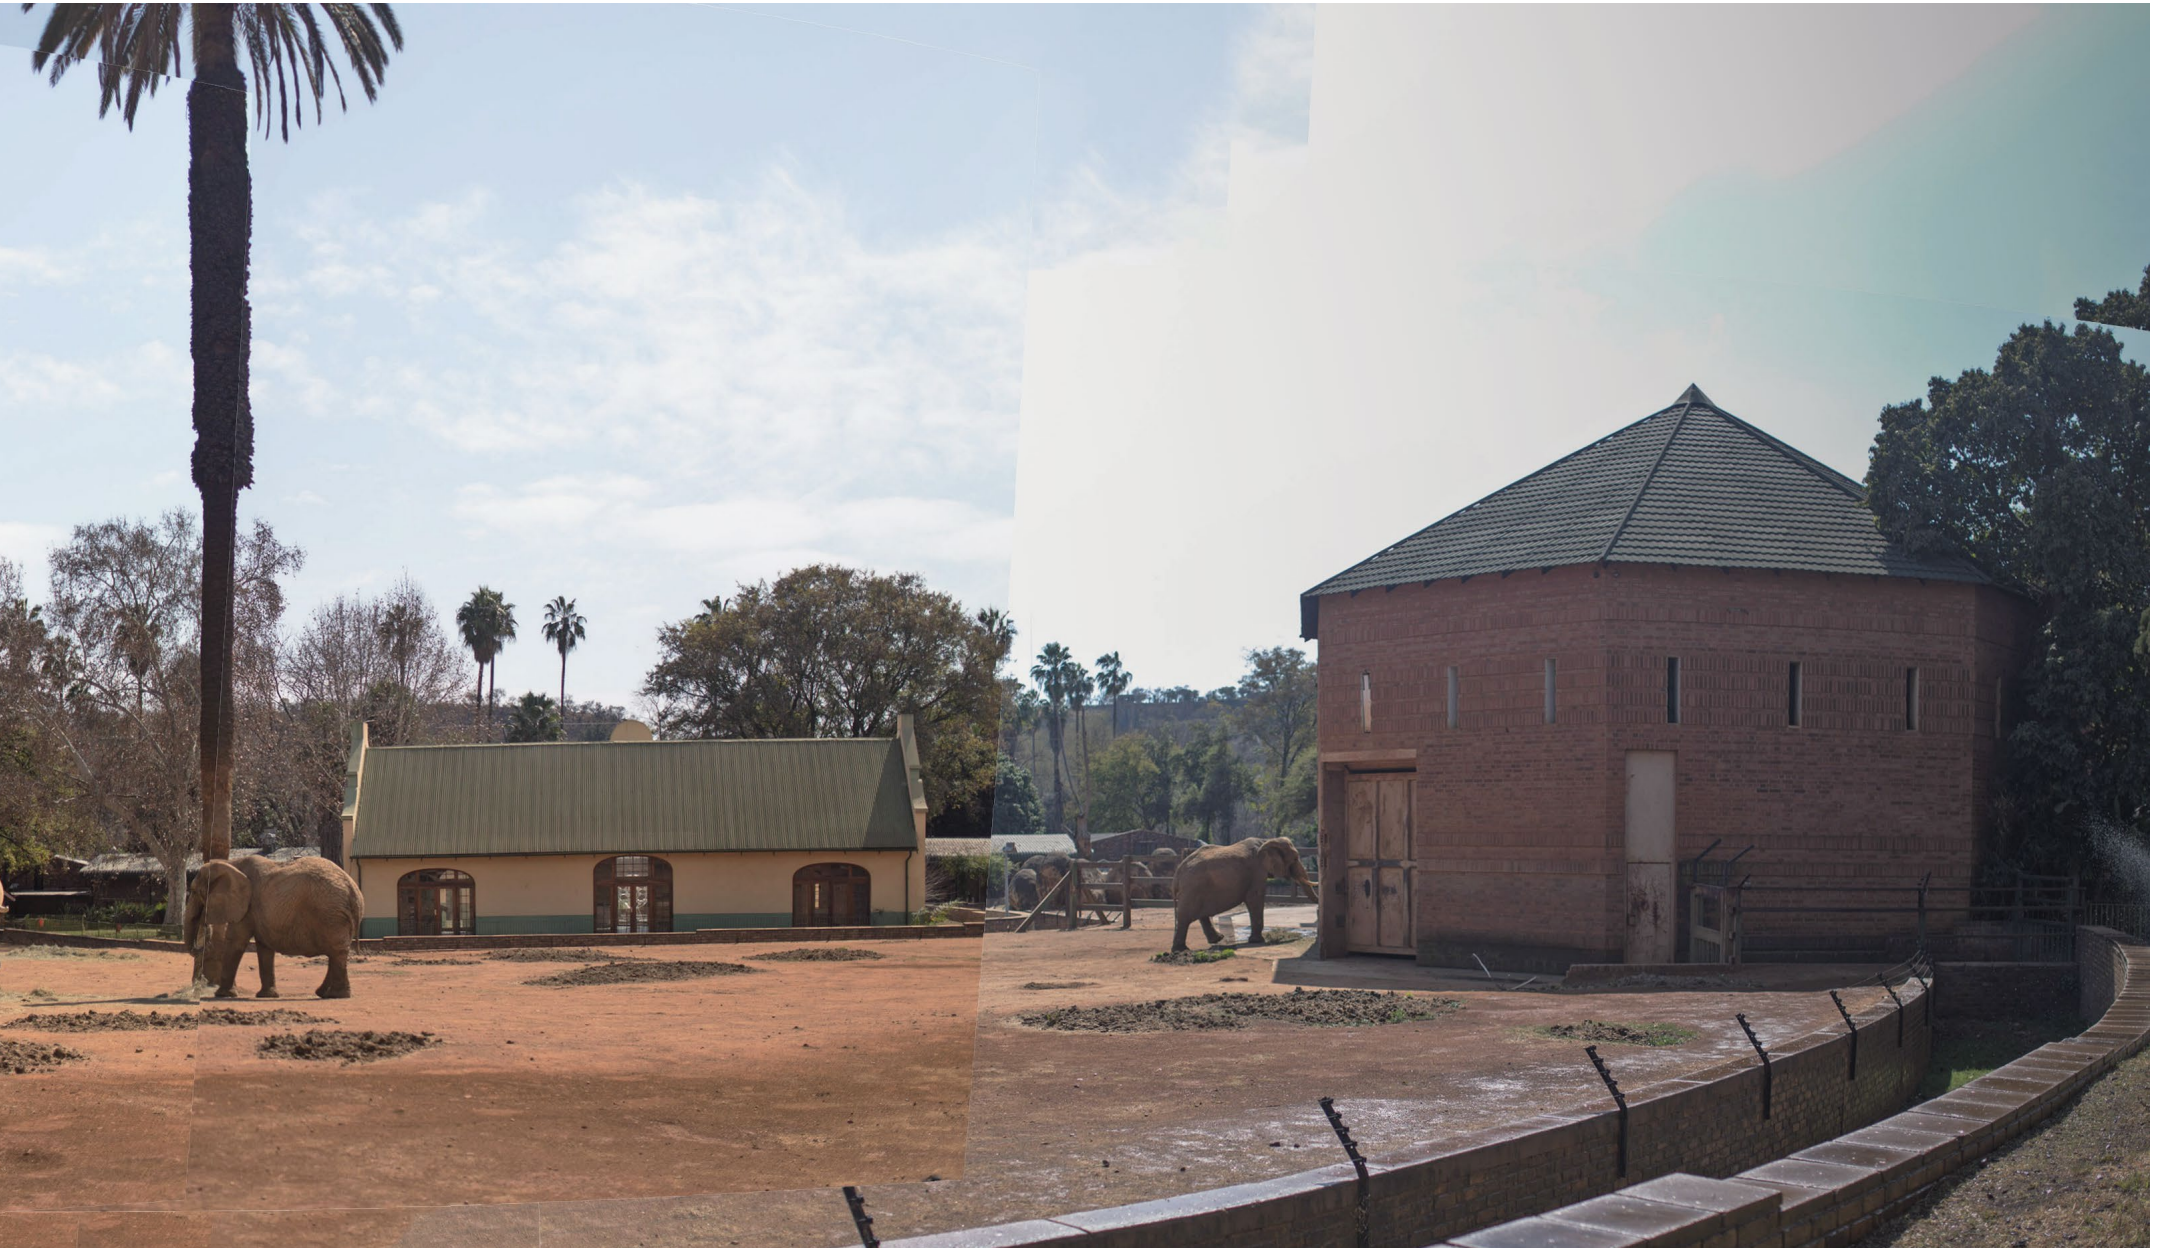
Figure 4.22 Panorama of the existing elephant enclosure

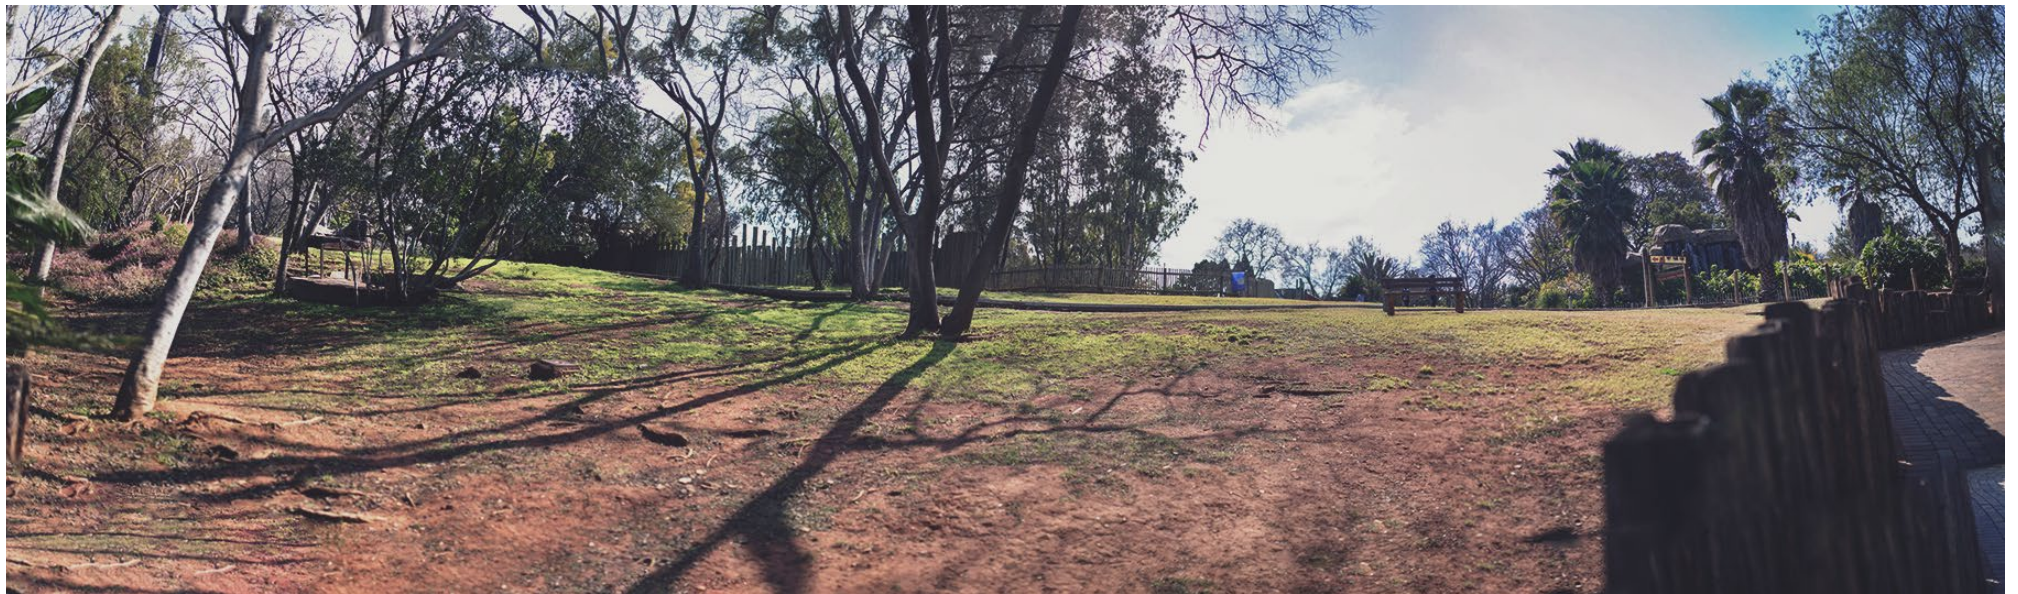
*Figure 4.23 Photo of new site for proposed elephant enclosure
(Author, 2016).*
