**P r e s e r v a t i o n -
c o n s e r v a t i o n
c o n t i n u i t y a n d
o v e r l a p p i n g
v a l u e s**

5. INTEGRATED VALUE ASSESSMENT

5.1 ASSESSMENT FRAMEWORK

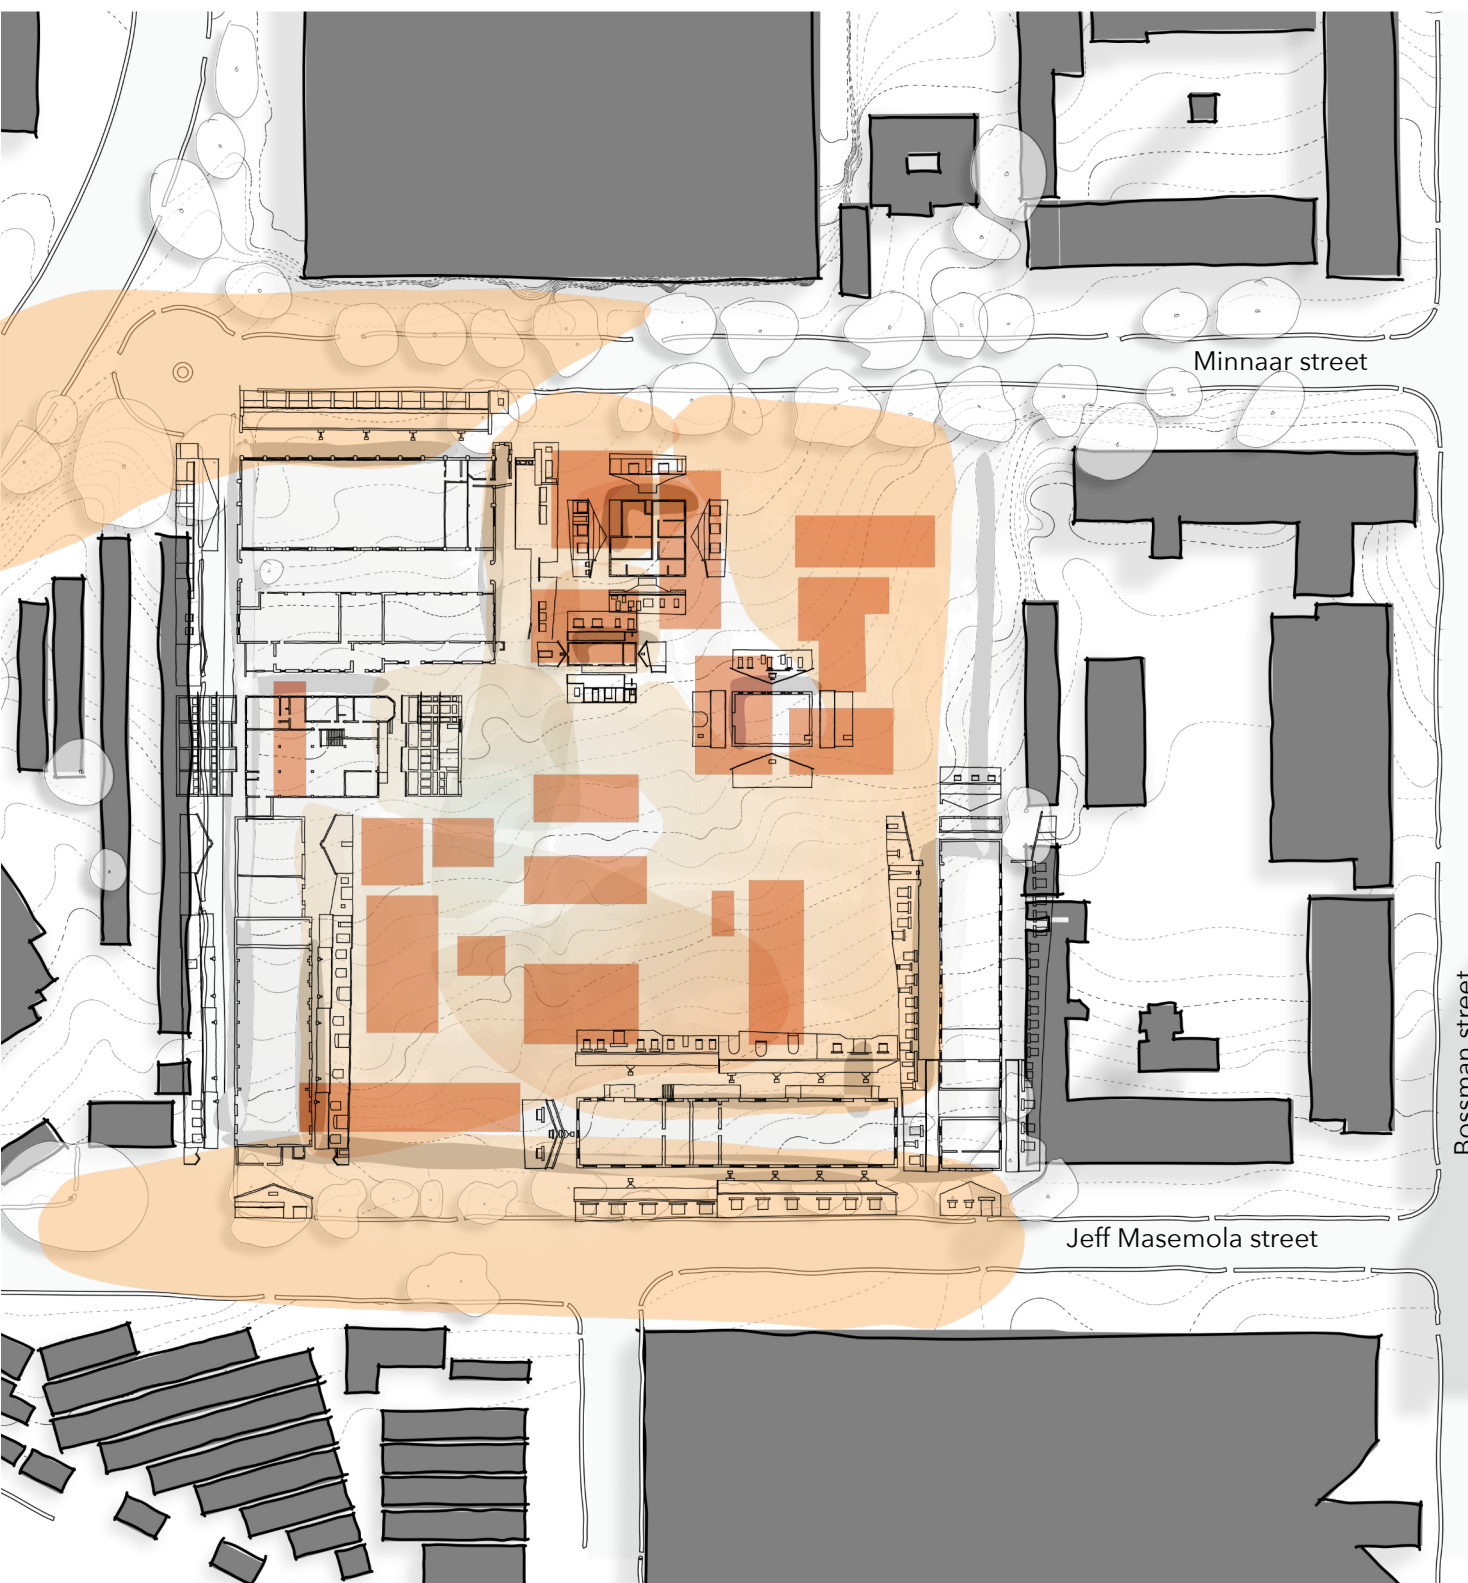
Fig. 5.4 Value assessment of the General Workshops

Fig. 5.5 Identified characteristics of value

General workshops and store rooms

Public interface value: The western edge of the building defines the alleyway. There are three windows on this edge. The building is barely visible from Jeff Masemola street, along the southern perimeter.

Utility: The buildings have predominantly been used as storage. The interior of the building is almost completely dilapidated. The ceilings are disintegrating, the internal partitioning is almost entirely removed, and all fixtures have been stripped. Nevertheless, the building holds potential for evolution, especially in terms of program (Peres, 2016: 99, 189).

Historical characteristics: The rooms are estimated to have been built between 1920 and 1935. The buildings are built on sandstone plinths, which could date the buildings as far back as 1910. The openings into the rooms are defined either by large concrete lintels or segmental brick arches. Internal openings between rooms are large arched openings. The original vents on the roof are intact.

Architectural Characteristics: It is critical to retain the east elevation of the building, as the gradual development of the site is demonstrated in the segmented character of the building. In addition, the unaligned openings in the building are characteristic of the utilitarian nature of industrial heritage sites.

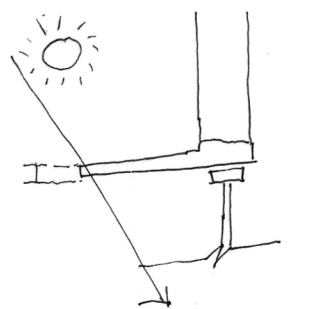
Thin concrete roof overhang

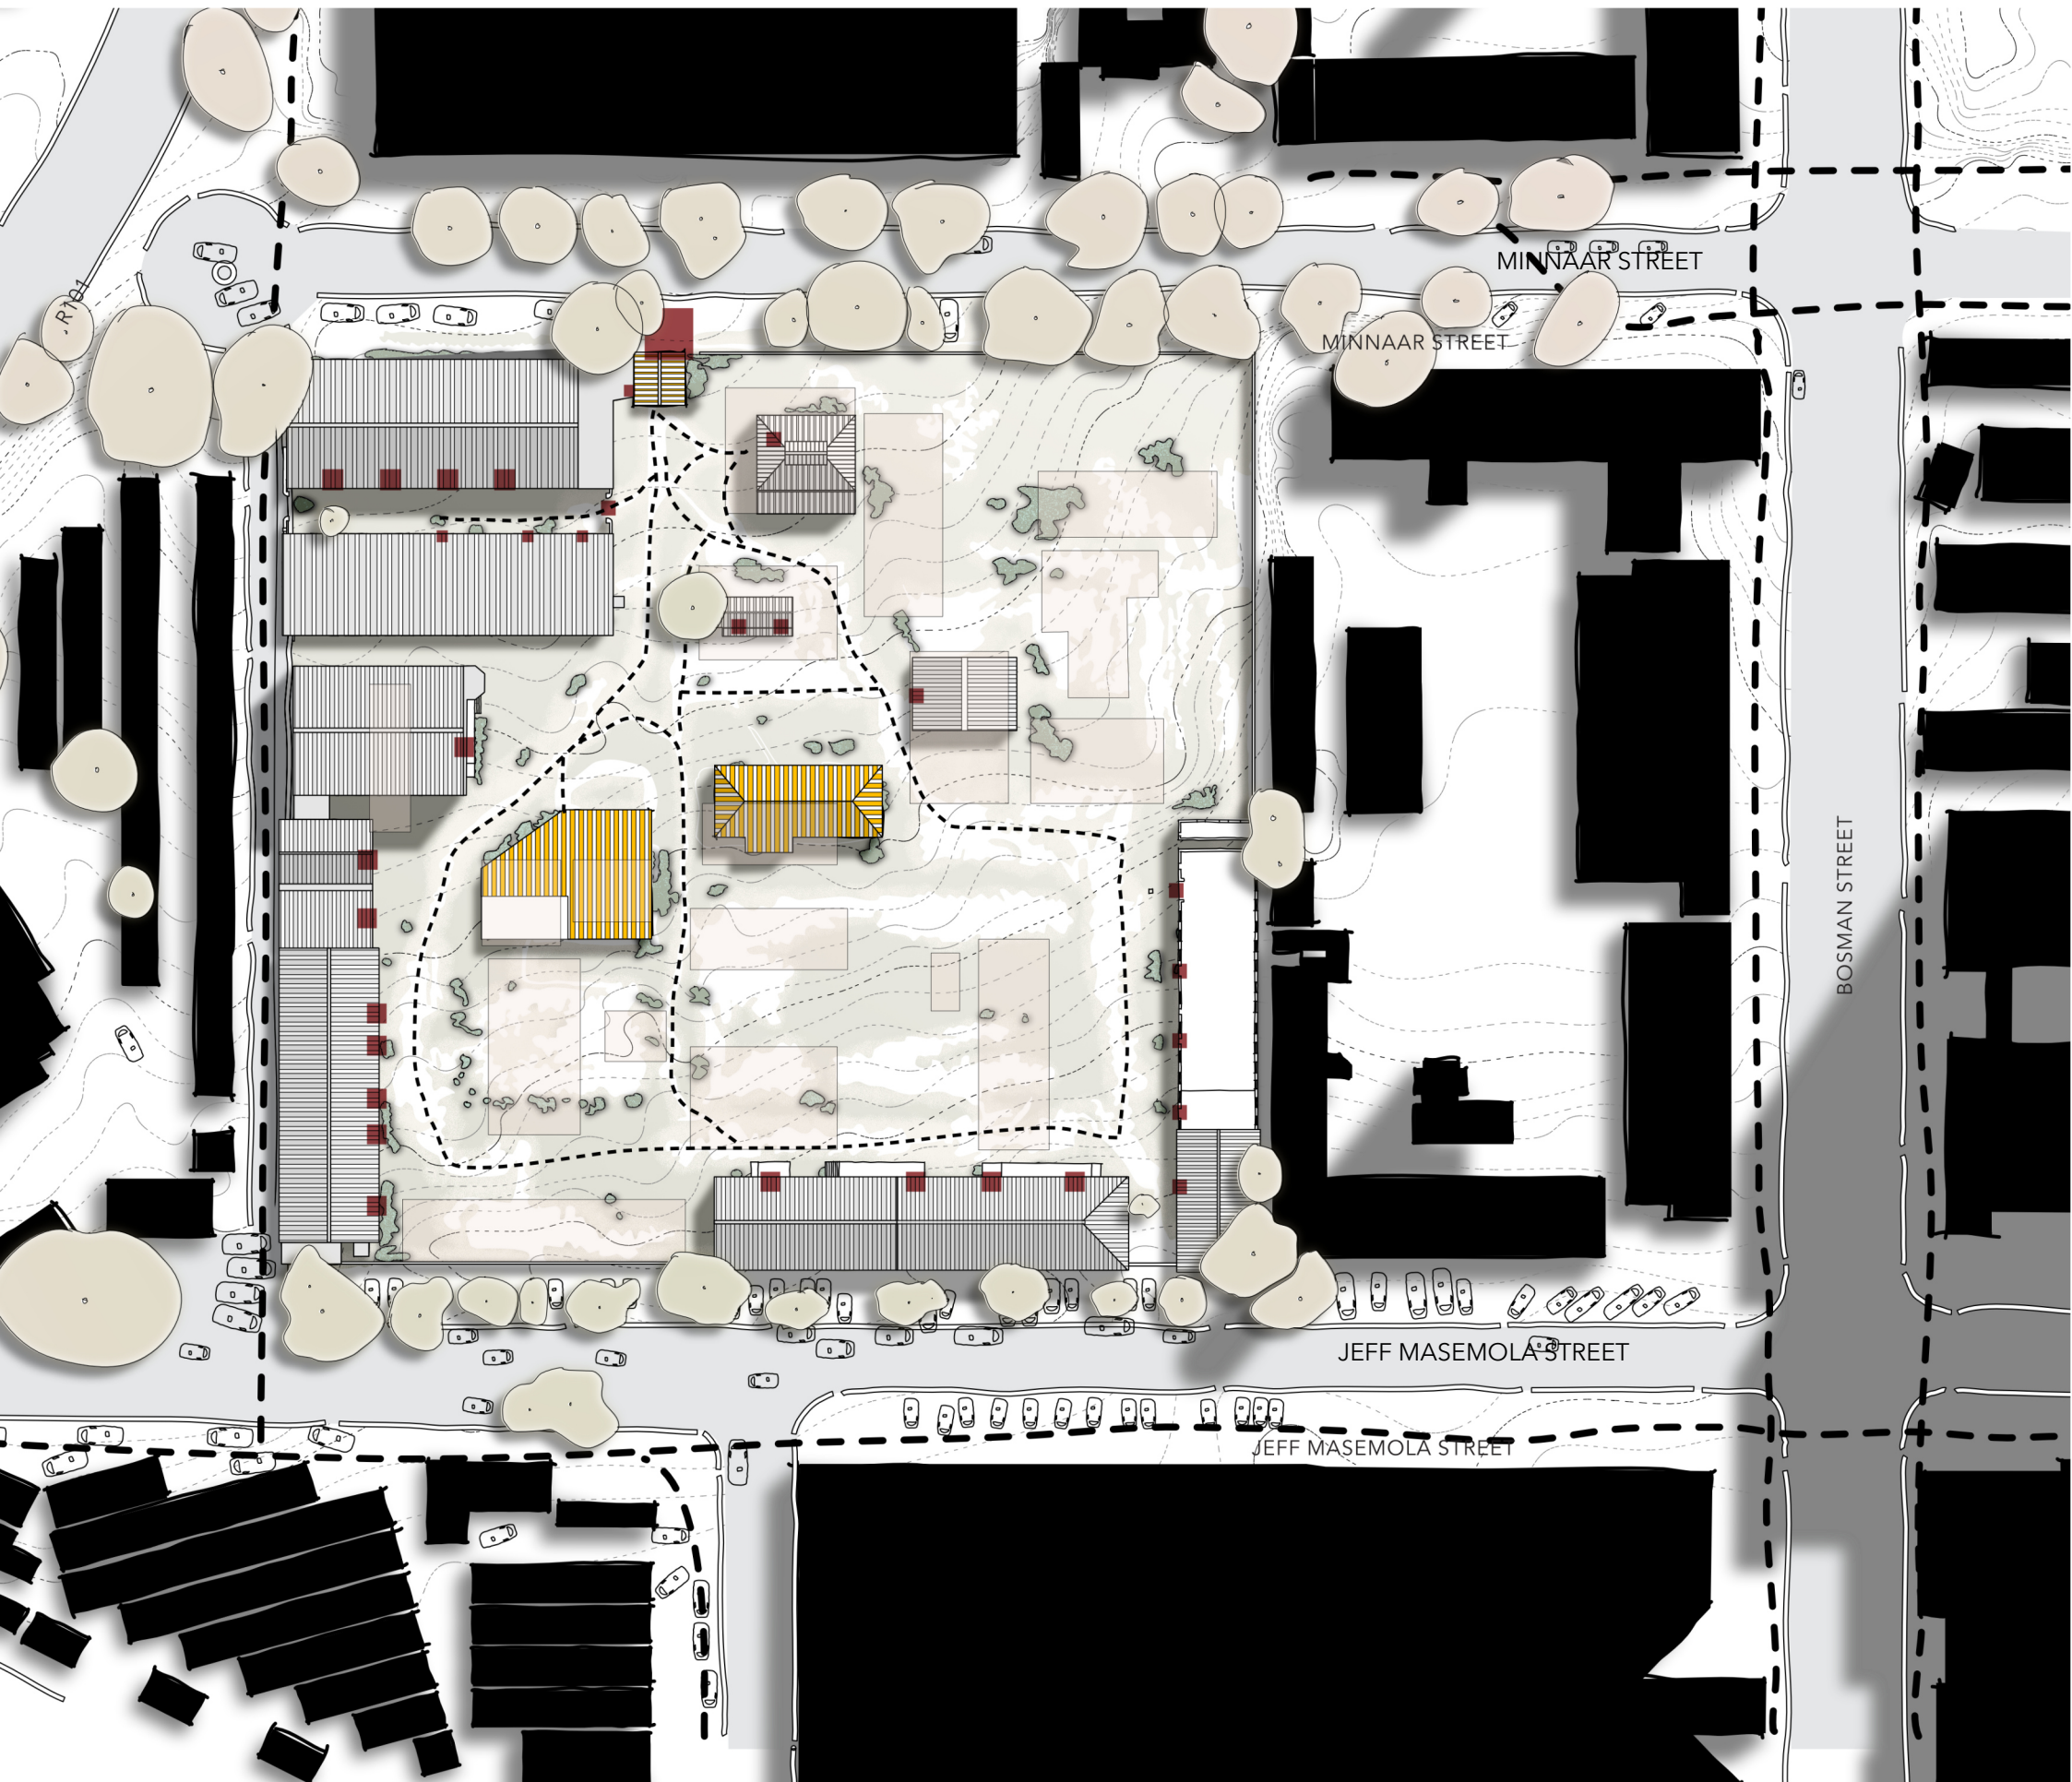
Fig. 8.1 Site analysis depicting entrances, lost heritage, reclaimed landscapes, footpaths on site and predominant pedestrian movement
© University of Pretoria

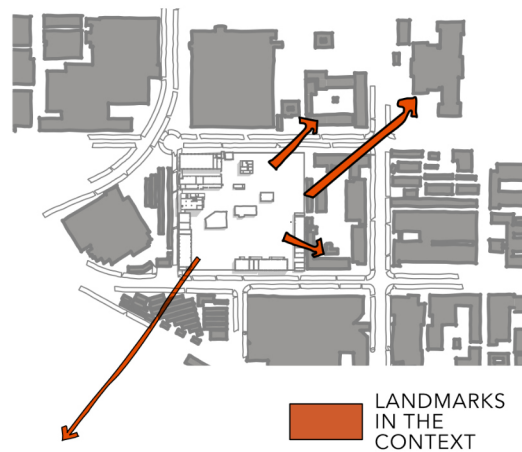
Fig. 8.2 Landmarks visible from the site in the context

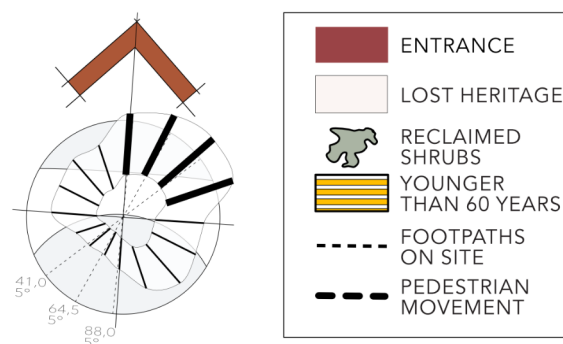
Fig. 8.3 Landmarks visible from the site in the context

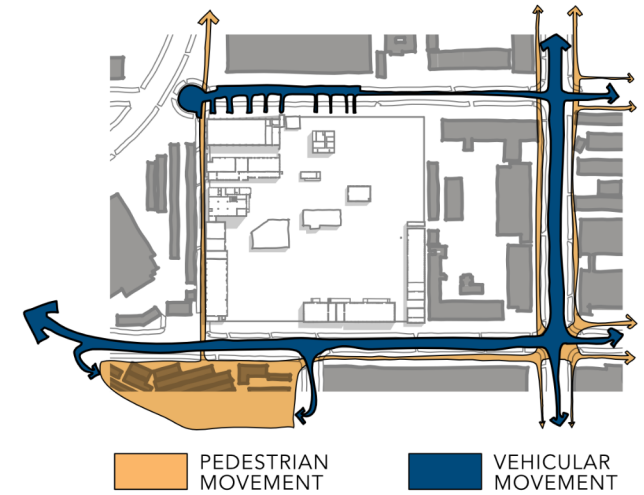
Fig. 8.4 Site accessibility and movement

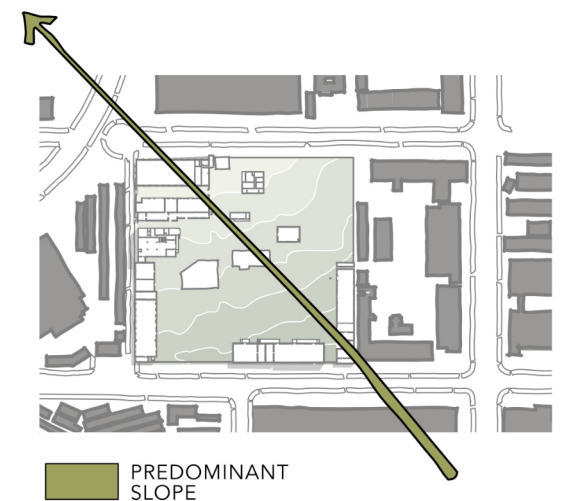
Fig. 8.5 Contours and predominant slope of the site

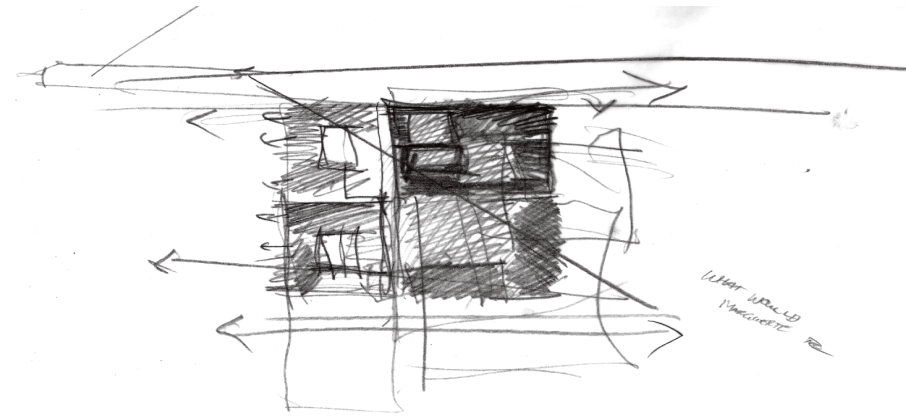
Fig. 8.6 Iteration 1 of site framework exploring heights and connections

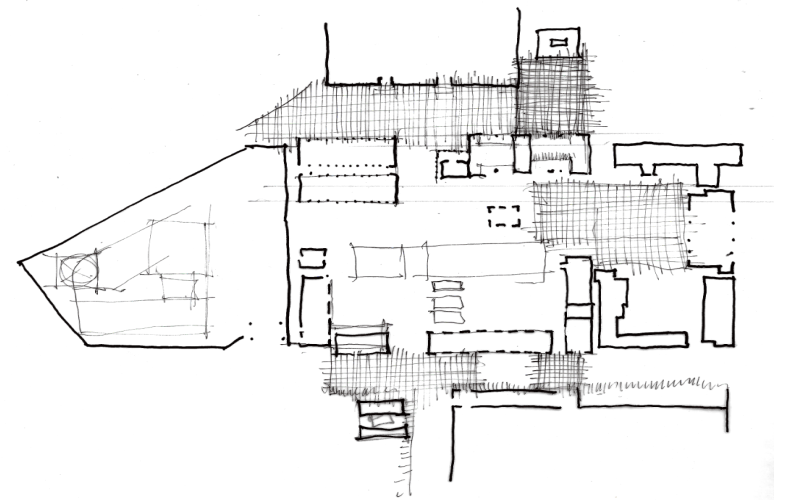
Fig. 8.8 Iteration 3 of the site framework considers the opportunities for public open space on the edges of the site

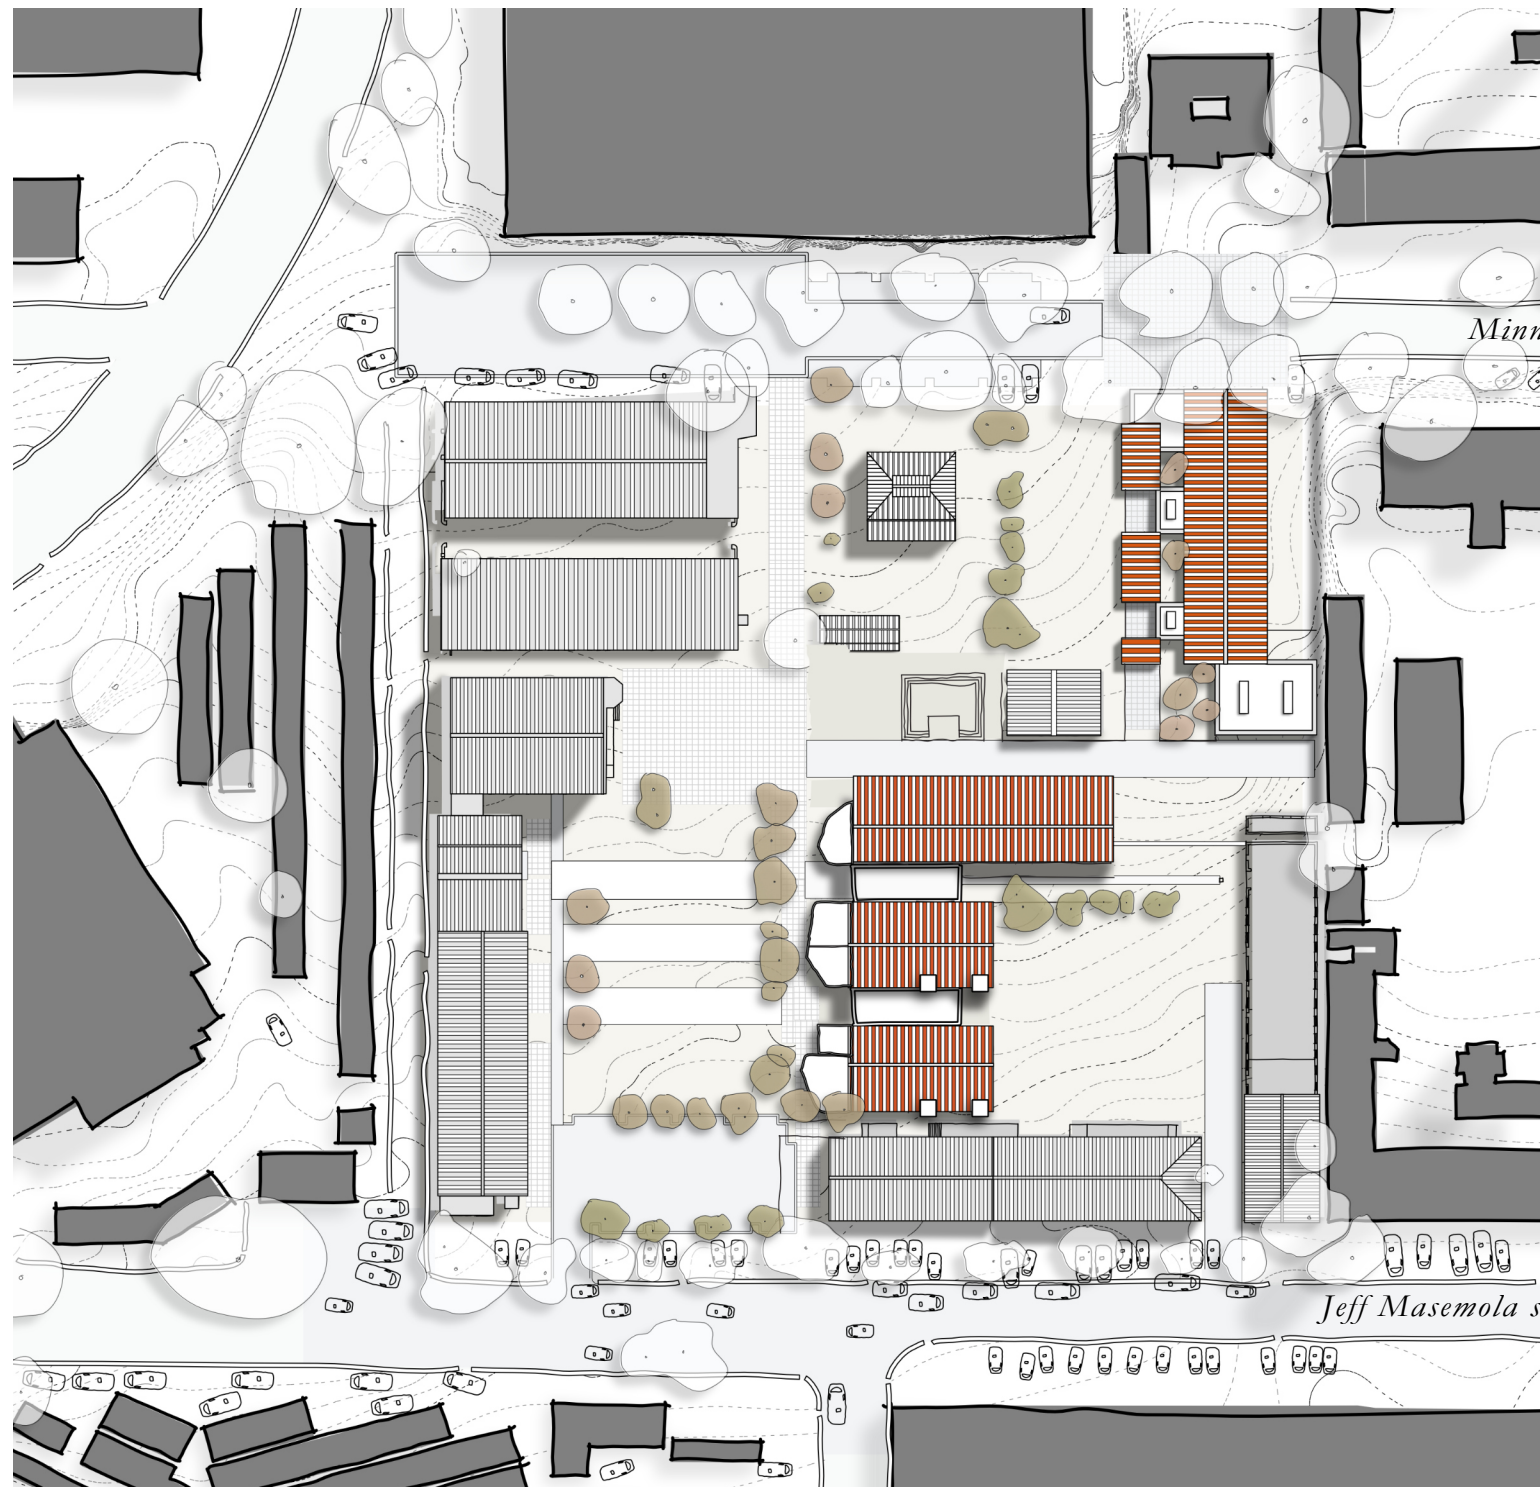
Fig. 8.9 Arrangement of the program on site

Steps lead from the main path to the grassy landscape. The bio-swales capture stormwater and soften the impact of the parking area. The main pedestrian route is next to the proposed workshops on site. Secondary paths branch off the main route.

Except for the Carpenter's workshop, the existing buildings on Minnaar Street do not define an edge to the site. The framework proposes a public entrance for the Craft Museum and Repository with engaging exhibits facing the street and sidewalk (Jacobs, Ibid.:6.3-4). The entrance to basement parking is on Minnaar street.

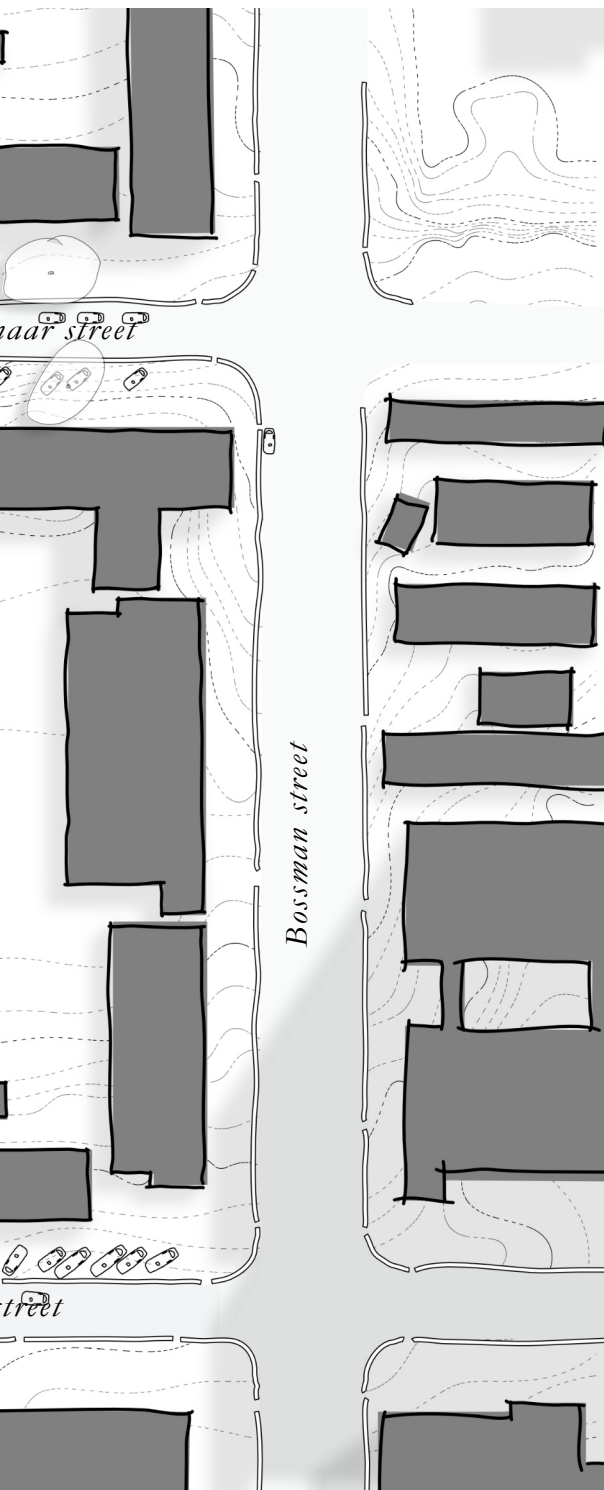
Fig. 8.10 Arrangement of the program on site

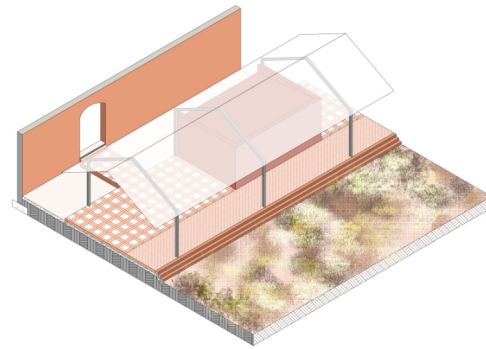
Fig. 8.11 Arrangement of the program on site

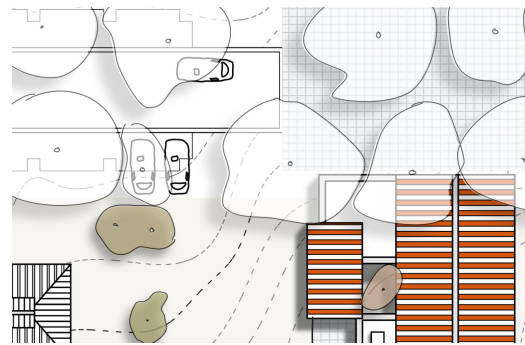
Fig. 8.12 Arrangement of the program on site

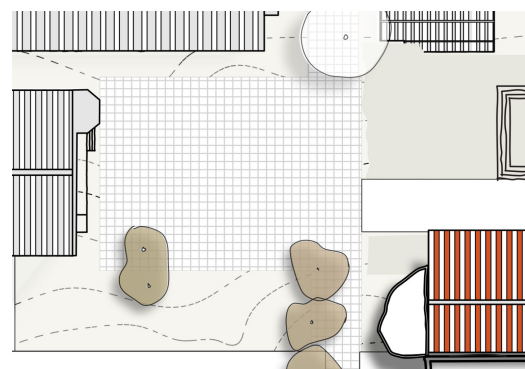
Fig. 8.13 Arrangement of the program on site

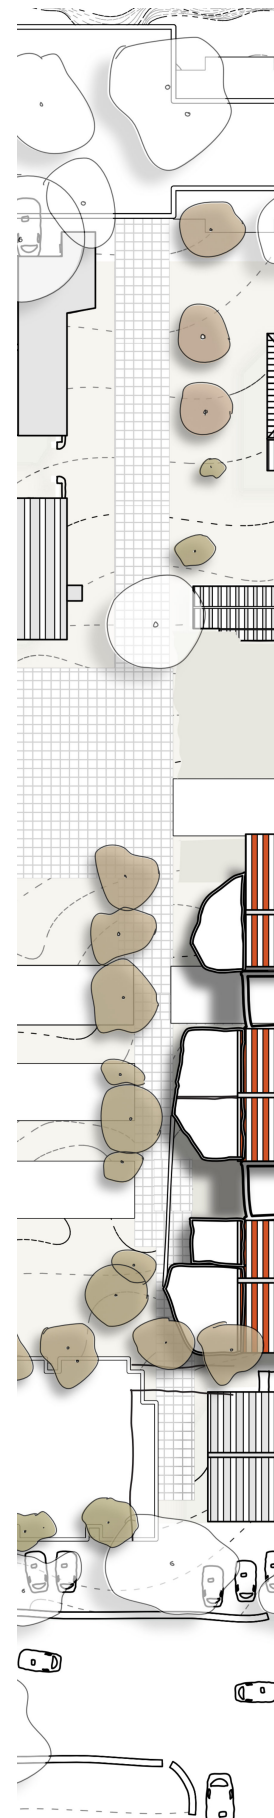
Moments in-between

The broader linger areas are found where the pedestrian route and the secondary paths intersect. These moments are defined with focal points like water fountains, signage, benches, or a small commemorative sculpture.

The bio-swales capture most of the runoff accumulated on-site during the rainy seasons. The invasive grass species are systematically replaced with indigenous varieties. The areas of tall grass are kept within the boundaries of the lost heritage and in the planters allocated to the edges of buildings.
