The crack growth resistance behaviour of aluminium alloy 2024-T3 at slow strain rates after exposure to standard corrosive environments

C.C. Pretorius¹, R.J. Mostert¹, and S. Ramjee¹

The study investigates the effect of prior corrosive exposure on crack growth resistance behaviour of thin sheet (3 mm thick) aluminium alloy 2024-T3 at slow strain rates. Compact tension specimens were exposed to standard corrosive environments that simulate accelerated atmospheric corrosion attack. Two corrosive environments were considered – an exfoliation corrosion (EXCO) solution and a 3.5 wt% sodium chloride solution. The unloading compliance R-curves of the two-hour EXCO-exposed specimens revealed a significant degradation of approximately 11% in the crack growth resistance behaviour (Kc, values) compared to the baseline (air-exposed) values. Furthermore, secondary intergranular crack formation was also revealed in the plastic zone ahead of, and adjacent to, the crack tip of these specimens; which formed during the crack growth resistance loading. It is postulated that the observed degradation of the K_c, values of the EXCO-exposed material is due to hydrogen embrittlement since the exposure t

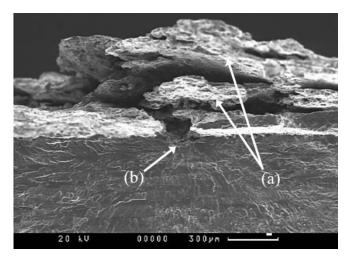
Figure 2—Macro exfoliation of Al 7075-T651 alloy after 48 hours exposure to an EXCO solution: (a), resulting in the initiation of a fatigue crack (b) (Sharp, Mills, and Clark, 2001)

International, 2018). Exposure to such corrosive environments ultimately gives rise to a layered surface appearance (ASTM International, 2018), as shown in the work by Sharp, Mills, and Clark (2001) on aluminium alloy 7075-T651 after exposure to the EXCO solution for 48 hours (refer to Figure 2).

The presence of such an exfoliated surface layer will, of course, affect the mechanical properties in a deleterious way. Various authors have described a loss in both strength and ductility with increasing corrosion exposure time (Alexopoulos et. al., 2012, 2016; Kamoutsi et.al., 2006; Sharp et. al., 1998; Sharp, Mills, and Clark, 2001). Furthermore, as a result of localized stress concentrations (notch effects) at the exfoliated surface, the probability that the corrosion will interact with other damage mechanisms also increases with the extent of exfoliation (Kamoutsi et. al., 2006). An example of such interaction may be seen by referring again to the work by Sharp, Mills, and Clark (2001), which shows that the exfoliated surface resulted in the initiation of a fatigue crack in aluminium alloy 7075-T651 (Figure 2).

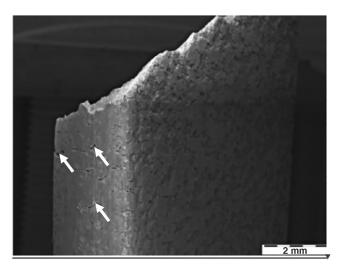
Figure 3—Scanning electron image of a peak-aged (48 hours at 170°C) aluminium alloy 2024 after 2 hours of exposure to an exfoliation corrosion solution, showing secondary cracking (white arrows) near the exposed surface (Alexopoulos et. al., 2016)

Examination of certain photographs in the published work by Alexopoulos *et al.* (2016) led to the impression that the application of plastic strain to EXCO-embrittled tensile specimens after short-term exposure resulted in the formation of numerous surface cracks prior to the fracture of the specimens (Figure 3). The initiation of such surface cracks at relatively low strains, or alternatively, in the vicinity of stress concentrations (such as a notch or a fatigue crack), poses a significant risk to the structural integrity of components constructed from these alloys. This is especially true in the aeronautical industry, in

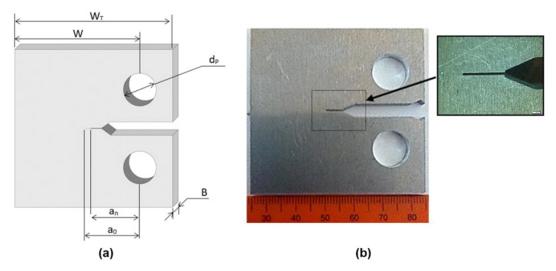
Figure 4—Crack growth resistance C(T)(L-T) specimen geometry with (a) a schematic showing the relevant specimen dimensions, and (b) a photograph of the specimen and specimen notch configuration

Machining commenced with the sectioning of blank squares (60 mm \times 60 mm) from the 3.2 mm thick plate material of aluminium alloy 2024-T3, providing the basis for compact tension (C(T)) specimens as prescribed in section 8.3 of the ASTM E561-15a standard (ASTM International, 2019). The blank specimens were then notched to produce C(T)(L-T) type crack growth resistance test specimens, with a fatigue starter notch (radius 0.12 mm) in accordance with the ASTM E561-15a standard. The specimens were further processed by the mechanical testing laboratory at CSIR to introduce the required fatigue pre-cracks using an Instron 1342 servo-hydraulic testing machine operating on Instron crack propagation software. The specimen geometry and relevant specimen dimensions are shown in Table I and Figure 4.

the crac		h-resis		the relevant dimensions o ance C(T)(L-T) specimen a			
W_{τ}	W	В	a _n	a ₀	a _{fat}	d_p	
60.00 mm	48.00 mm	3.16 mm	≈ 22.50 mm	≈ 24.50 mm	≈ 2.00 mm	12.50 mm

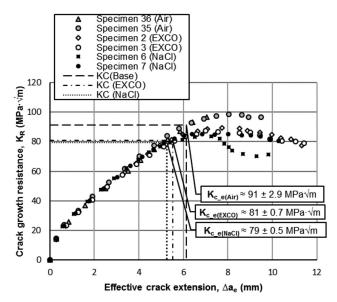
Figure 6—Comparison between the crack growth resistance behaviour after exposure to different corrosive environments. Note the degradation in the apparent crack growth resistance ($K_{\text{c.e}}$) after prior exposure to the EXCO and NaCl environments

The K_R curves for the environmentally exposed and baseline results are compared in Figure 6. A significant degradation may be seen in the crack growth-response of both the sodium chloride- and EXCO-exposed materials. With regard to the former, a reduction in the apparent crack growth resistance (K_{c_e}) of approximately 13.0 \pm 0.5% is observed, with a K_{c_e} of 79.0 \pm 0.5 MPa \sqrt{m} . Similarly, the EXCO-exposed material revealed a reduction of approximately 11.2 \pm 0.1% with a K_{c_e} of 81.0 \pm 0.7 MPa \sqrt{m} . The degradation in the crack growth resistance behaviour is recorded in more detail in Table II.

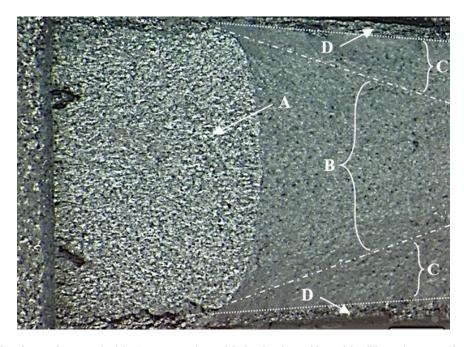
Figure 7—Post-crack growth resistance fractograph of the Exco-exposed material, showing the positions of the different fracture surface types; (A) fatigue precrack, (B) the stable crack extension, (C) shear fracture opposite the stable crack extension, and (D) the intergranular fracture surface

The fracture surface appearance of the EXCO-exposed material is shown in Figure 7. From this fractograph, it is clear that the fracture surface may be subdivided into four regions. That is, (A) the fatigue precrack perpendicular to the applied load, (B) the

stable crack extension fracture surface (also perpendicular to the applied load), (C) the shear (ductile) type fracture surface with an orientation of approximately 45° to the applied load, and (D) an intergranular type fracture surface near the edge of the specimen.

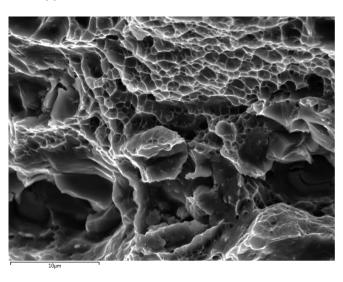
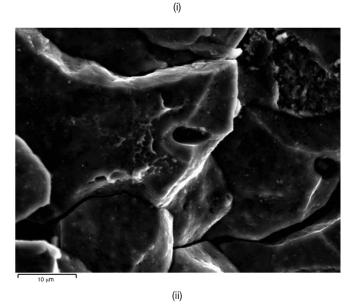
Figure 9—Higher magnification scanning electron micrographs of the fracture surface in Figure 8, with (i) the fracture surface labelled C (ductile, dimpled fracture facets), and (ii) the fracture surface labelled D (intergranular fracture)

The fracture surface types (A) to (C) were found to repeat during all the exposure conditions investigated. However, only the EXCO-exposed specimens revealed the type (D) fracture surface appearance. The high-resolution scanning electron fractograph in Figure 8 shows the transition from intergranular (type D) to dimple fracture for the EXCO-exposed material in more detail, with Figure 9 showing higher magnification scanning electron fractographs of the fracture surfaces labelled C (Figure 9i) and D (Figure 9ii). It becomes apparent that significant weakening of the grain boundary strength has occurred during the two-hour exposure to the EXCO solution. It is also found that the intergranular fracture surfaces correlate well with the

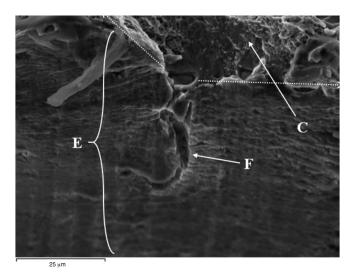
Figure 10—Scanning electron fractograph showing the fracture surface appearance near the exposed surface (E) of the sodium chloride-exposed specimen with dimpled shear fracture (C) directly adjacent to the exposed surface near corrosive attack (F)

Optical microscopy of the EXCO-exposed surfaces prior to the $K_{\rm R}$ loading revealed no evidence of substantial pitting and/or intergranular corrosion. Also, secondary intergranular cracking was not observed in the sodium chloride-exposed specimens, with a ductile (dimple-facet) type fracture surface directly adjacent to the exposed surface (refer to Figure 10). Additionally, microscopy of the sodium chloride-exposed alloy prior to $K_{\rm R}$ loading revealed localized attack in the form of isolated pitting and intergranular corrosion on the exposed surfaces. It is thought

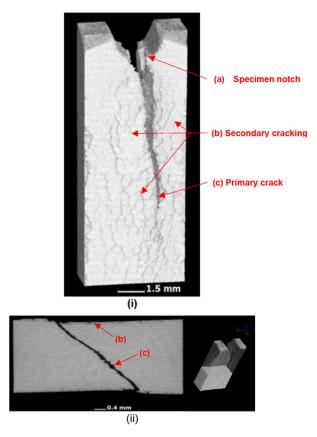
Figure 11—MicroCT scans of the notch/crack configuration in Exco-exposed aluminium alloy 2024-T3 after crack growth resistance loading until a crack mouth opening displacement of 3 mm, with (i) showing a three-dimensional MicroCT map of the notch/crack configuration and (ii) a cross-sectional view on the plane shown on the right of (i). Note that the secondary crack depth in (ii) may be correlated to the depth of the apparently intergranular fracture surface in Figure 8.

secondary crack formation (refer to the MicroCT scan in Figure 11) that resulted within the plastic zone of the material during crack growth resistance loading.
