International Conference on Structural Integrity 2023 (ICSI 2023)

The role of hydrogen in the corrosion-induced reduction of plane-stress fracture toughness and strain-induced intergranular cracking of AA2024

Abstract

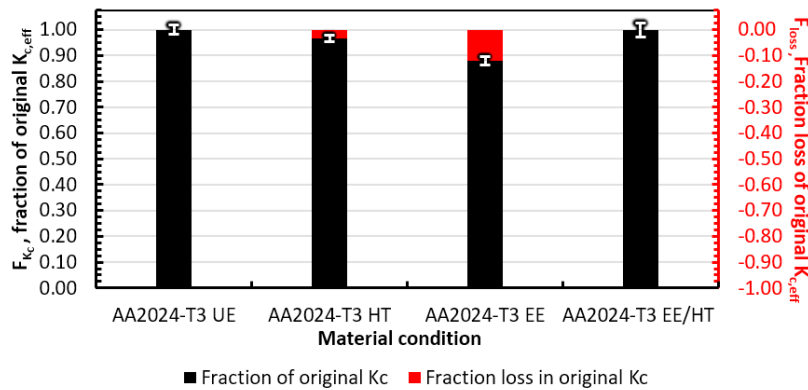
Fig. 2 Comparison of the $K_{c,eff}$ test results according to the fraction of original toughness and fractional loss in toughness.

Fig. 2 compares the $K_{c,eff}$ values in terms of the fraction of original toughness (equation 1) and fractional loss in toughness (equation 2) using AA2024-T3 UE as the reference specimen. A very minor decrease ($F_{loss} \approx -3.4 \pm 1.2$ %) could be observed in the $K_{c,eff}$ value after purely performing the heat treatment on the 2024-T3 alloy. The 2h-EXCO exposed samples, however, revealed a significant degradation in the $K_{c,eff}$ value of approximately 12.0 ± 1.7 %; which was found to be comparable to the 11.2 % loss earlier reported by Pretorius et.al. (2021). Finally, the post-exposure heat-treatment appears to have restored the $K_{c,eff}$ values when compared to the AA2024-T3 UE specimens.

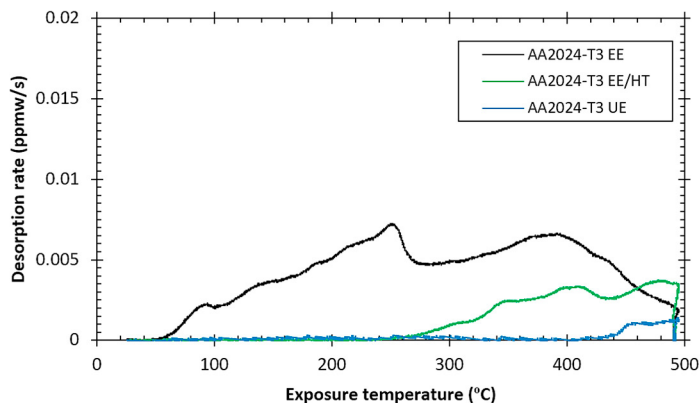
Fig. 3 TDS profiles for the various exposure condition of the aluminium alloy 2024-T3 (ramp-rate of 10°C/min)

The K_c results, therefore, imply that the crack-growth resistance behaviour of AA2024 has been degraded due to corrosion induced hydrogen embrittlement. If this is the case, the TDS results are expected to reveal a higher hydrogen concentration when compared to the as received material. The overall hydrogen content according to the TDS analysis is summarised in Table 3. It is clear that the unexposed specimen revealed the lowest hydrogen concentration. From the hydrogen desorption-rate curve (TDS-profile) in Fig. 3, it appears that most of the hydrogen was liberated at temperatures in excess of 410 °C. Considering the work by Kamoutsi et.al. (2006), this may be attributed to the release of hydrogen from trapping sites T3 and T4. Trapping site T3 (410 °C) has been attributed to the formation of magnesium hydride, whilst T4 (solution temperature range) has been attributed to the dissolution of the
