TECHNICAL INVESTIGATION

Structure of the Old Police building:

The New Building:

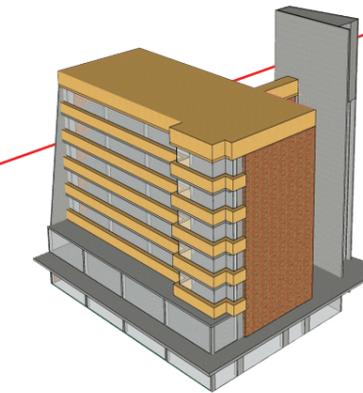
Existing

The centre for youth sub cultural expression is part of an existing intervention. The old police building consists of face brick external walls, it has a one way post tensioned structural system whereby the main structural columns are placed on the edge of the building in a west – east orientation. The building has two existing service ducts that extend from the sixth floor slab up to the first floor slab; this slab is a 300mm thick and carries the service pipes from the ducts.

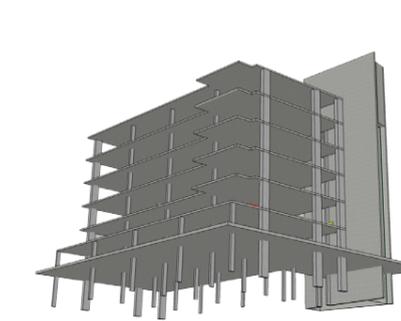
Slabs and columns

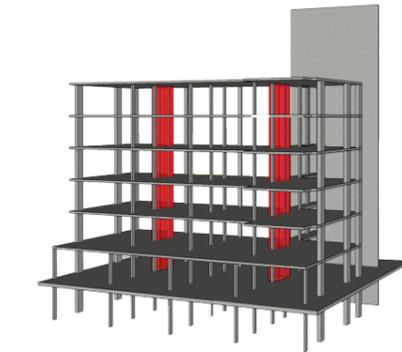
Ducts

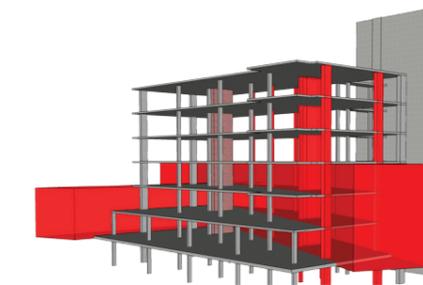
Perspective of intervention and elements to be demolished

The intervention punctures through the first, second and third floor slabs of the existing building. The columns that run down from the bottom of the third floor slab to the column's foundation will be demolished. The process of this system is a complex procedure. Specialist engineers render the process viable, as long as the proposed intervention will support the existing structural system. The new structural system both supports the existing structure and facilitates the new functions proposed for the building.

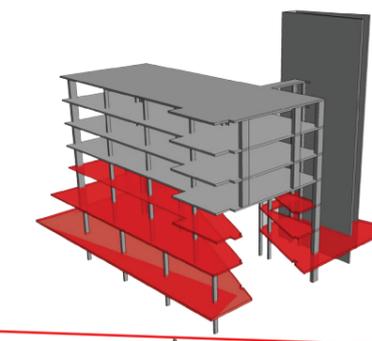
Proposed

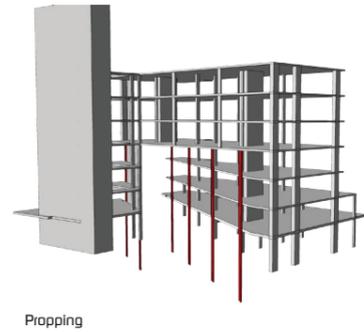
Propping

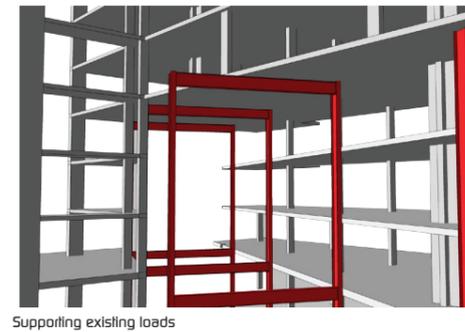
Supporting existing loads

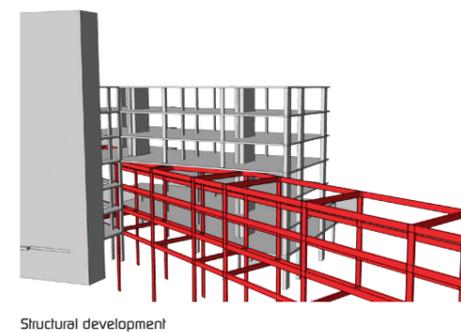
Structural development

The structure for the new building effectively acts as a large girder truss or space frame. The new structure is three floors high and comprises of steel beams and columns that holistically acts as one major beam punctured through the existing building.

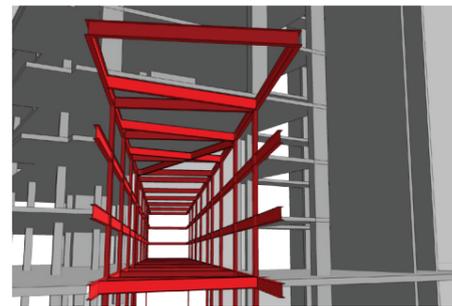
Perspective showing beams

The new building's structure comprises of I – section steel beams and columns, the beams are 533mm deep and 210mm wide. The beams support the loads from the existing floor slab and columns that have been retained above the third floor. In order to achieve symmetry, the beams of the new building must cater for the load distribution along the grid lines of the existing building. The design of the structure, essentially provided a beam running in the direction of the initial space occupied by the demolished column. Therefore, the beam running underneath the retained column transfers the loads along the edge beams of the new structure and then into the foundation via the new columns. This load distribution via the new beam must be implemented at all areas within the existing structure whereby its initial load has been affected.

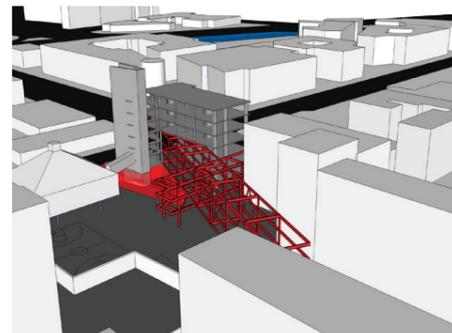
Structure works as a holistic beam through the old building

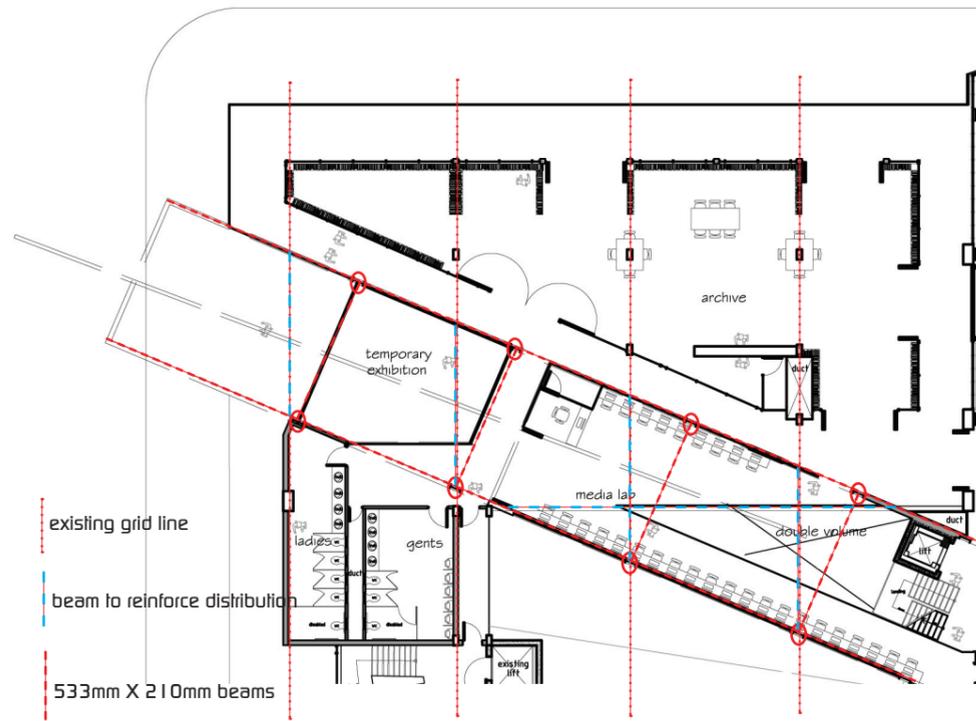
- existing grid line
- beam to reinforce distribution
- 533mm X 210mm beams
- 533mm X 210mm columns

Fig.169 Structural system in plan

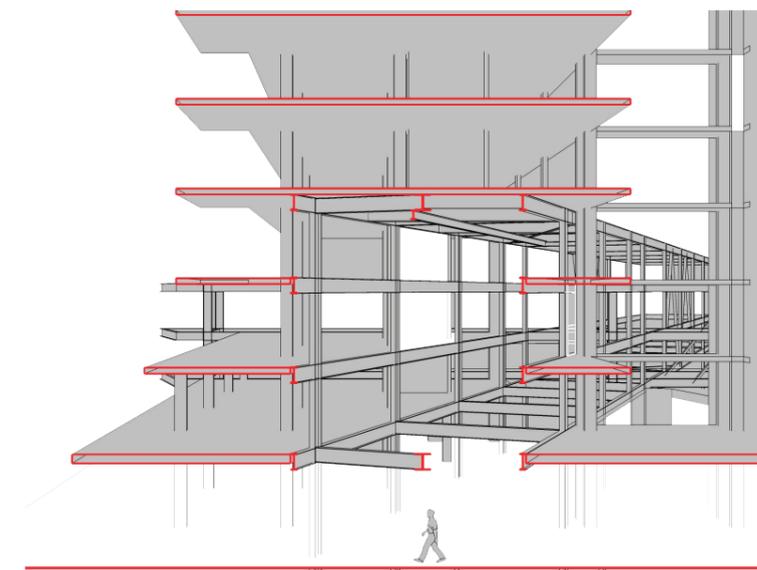
Fig.170 Sectional perspective of structure through the building

The section of the steel structure for the new building that penetrates the old police building does not have to be braced because it is automatically a stiffened system due to the connections with the existing slabs as well as the loads implemented on it by the retained columns and slabs. The southern part of the structure is braced on the sides and the bottom with equal steel channels. This system is enough, according to specialist engineers to keep the structure in equilibrium.

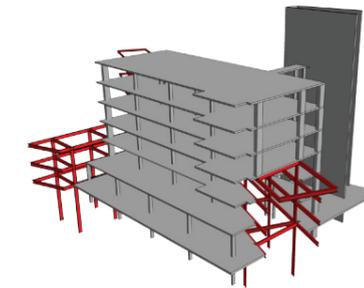
Northwest perspective of fused structural system

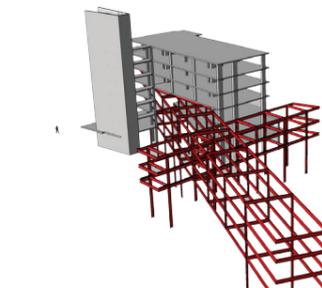
Southeast perspective of fused structural system

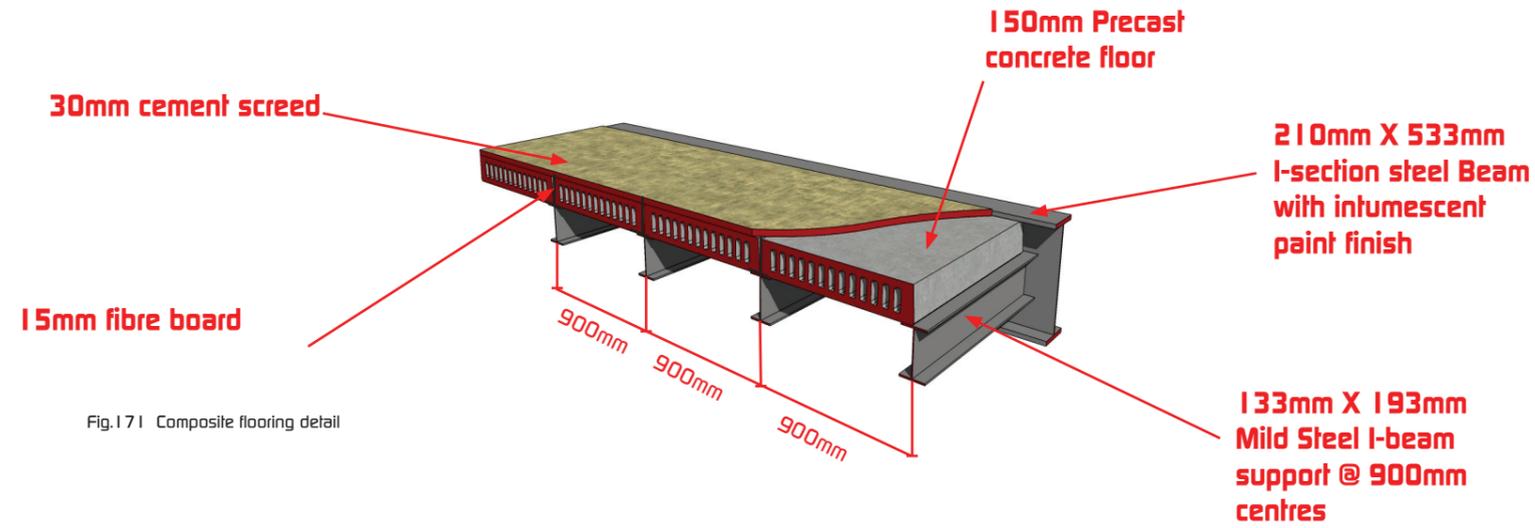
Fig.171 Composite flooring detail

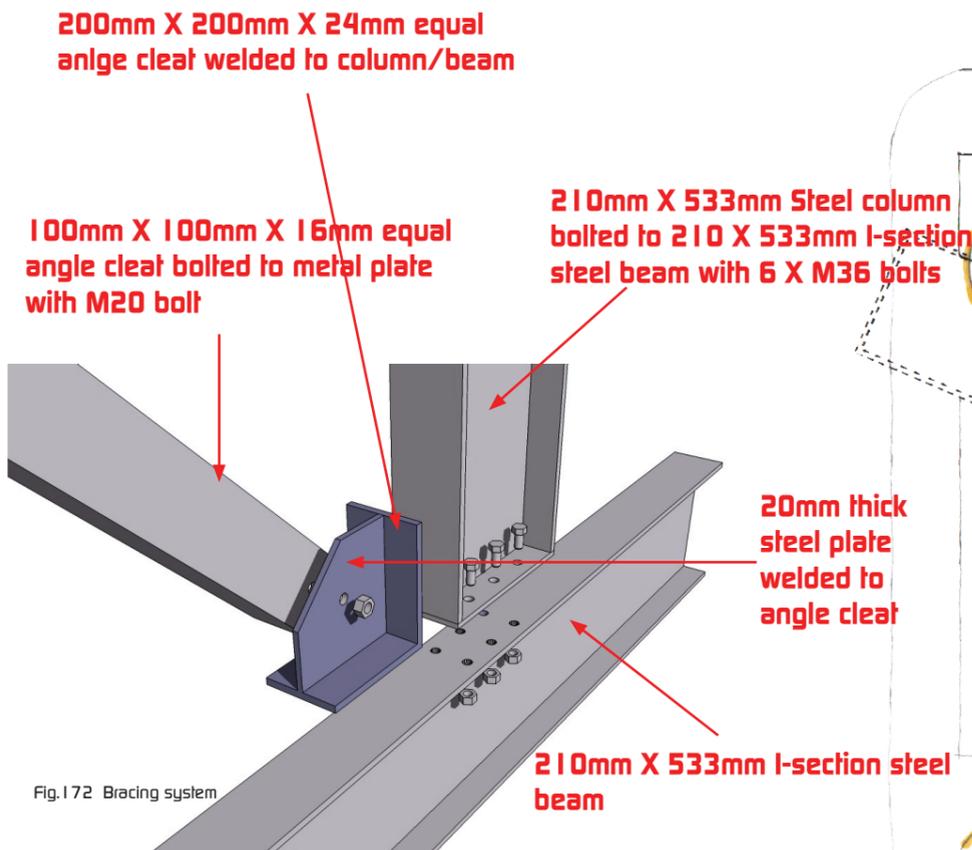
Fig.172 Bracing system

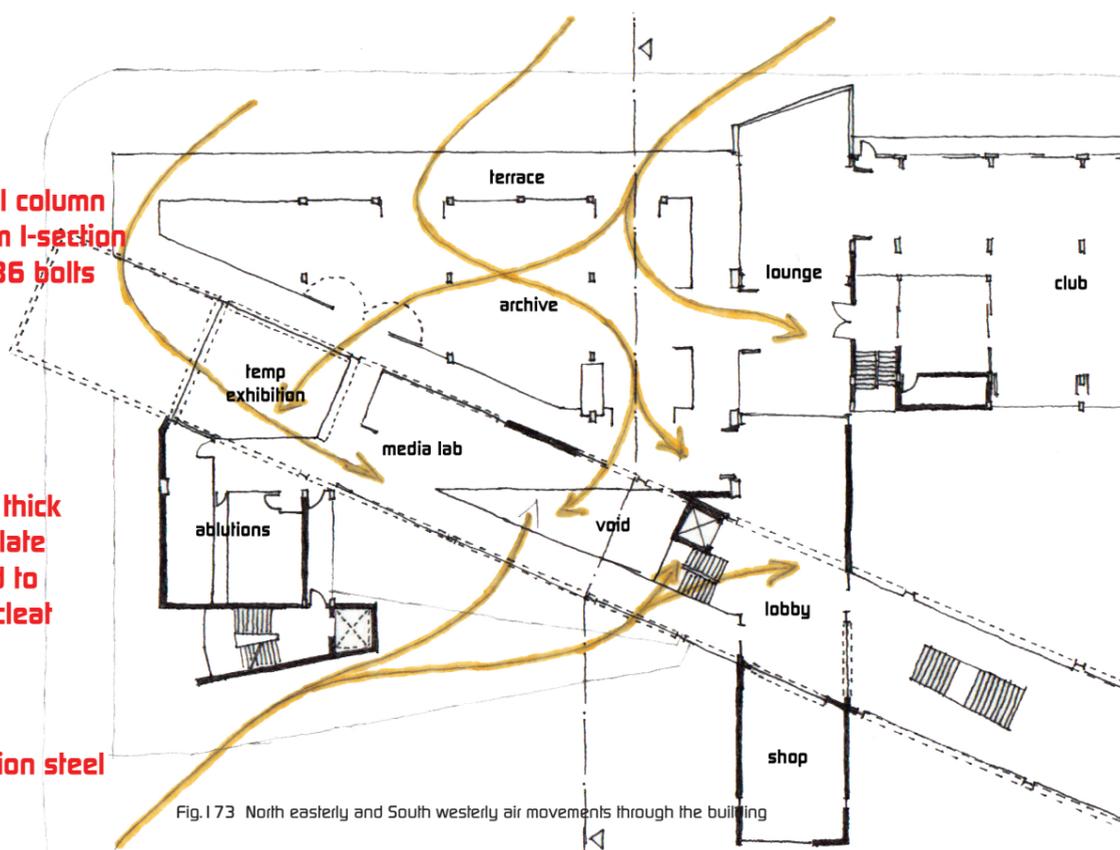
Fig.173 North easterly and South westerly air movements through the building

The centre for youth sub cultural expression employs a lot of openable sections within the building. Natural ventilation is achieved through these openings since the building articulates a permeable envelope. The structure employs passive design principles; air flows due to the stack effect, and wind on the surfaces. The provision of a void compliments the stack effect; since hot air rises, it is extracted upwards and the sinking nature of cold air cools areas such as the music studio.

Pressure differentials at openings cause air flow through rooms. Openings at angles greater than 60 degrees relative to the wind will promote good cross ventilation. The efficiency of cross-ventilation depends on the shape and orientation of openings. The leeward openings within the building are larger than the windward openings hence optimal ventilation is achieved. [AAL 210 notes, 2003 - Pieter Joubert]

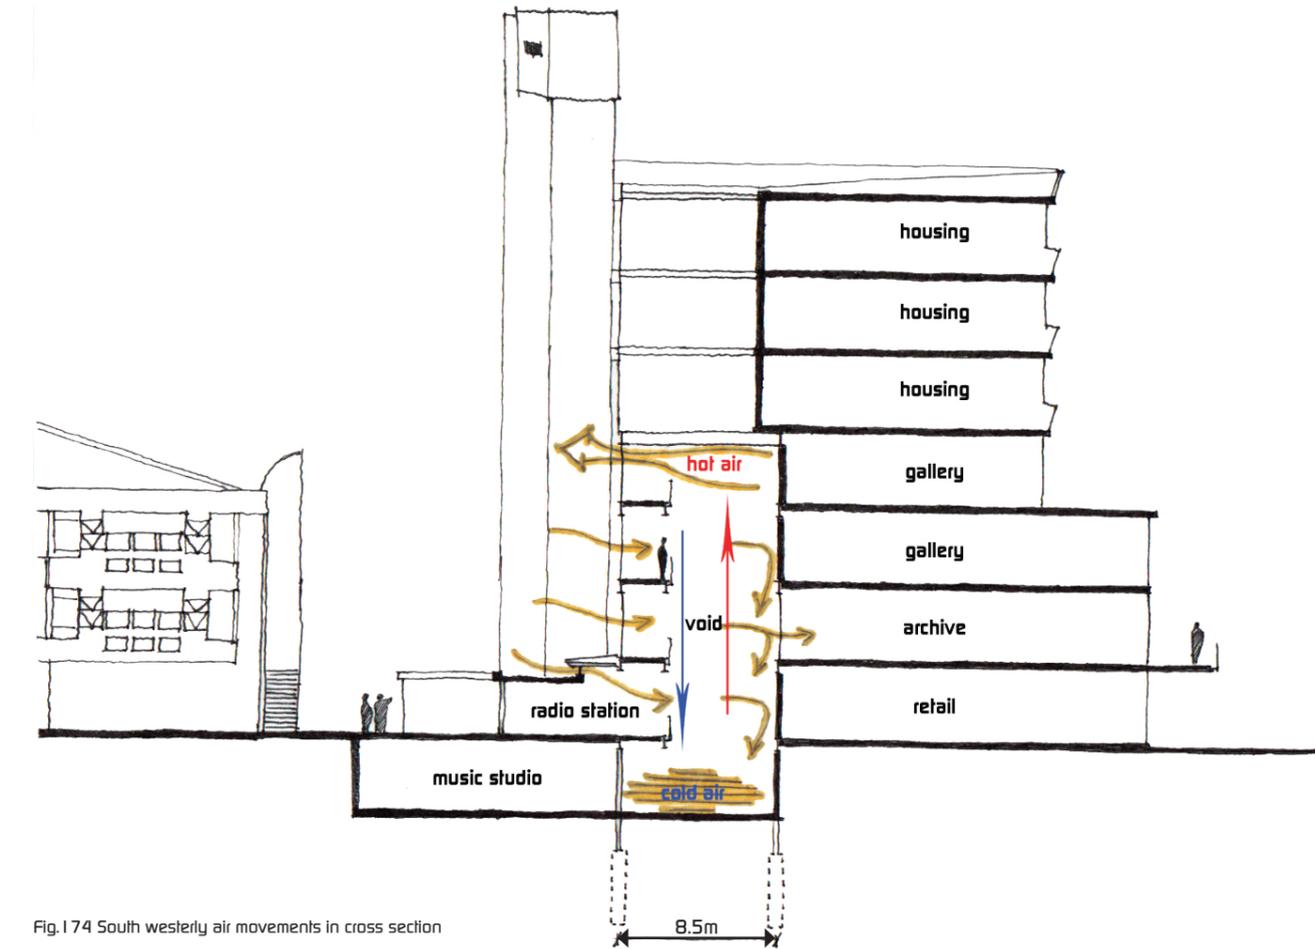
Fig.174 South westerly air movements in cross section

The building's width is 8.5m, which is optimal to achieve cross ventilation since ventilation rate drops with distance between openings. A shallow room with small openings will be better cross-ventilated than a deeper space [AAL 210 notes, 2003 - Pieter Joubert]. Joubert states that it is recommended that room depth not exceed 5x the room height ($d < 5H$), the distance that the air has to flow in the building is minimized.

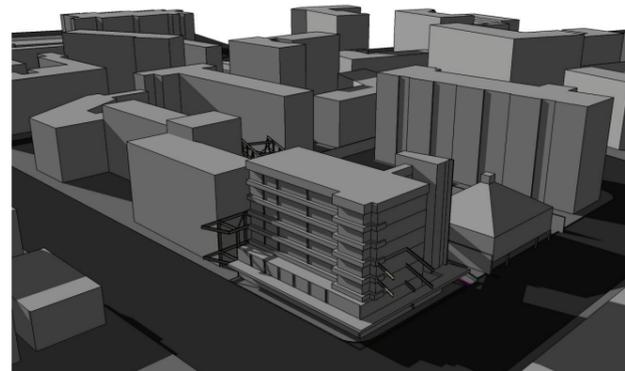
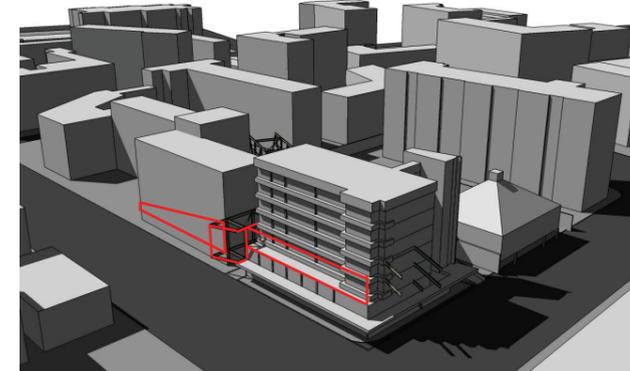
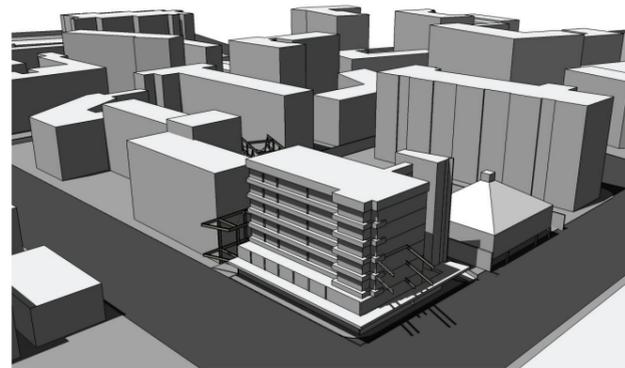
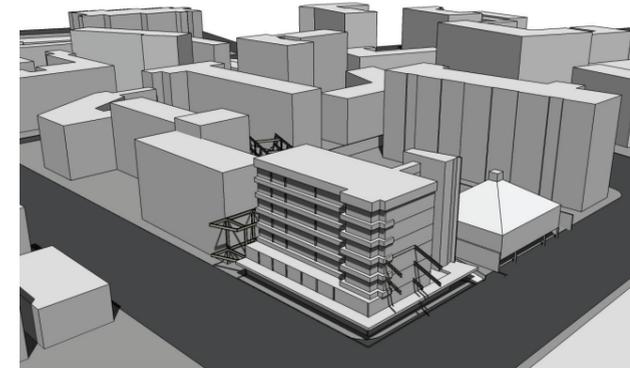
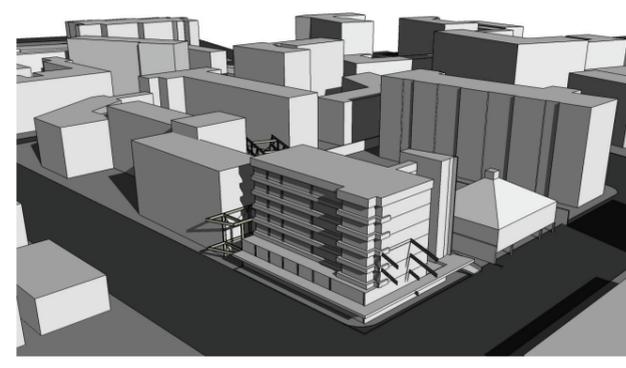
21 March / September @ 08H00

21 March / September @ 10H00

21 March / September @ 12H00

21 March / September @ 14H00

21 March / September @ 16H00

An analysis of the existing sun penetration onto the northern façade of the old police building was done in order to gain insight into the specific design of sun control.

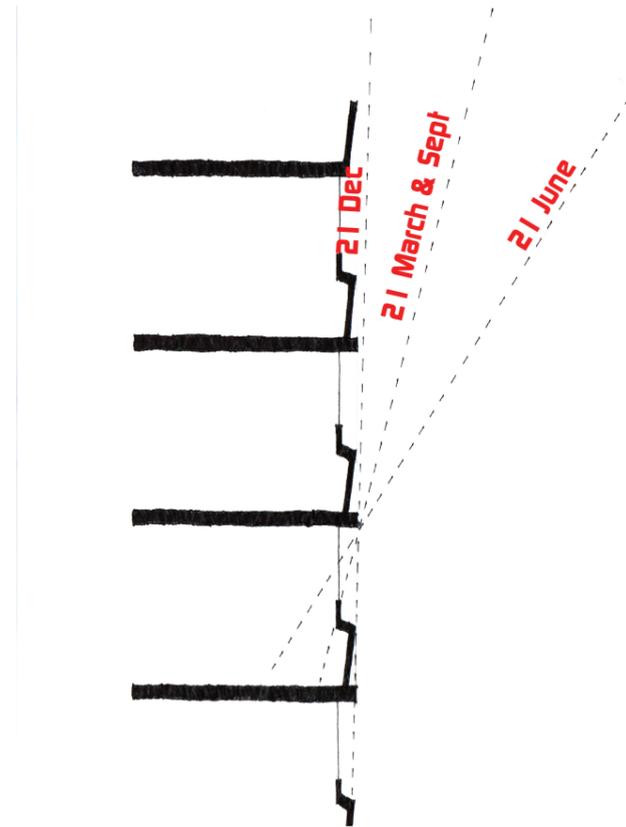
Fig.175 External window and wall of Old Police building

The northern façade of the old police building is well design for shading; the existing slabs extend out enough for the building to be shaded against the sun. By referring to the sketches, one can notice how the façade is shaded for summer sun in December but allows sun penetration during winter. For the equinoxes, (March and September), the vertical shadow angle remains constant.

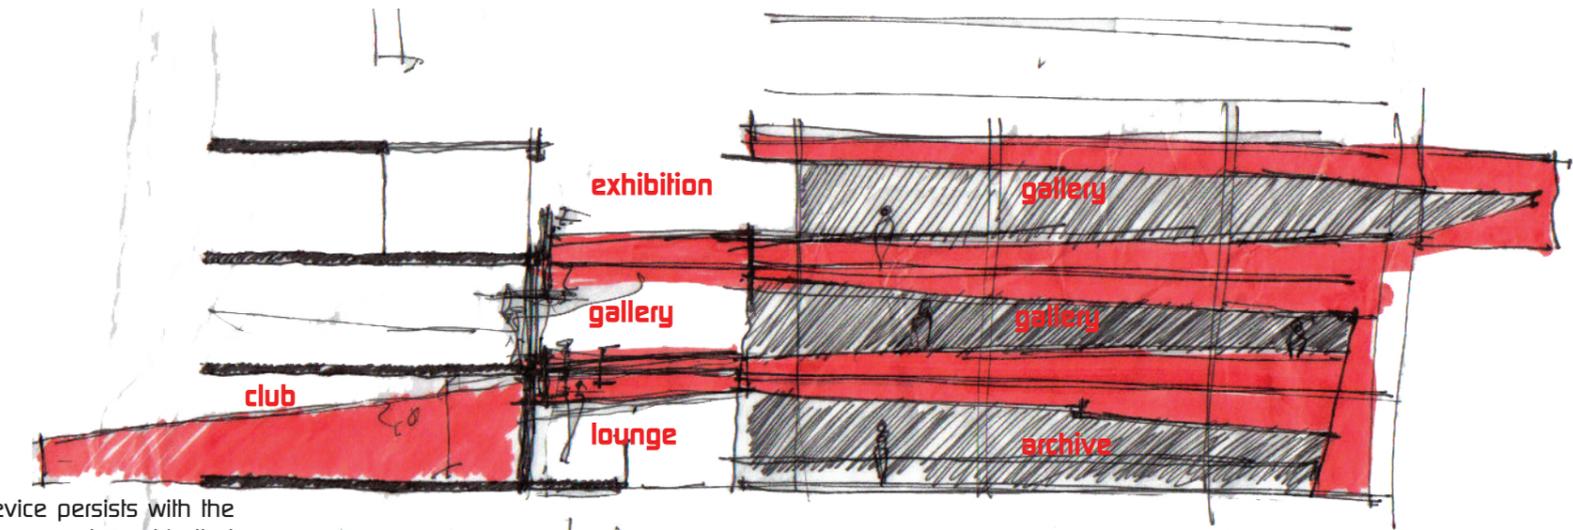
Fig.176 Sketch of northern facade articulation

The initial bi functional nature of the shading device perseveres yet again, the design of the device for the new building works as a balustrade as well as a shading device. The device is constituted of red Cor – ten steel mesh, the motive is for the mesh to stain the existing building which will signify the building as an invaded space by the subculture.

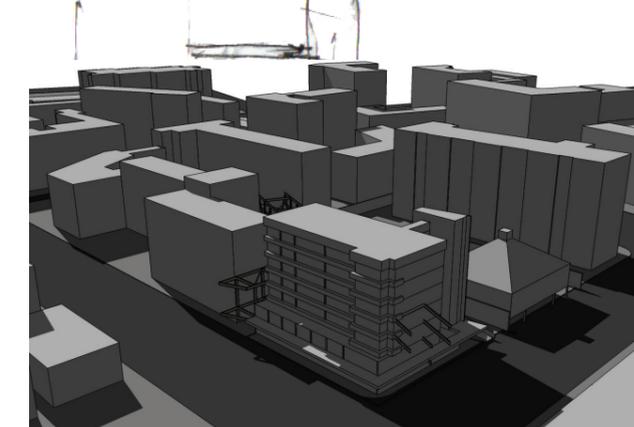
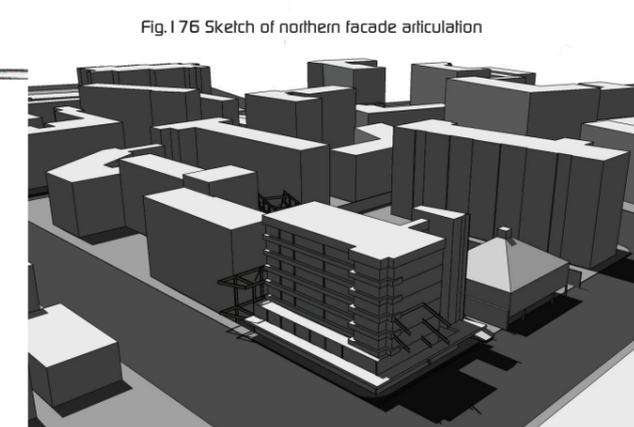
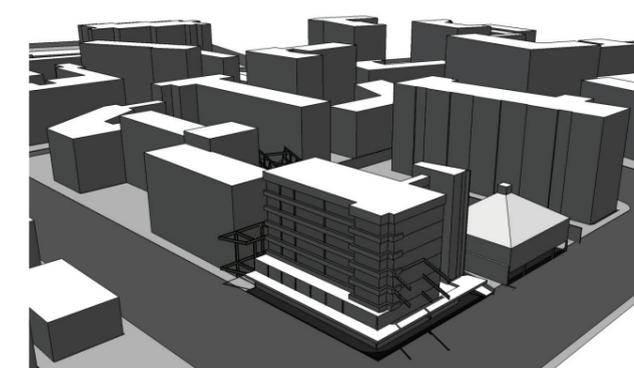
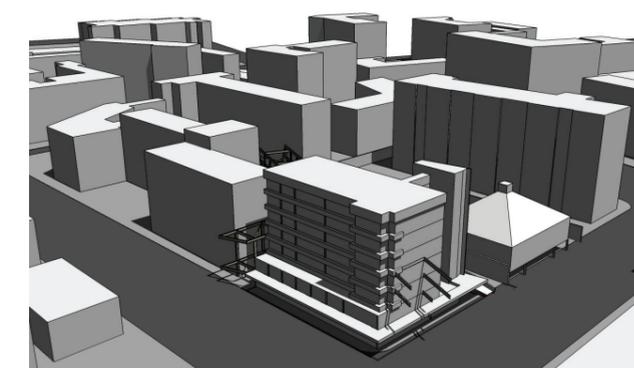
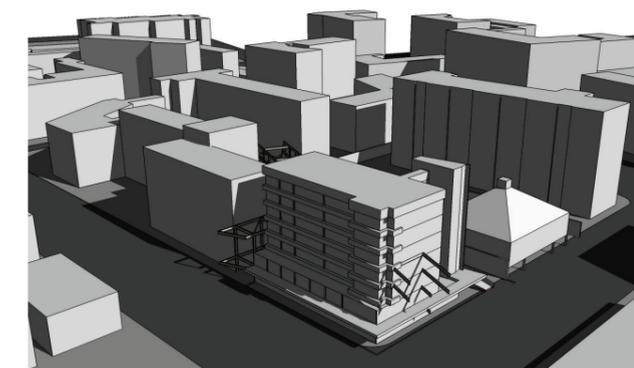
21 December @ 08H00

21 December @ 10H00

21 December @ 12H00

21 December @ 14H00

21 December @ 16H00

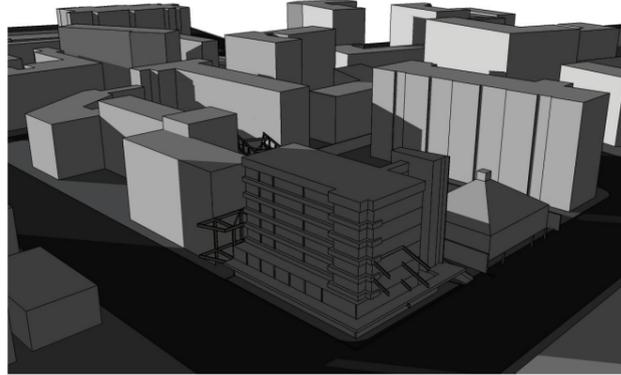
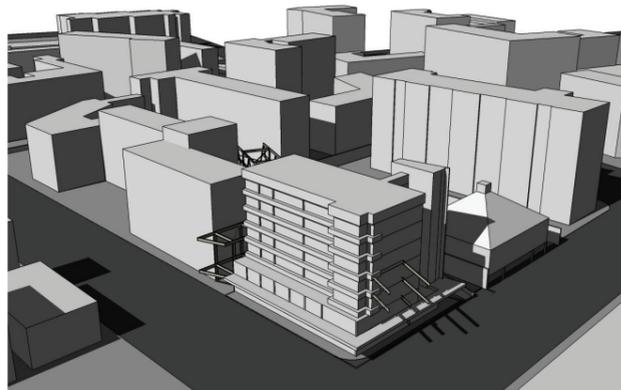
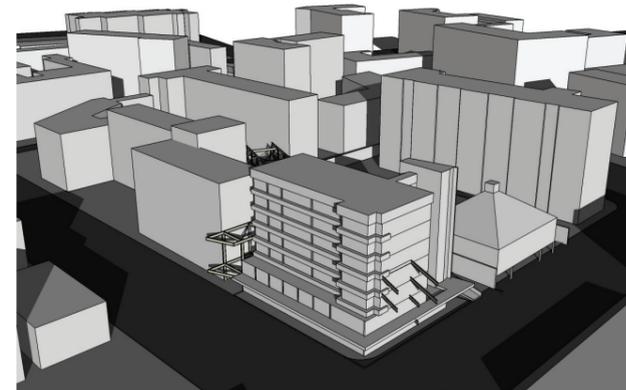
21 June @ 08H00

21 June @ 10H00

21 June @ 12H00

21 June @ 14H00

21 June @ 16H00

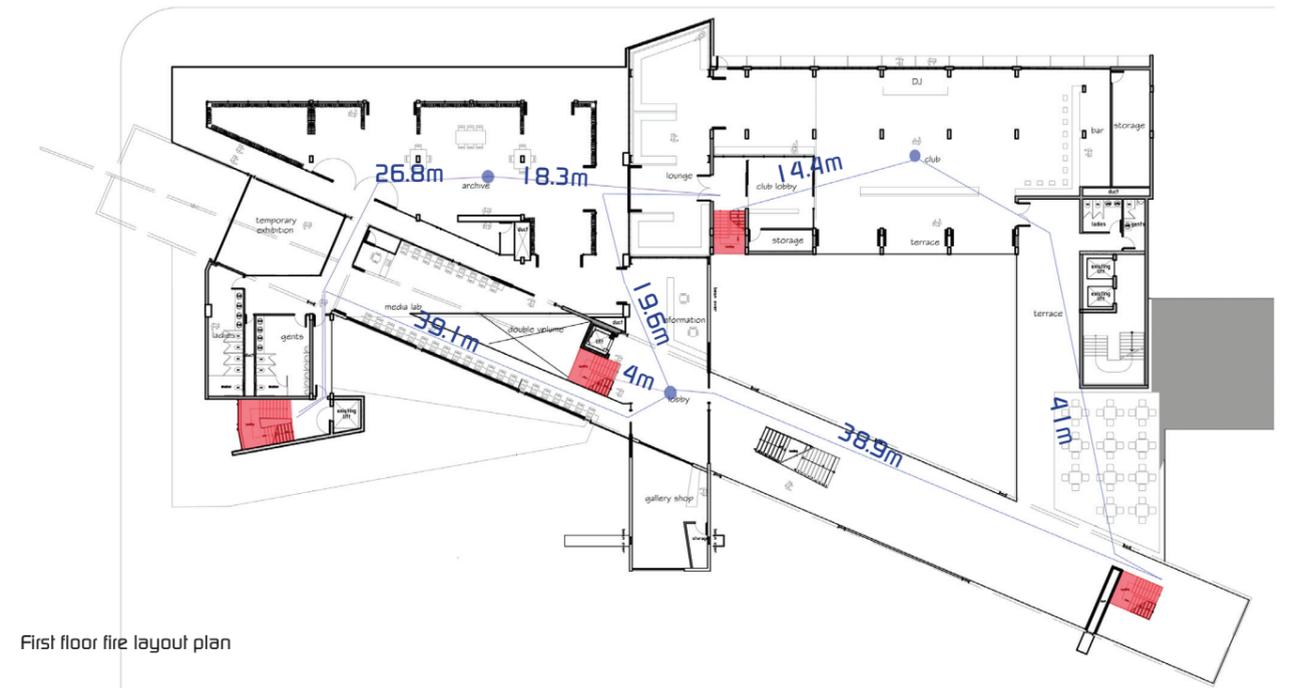
First floor fire layout plan

The building has four emergency fire escape stairways that comply with SABS 0400 - 1900 section T. The stairway on the ground floor that opens out onto the public space has a roller shutter door system, according to SABS 0400-1900 Section TT22, any revolving or sliding door or automatically operated door shutter may form part of an emergency route where such door or shutter is positioned at the end of such route discharging to a safe area. This roller shutter door will be opened during most part of the day; therefore the stairway will discharge people out of the building onto the public space.

The emergency stairways exposed outside must all have railings on both sides, the exposed stairway that discharges the club and lounge space are subject to SABS 0400-1900 rule TT2.4.

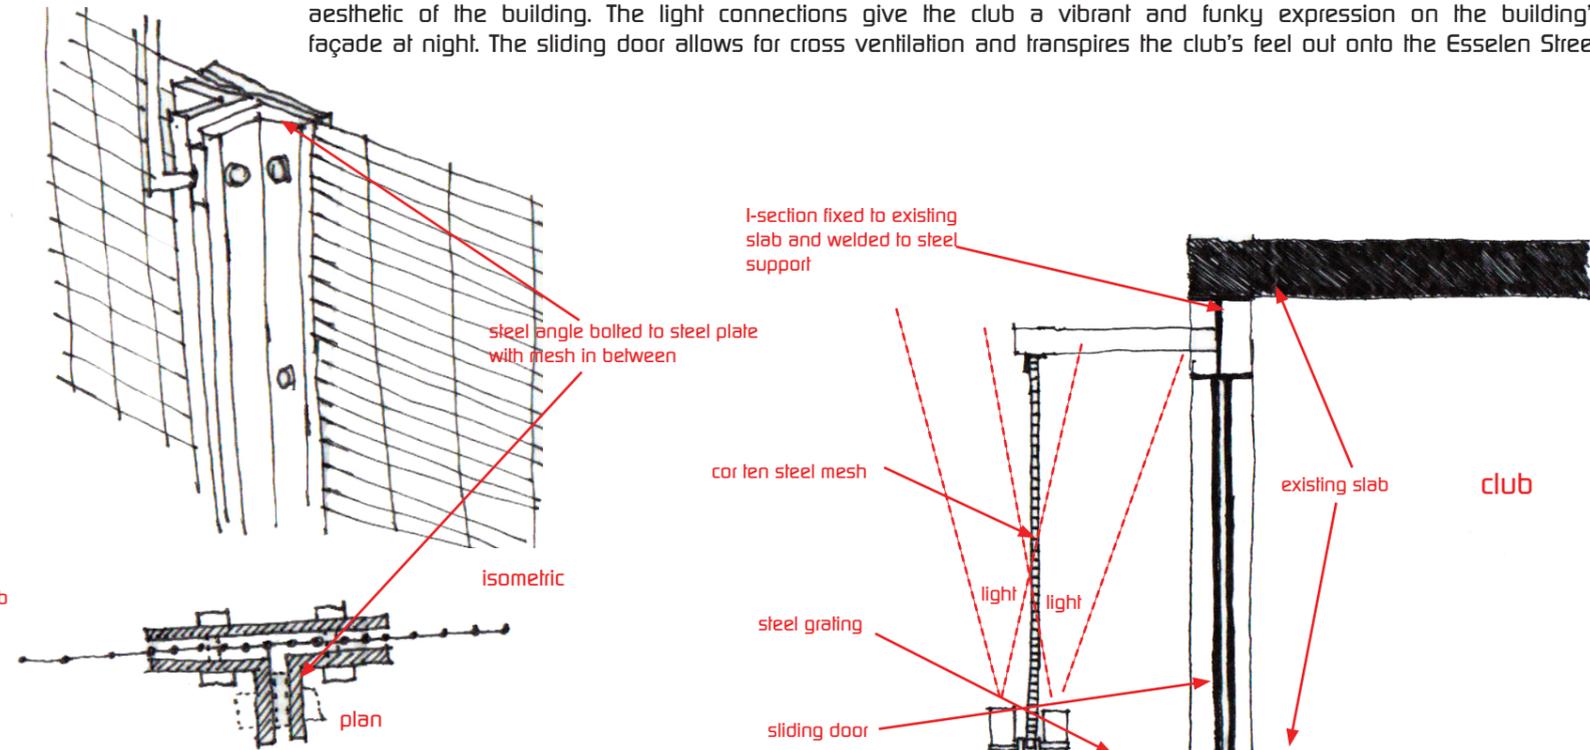
Fig. 1 78 Section of Club facade

The club is fully glazed from slab to slab; the shading device shades the club as well as contributing to the robust aesthetic of the building. The light connections give the club a vibrant and funky expression on the building's façade at night. The sliding door allows for cross ventilation and transpires the club's feel out onto the Esselen Street.

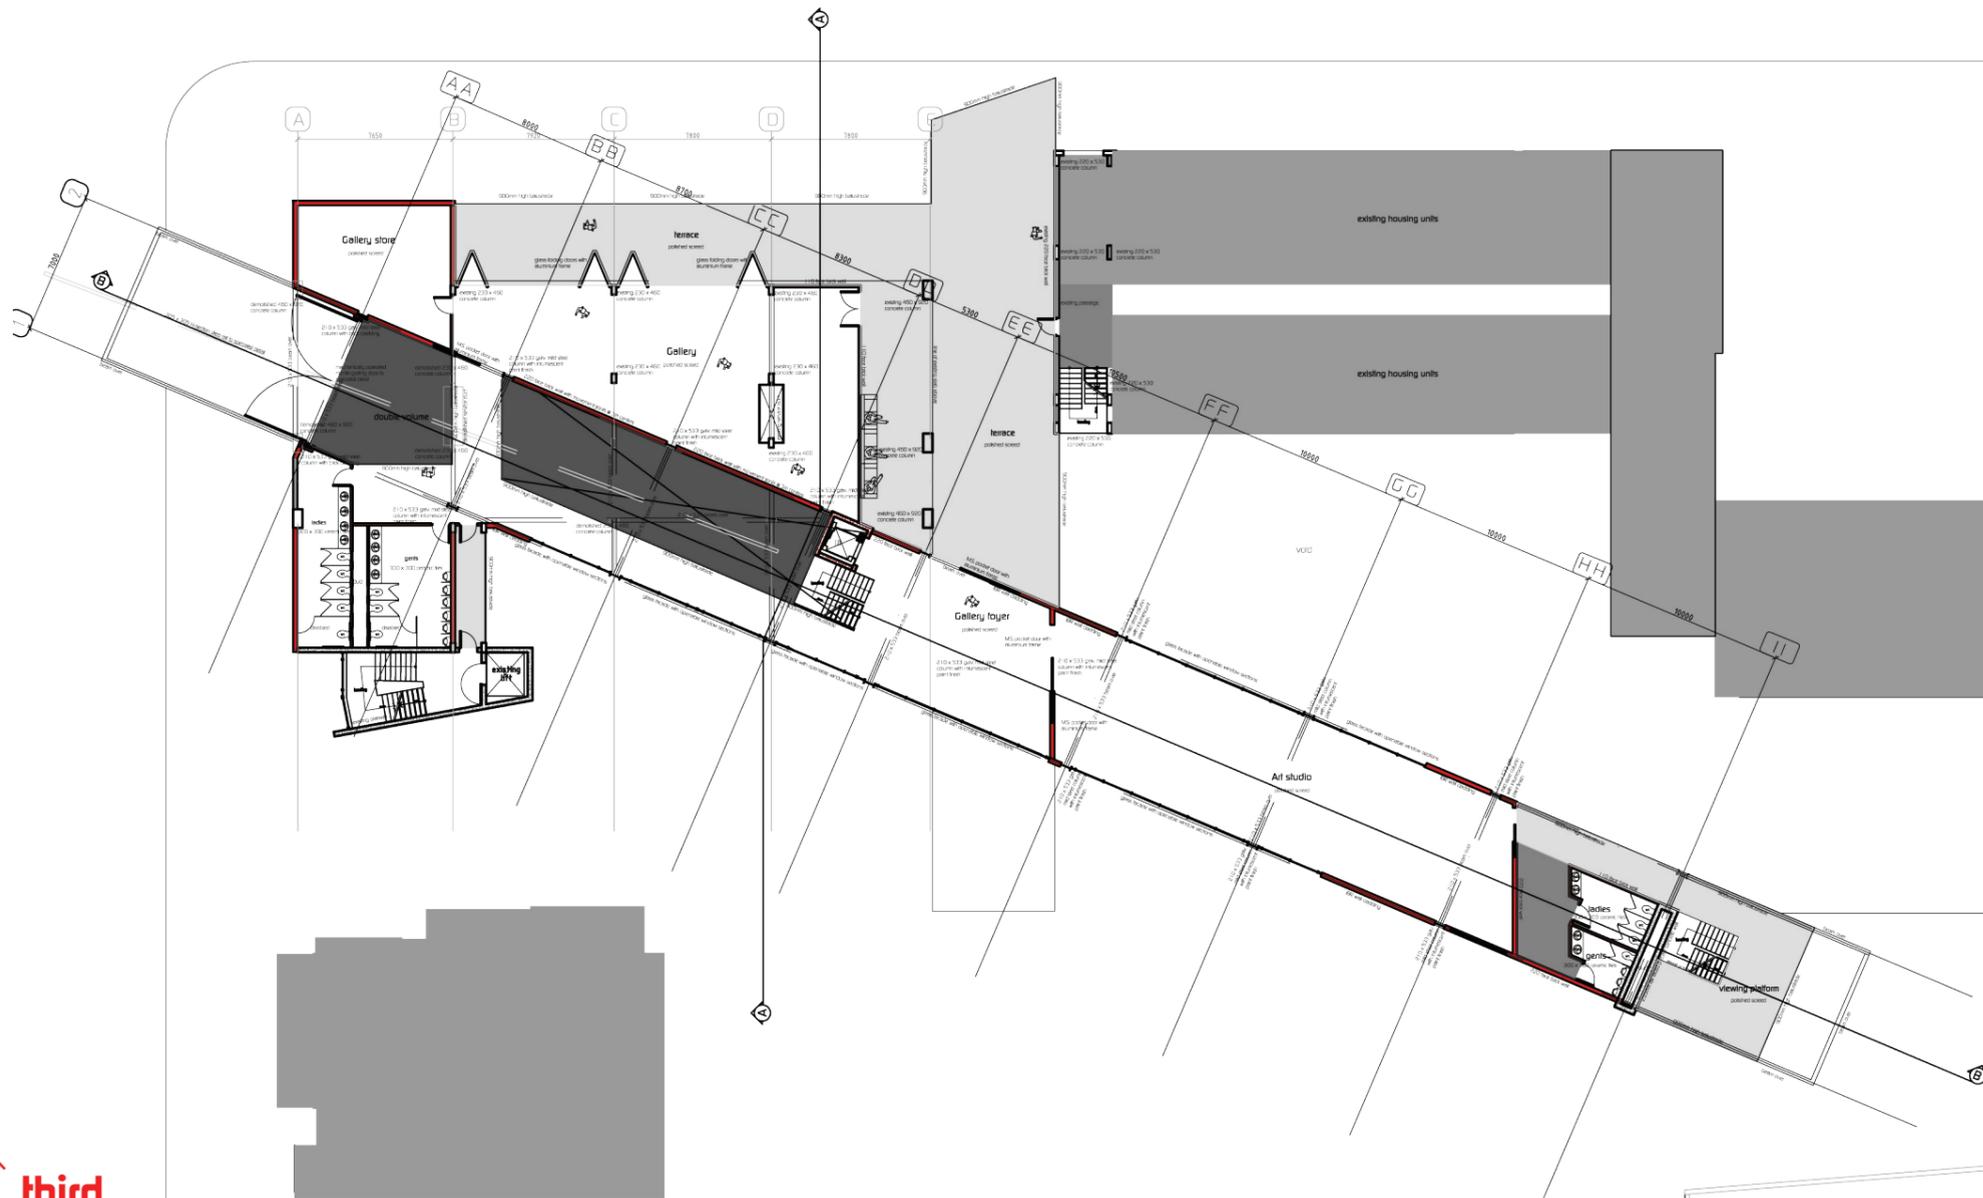
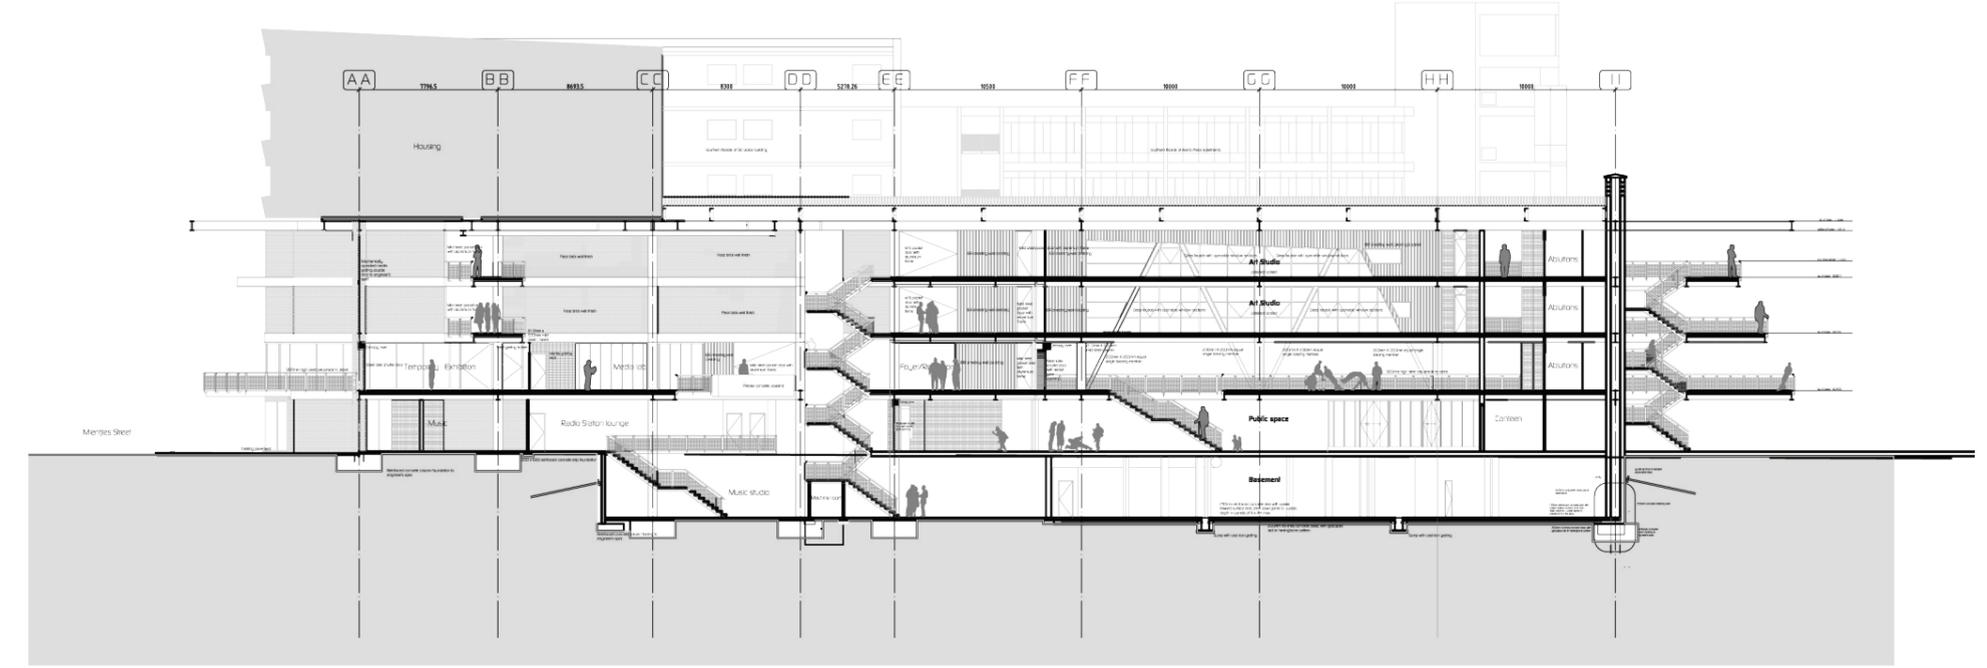
section b-b

sections
