**REHABILITATION OF SINKHOLES AND  
SUBSIDENCES ON DOLOMITIC LAND,  
EKURHULENI METROPOLITAN MUNICIPAL AREA  
OF JURISDICTION, GAUTENG, SOUTH AFRICA**

**Submitted in partial fulfilment of the  
requirements for the degree of Doctor of  
Philosophy in the Faculty of Natural and  
Agricultural Sciences**

**UNIVERSITY OF PRETORIA**

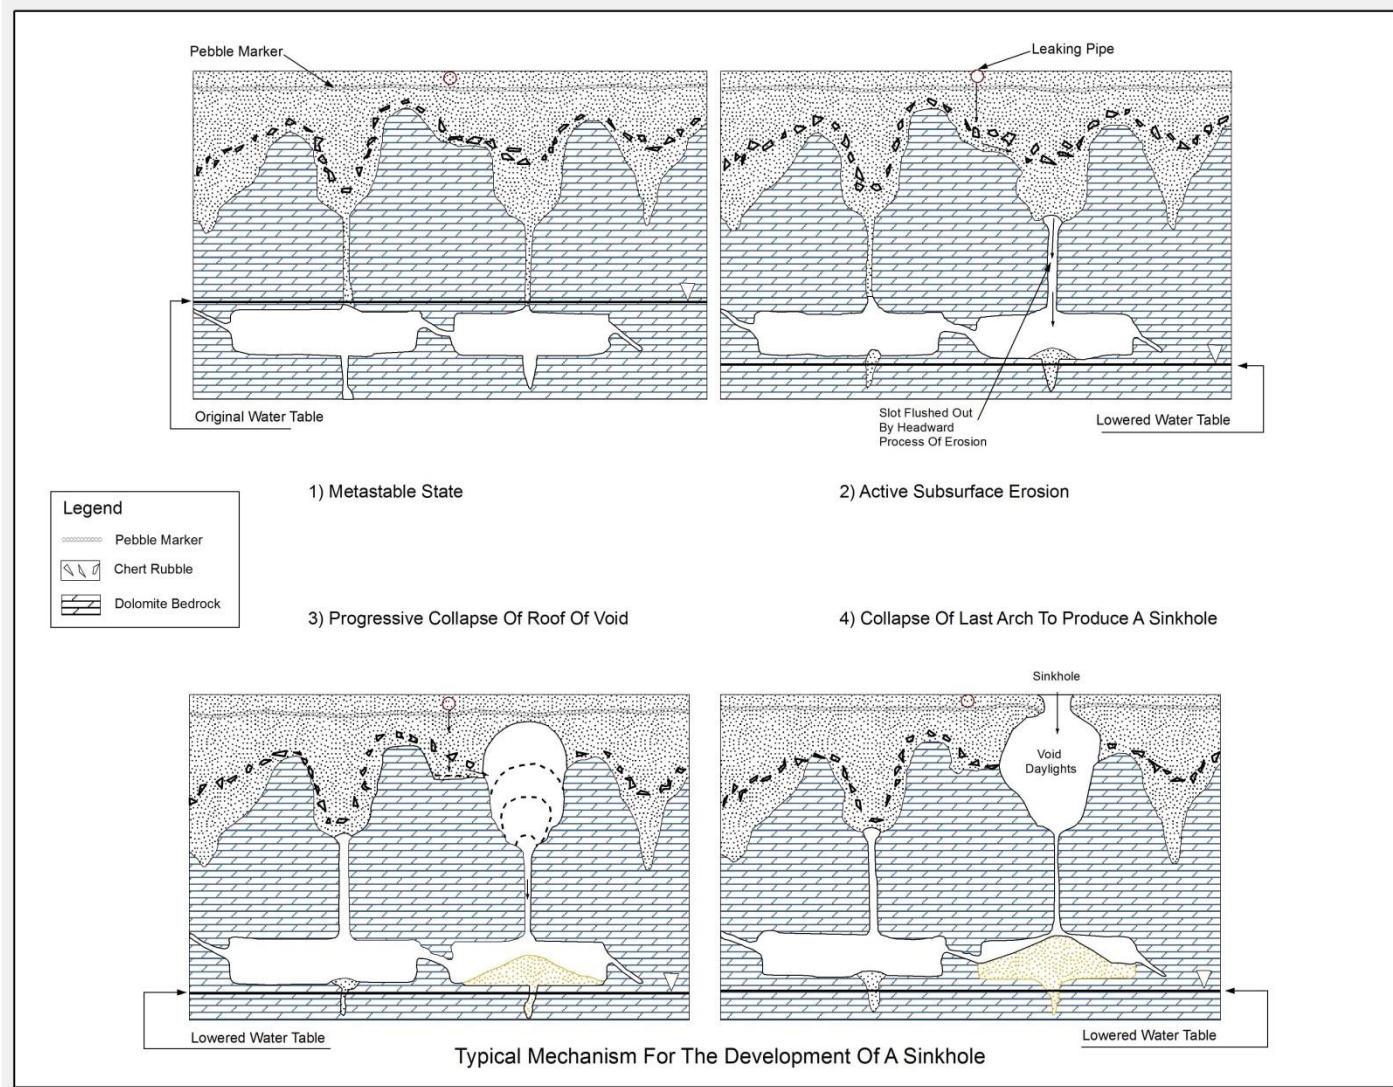
- Diagram 1: Cavities, which may be in a metastable state, exist within bedrock or the overburden.

Figure 6: Mechanism of Sinkhole Formation (modified after Jennings *et. al.*, 1965)

- Diagram 2: Active subsurface erosion caused by concentrated ingress water will result in transportation (mobilization) of materials downwards into the nearest underlying cavity or cavities (receptacles) in or above the dolomite bedrock.

The mechanism of sinkhole formation as described by Jennings *et al.* (1965) and Brink (1979) is illustrated in Figure 6 and may be summarised as follows (Council for Geoscience, 2003):

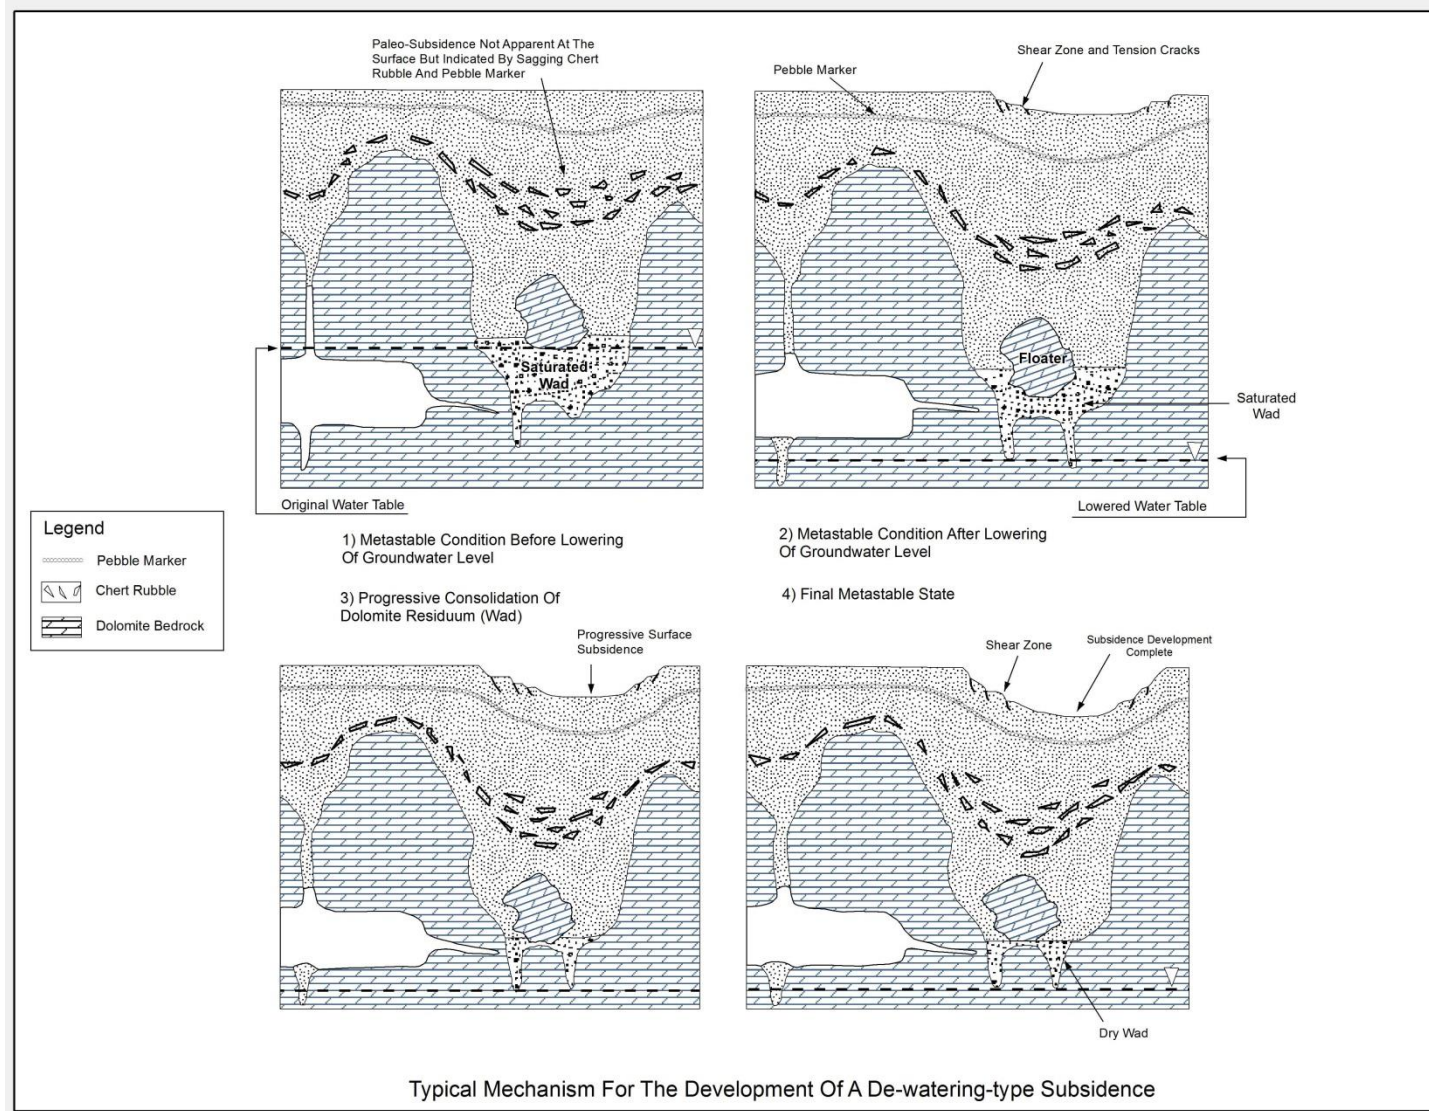
- An area underlain by compressible dolomitic residuum material at relatively shallow depth with the groundwater level within or below the compressible material. The movement of the groundwater level does not play a role in ground-surface movement.
- The surface materials are saturated owing to poor water management, i.e. poor drainage or a leaking wet-service.
- The wetting front penetrates the surface material and reaches the low-density material.
- A surface depression occurs gradually due to the mobilisation of the deeper low density materials which then settle into a dense state (saturation driven), causing the overlying soils to migrate downwards in the subsurface profile to take up the gap left by the material that has settled to the denser state. The movement will generally decrease rapidly when the cause of wetting is stopped.

Figure 7: Mechanism of dewatering-type subsidence formation (modified after Jennings *et. al.*, 1965).

- The size of the feature depends on the profile underlying the saturated area, i.e. the thickness, nature and depth of the near surface and deeper low-density materials, the configuration and depth of the bedrock dolomite and the extent of the saturation (e.g. the extent of the area covered by water, the volume of the water and the length of the period during which saturation occurs).

A dewatering-type subsidence occurs gradually and typically manifests itself as a large, enclosed depression. The mechanism of this type of subsidence formation is illustrated in Figure 7 and summarised as follows (SANS 1936, 2012):

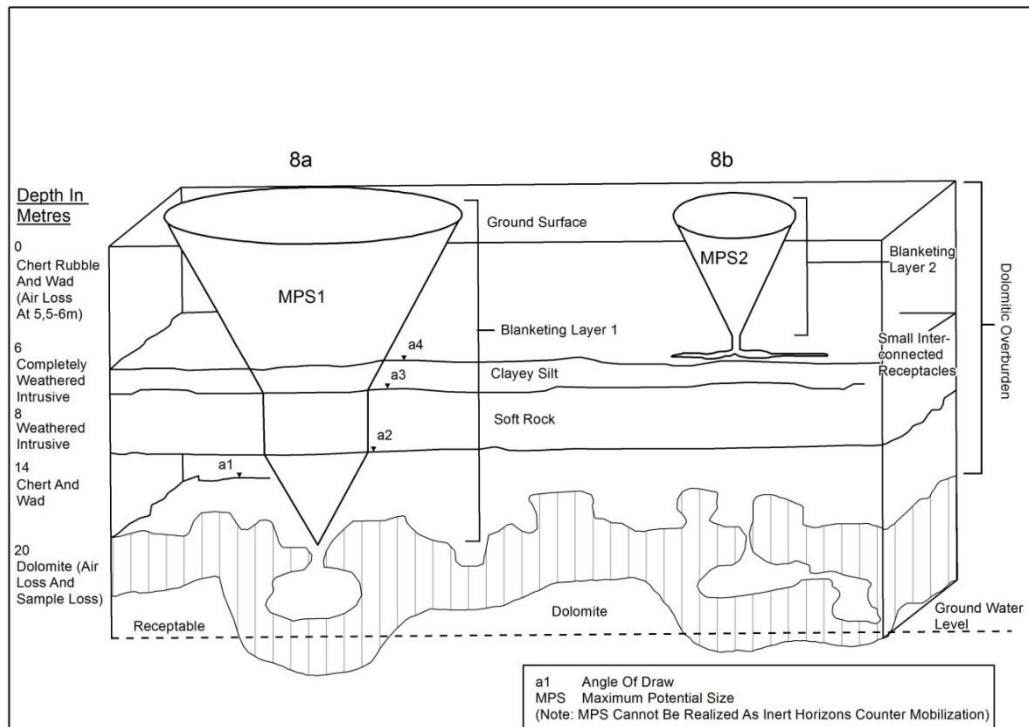
Figure 8: Schematic Three-dimensional Model Showing Various Components Of Dolomite Land (after Buttrick, 1992)

Figure 8 displays this concept schematically. The depth to the potential receptacle is obtained from borehole information and the radius of the potential development space on surface is obtained by a simplified diagrammatic construction. The 'angle of draw' of the various materials and the depth of the receptacle, are used to project and estimate the radius.

In reality, the receptacle may be too small to accommodate the mobilized and hence potential development space may not be fully utilized (Figure 8). In such an instance, where a profile is characterised by receptacles of an inadequate volume, the maximum size sinkhole will be smaller than the potential development space. As there is no efficient technique available at present to ascertain the volume of receptacles, it must be assumed that receptacles of adequate volume are present. It must be emphasized that the potential development space represents the maximum space available in the profile for a sinkhole.

Figure 8(a) depicts a profile with a deep groundwater level situated within the bedrock. The blanketing layer and hence the potential 'development space' are fully exposed to the potential activities of extraneous mobilizing agencies. This figure also depicts a significant layer of intrusive material with a low mobilization potential. This horizon acts as either an aquitard or an aquiclude that prevents mobilization and movement of material into the receptacle. The material within the 'development space' is thus protected from the mobilization agency.

Figure 8(b) reveals the presence of potential disseminated receptacles above the intrusive horizon displaying the low mobilization potential, a smaller potential development space is thus available for exploitation by a mobilizing agency.

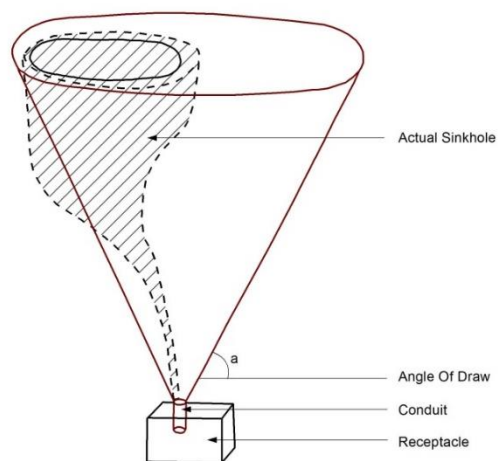
Figure 9: Maximum Potential Development Space Is Not Fully Utilized (after Buttrick, 1992)

The `maximum potential development space` is a simplified estimation of the maximum size sinkhole that can be expected to develop in a particular profile, provided that the available space is fully exploited by a mobilizing agency (Figure 9).

Realization of the full sinkhole may occur in stages, including an initial catastrophic event when it 'daylights', followed by the growth of the feature owing to slip failures and raveling along the side walls. This process will continue until a metastable state is achieved. The sinkhole could potentially grow until it fully utilizes the limits defined by the potential development space (Figure 9).

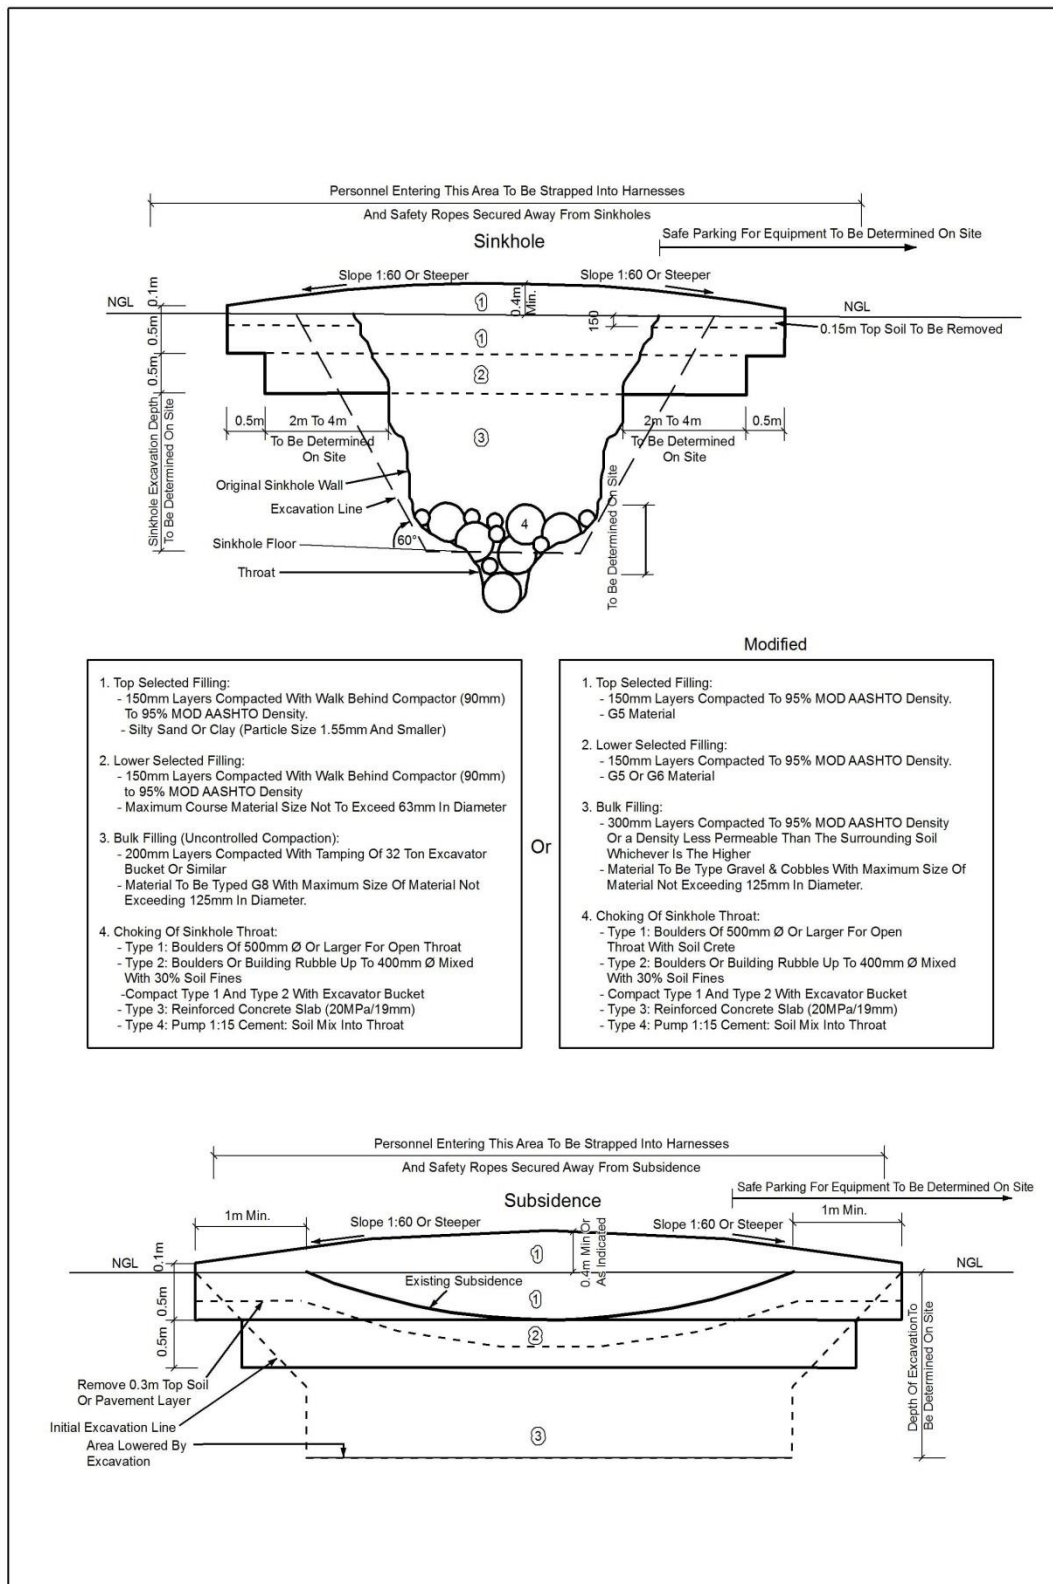
- Bulk excavation of the sinkhole or subsidence area extending 2 m to 4 m beyond the outer perimeter of the sinkhole or subsidence, with a 1 m deep margin at the surface, extending from the initial excavation outward. The depth of excavation will be based on the subsurface conditions encountered during the dolomite stability investigation. The sidewalls of the excavation should be excavated at 60 Degrees to the horizontal or at 45 Degrees (V:H 1:1) where poor subsurface soils like residual dolomite (wad) is encountered in the subsurface profile during investigations.
- Choking the throat of the sinkhole with:
  - Boulders of 500 mm and larger (no fines allowed) with or without a 3% cement soilcrete mix or,
  - Building rubble (not exceeding 400 mm diameter (excluding tin, wood or other degradable materials) with a mixture of fines not exceeding 30% of mix) or;

Figure 11: Inverted Filter Method of Rehabilitation (modified after PW344, 2010).

- Mass concrete (Pump 1:15 cement:soil mix) in throat or;
- Reinforced concrete slab (20 MPa/19 mm) or;
- A combination of all these solutions.

A schematical presentation of the Inverted Filter Method used to rehabilitate a sinkhole and a subsidence is illustrated in Figure 11.

The rehabilitation of a sinkhole or a subsidence by means of the Inverted Filter Method will typically comprise of the following operations (PW344, 2010):

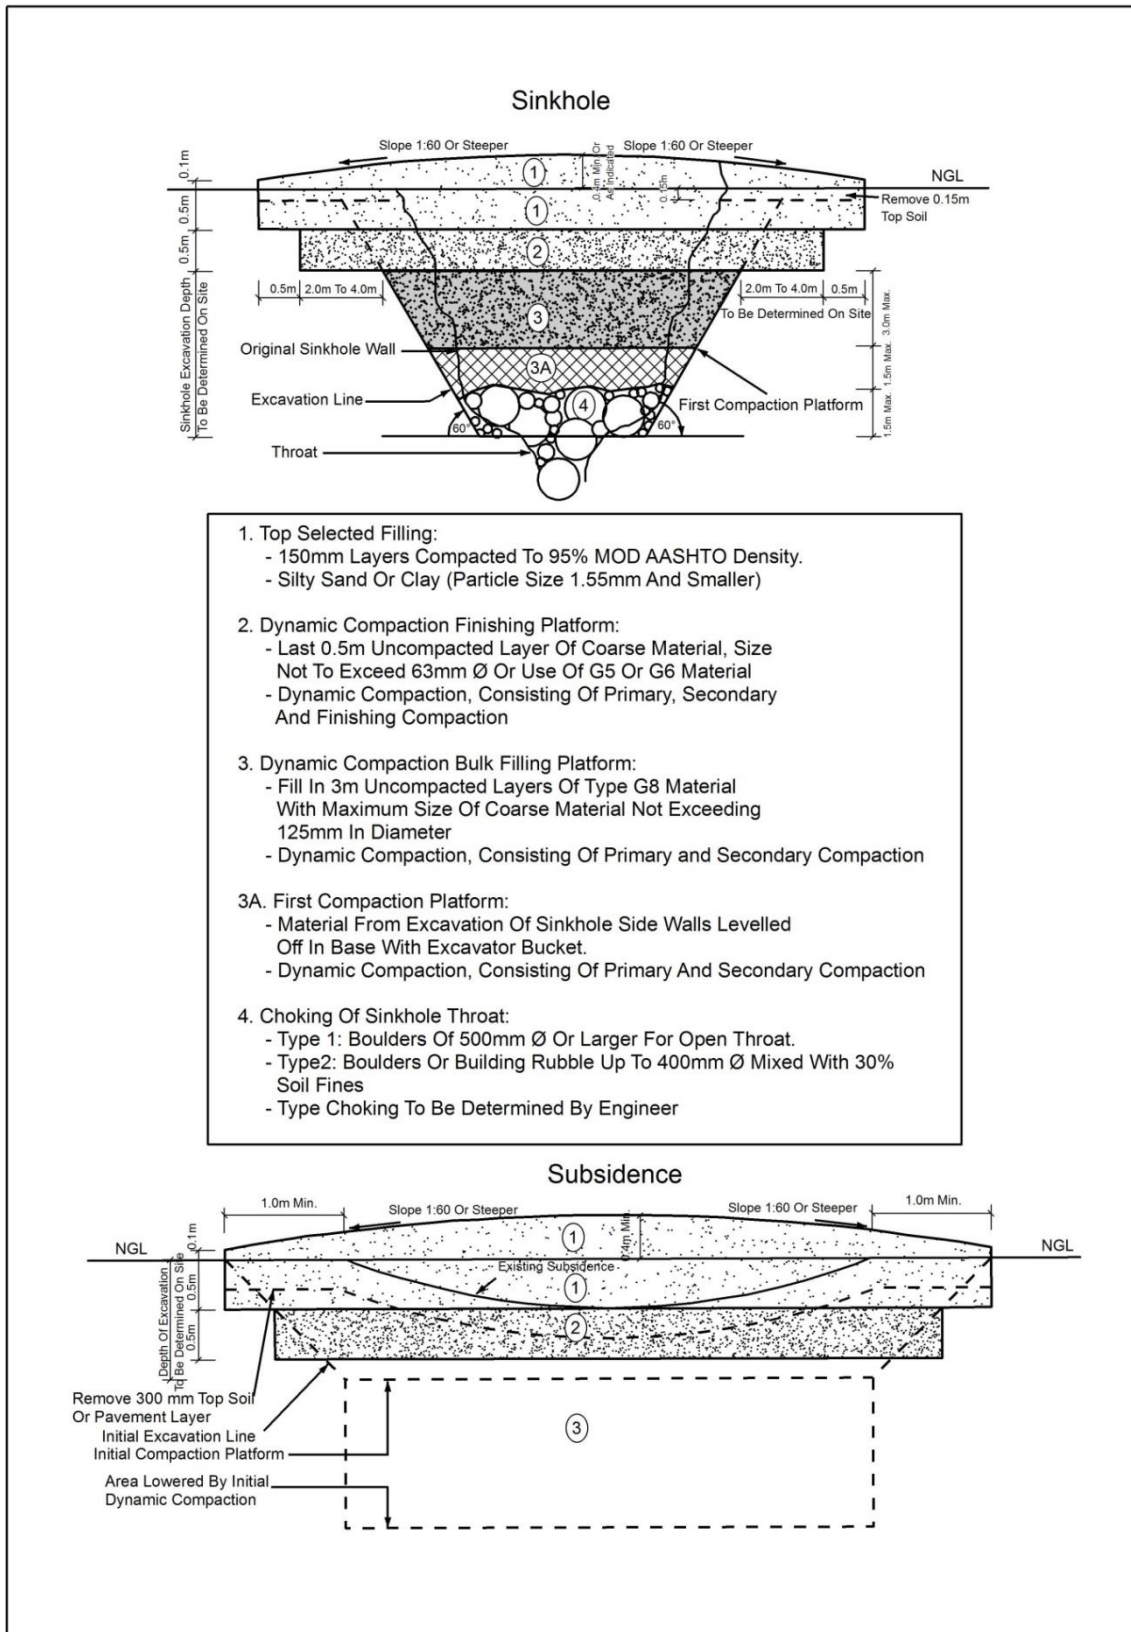
Figure 13: Dynamic Compaction Rehabilitation Method (after PW344, 2010).

A schematical presentation of the Dynamic Compaction Method used to rehabilitate a sinkhole and a subsidence is illustrated in Figure 13.

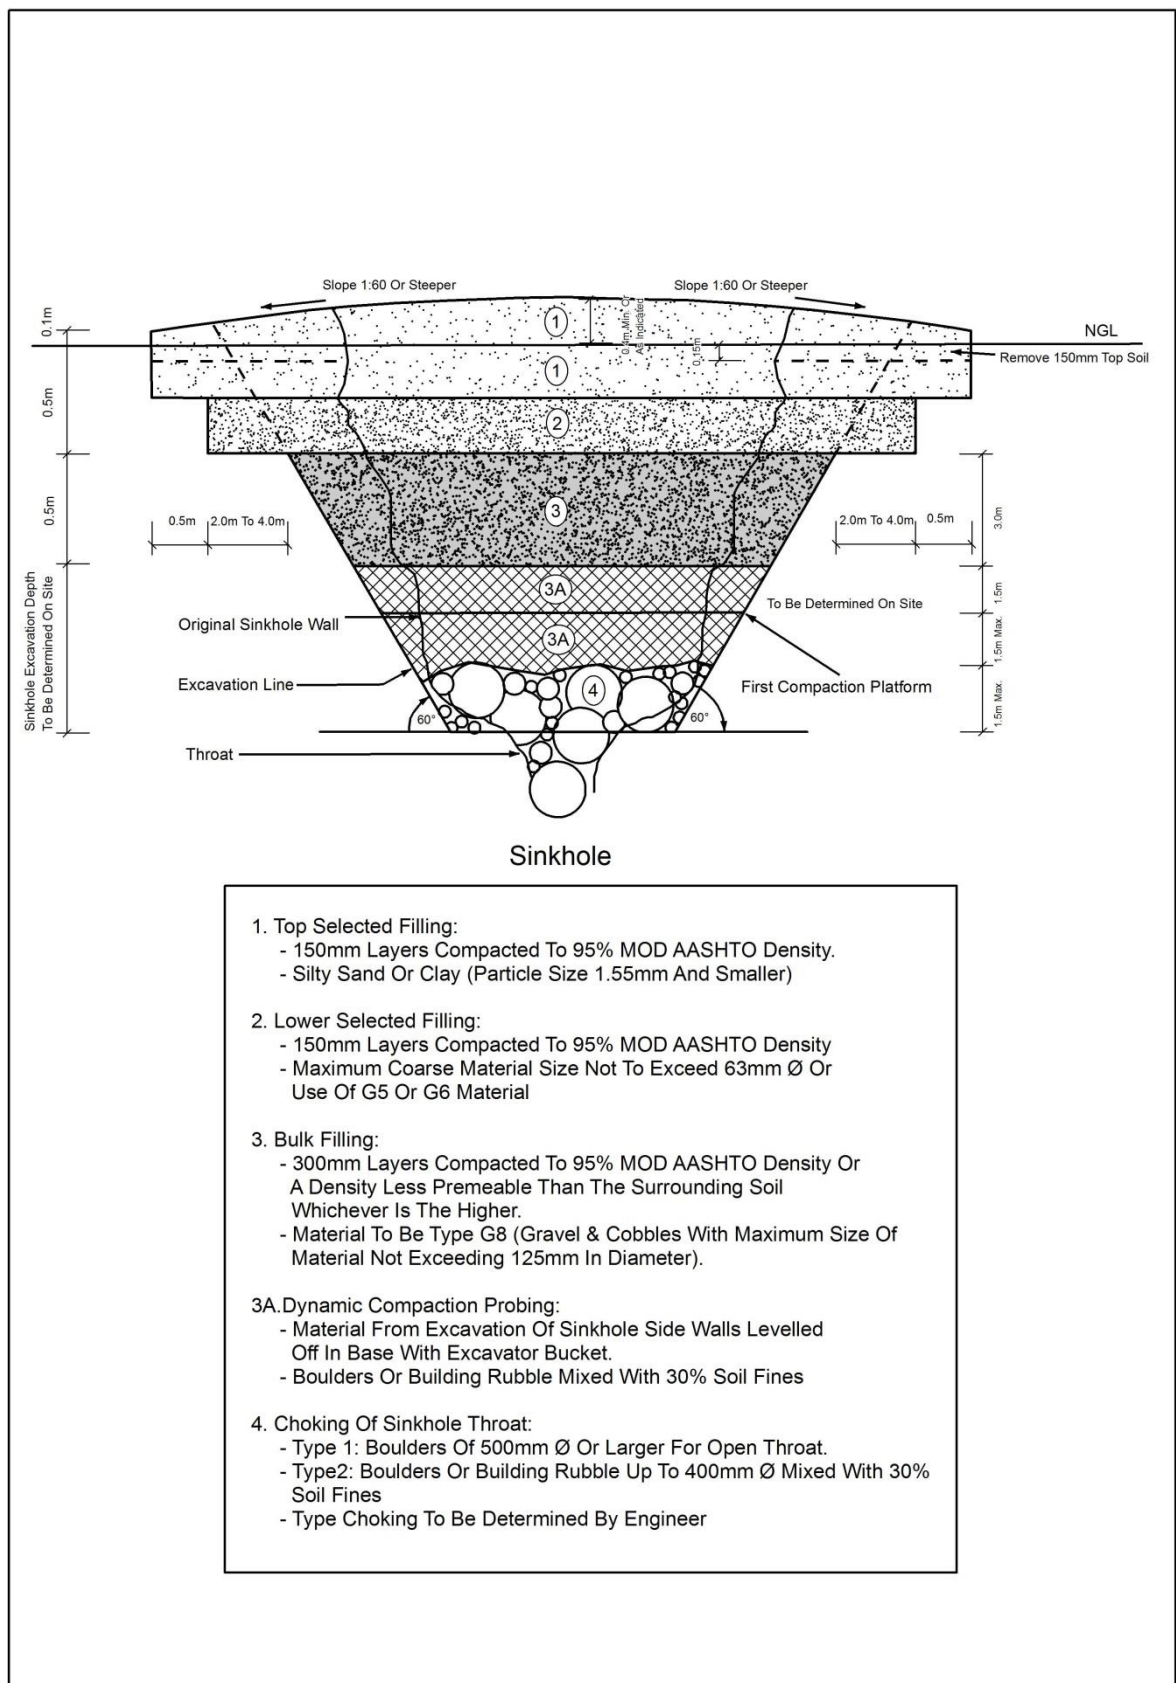
- Bulk excavation of the sinkhole or subsidence area extending 2 m to 4 m beyond the outer perimeter of the sinkhole or subsidence, with a 1 m deep margin at the surface, extending from the initial excavation outward.

The depth of excavation will be based on the subsurface conditions encountered during the dolomite stability investigation, but will typically range between 4 m to 6 m below natural ground surface. The sidewalls of the excavation should be excavated at 60 degrees to the horizontal or at 45 Degrees (V:H 1:1) where poor subsurface soils like residual dolomite (wad) is encountered in the subsurface profile.

**Figure 14: Combined Dynamic Compaction and Inverted Filter Method of Rehabilitation (modified after PW344, 2010).**

- In the area of the sinkhole throat over excavate to the maximum reach of the excavator from a depth of the bulk excavated floor area, therefore over-excavated depth of 10 m to 12 m below natural ground surface.

A schematical presentation of a combination of the Dynamic Compaction Method and the Inverted Filter Method used to rehabilitate a sinkhole is illustrated in Figure 14.

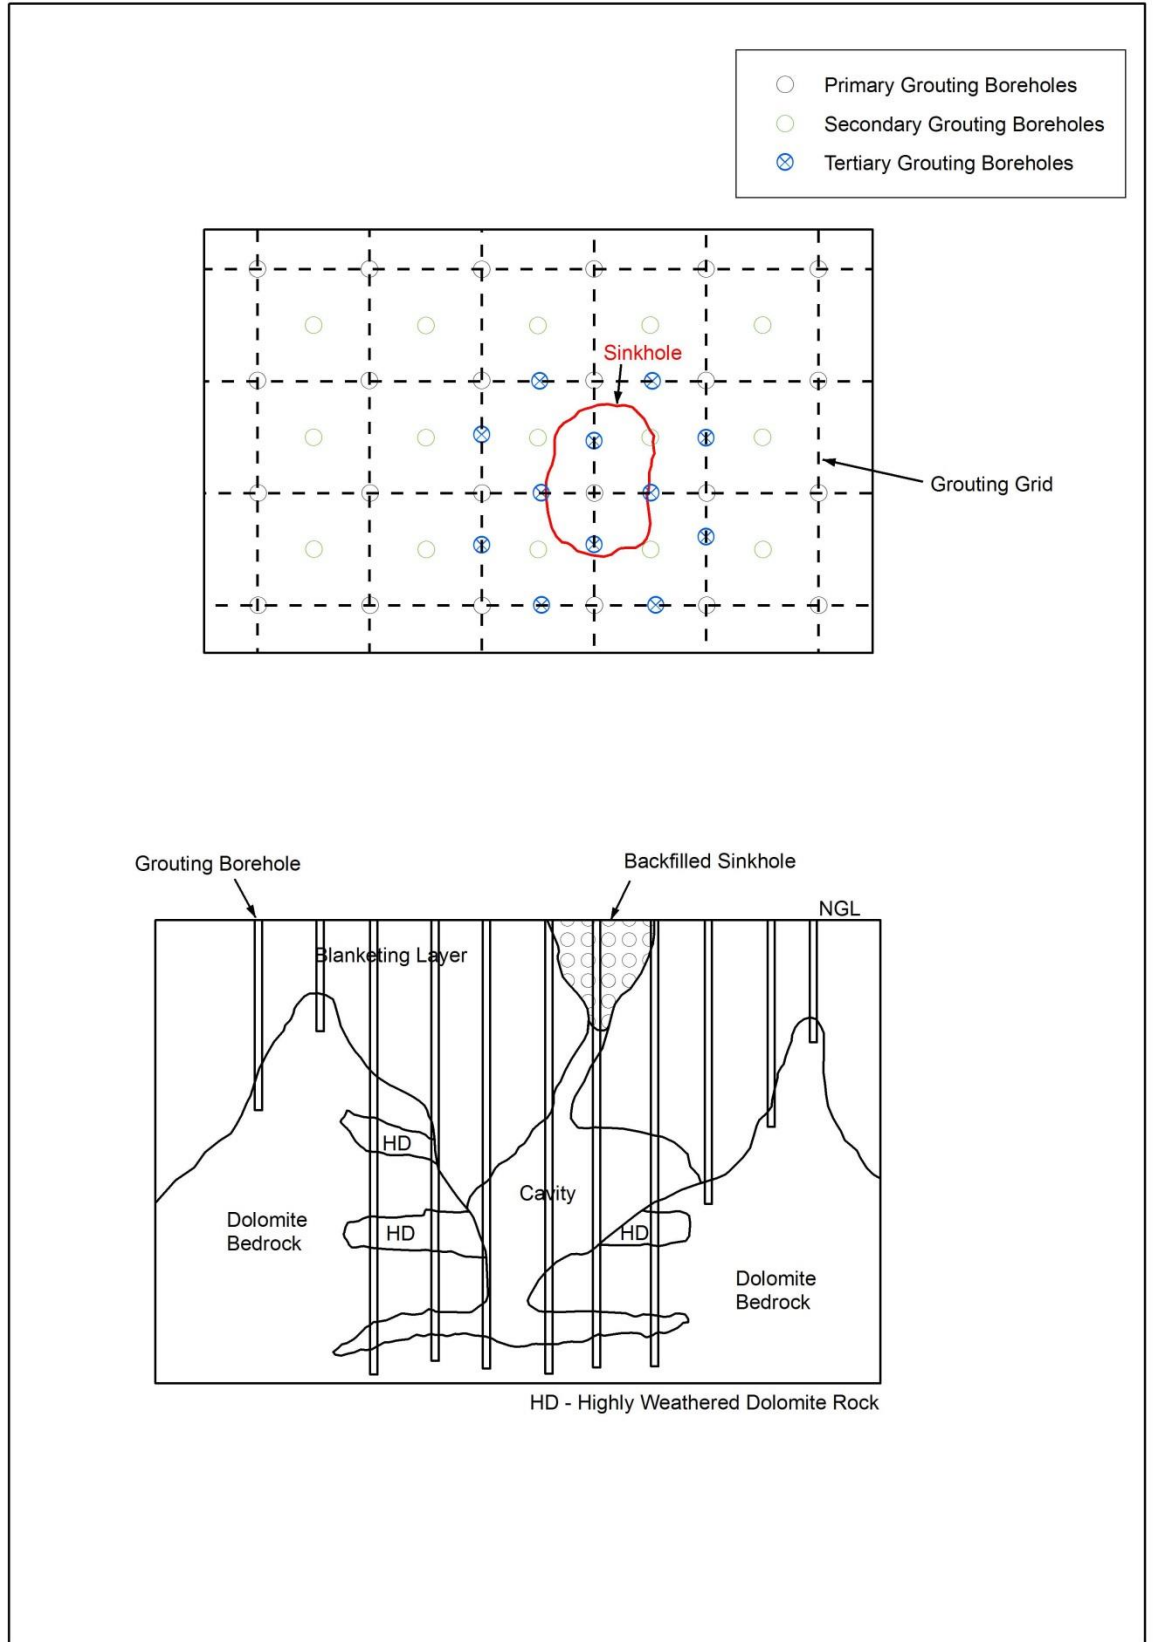
Figure 15: Schematic representation of a grouting grid to rehabilitate a sinkhole.

A schematic representation of a grouting grid comprising primary, secondary and tertiary grouting points to rehabilitate a sinkhole is illustrated in Figure 15.

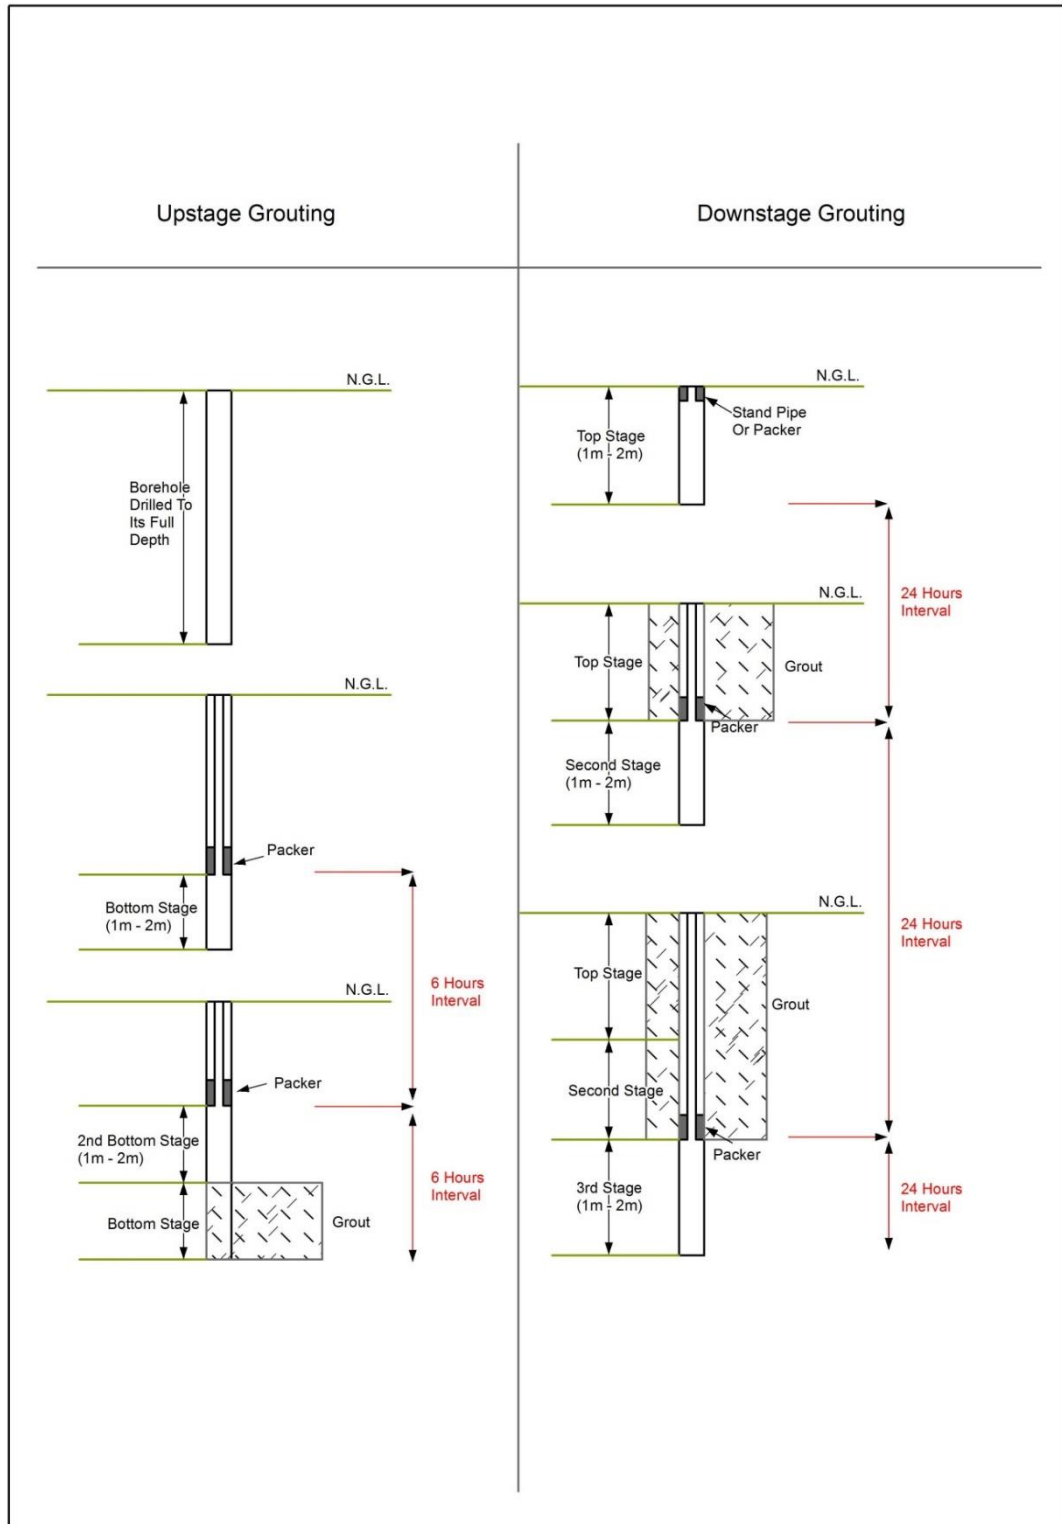
- Downstage Grouting (SANS 2001-BE3, 2012): Is used in unstable ground where collapse of the hole and air loss during drilling has prevented drilling the hole to the required depth in a single operation. In such cases, the hole is advanced through the unstable area in 1,0 m to 2,0 m stages that are then grouted and the grout allowed to set for at least 24 hours. The hole is then re-drilled and advanced to the depth of the next stage.

- Downstage and Upstage Grouting combined: A combination of upstage and downstage grouting is considered where for example the blanketing layer covering a cavity is thin and a stable working environment needs to be created first by downstage grouting, followed by upstage grouting of the balance of the stratum (Byrne *et al.*, 1995). In addition, much higher pressures can then be applied at depth to inject grout, due to the stable surficial environment created by downstage grouting.

Figure 16: Schematic representation of the upstage and downstage grouting method (after Water Resources Commission, NSW Australia, 1981).

A schematic representation of the upstage and downstage grouting method (after the Water Resources Commission, NSW Australia, 1981) is illustrated in Figure 16.

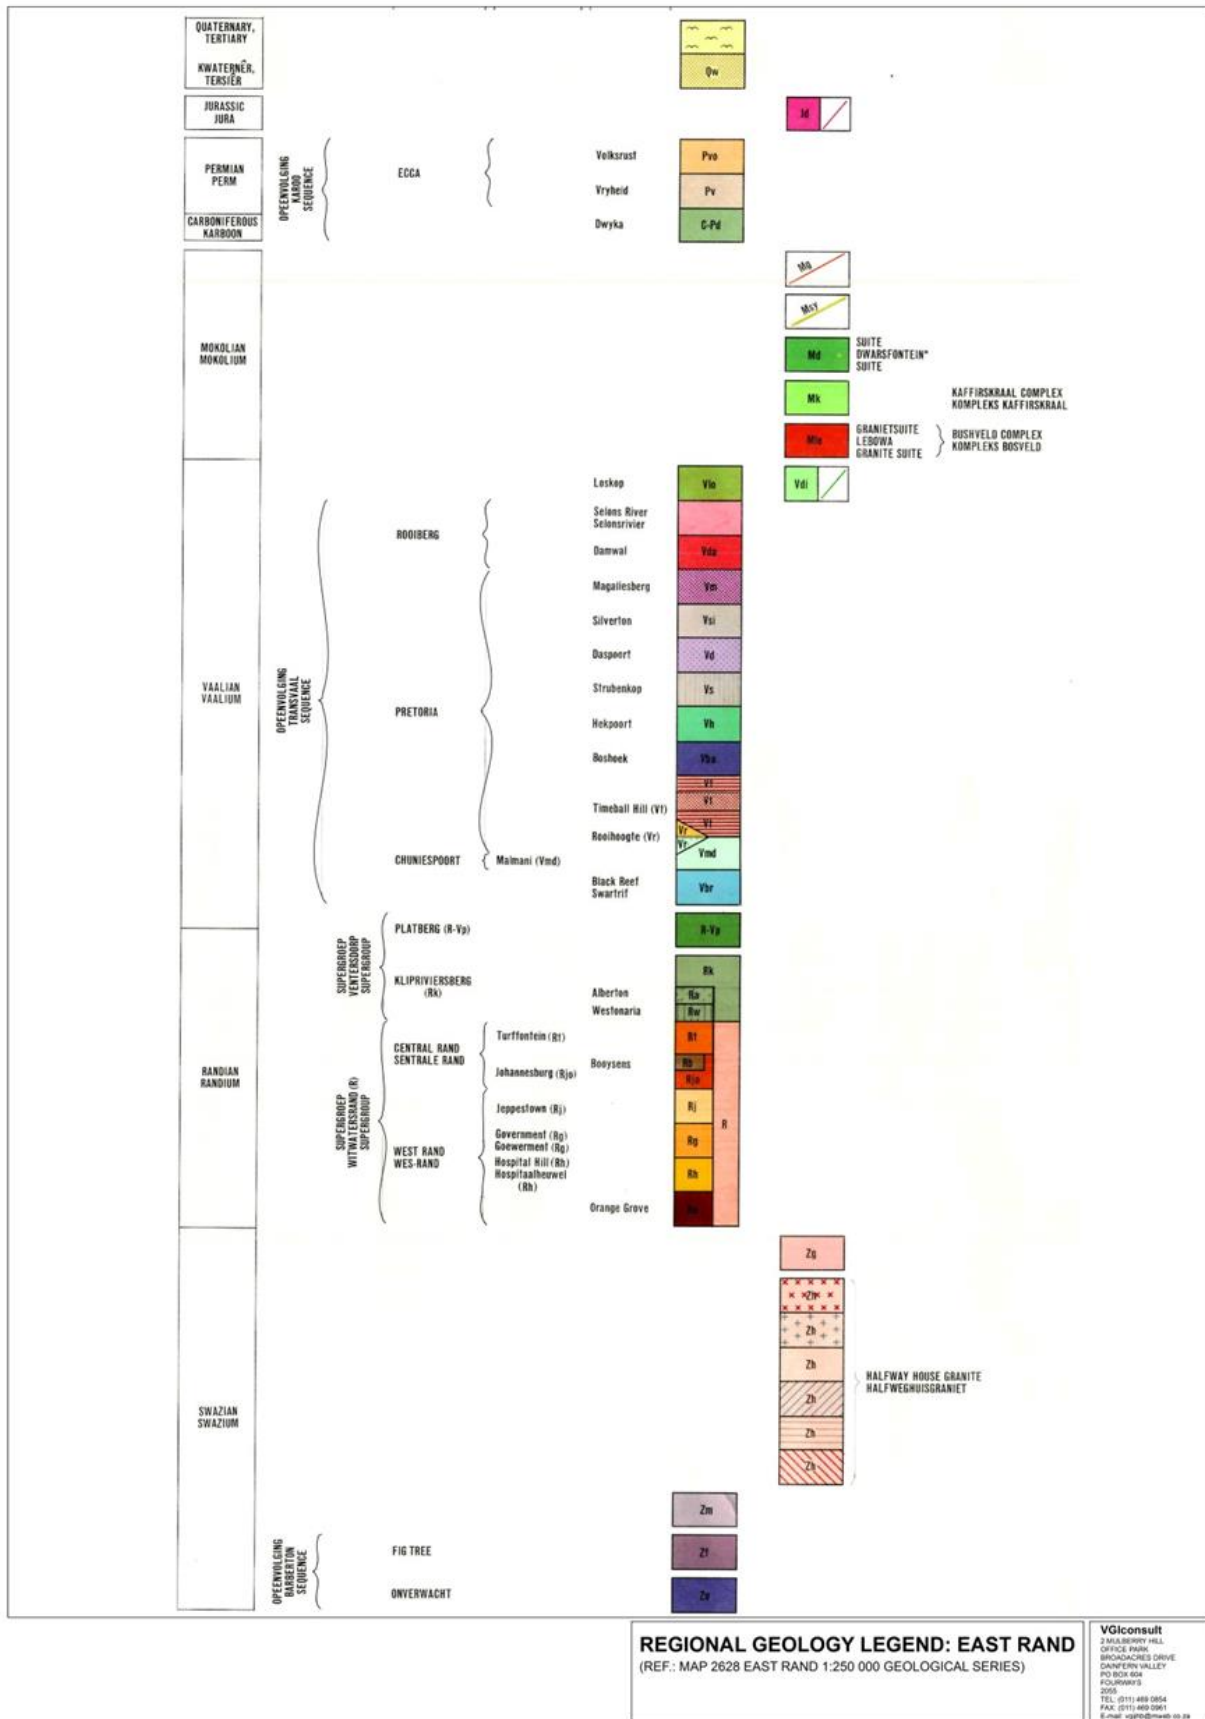
Figure 17: Published 1:250 000 geological maps of Pretoria (2528) (after Geological Survey of South Africa, 1978) and the East Rand (2628) (after Geological Survey of South Africa, 1986).

Figure 17: Regional Geology Legend - East Rand

The regional geology of the study area based on the 1:250 000 scale published geological map of Pretoria (2528) and the East Rand (2628) is indicated on Figure 17. The different Formations of the Malmani Subgroup are indicated on Figure 4.

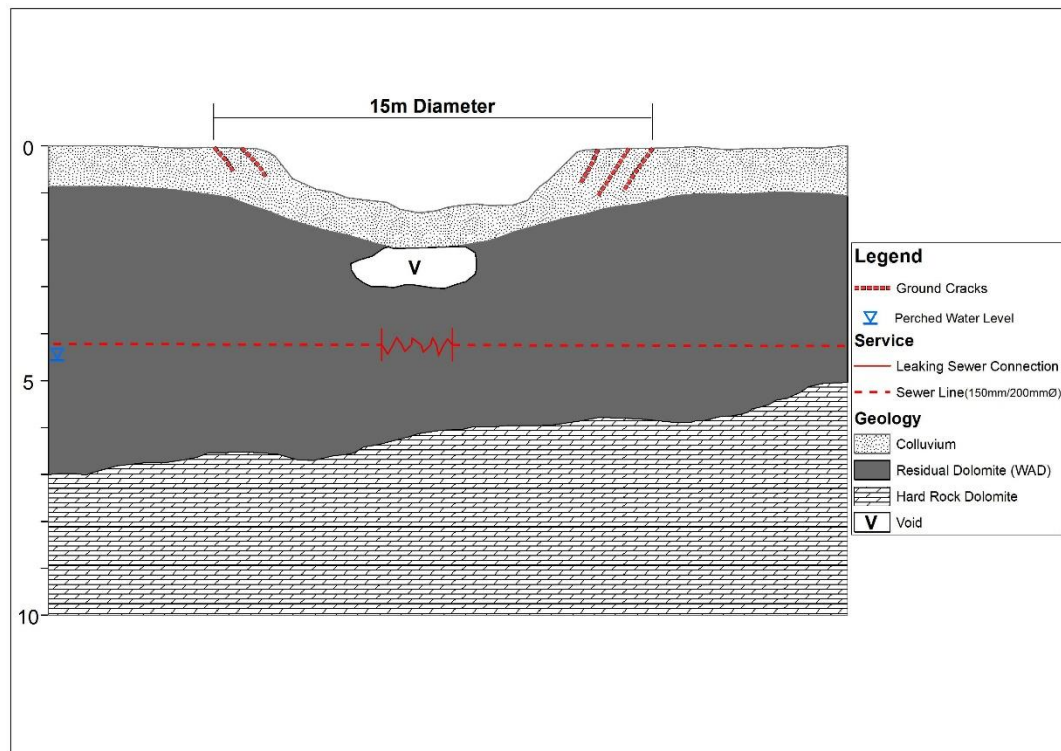
**Figure 26: Generic Geological Model 1**

The geological model is based on five percussion boreholes. Three boreholes were drilled within the subsidence area and two within the area of the demolished residential structure. The geological model is illustrated in Figure 26.

- Complexity: Simple, presenting a homogeneous profile.
- Blanketing Layer: Comprising a horizon of ferruginised colluvium (1 m) underlain by a horizon of 4 m to 6 m thick residual dolomite (wad), highly susceptible to subsurface erosion or consolidation. Void encountered.
- Dolomite bedrock: At a shallow depth of 5 m to 7 m. No cavities encountered.

- Groundwater Level: In dolomite bedrock. Perched groundwater table at a depth of approximately 4 m.

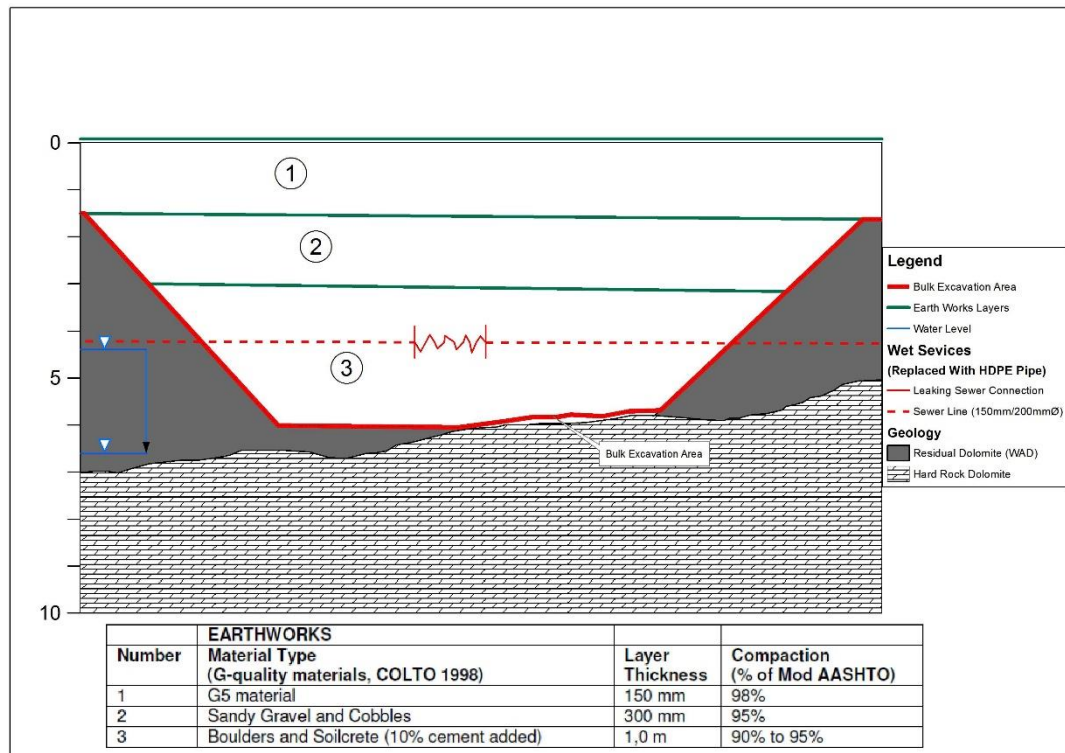
Figure 27: Recommended Rehabilitation Method Generic Geological Model 1

Inverted Filter Method: Refer to the Rehabilitation Model for various earthworks layers (Figure 27).

- Shallow dolomite bedrock, with residual dolomite (wad) highly susceptible to subsurface erosion or consolidation within maximum reach of an excavator.

As the house was demolished no access constraints for proposed and recommended rehabilitation method. The remaining profile below the excavated area comprises 1 m and less highly susceptible material.

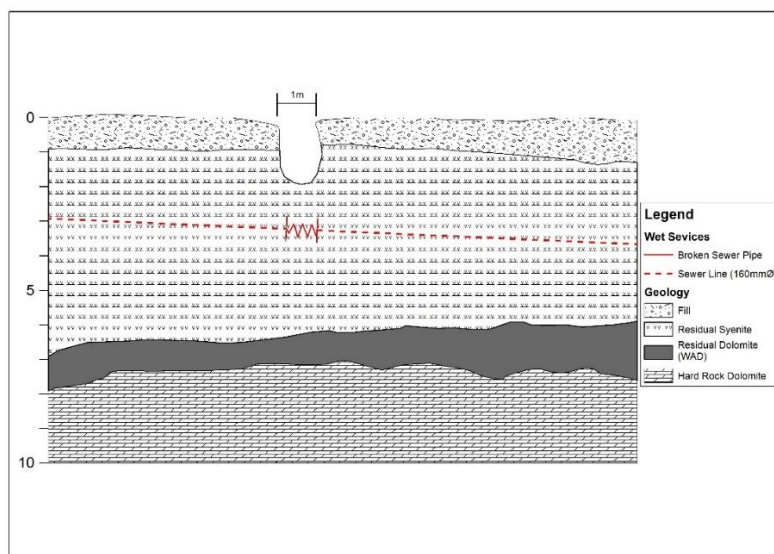
**Figure 29: Generic Geological Model 2**

The geological model is based on two percussion boreholes, positioned on both sides of the sinkhole in the road. The geological model is illustrated in Figure 29.

- Complexity: Simple, presenting a homogeneous profile.
- Blanketing Layer: Comprising a horizon of road fill (1 m) underlain by a horizon of low susceptible residual syenite (5 m to 6 m thick), followed at depth by a horizon of 1 m thick residual dolomite (wad) with a high susceptibility to subsurface erosion or consolidation. No voids encountered.
- Dolomite bedrock: At a shallow depth of 8 m. No cavities.
- Groundwater Level: In dolomite bedrock.

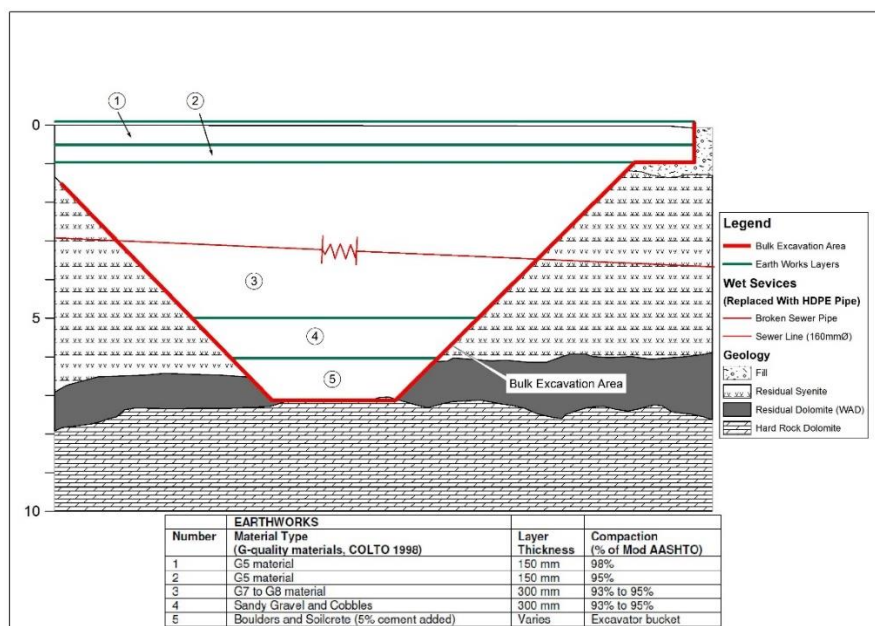
**Figure 30: Recommended Rehabilitation Method Generic Geological Model 2**

Inverted Filter Method: Refer to the Rehabilitation Model for various earthworks layers (Figure 30).

- Shallow dolomite bedrock, with a thin horizon (1 m) of residual dolomite (wad) highly susceptible to subsurface erosion within reach using an excavator and over-excavated trench of 1 m at base.

No access constraints for proposed and recommended rehabilitation method. The remaining profile below the excavated area comprising dolomite bedrock.

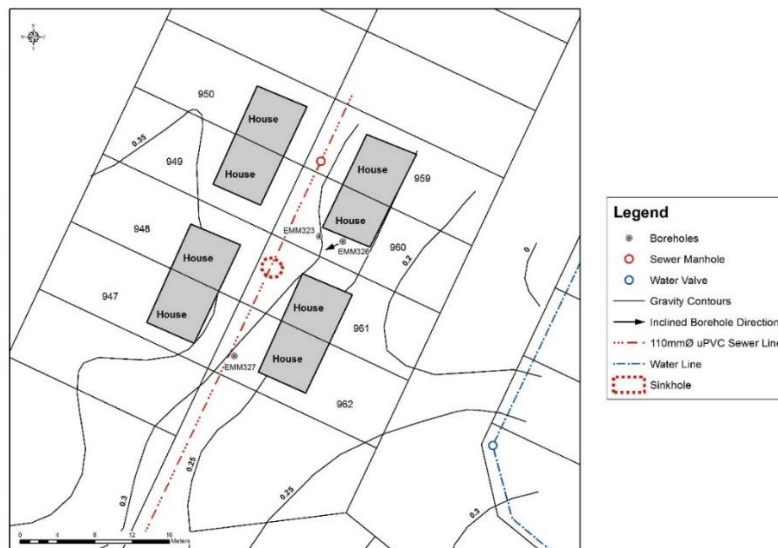
**Figure 31: Plan View of Generic Geological Model 3.**

A sinkhole of 2 m diameter size extending to a depth of 2 m occurred on the boundary between Stand 948 and Stand 961 (Buttercup Close Road), Rondebult, during January 2009 (Report No. VGI3118/201/2). The affected area, existing infrastructure and the positions of boreholes are displayed in Figure 31.

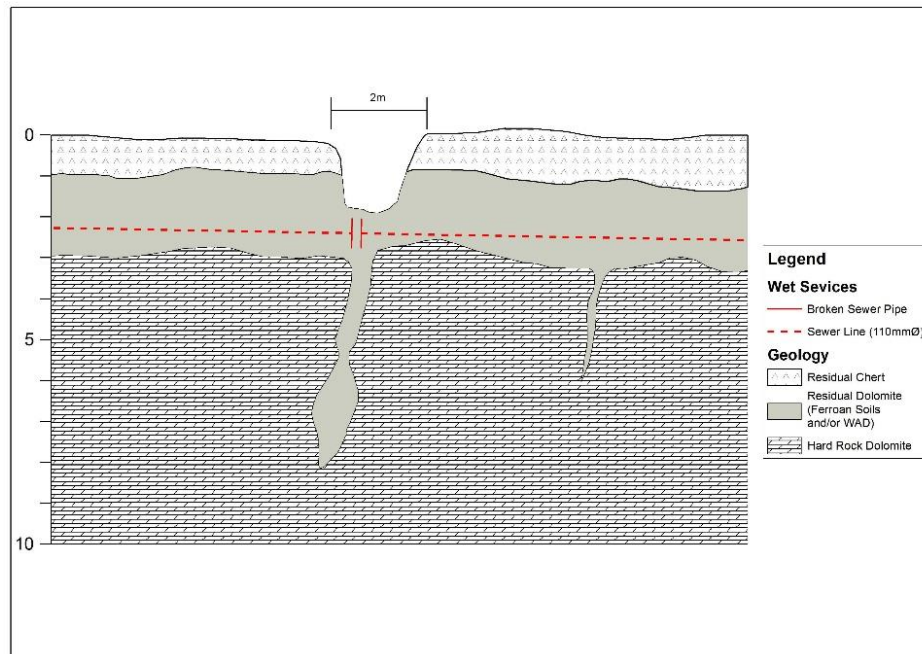
**Figure 32: Generic Geological Model 3.**

The geological model is based on three percussion boreholes, positioned in the area surrounding the sinkhole and between houses. The position of existing houses made it difficult to place more boreholes. The geological model is illustrated in Figure 32.

- Complexity: Simple, presenting a homogeneous profile.
- Blanketing Layer: Comprising a horizon of residual chert (1 m) underlain by a horizon of 2 m thick residual dolomite (wad and ferroan soils) with a high susceptibility to subsurface erosion or consolidation. No voids encountered.
- Dolomite bedrock: At a shallow depth of 3 m with 1 m grykes and smaller, extending to a depth of approximately 8 m. No cavities.
- Groundwater Level: In dolomite bedrock.
