**REHABILITATION OF SINKHOLES AND  
SUBSIDENCES ON DOLOMITIC LAND,  
EKURHULENI METROPOLITAN MUNICIPAL AREA  
OF JURISDICTION, GAUTENG, SOUTH AFRICA**

**Submitted in partial fulfilment of the  
requirements for the degree of Doctor of  
Philosophy in the Faculty of Natural and  
Agricultural Sciences**

**UNIVERSITY OF PRETORIA**

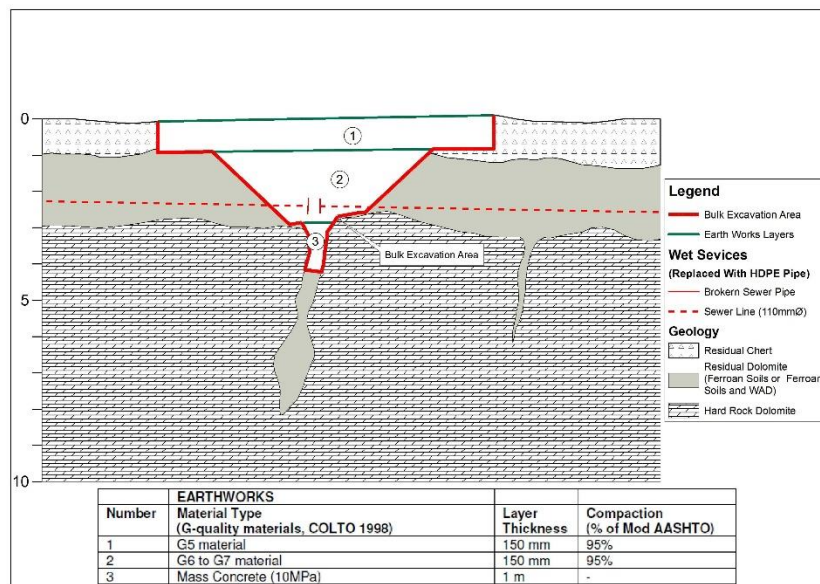
**Figure 33: Recommended Rehabilitation Method Generic Geological Model 3.**

Layer works:

The 2 m thick horizon of residual dolomite (wad and ferroan soils) that accommodated subsurface erosion needed to be removed and replaced by more competent material. The dolomite profile after rehabilitation presents a profile with a low susceptibility for sinkhole or subsidence formation.

Inverted Filter Method: Refer to the Rehabilitation Model for various earthworks layers (Figure 33).

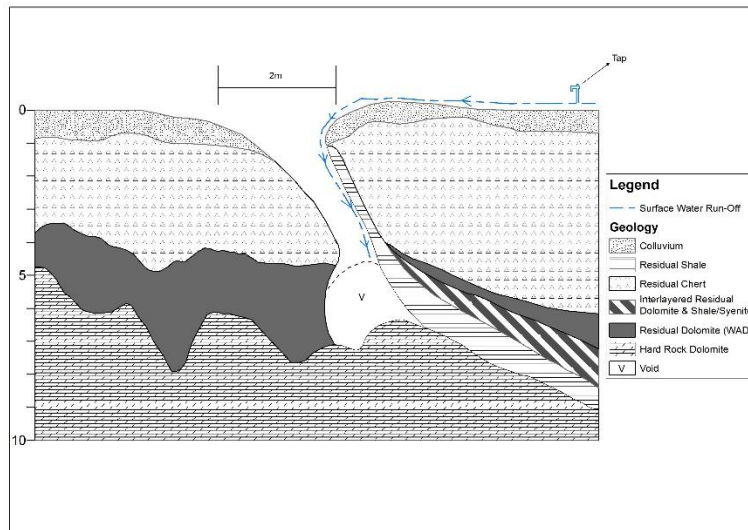
**Figure 38: Generic Geological Model 5.**

The geological model is based on a gravity survey (10 m station interval), drilling of two percussion boreholes and bulk excavation of the affected area. The geological model is illustrated in Figure 38.

- Complexity: Intermediate to complex, with horizontal and sub-vertical orientated horizons.
- Blanketing Layer: Comprising a horizon of colluvium (1 m) underlain by a horizon of residual chert (3 m to approximately 6 m thick) in turn underlain by 1 m to 3 m residual dolomite (wad), highly susceptible to subsurface erosion or consolidation and a less than 1 m thick horizon of interlayered residual dolomite (wad) and shale in sub-areas. A sub-vertical to vertical shale horizon cuts through the profile. Void encountered.
- Dolomite bedrock: At a shallow depth of 5 m to 8 m.
- Groundwater Level: In dolomite bedrock.

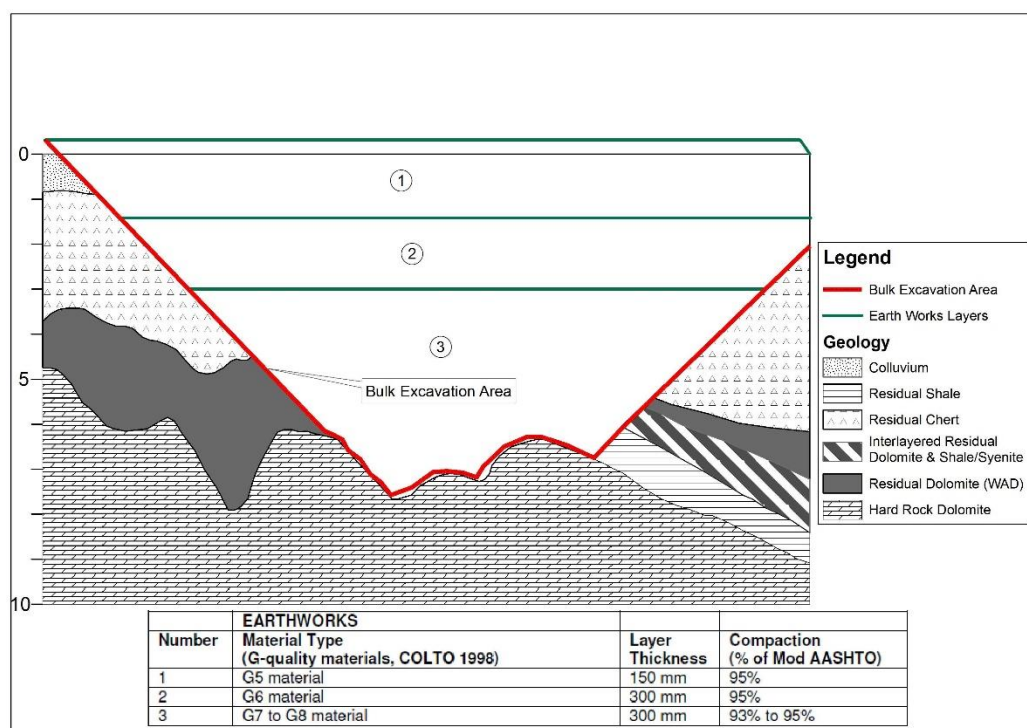
**Figure 39: Recommended Rehabilitation Method Generic Geological Model 5.**

Inverted Filter Method: Refer to the Rehabilitation Model for various earthworks layers (Figure 39).

- Shallow dolomite bedrock, with residual dolomite (wad) highly susceptible to subsurface erosion or consolidation within maximum reach of an excavator.

As the houses were demolished the recommended rehabilitation method were not affected by access constraints. Remaining profile below excavated footprint area comprising dolomite bedrock.

Rebuilding of low cost houses each placed on a reinforced concrete raft foundation, catering for a loss of support of 5 m diameter. The rehabilitated profile, of low susceptibility to mobilisation and erosion is deemed suitable for residential single storey structures. For more information related to a similar geological and rehabilitation model refer to Case Study 4.

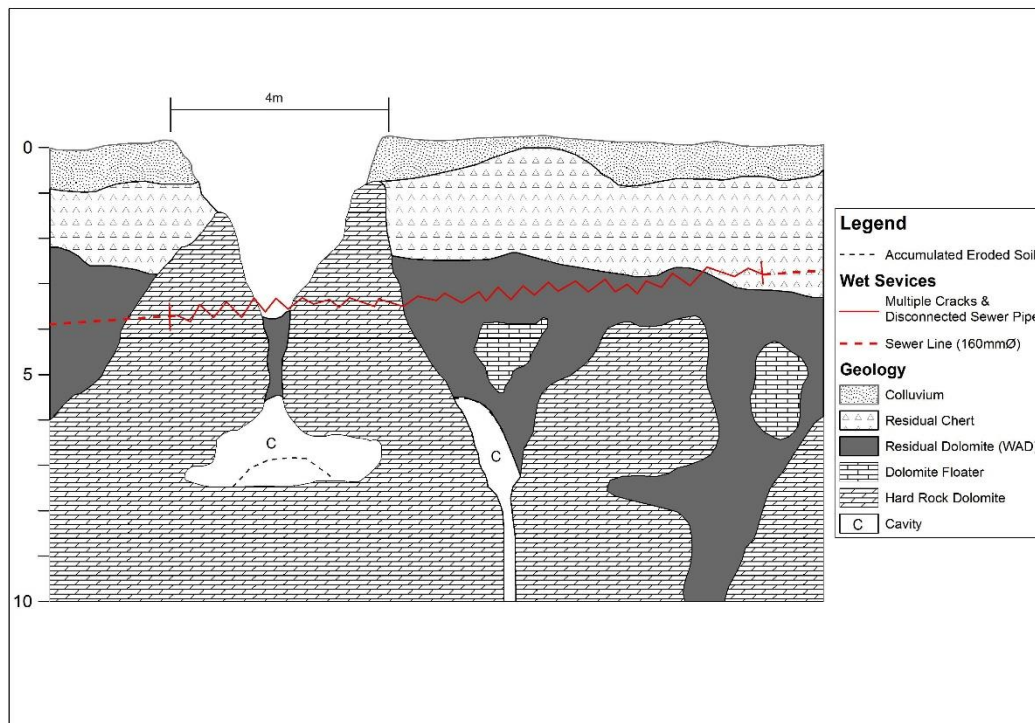
**Figure 41: Generic Geological Model 6.**

The geological model is based on a gravity survey (10 m station interval), three percussion boreholes drilled to the south of the sinkhole, a number of DPSH tests and bulk excavation of the affected area. The geological model is illustrated in Figure 41.

- Complexity: Complex, due to a highly variable bedrock profile.

- Blanketing Layer: Comprising a horizon of colluvium (1 m) underlain by a horizon of residual chert (1 m to 2 m thick), followed at depth by a horizon of 4 m to 6 m thick residual dolomite (wad) with 1 m to 2 m diameter dolomite floaters, highly susceptible to subsurface erosion or consolidation. Voids encountered.
- Dolomite bedrock: Pinnacled dolomite bedrock from a depth of 1 m to 8 m, adjoining v-shaped grykes. Cavities present.
- Groundwater Level: In dolomite bedrock.

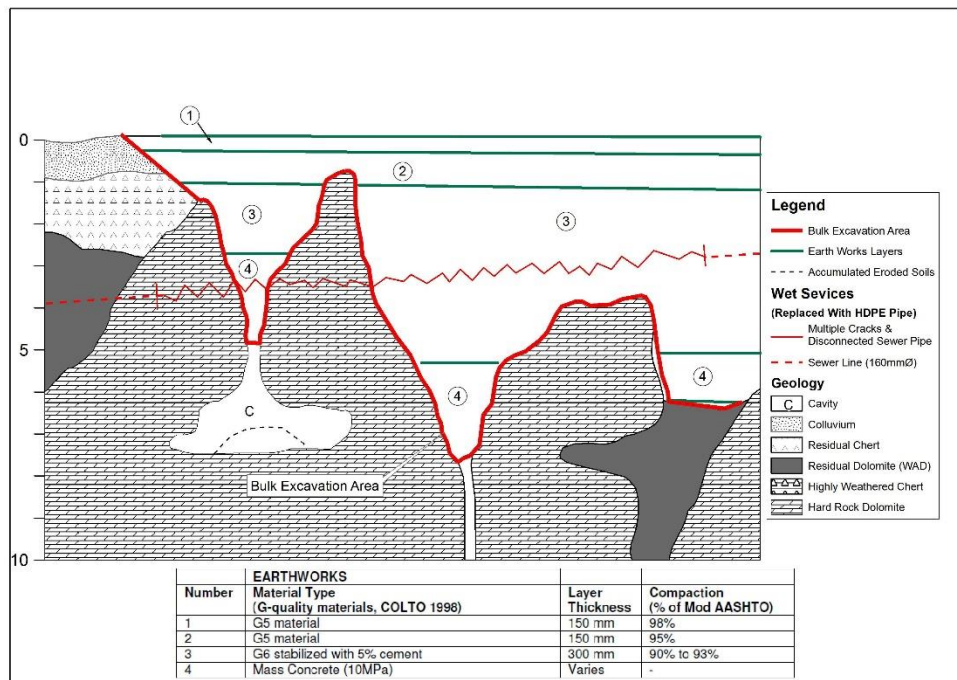
Figure 42: Recommended Rehabilitation Method Generic Geological Model 6.

Inverted Filter Method: Refer to the Rehabilitation Model for various earthworks layers (Figure 42). The entire sewer line was replaced with a HDPE butt welded pipe from manhole to manhole, over a distance of approximately 100 m and construction of new HDPE manholes.

- Shallow pinnacle dolomite bedrock with v-shaped grykes between pinnacles filled with residual dolomite (wad) and voids, highly susceptible to subsurface erosion within maximum reach of an excavator.

No access constraints. Remaining profile below excavated area comprising residual dolomite (wad) along grykes between pinnacle dolomite bedrock.

As the area presented a number of voids and cavities which could lead to the formation of more sinkholes, the above mentioned rehabilitation method was required to ensure all receptacle areas were sealed and highly susceptible residual dolomite (wad) removed and replaced with competent material to create an earth mattress suitable for the construction of a road.

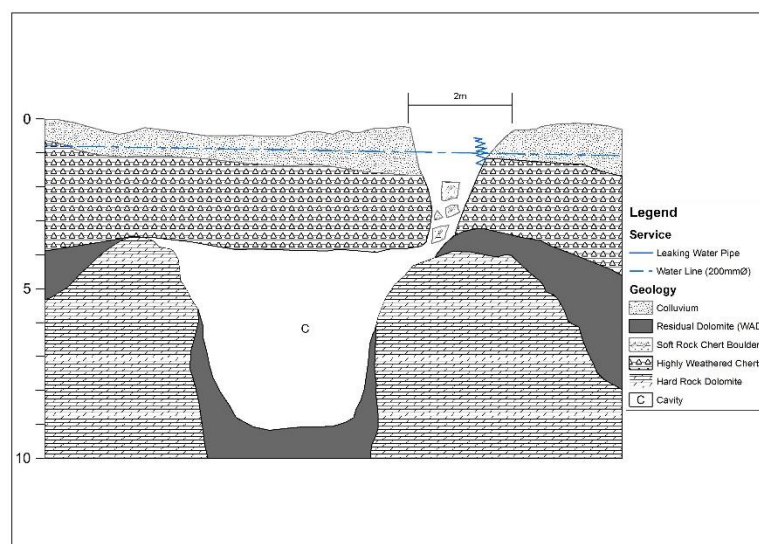
**Figure 44: Generic Geological Model 7.**

above the void. The geological model is illustrated in Figure 44.

- Complexity: Complex, due to competent horizons above problematic horizons.
- Blanketing Layer: Comprising a horizon of colluvium (1 m) underlain by a horizon of highly weathered soft rock chert (3 m thick) followed at depth by a horizon of 1 m to 3 m thick but up to 10 m thick in subareas residual dolomite (wad), highly susceptible to subsurface erosion or consolidation. Large void (6 m diameter and 6 m high) encountered in residual dolomite (wad) below soft rock chert.
- Dolomite bedrock: At a depth of 4 m on both sides of the void extending to a depth of more than 10m in the central portion of void area.
- Groundwater Level: In dolomite bedrock.

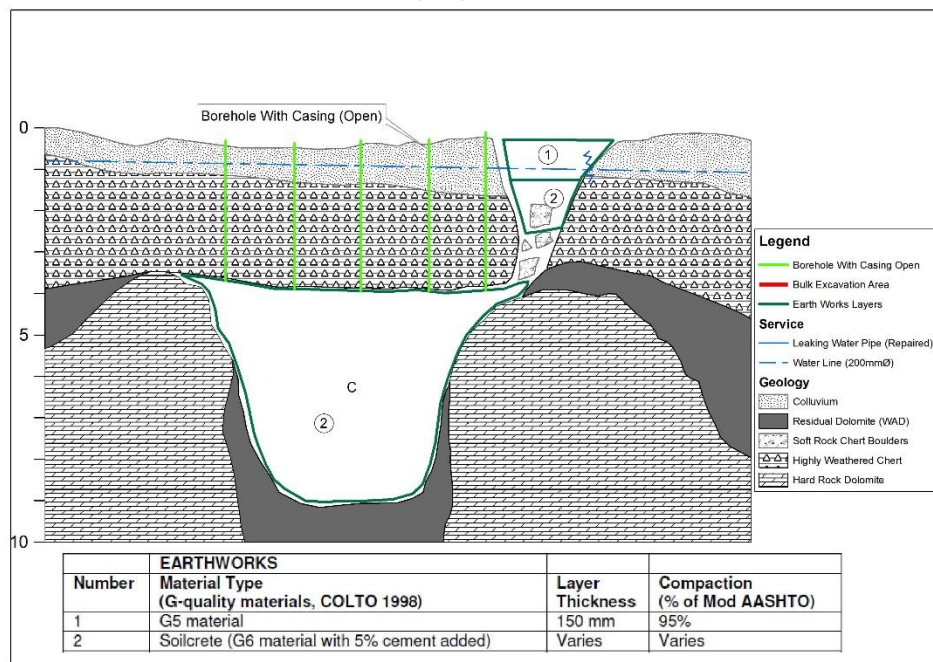
Figure 45: Rehabilitation Method Generic Geological Model 7.

Modified Inverted Filter Method: Refer to the Rehabilitation Model for various earthworks layers (Figure 45). Leak on waterline repaired.

- The highly weathered soft rock chert capping with dolomite abutments on both sides of the void provide a competent layer that should not be removed. To access the void below the competent soft rock chert capping boreholes were drilled into the void during the investigation phase and equipped with casings in order to gravity feed the void below the competent chert capping to fill the receptacle.

- As the chert capping presents a competent horizon it is only necessary to fill the void below it with material (without any strength requirements) to fill/choke the receptacle area.
- Number 1: The upper 1,0 m comprising 150 mm G5-quality material compacted at 95% Modified AASHTO maximum dry density at optimum moisture content.
- Number 2: Filling of the void via open casings by means of the pumping of soilcrete (comprising G6-quality material and 5% cement) until completely filled. Alternatively, selfcompacting concrete can also be pumped into the void, however at a much higher cost.

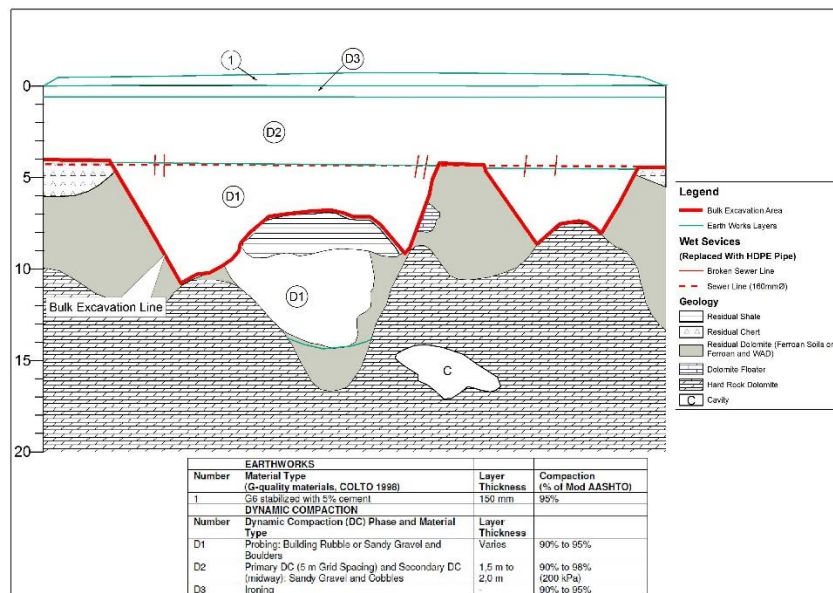
Figure 51: Rehabilitation Method Generic Geological Model 9.

Dynamic Compaction Method: Refer to the Rehabilitation Model (Figure 51). All wet services were replaced with HDPE butt-welded pipes and manholes.

- The highly susceptible subsurface area requiring improvement is extending to a maximum depth of 16 m below ground surface, comprising a thick horizon of residual dolomite, a number of voids and cavities. The use of the Inverted Filter Method, typical applied to a maximum depth of 6 m (but up to 8 m possible) below ground surface will therefore not be suitable as rehabilitation method as the problem extends much deeper than 8 m. The recommended rehabilitation method is the Dynamic Compaction (DC) method, as this method can be used to collapse the arch of a void, densify deeper subareas typically presenting the throat of a sinkhole and densify thick layers of highly compressible residual dolomite (wad) at depths of between 10 m to 12 m as this geological model presents.

As the houses were demolished, these presented no access constraints to the recommended rehabilitation method. As the rehabilitated area is proposed for the rebuilding of houses, it was necessary to remove the problematic residual dolomite material, voids and cavities, by means of creating an engineered earth mattress with the DC method of between 4 m and 14 m.

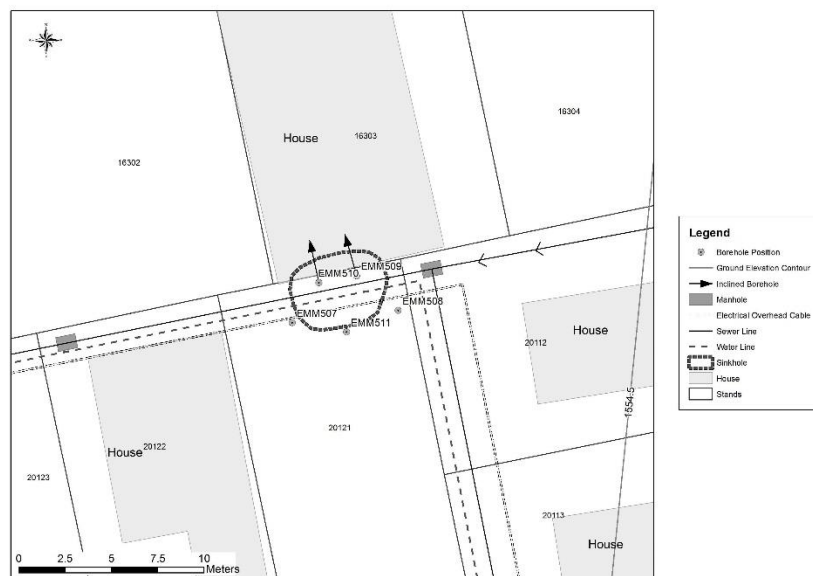
**Figure 52: Plan View of Generic Geological Model 10.**

A sinkhole (dimensions of 4,5 m by 2 m extending to a depth of 2,5 m) occurred in the north-eastern corner of Stand 20121, Vosloorus Extension 30, during September 2009 (Report No. VGI3118/245/1). The sinkhole is partially extending below a double storey house. The affected area, existing infrastructure and the positions of boreholes are displayed in Figure 52.

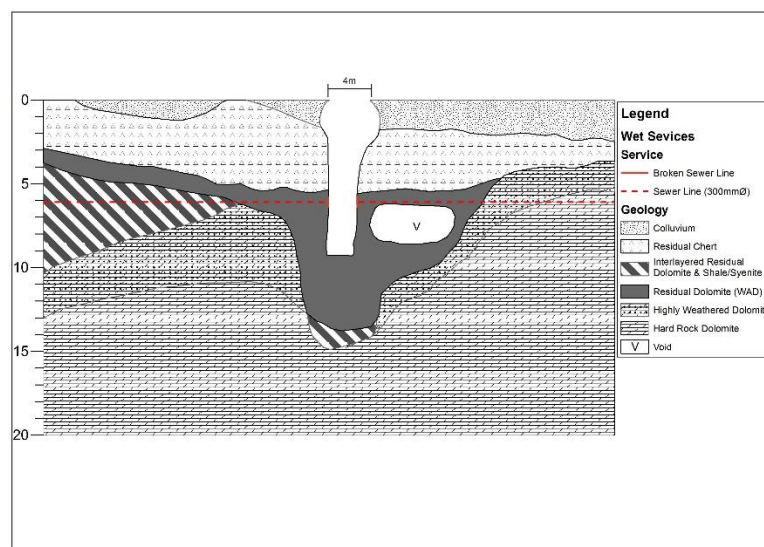
**Figure 56: Generic Geological Model 11.**

The geological model is based on a gravity survey (10 m station interval), six percussion boreholes and bulk excavation of the affected area. The geological model is illustrated in Figure 56.

- Complexity: Complex, heterogeneous profile.
- Blanketing Layer: Comprising a horizon of colluvium (1 m to 2 m or absent) underlain by a horizon of residual chert (1 m to approximately 5 m thick) followed by 1 m to 9 m residual dolomite (wad), highly susceptible to subsurface erosion or consolidation and at depth underlain by a 1 m to 6 m thick horizon of interlayered residual dolomite and shale or syenite encountered just above dolomite bedrock in subareas between depths of 4 m and 15 m. Void encountered within residual dolomite.
- Dolomite bedrock: At a variable depth of 6 m to 15 m.
- Groundwater Level: In dolomite bedrock.

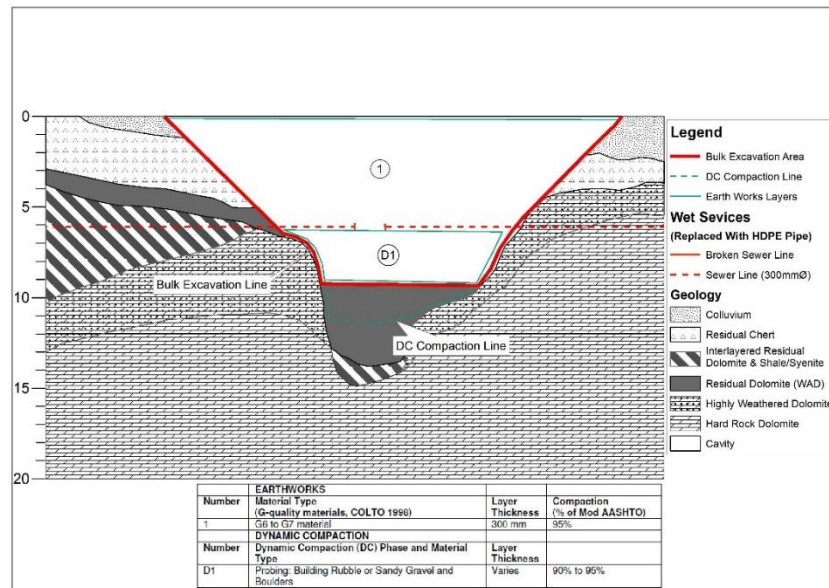
**Figure 57: Rehabilitation Method Generic Geological Model 11.**

Combination of the Inverted Filter Method and Dynamic Compaction Method: Refer to the Rehabilitation Model (Figure 57). All wet services were replaced with HDPE butt-welded pipes and manholes.

- The area requiring improvement extend to a maximum depth of 14 m below ground surface, comprising a thick horizon of residual dolomite, presence of a void and a sinkhole; with the broken sewer line located at a depth of 6 m below ground surface. Bulk excavation was therefore required to a depth of 6 m below ground surface to replace this wet service. The area of the sinkhole and the void was over excavated to a depth of 10 m; choked with sandy gravel and boulders and densified by means of the DC Probing Method up to a depth of 6 m below ground surface, placing of the sewer line and the remaining area backfilled in layers of 300 mm with G6 to G7-quality material compacted to 95% Modified AASHTO.

Taking into consideration the depth of excavation in sub-areas (10 m), within highly susceptible residual dolomite (wad), the DC Method is regarded the most appropriate rehabilitation method for densification of these deeper zones. In addition, existing residential structures was located at an adequate distance away (more than 20 m) in order to perform DC without causing damages to the existing structures. No access constraints for the recommended rehabilitation method. To ensure the integrity of the newly placed sewer line, it was necessary to remove the problematic residual dolomite material and replace with more competent material, backfill and densify deeper located residual dolomite and voids, by means of the DC Method.

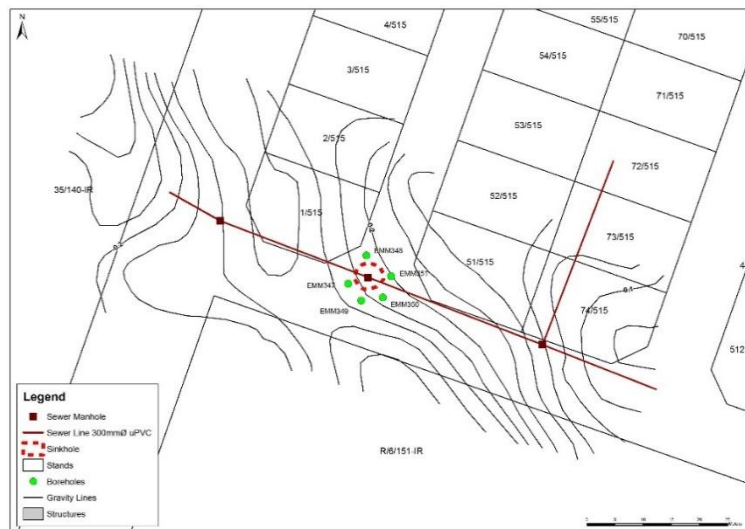
**Figure 58: Plan View of Generic Geological Model 12.**

A sinkhole of 3 m diameter size extending to a depth of 2 m occurred along Msomi Street, Katlehong, during March 2009 (Report No. VGI3118R-WO39A & WO215-2). The affected area, existing infrastructure and boreholes are displayed in Figure 58.

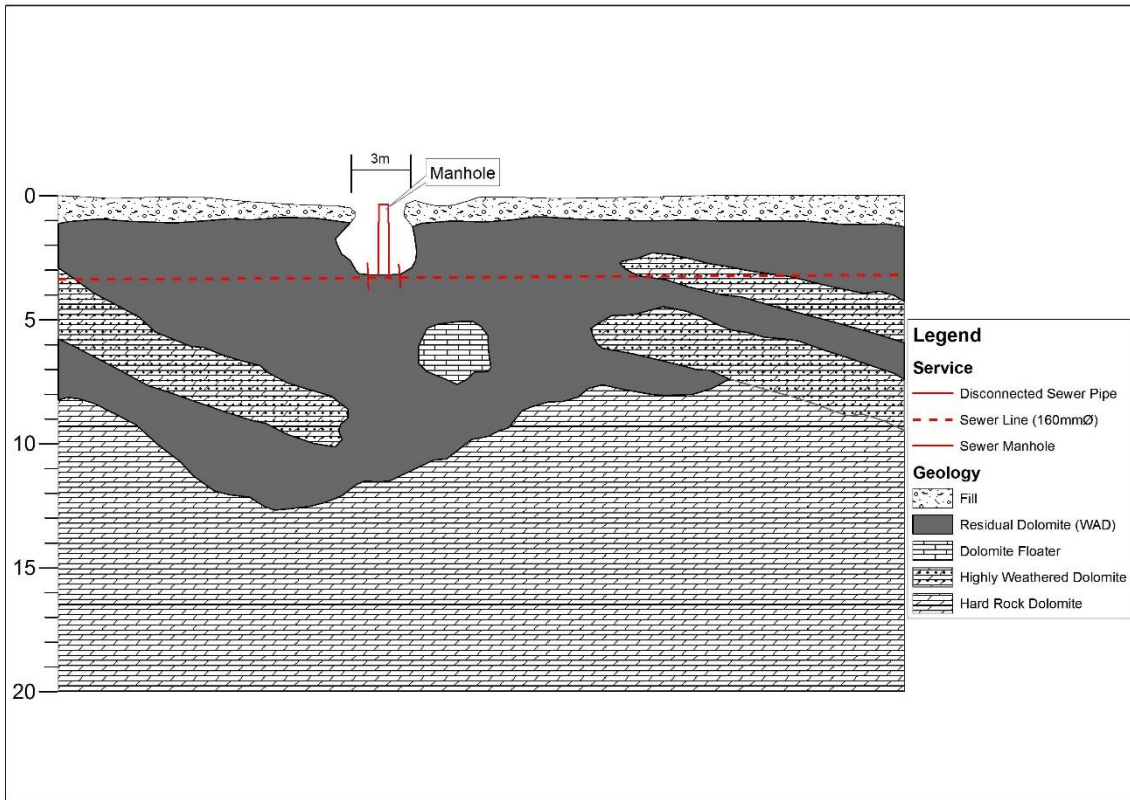
**Figure 59: Generic Geological Model 12.**

The geological model is based on a gravity survey (10 m station interval) and five percussion boreholes drilled in the area surrounding the sinkhole. The geological model is illustrated in Figure 59.

- Complexity: Complex, due to weathered rock and floaters located within problematic soil horizons.
- Blanketing Layer: Comprising a horizon of colluvium (1 m) underlain by a horizon of 8 m to 13 m thick residual dolomite (wad), highly susceptible to subsurface erosion or consolidation. Highly weathered soft rock dolomite horizons of 1 m to 2 m encountered within the residual dolomite (wad) between a depth of 3 m and 10 m. No voids encountered.
- Dolomite bedrock: At a depth of 8 m to 13 m. No cavities.
- Groundwater Level: In dolomite bedrock.

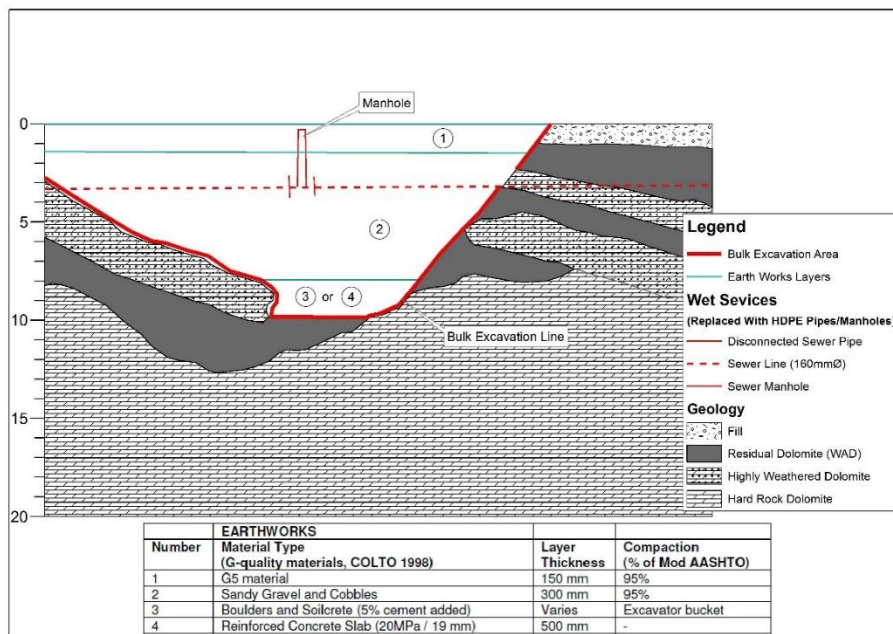
Figure 60: Rehabilitation Method Generic Geological Model 12.

Inverted Filter Method: Refer to the Rehabilitation Model for various earthworks layers (Figure 60). Entire sewer line replaced with HDPE butt welded pipe and two HDPE manholes from manhole to manhole over a distance of approximately 60 m. It should be noted that all HDPE pipes are placed within a 100 mm thick layer of pipe bedding material.

- The highly susceptible subsurface area requiring improvement is extending to a maximum depth of 13 m below ground surface, comprising a thick horizon of residual dolomite with some highly weathered soft rock dolomite horizons in sub-areas. As the intended land use after rehabilitation includes a road and ensuring the integrity of the newly placed sewer line and manholes, it was decided to use the Inverted Filter Method. Bulk excavation with an excavator to a maximum depth of 10 m within the area of the sinkhole.

No access constraints for proposed and recommended rehabilitation method. Remaining profile below excavated area comprising no more than 3 m highly susceptible residual dolomite (wad) material and some highly weathered soft rock dolomite horizons.

To ensure the integrity of the newly placed sewer line and the road, it was necessary to remove the problematic residual dolomite material and replace with more competent material.

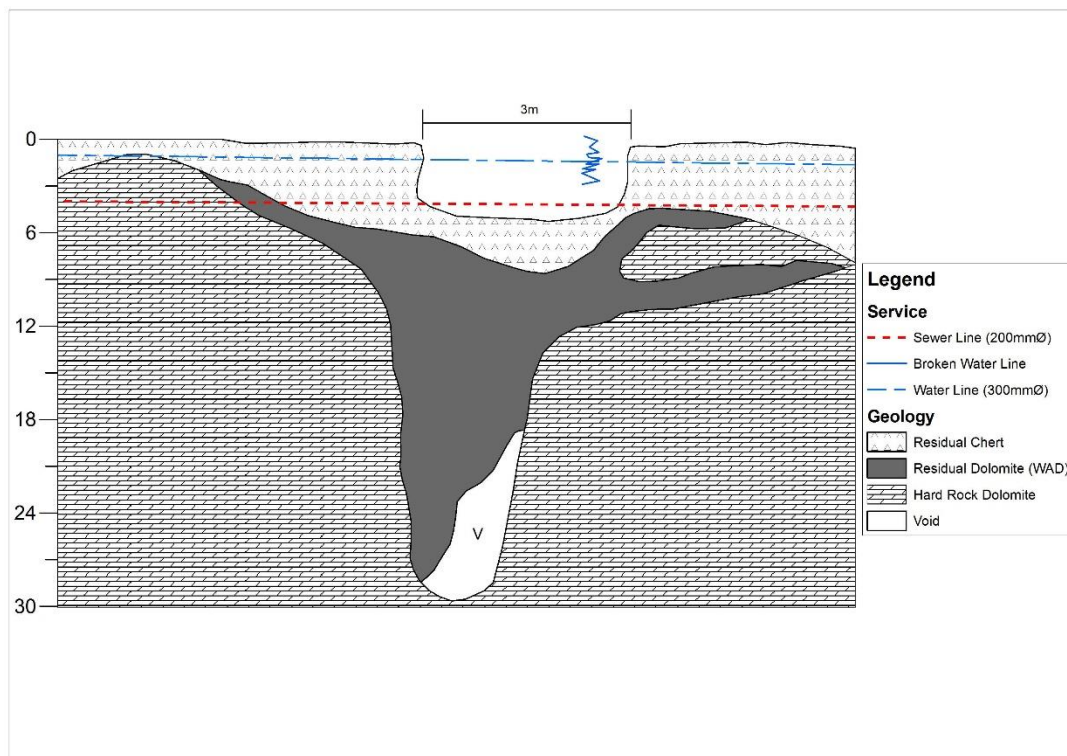
The geological model is based on six percussion boreholes drilled during the investigation phase, placed in the area surrounding the sinkhole and the drilling of eighteen percussion boreholes during the grouting (backfill) programme. A large number of DPSH tests were also conducted on Stand 16463 in the area between the sinkhole and the house (not indicated). The geological model is illustrated in Figure 62.

- Complexity: Complex, due to deeply weathered dolomite zone presenting gryke.
- Blanketing Layer: Comprising a horizon of residual chert (1 m to 8 m) underlain by a (1 m to 29 m thick) horizon of residual dolomite (wad) to a depth of 3 m and 29 m with a 1 m to 3 m thick horizon of highly weathered soft rock dolomite between 5 m and 8 m located within the residual dolomite in subareas. No voids encountered.
- Dolomite bedrock: At a variable depth of 1 m to 29 m, presenting a gryke.
- Groundwater Level: In dolomite bedrock.

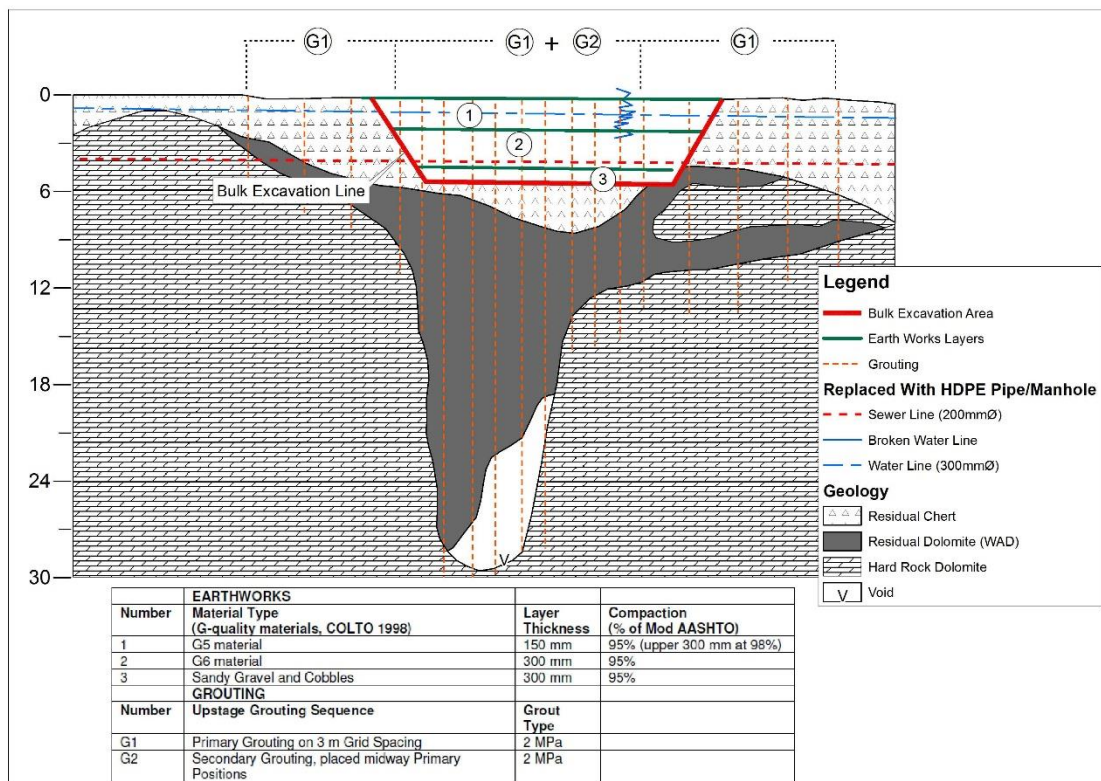
Figure 63: Rehabilitation Method Generic Geological Model 13.

Compaction Grouting and Inverted Filter Method: Refer to the Rehabilitation Model (Figure 63).

- As the dolomite bedrock profile presents a 29 m deep gryke (deep narrow slot) filled with highly susceptible residual dolomite (wad) and possibly also comprising voids; extending below the residential structure located 10 m away that needs soil improvement, the Inverted Filter Method typically applicable for rehabilitation of areas up to a depth of 8 m and the DC Method applicable for the rehabilitation of areas up to a depth of 12 m; will not be suitable. The Inverted Filter Method is however applicable to improve soil conditions within the area of the sinkhole and section of wet services that needed to be replaced.

The recommended rehabilitation method is the Compaction Grouting Method, as this method can be used to fill voids or cavities at depth, also below the residential structure, and to densify the low density compressible residual dolomite down to bedrock depth at 29 m.

- The grouting programme included a primary and secondary stage in the gryke, between the sinkhole and the house and also adjacent to the structure in area of structural subsidence. Grouting below the structure was done by means of inclined boreholes. Micro-driven piles installed at a 2 m interval below the foundation was done as part of the stabilisation of the structure and a 150 mm thick reinforced concrete slab was constructed inside the house in the portion subsided.

- Conditions within the area of the sinkhole and affected wet services were improved by means of the Inverted Filter Method: Below the sewer line, placing of 300mm thick layers of sandy gravel cobbles compacted at 95% Modified AASHTO compaction; between 1,5 m and 4,5 m placing of 300 mm thick layers of G6-quality material compacted at 95% Modified AASHTO and the upper 1,5 m comprised 150 mm thick layers of G5-quality material compacted at 95% Modified AASHTO, with the upper 0,3 m compacted at 98% as part of the road layer works.

To stabilize the conditions below the existing house, it was necessary to improve subsurface conditions by means of the Compaction Grouting method, including the densification of low density residual dolomite and filling of potential voids or cavities at depth below the house and the area between the sinkhole and the house. The sinkhole and affected wet services was improved by means of the Inverted Filter Method.

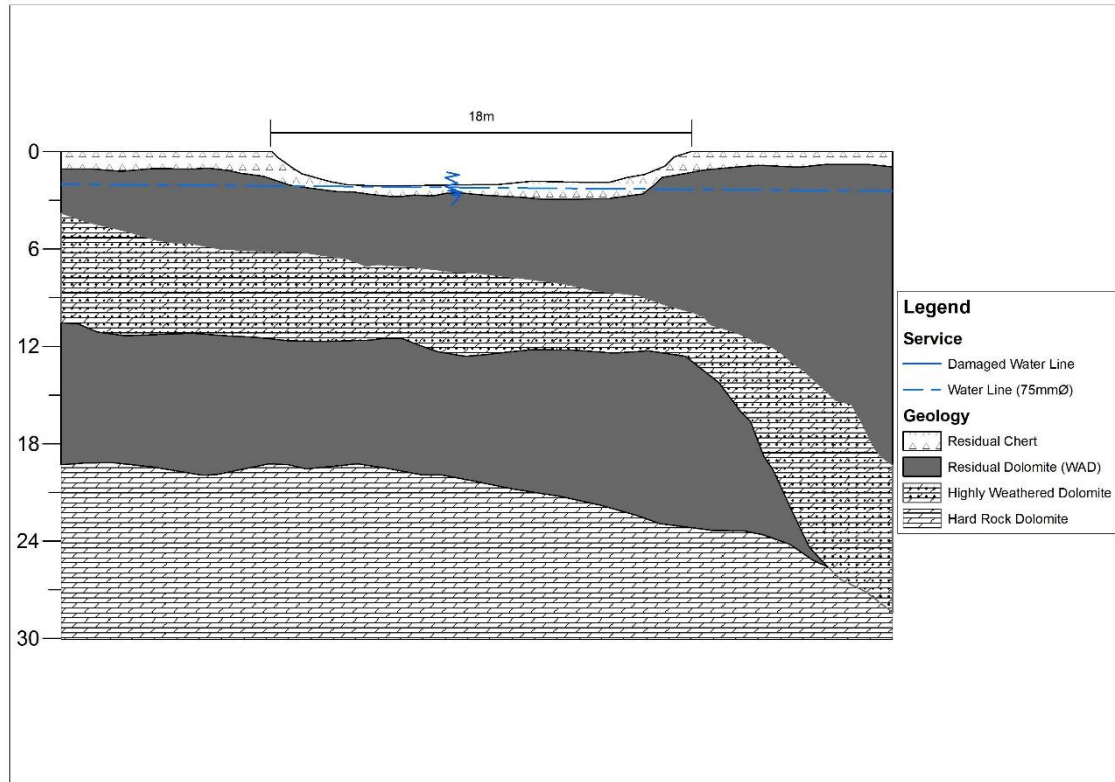
**Figure 65: Generic Geological Model 14.**

The geological model is based on three percussion boreholes drilled within the subsidence area. The geological model is illustrated in Figure 65.

- Complexity: Complex, weathered rock horizon within problematic soils.
- Blanketing Layer: Comprising a horizon of residual chert (1 m) underlain by a horizon of 2 m to 12 m thick residual dolomite (wad), highly susceptible to subsurface erosion or consolidation within area of subsidence, although extending to a maximum depth of 18 m in subareas; a second 1 m to 10 m thick horizon of residual dolomite (wad) occurs below a highly weathered soft rock dolomite horizon of 3 m to 6 m encountered between a depth of 4 m and 27 m. No voids encountered.
- Dolomite bedrock: At a depth of 19 m to 28 m. No cavities.
- Groundwater Level: In dolomite bedrock.

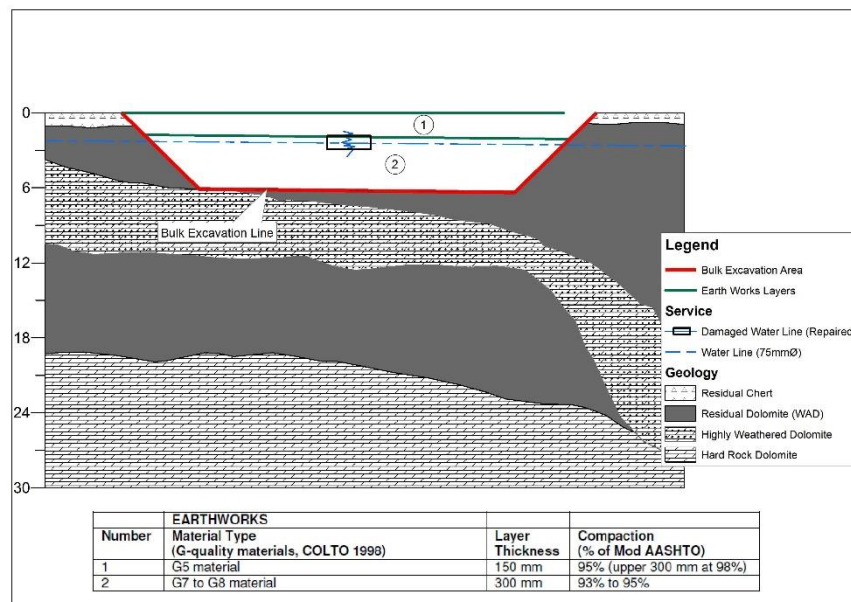
Figure 66: Rehabilitation Method Generic Geological Model 14.

Remaining profile below excavated area comprising 3 m and less highly susceptible residual dolomite (wad) material, 3 m to 6 m highly weathered dolomite, followed at depth by a 10 m thick horizon of residual dolomite (wad).

Inverted Filter Method: Refer to the Rehabilitation Model for various earthworks layers (Figure 66).

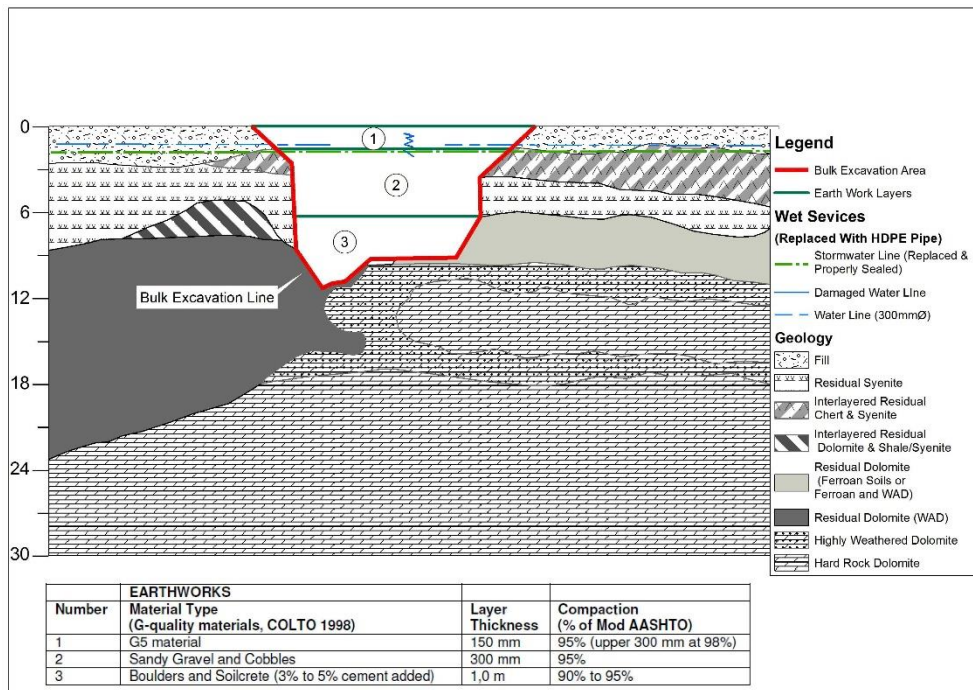
Figure 69: Rehabilitation Method Generic Geological Model 15.

- As the intended land-use after rehabilitation includes a road with servitude, the Inverted Filter Method is recommended as rehabilitation process in the area of the sinkhole, including the removal of residual dolomite (wad and ferroan soils) to a depth of 9 m.

No access constraints for proposed and recommended rehabilitation method. Remaining profile below excavated area comprising highly weathered dolomite and dolomite bedrock.

Inverted Filter Method: Refer to the Rehabilitation Model for various earthworks layers (Figure 69).

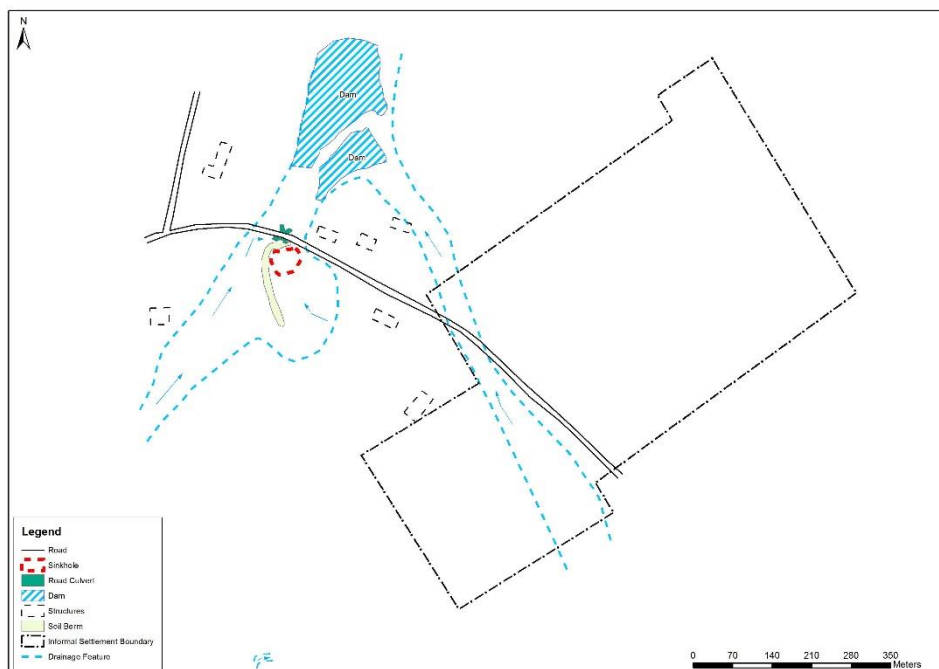
**Figure 70: Plan View Generic Geological Model 16.**

A sinkhole of 50 m diameter size extending to a depth of 25 m occurred next to a road in the Bapsfontein area during January 2004. The affected area and existing infrastructure are displayed in Figure 70.

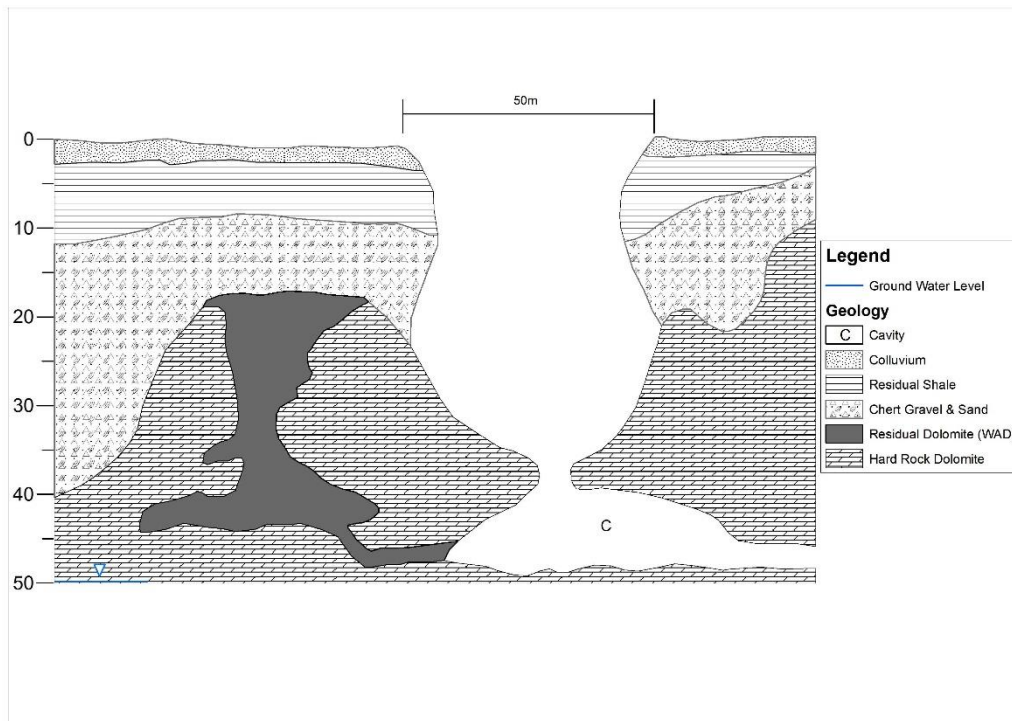
**Figure 71: Generic Geological Model 16.**

The geological model is based on the model presented by Wagener (2009) and the extrapolation of borehole information from an investigation conducted within the informal settlement by the author (Report No. VGI3118R-WO6). The geological model is illustrated in Figure 71.

by residual shale of the Karoo (2 m to 10 m thick) and chert gravel and sand (5 m to 27 m thick), followed at depth by residual dolomite (wad) that are absent to 25 m thick. No voids encountered.

- Dolomite bedrock: At a depth of 8 m to 40 m. Number of inter-connected cavities.
- Groundwater Level: Original groundwater level located in chert gravel and sand at 19 m, drawdown into dolomite bedrock and currently located at 50 m.

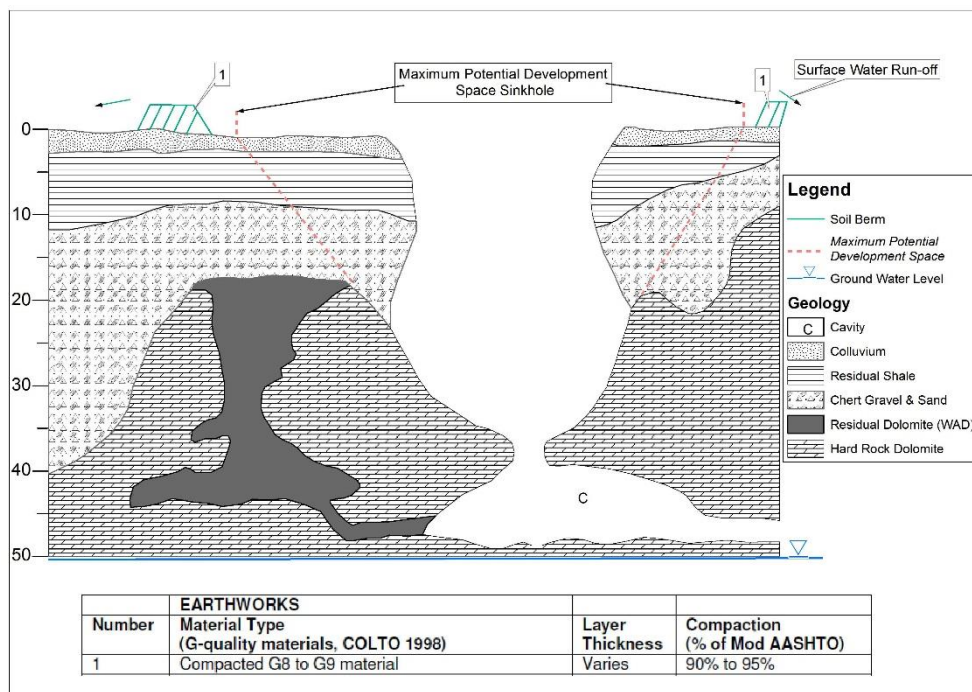
Figure 72: Rehabilitation Method Generic Geological Model 16.

- The rehabilitation of instability features of this extent is costly and not economically viable to rehabilitate, especially when located on agricultural land. The long term rehabilitation measure for instability features caused by dewatering is the proper management and control of groundwater in dolomite compartments by ensuring groundwater levels are restored to their original level, thereby creating stability. Consideration can only be given to the rehabilitation of existing instability features after the groundwater level has been restored to its original or near original level, if such feature poses a risk to existing structures.

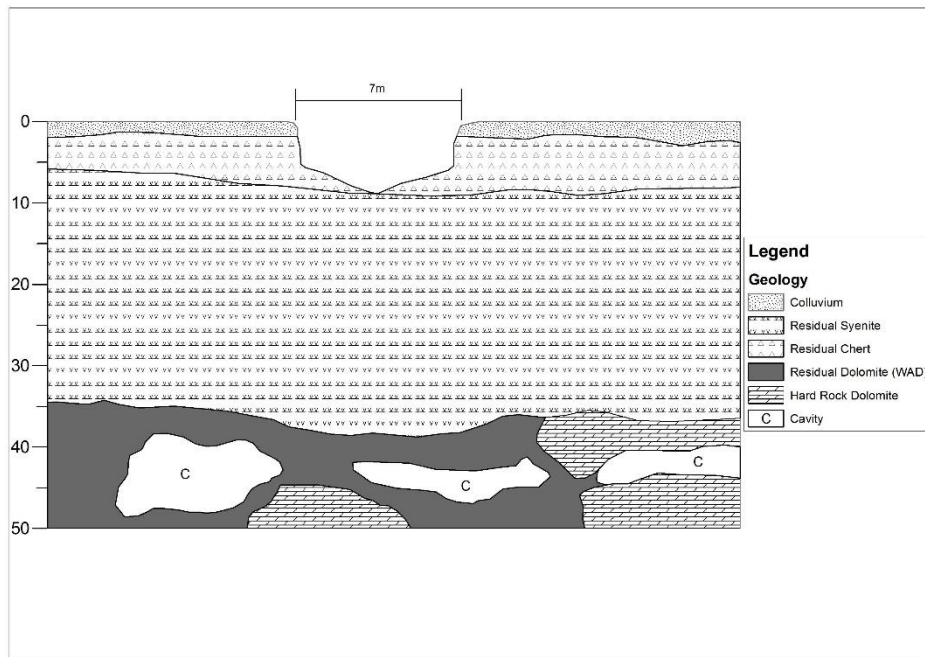
**Figure 74: Generic Geological Model 17.**

The geological model is based on a gravity survey (10 m station interval) and the drilling of ten percussion boreholes in the area surrounding the sinkhole. The geological model is illustrated in Figure 74.

- Complexity: Complex, thick horizon of low susceptibility material above problematic zone.
- Blanketing Layer: Comprising a horizon of colluvium (1 m) and residual chert to a depth of between 5 m and 7 m, underlain by residual syenite to a depth of 35 m to 38 m, followed at depth by 10 m to approximately 15 m thick residual dolomite (wad) highly susceptible to subsurface erosion or consolidation. Voids encountered.
- Dolomite bedrock: At a depth of 35 m to 45 m. Cavities encountered.
- Groundwater Level: In dolomite bedrock.

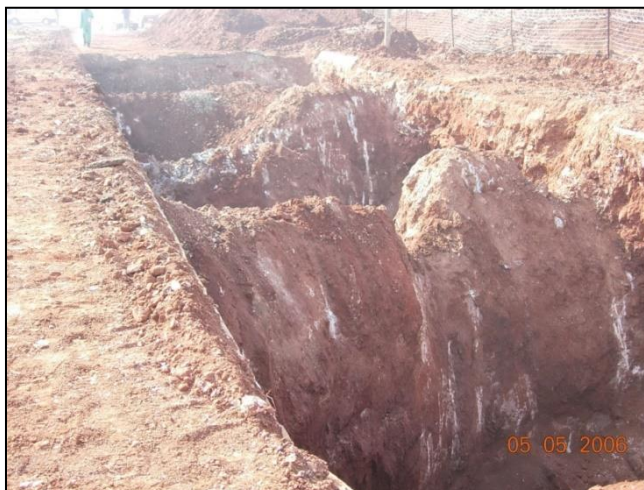
**Plate 4:**  
**Bulk excavation Bierman Road exposing shallow dolomite bedrock, photo taken towards the east.**

- It was found that the road was underlain by an extensive network of dolomite bedrock pinnacles and a number of cavities (Plate A.4). The cavities formed within the troughs between the dolomite pinnacles, comprising residual dolomite (wad) at depth, causing tunnel erosion (Refer to Figure A.6).

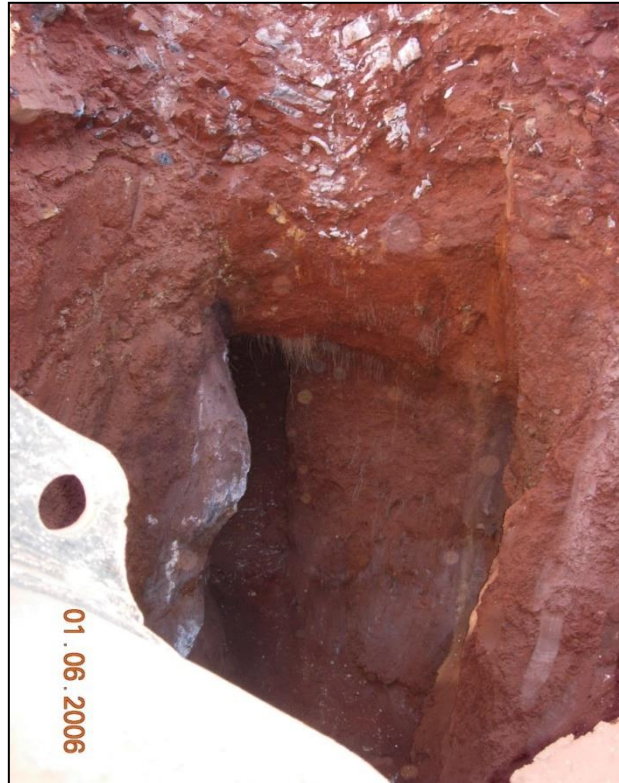
- Areas of troughs were over excavated to a maximum depth of 5m to 6m below natural ground level. A 1m wide and 3m high erosion tunnel filled with rock fill was observed on the southern boundary of Bierman Road within one of the troughs (Plates A.5 and A.6).

**Plate A.5: Exposure of erosion tunnel in southern side wall of Bierman Road excavation.**

- The tunnel erosion extending towards the south was opened with an excavator discovering a large cavity 6m to the south where the erosion tunnel opened up. The cavity of approximately 5m to 6m diameter at a depth of 2m below natural ground level was also opened with the excavator down to a depth of 7m below natural ground level.

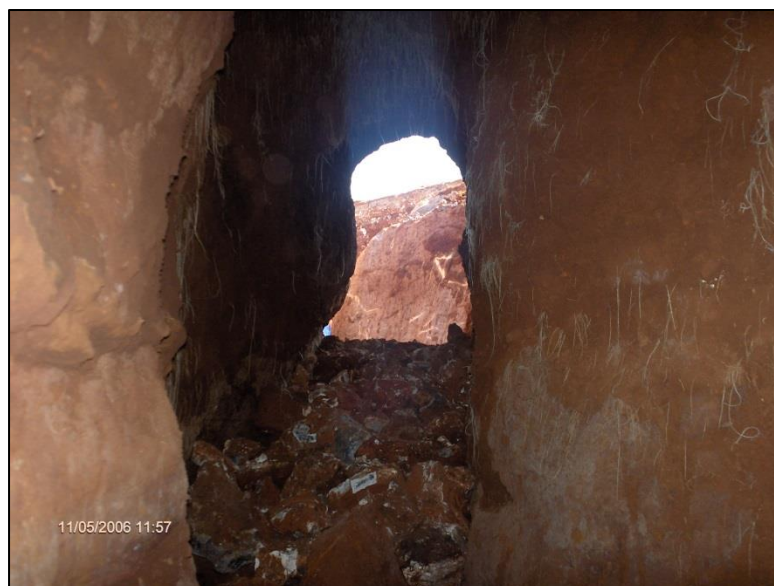
**Plate A.6: Photo taken from the inside of the erosion tunnel outwards.**

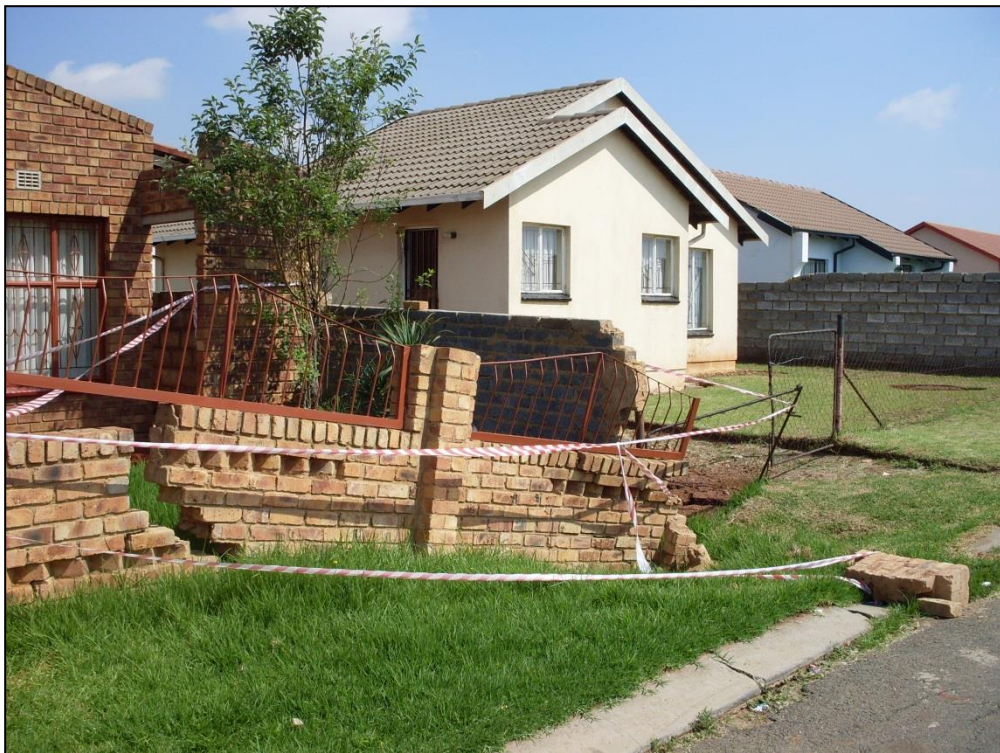
**Plate B.1: Sinkhole on eastern boundary of Stands 1063 and 1064, Njakata Crescent Street, Vosloorus Extension 2.**

A sinkhole occurred on the eastern boundary between Stands 1063 and 1064 in the north-western servitude of Njakata Crescent, Vosloorus Extension 2, on 20 November 2008 (Plate B.1). The sinkhole was caused by a broken water pressure release valve used while repairing a leak on the EMM bulk water line. A site inspection of the affected area was conducted on 26 November 2008 and revealed the following (Report Number VGI3118/193/2, 2008):

- A 5 m diameter sinkhole extending to a depth of 3 m below natural ground surface, with an approximately 1m diameter erosion tunnel extending to a depth greater than 5 m towards the central eastern boundary of the house (approximately 2 m away from the sinkhole) on Stand 1064.
- The sinkhole is situated partially on Stand 1063, Stand 1064 and stretching a meter into the tar road.
- Severe damage to the boundary wall of Stand 1064 facing the street and nearly a meter subsidence of the gatepost at Stand 1063, within the affected area.
- An EMM water pressure release valve is situated within the subsided area, between the tar road and the south-eastern boundary of Stand 1063 and Stand 1064.
