**REHABILITATION OF SINKHOLES AND  
SUBSIDENCES ON DOLOMITIC LAND,  
EKURHULENI METROPOLITAN MUNICIPAL AREA  
OF JURISDICTION, GAUTENG, SOUTH AFRICA**

**Submitted in partial fulfilment of the  
requirements for the degree of Doctor of  
Philosophy in the Faculty of Natural and  
Agricultural Sciences**

**UNIVERSITY OF PRETORIA**

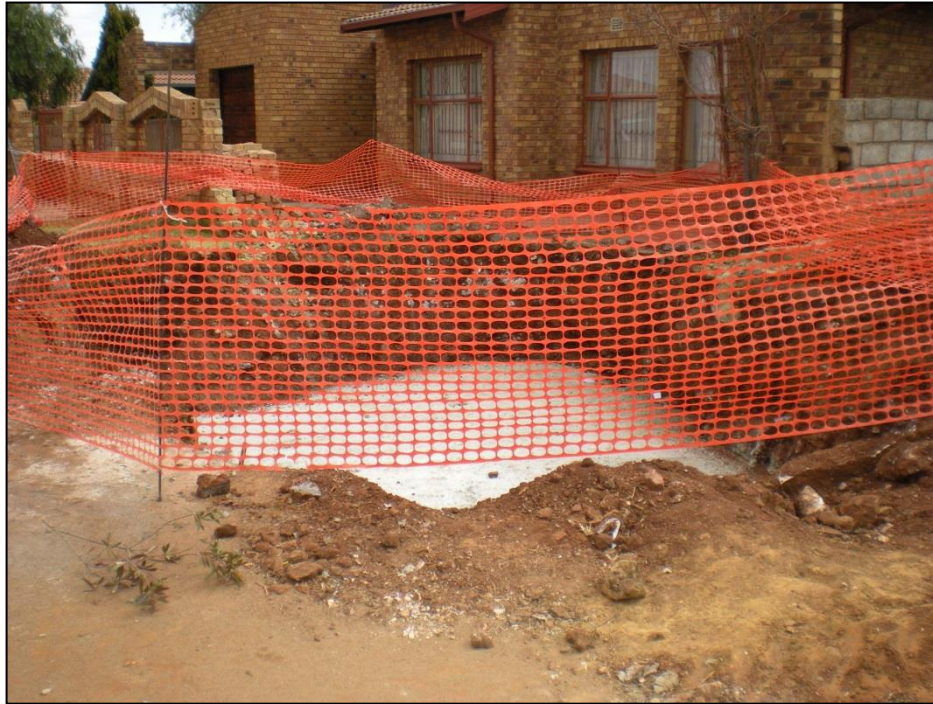
**Plate B.2: Bulk excavated area and cavity backfilled with 10 MPa mass concrete.**

- The bulk excavated area and cavity below the house on Stand 1064 was backfilled with 10 MPa mass concrete up to 1 m below natural ground level (Plate B.2). The remaining 1 m of the excavation was backfilled with silty/gravelly sand (G5 quality) in 150 mm thick layers up to ground level, each layer compacted to 95% of Modified AASHTO maximum dry density at optimum moisture content. The upper 0,3 m was compacted at 98% of Modified AASHTO maximum dry density at optimum moisture content. The entire site was landscaped to facilitate surface water drainage away from the structure.

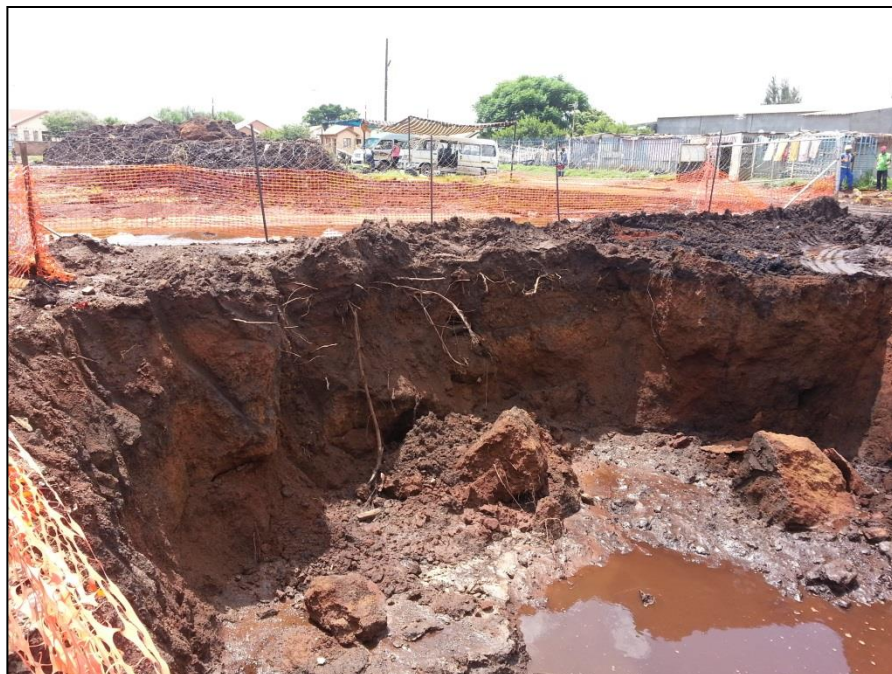
- Blocking off and removal of all internal wet services.
- Bulk excavation (15 m by 11 m at base of excavation) to a depth of 6 m. Excavation slopes at 1:1 to 6 m depth. Care was to be taken of water within the excavation area from a depth of 4 m, as it would cause the dolomite residuum (wad) to liquefy and slope failure could occur (Plate C.1). All mandatory safety requirements pertaining to working in excavations were to be applied. A pump was available on site to drain the excavation area during works.

**Plate C.1: Bulk excavation in progress below water level causing unstable side slopes and collapse.**

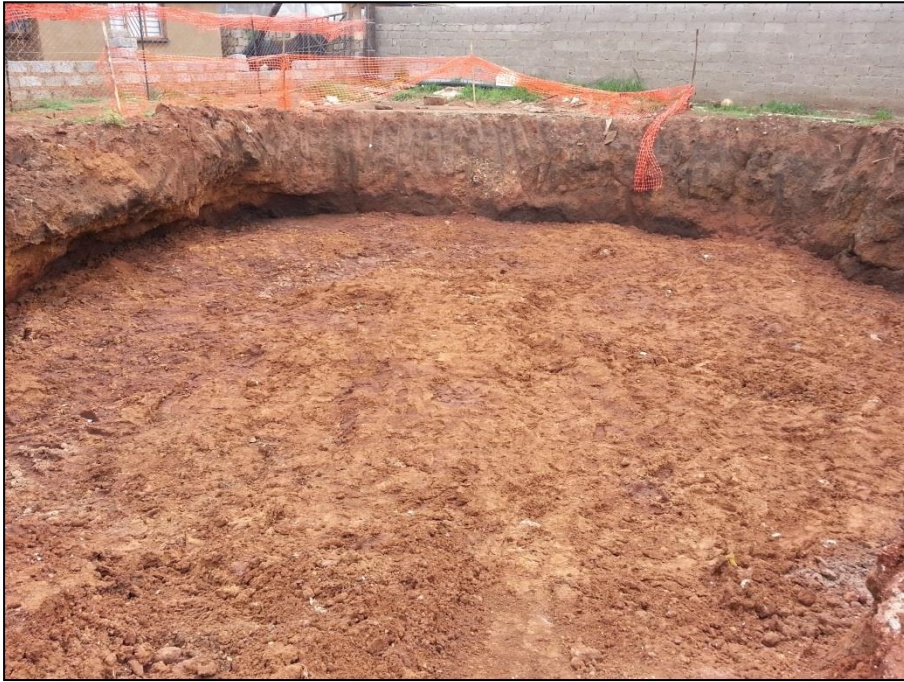
- Backfilling of the excavation involved the placing of large boulders and stones in filled with soilcrete (10% cement) and compacted with an impact roller in 1 m lifts up to 3 m from ground surface (Plate C.2).

**Plate C.2: Bulk excavated area backfilled to stable level.**

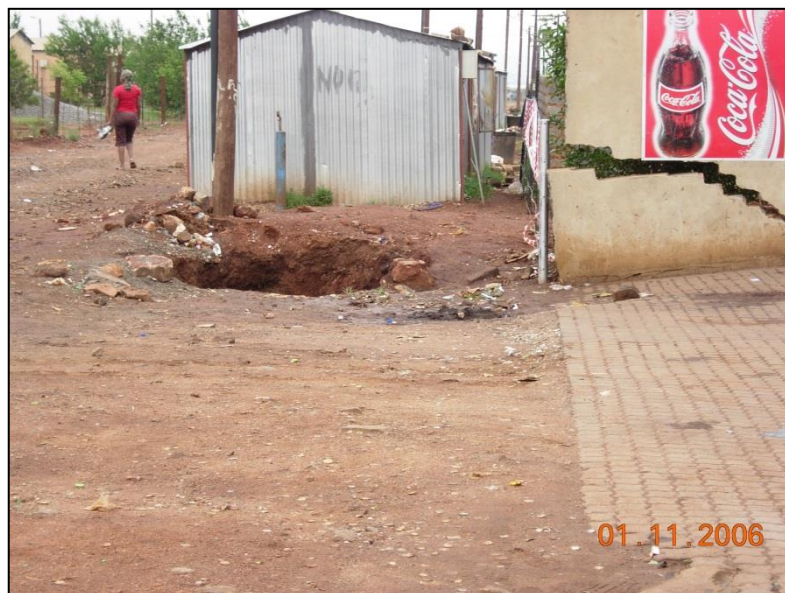
**Plate D.1: Sinkhole and subsidence in area of Borehole BH8.**

A follow-up inspection on 5 October 2006, revealed that the subsidence had extended towards the east. In addition, a new subsidence and sinkhole formed along the sewer line and a manhole, allowing sewage to flow directly into the sub-surface (Plate D.1).

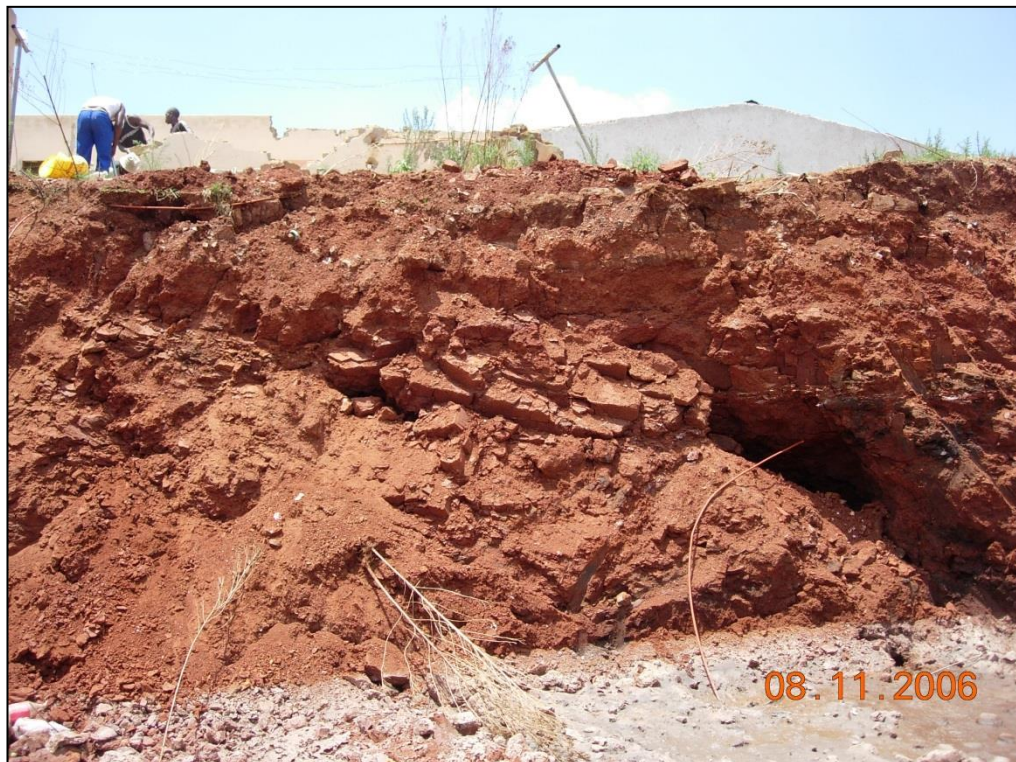
**Plate D.2: Cavity exposed during bulk excavation in area of Borehole BH5.**

- Demolish all structures in the affected area and stockpile the building rubble (excluding metal).
- Blocking off and removal of all subsurface wet services in the area; rerouting of the existing 4,5 m deep broken mid-block sewer line section above ground.
- Bulk excavation of the affected area (40 m by 100 m) to a depth of 4 m. The two subsidence areas were then excavated to the maximum reach of the excavator (approximately 10 m) to expose the throat of the subsidence (potential sinkhole). During excavation the cavity encountered in Borehole BH5 was exposed (Plate D.2).

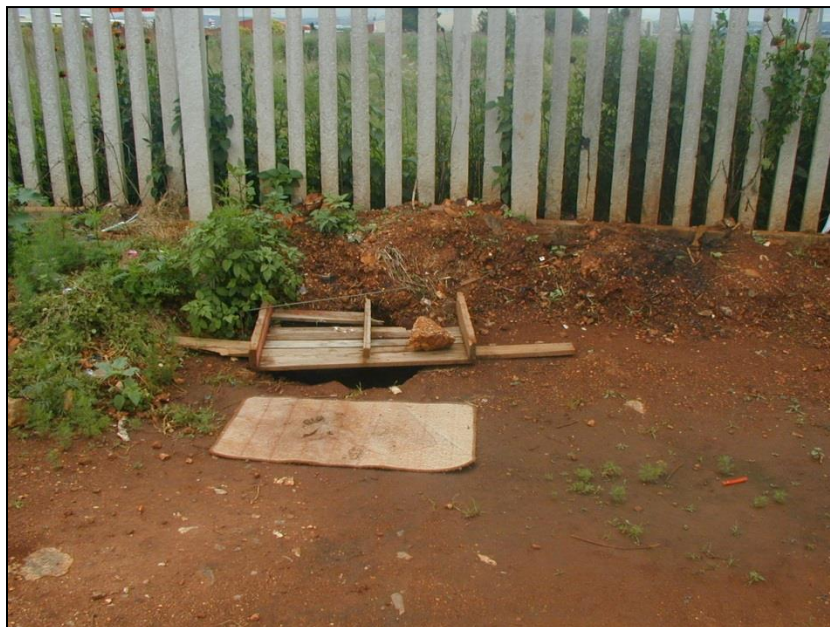
**Plate E.1: Sinkhole on western boundary of Stand 2636.** A sewer manhole is situated 18 m north-east of the sinkhole.

- A sinkhole of 4 m diameter size extending to a depth of more than 8 m below natural ground surface, opened up down to the sewer line depth on the western boundary of Stand 2636 (Plate E.1).

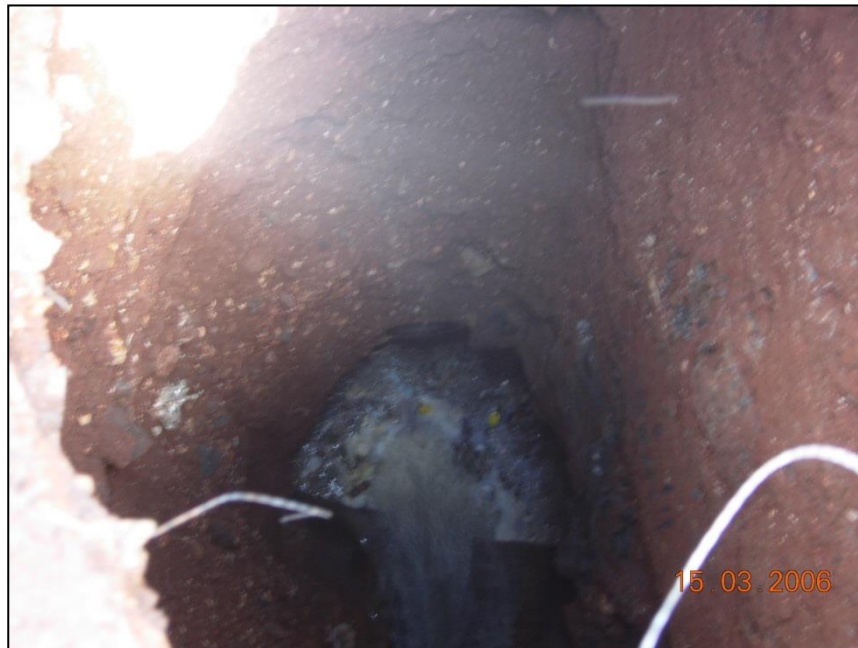
**Plate E.2: Broken sewer with fast flowing effluent causing subsurface erosion.**

- A broken sewer line with fast flowing effluent entering the subsurface ground profile causing subsurface erosion was observed within the sinkhole area (Plate E.2).

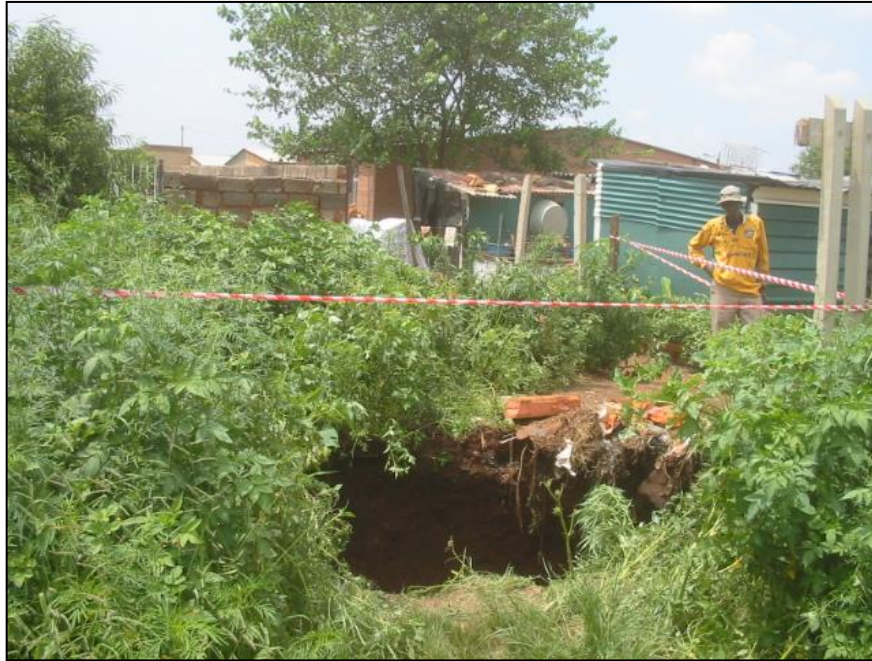
- A 5 m diameter size sinkhole extending to a depth of approximately 7 m below natural ground surface, located on the north-western boundary of Stand 2656 in an area of a south-west to north-east aligned 300mm diameter uPVC EMM bulk sewer line (Plate E.3).
- A section of the palisade fence has fallen into the sinkhole.
- No structural damages to houses observed, situated approximately 15m to the south-east of the sinkhole.

**Plate E.3: Sinkhole at north-western boundary of Stand 2656.**

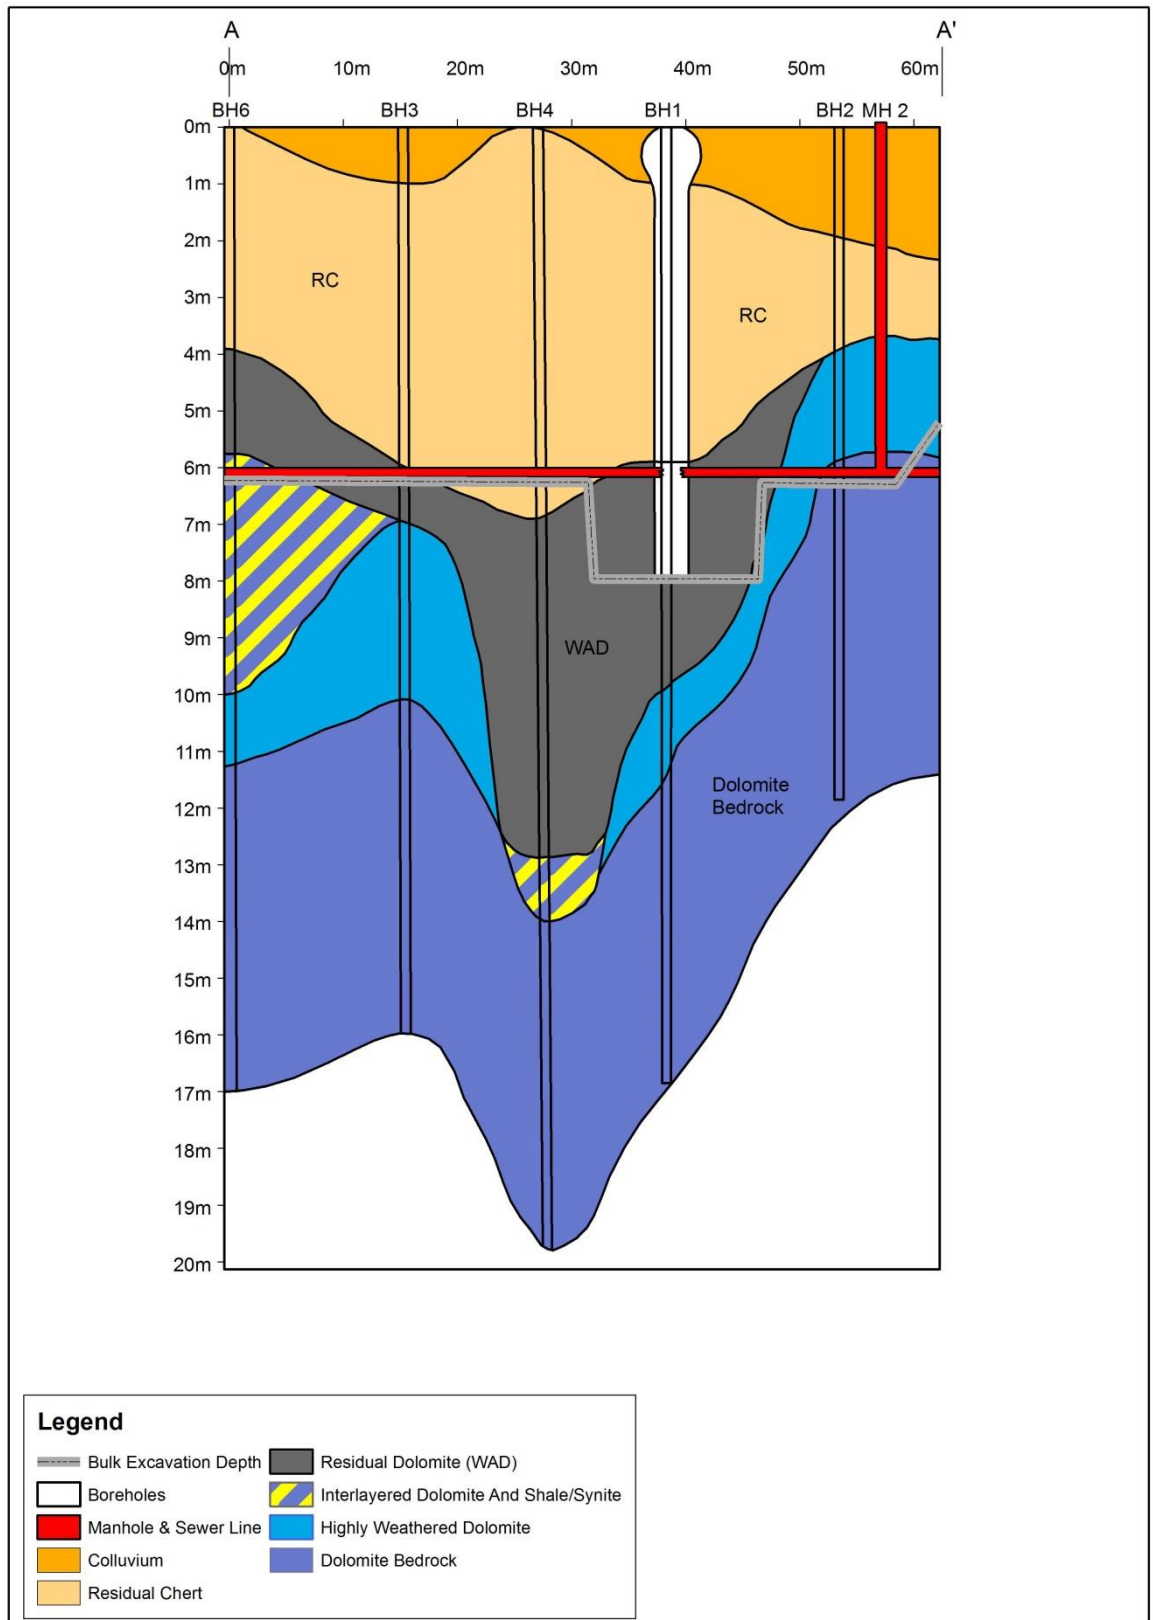
Figure E.2: Case Study 5 – Interpreted Geological Cross-Section A – A` from Manhole MH1 to MH2.

The sinkhole investigation during 2006 revealed the following sub-surface profile in the area of the sinkhole as illustrated by the Geological Cross-Section A-A' from Manhole MH1 to Manhole MH2 in Figure E.2:

- Dolomite bedrock at a depth ranging from 6 m to 14 m. A 1 m to 4 m thick horizon of highly weathered soft rock dolomite at variable depths ranging from 4 m to 11 m. Interlayered highly weathered soft rock dolomite and shale was encountered in one borehole between a depth of 13 m and 14 m just above dolomite bedrock.

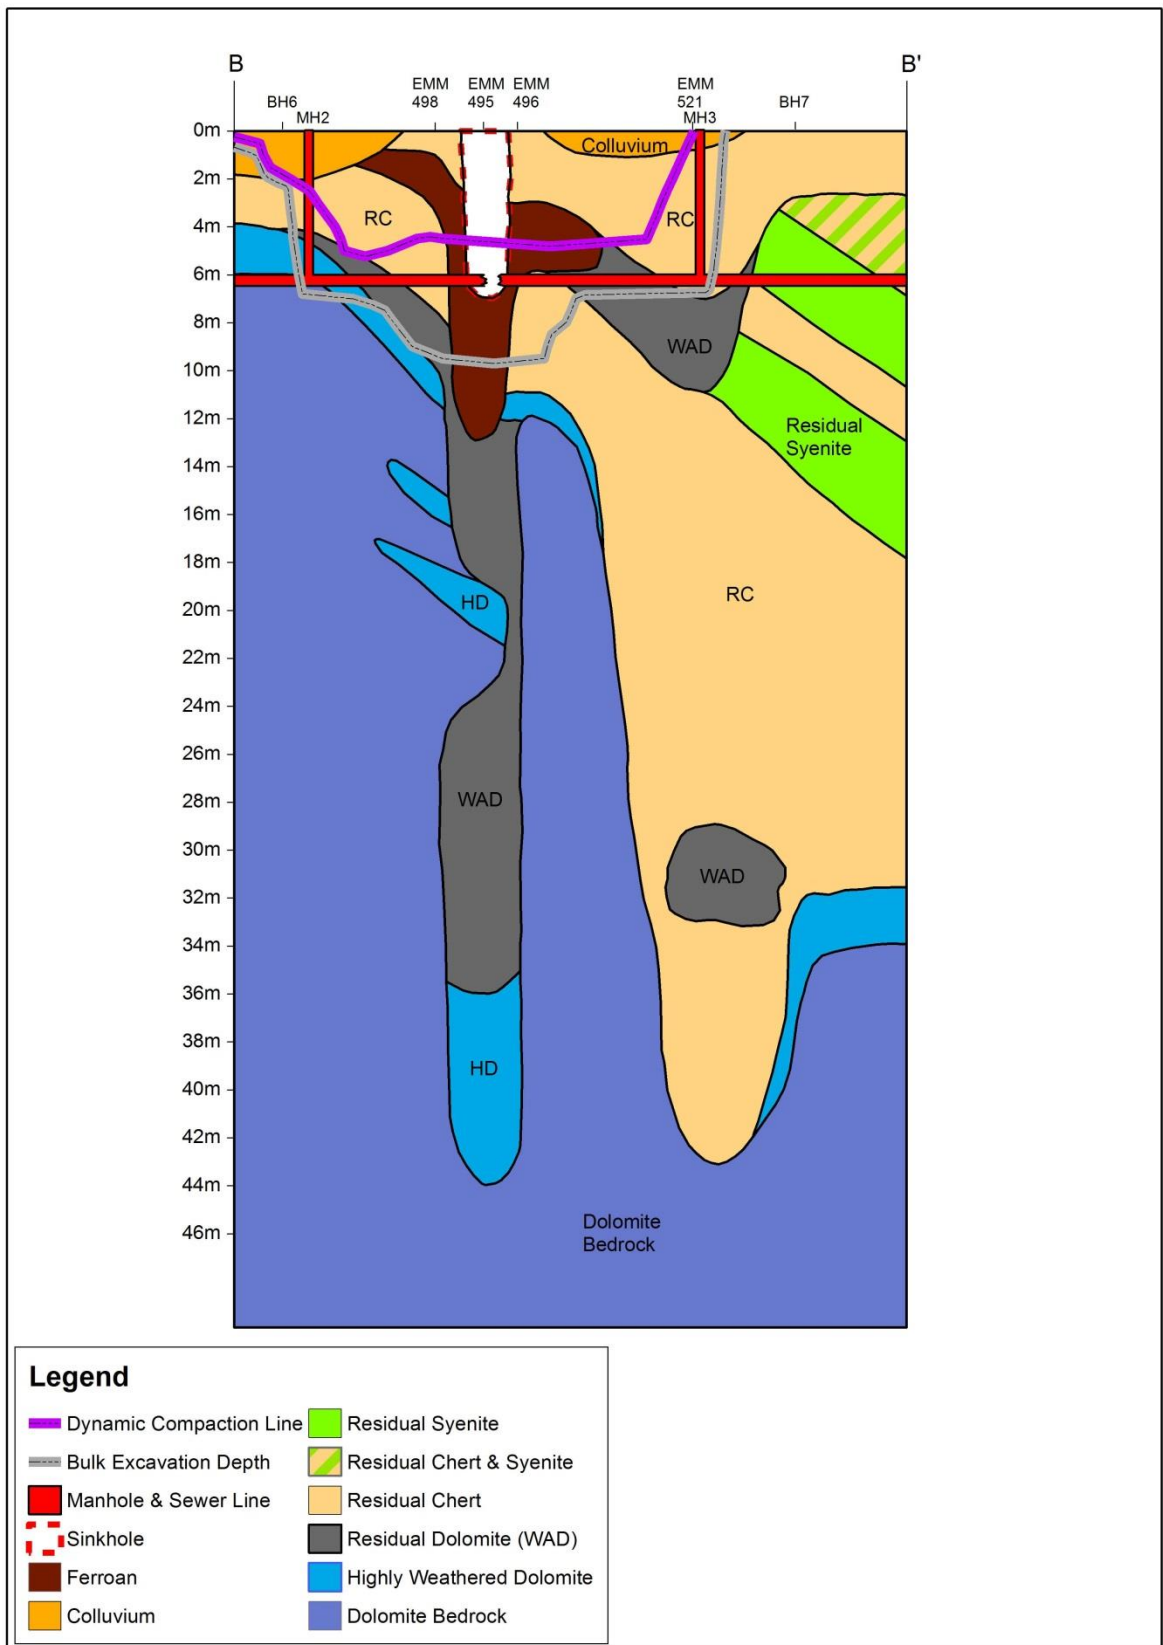
Figure E.3: Case Study 5 – Interpreted Geological Cross-Section B – B'.

A geological cross-section B-B` presenting sub-surface conditions as encountered during the dolomite stability investigation parallel to the broken sewer line and through the sinkhole area that occurred in January 2010 is illustrated in Figure 48 and revealed the following:

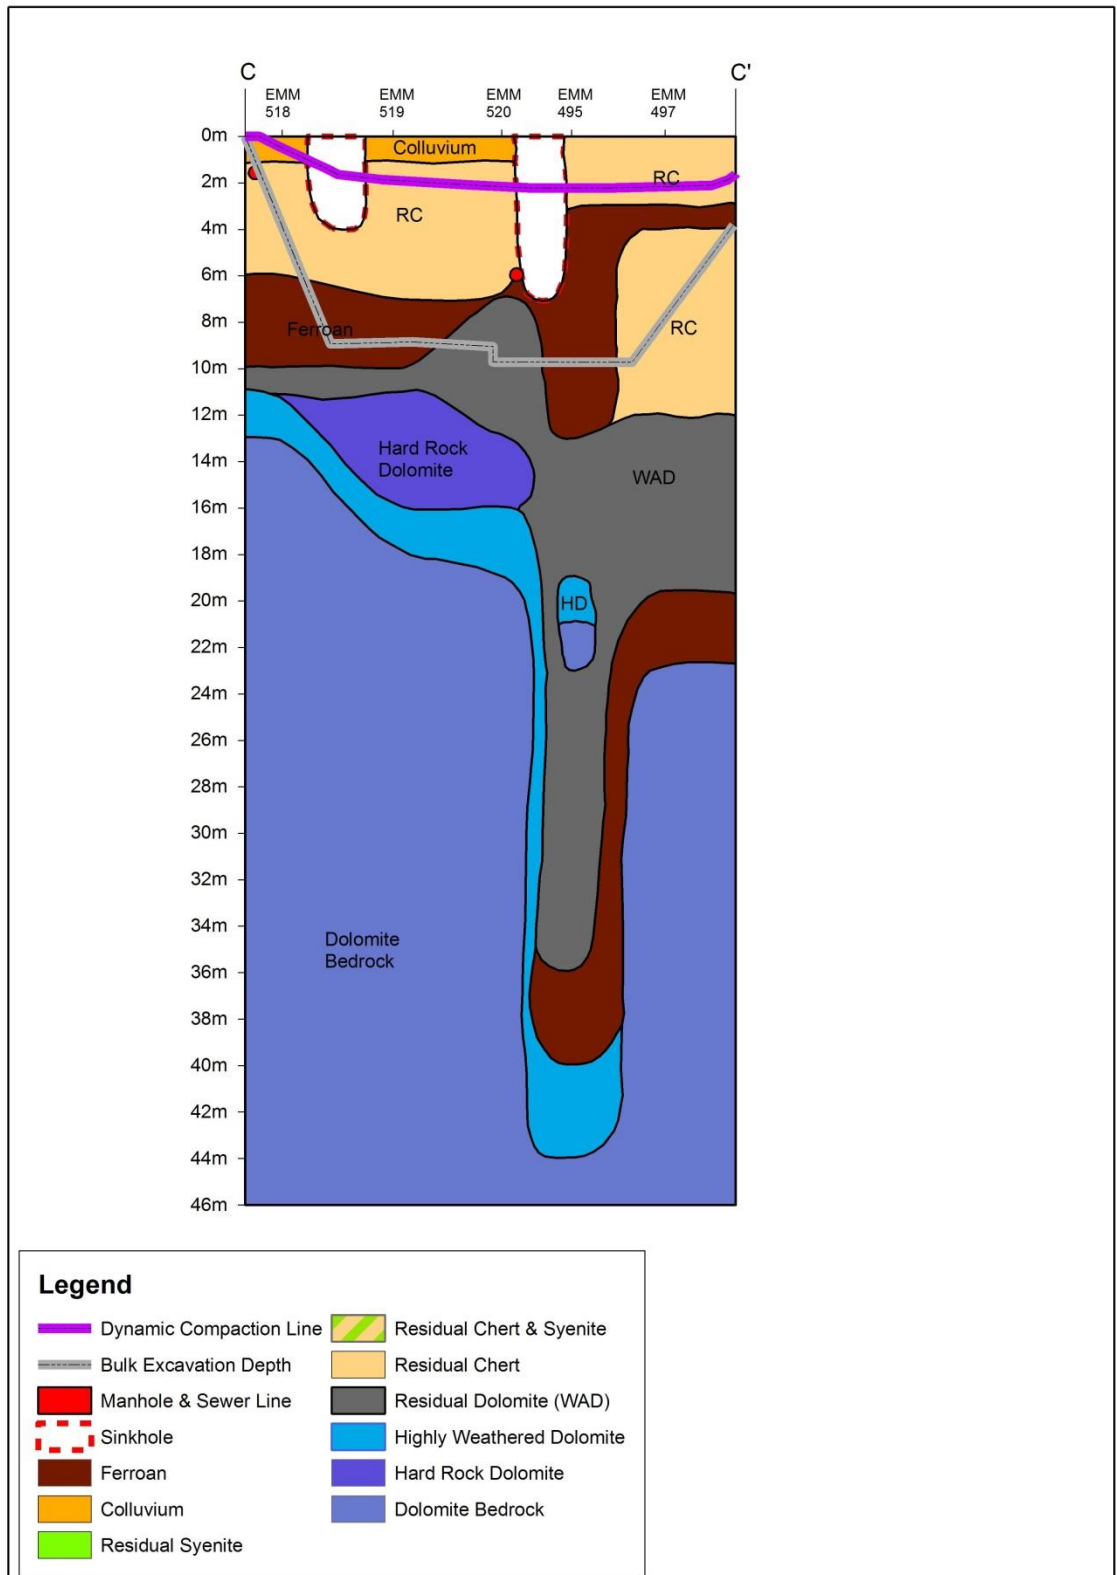
Figure E.4: Case Study 5 – Interpreted Geological Cross-Section C – C`.

A geological cross-section C-C` presenting sub-surface conditions as encountered during the dolomite stability investigation through both sinkhole areas that occurred in 2010 is illustrated in Figure E.4 and revealed the following:

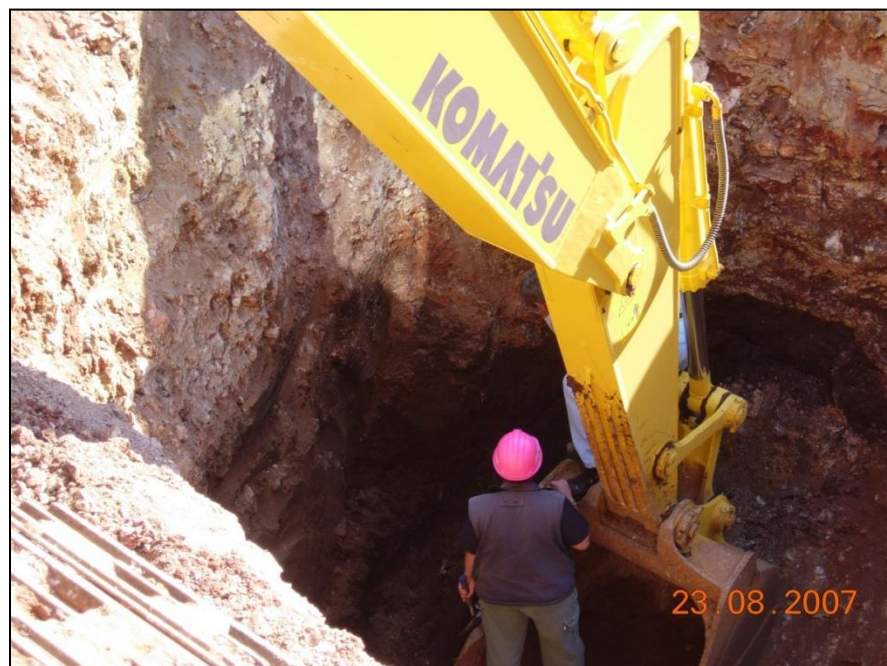
- During the trench excavation to replace the broken sewer line between Manholes MH1 and MH2 a cavity (2 m height and 7 m diameter in size between 6 m and 8 m below ground level) was encountered at the base of the excavation in the north-western side wall of the trench excavation in the area where the sinkhole was over-excavated to a depth of 8 m (Plate E.4). All material above the cavity was removed with an excavator and the cavity was excavated down to a depth of 12 m below natural ground level. Dynamic Compaction (DC) probing was performed within the deeper exposed section to collapse potential additional subsoil cavities, after which dump rock and granular soil was used to choke the throat. This process was followed by backfilling of the excavation in 1,5 m to 2,0 m lifts with gravelly soils, compacted using DC to construct a soil raft. The site was levelled and an ironing operation was conducted over the entire area to complete the shallow DC treatment. The purpose of the DC was to densify the upper 12 m of the soil profile substantially within the area where the cavity was encountered, thereby decreasing permeability and erodibility.

**Plate E.4: Cavity exposed during bulk excavation of sewer and sinkhole north-west of Stand 2636.**

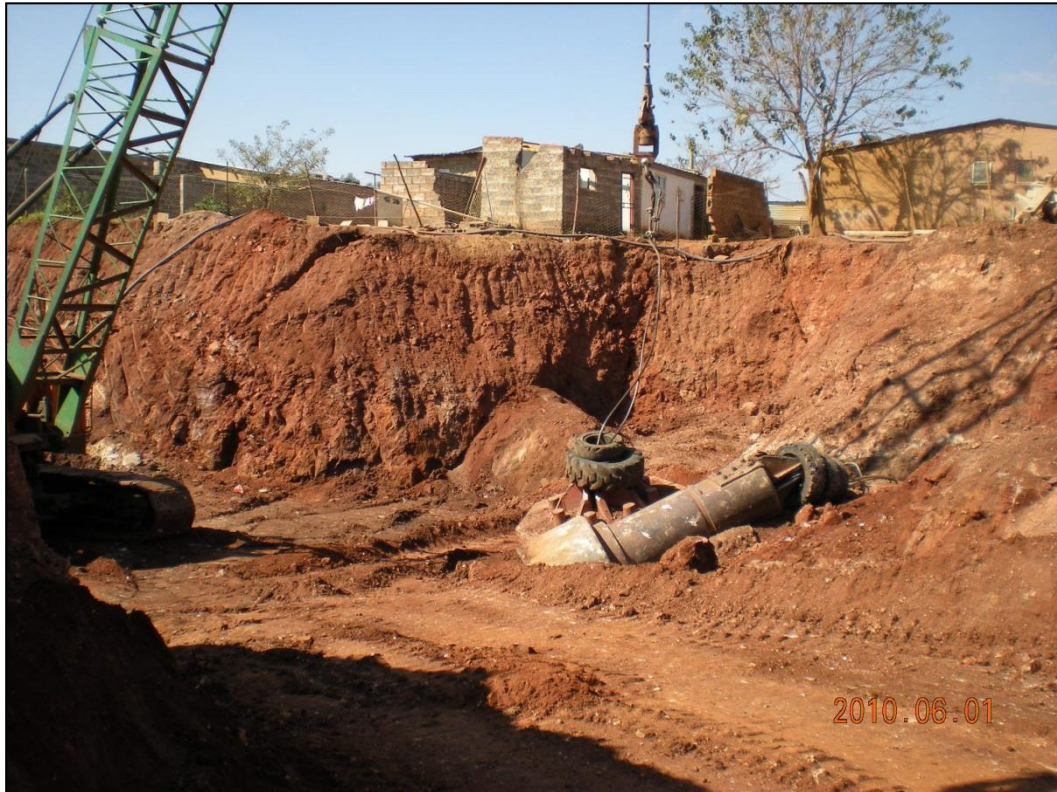
Dynamic Compaction (DC) probing was first performed within the deeper exposed sinkhole sections to collapse potential subsoil cavities and to densify residual dolomite (wad) at depth, after which dump rock and gravelly soils was used to choke the throat. This process was followed by backfilling of the excavation in 1,5 m to 2,0 m lifts with gravelly soils, compacted using DC to construct a soil raft to a depth of approximately 5 m below natural ground level. The deep DC consisted of primary and secondary prints on a 5 m by 5 m grid spacing with volume and blow counts recorded for quality purposes for each print position. The purpose of the DC was to densify the soil profile to a depth of 5 m below natural ground level substantially, thereby decreasing permeability and erodibility (Plate E.5).

**Plate E.5: Dynamic Compaction in progress in affected area at Stands 2655 to 2657.**

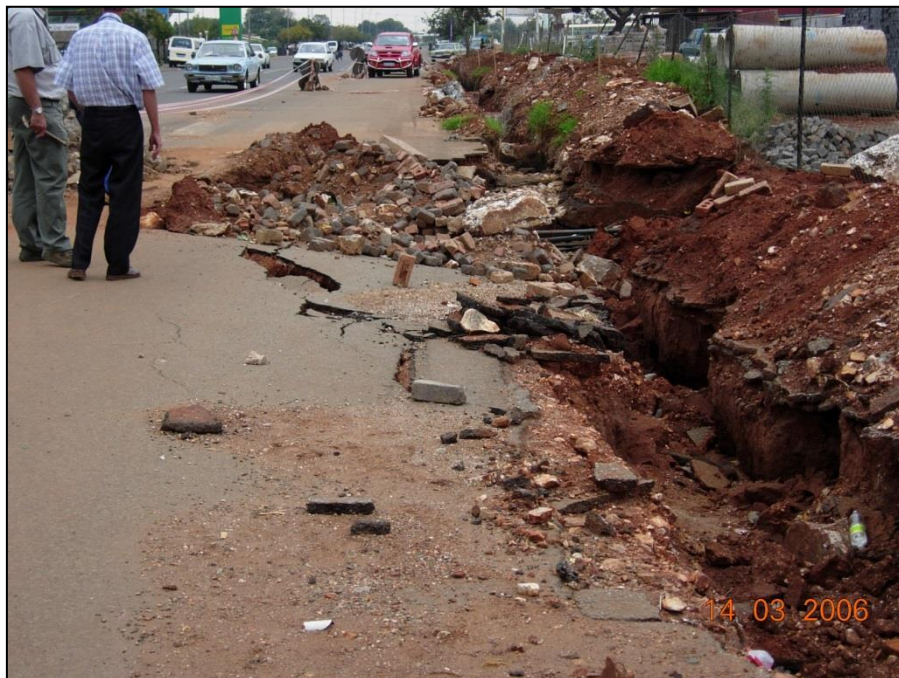
- An oval shaped sinkhole, 20 m long, 6 m wide (defined by 0,5 m wide surface cracks extending to a depth of at least 1m in the tar road) extending to a depth of 2 m. Located within the south-eastern servitude of M.C. Botha Road along an open trench excavation (Plate F.1). The sinkhole extending below M.C. Botha Road westwards to the Vosloorus Library and Vosloorus Civic Centre.

**Plate F.1: Sinkhole in south-eastern servitude of M.C. Botha Road.**

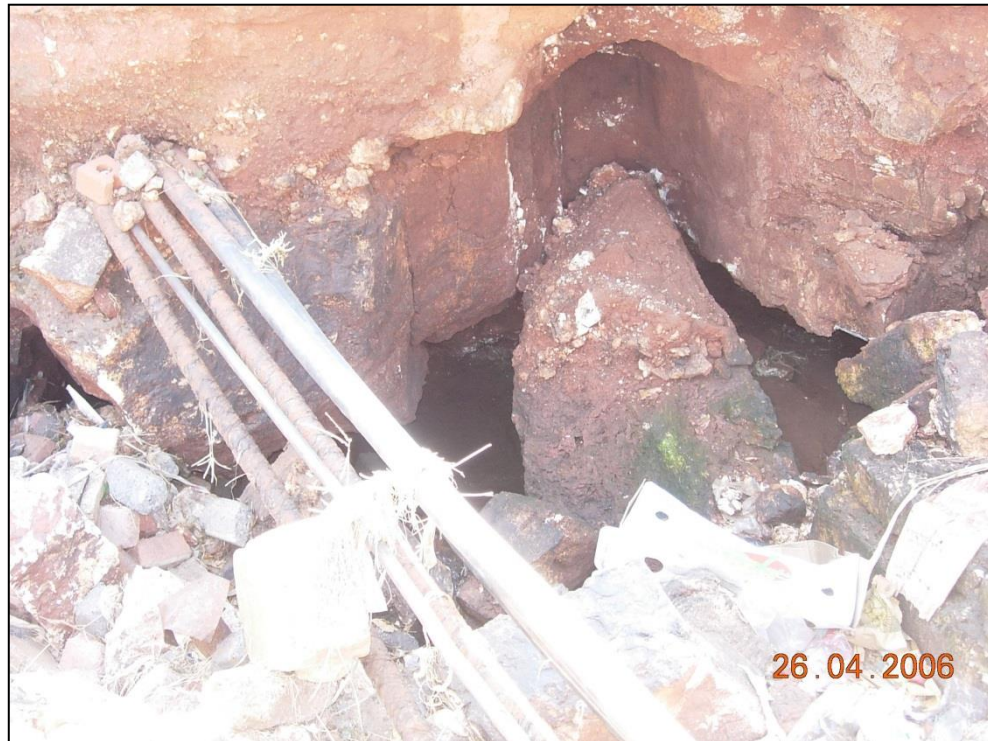
- The sinkhole is partially filled with large chert boulders and soil with cavernous conditions (air filled voids) visible (Plate F.2). The disappearance of backfill material placed in the sinkhole area by Municipal officials indicated that subsurface erosion was taking place with a high risk for a very large sinkhole to develop.

**Plate F.2: Cavernous conditions visible between chert boulders in sinkhole area.**

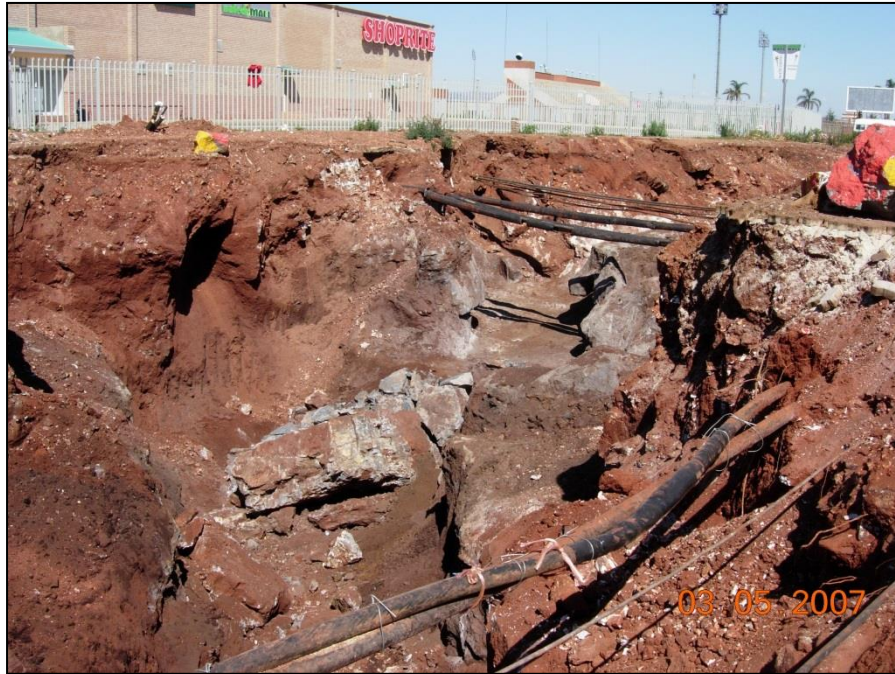
**Plate F.3: Photo of gryke taken towards the south with soft rock dolomite capping removed over cavity in area of east-west aligned cables.**

- The interpreted geological cross-section B - B' (Refer to Figure F.2) is located along the gravity low area that represents a gryke-type feature (deeply weathered zone typically filled with residual dolomite (Plate F.3).
- Dolomite bedrock at a depth ranging from 9 m to 21 m. Hard rock dolomite was also encountered in two boreholes between a depth of 5 m and 8 m. A 1 m thick (or absent) horizon of highly weathered soft rock dolomite just above dolomite bedrock between 13 m and 21 m. A 1 m to 4 m (or absent) thick horizon of highly weathered soft rock dolomite is encountered within the blanketing layer at variable depths ranging from 2 m to 10 m in four boreholes. Interlayered soft rock dolomite and shale encountered between a depth of 8 m and 11 m comprising a little wad between a depth of 10 m and 11 m in one borehole.

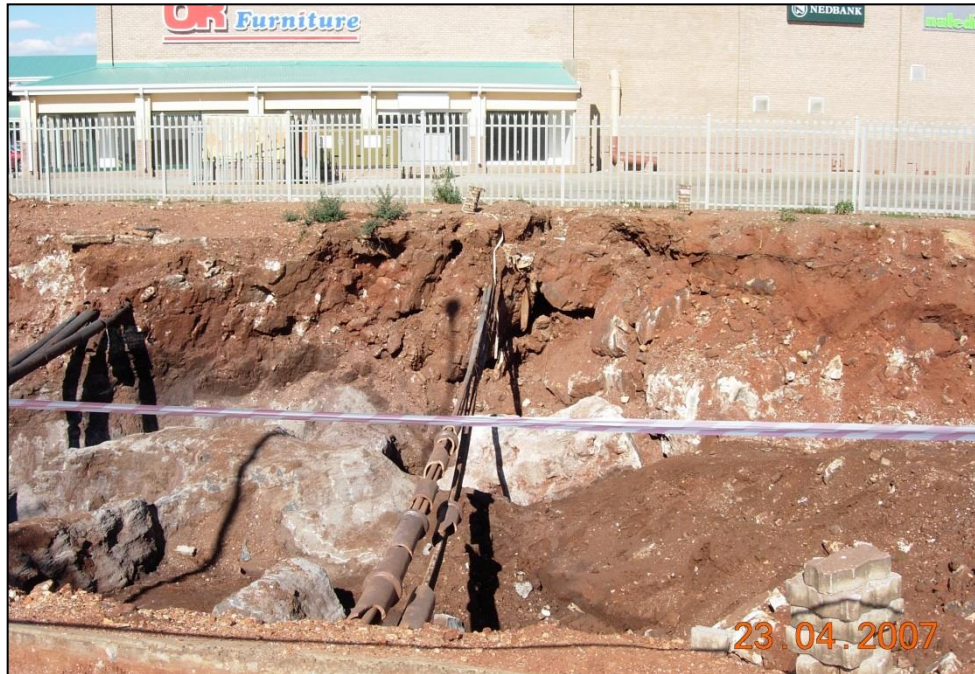
During the bulk excavation a cavity of approximately 10 m diameter and 1 m high with a 1 m to 1,8 m thick highly weathered soft rock dolomite roof was encountered within the gryke area directly adjacent to the sinkhole at an approximate depth of between 4 m and 5 m (Plate F.4). The cavity is connected to the sinkhole. The roof of the cavity was removed by drilling and blasting (Plate F.20). A second cavity of approximately 11 m diameter and 3m high with a 4 m thick highly weathered soft rock chert roof was encountered at a depth of 4 m to 7 m below natural ground level within the northern corner of the bulk excavation area (Plate F.5).

**Plate F.4: Soft rock dolomite roof over a 1 m high and 10 m diameter cavity.**

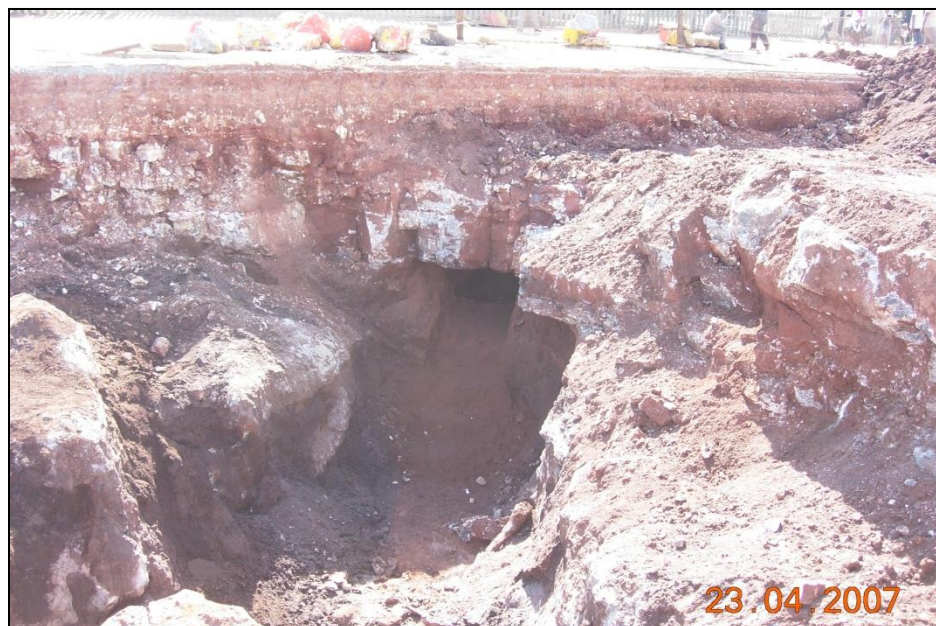
**Plate F.5: Cavity exposed in northern corner of bulk excavation area with soft rock chert roof.**

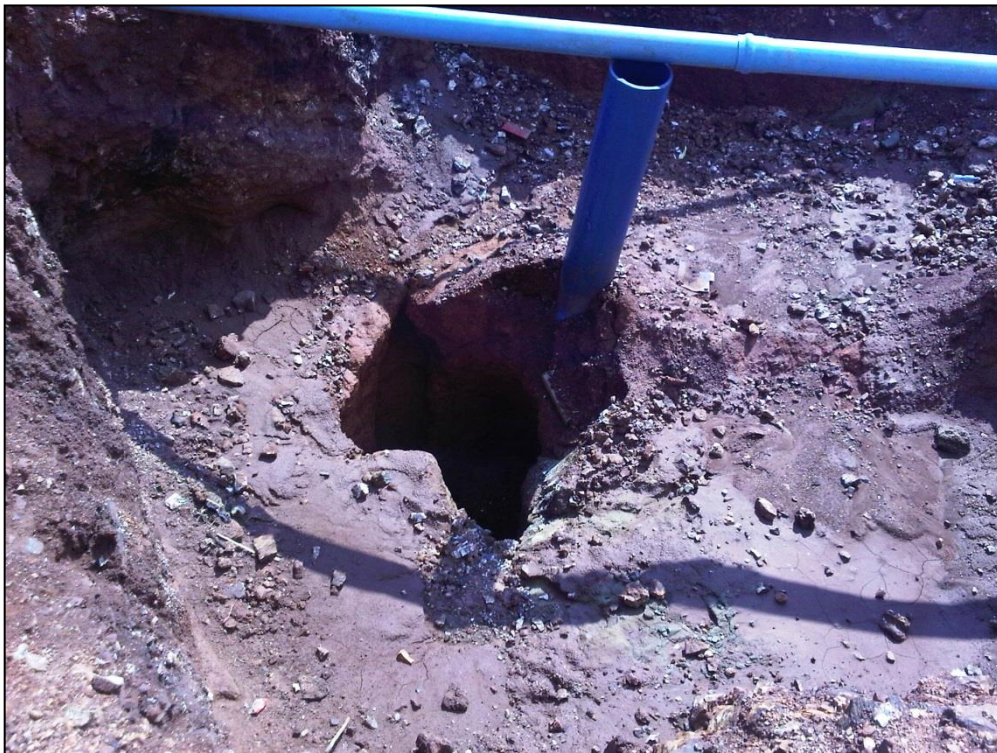
- A sinkhole (dimensions of 2 m diameter extending to a depth of 2 m) occurred west of the Credi Reservoir, in a 1,5 m deep trench excavated for a proposed new 400 mm diameter PVC water line (Plate G.1).

**Plate G.1: Sinkhole in trench excavation for a proposed water line.**

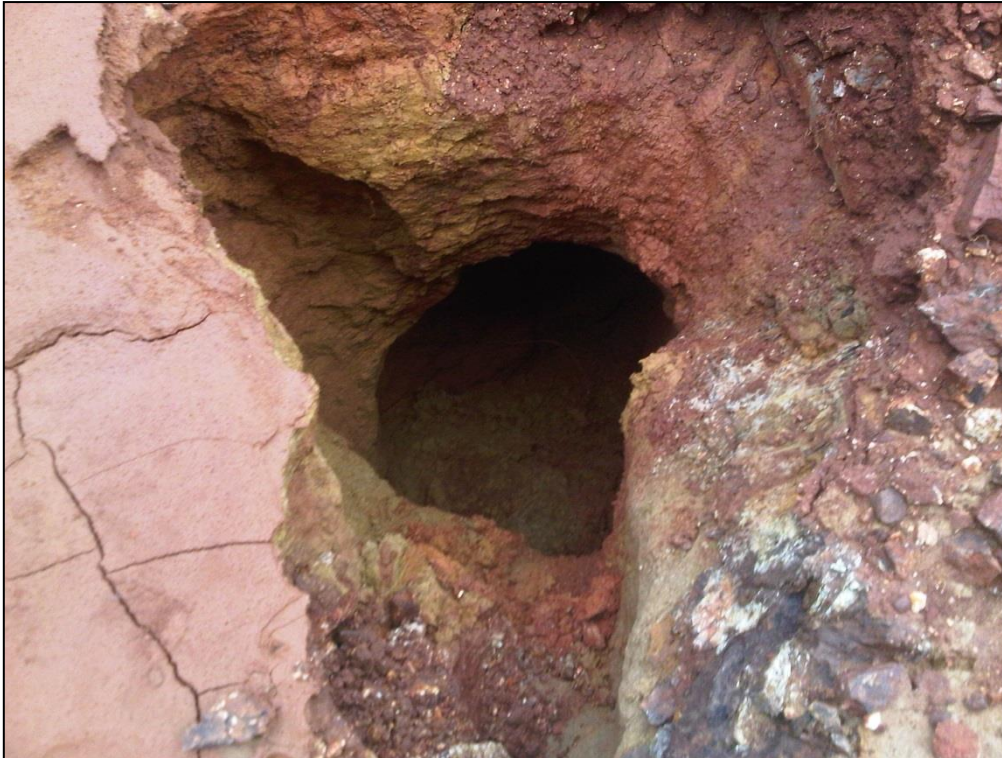
- Residual dolomite (wad with chert gravel) observed at the lower 0,5 m of the trench in the western side wall and residual syenite within the cavity with an erosion tunnel extending towards the west at depth (Plate G.2).
- No structural damages to the reservoir due to the formation of the sinkhole.
- A north-east to south-west aligned 500 mm diameter steel bulk water line connected to the Credi Reservoir is located approximately 3 m to the south of the sinkhole. A leak on the steel line approximately 1 m before it connects to the Credi Reservoir was repaired with a clamp, with water still running from the area repaired.
- A north-east to south-west aligned 110 mm diameter PVC water line located within the area of the trench and sinkhole.

**Plate G.2: Residual syenite visible in sinkhole sidewall and erosion tunnel.**

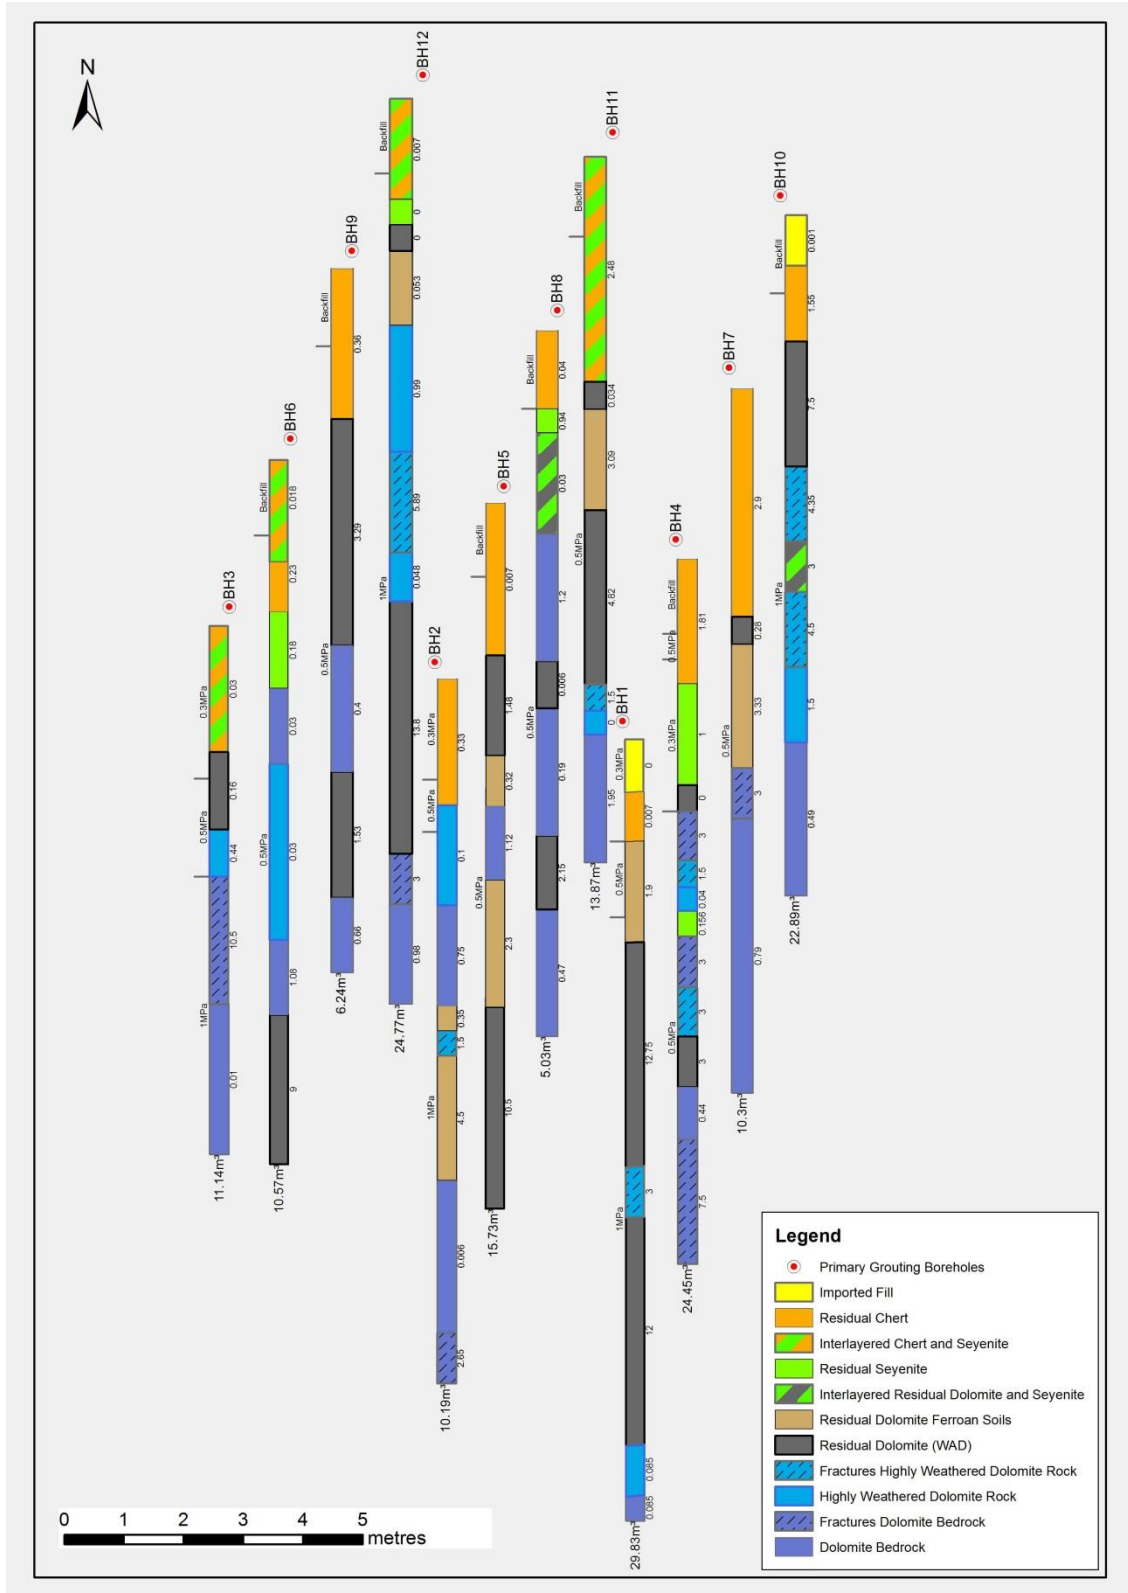
Figure G.4: Case Study 7 – Grouting boreholes with geological profile, grout volumes and pressure applied at depth.

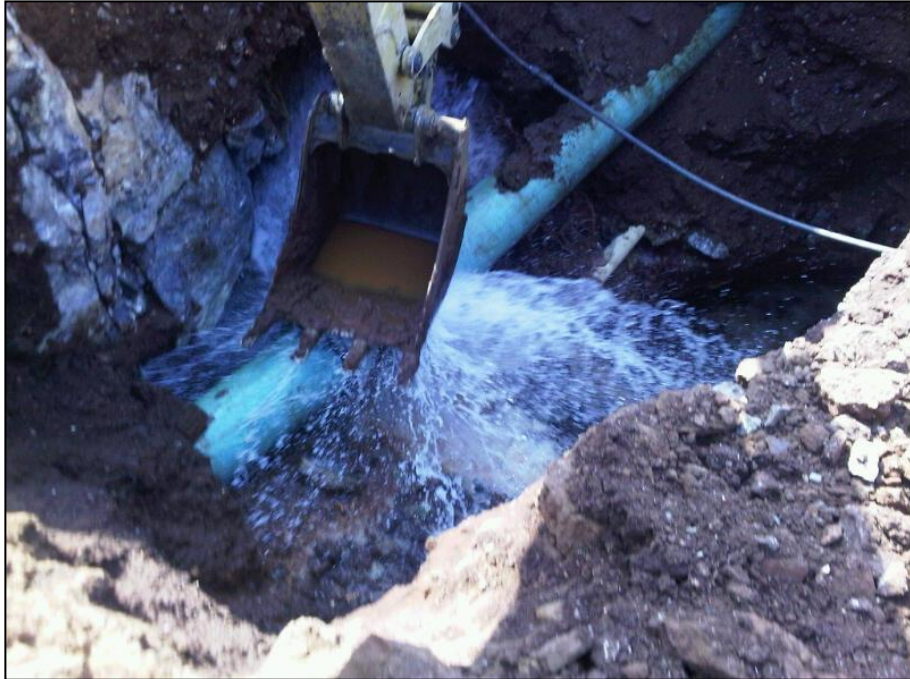
**Plate H.1: Water from broken water line disappearing along a subsurface erosion tunnel in a northerly direction.**

- Large volumes of water from the displaced 300 mm diameter waterline disappearing along a 1 m diameter size sub-surface erosion tunnel into a northerly direction, at the base of the sinkhole (Plate H.1). All leaks on the waterlines internal and bulk were repaired immediately by the Vosloorus Water Department and the affected area barricaded. The leak on the bulk water line was repaired with a steel clump. However, the bulk EMM water line started to leak within the same area where it was repaired, on 14 February 2012 and again on 18 March 2012. On both occasions the Vosloorus Water Department was informed about the leak and requested to repair the leak.
