**REHABILITATION OF SINKHOLES AND  
SUBSIDENCES ON DOLOMITIC LAND,  
EKURHULENI METROPOLITAN MUNICIPAL AREA  
OF JURISDICTION, GAUTENG, SOUTH AFRICA**

**Submitted in partial fulfilment of the  
requirements for the degree of Doctor of  
Philosophy in the Faculty of Natural and  
Agricultural Sciences**

**UNIVERSITY OF PRETORIA**

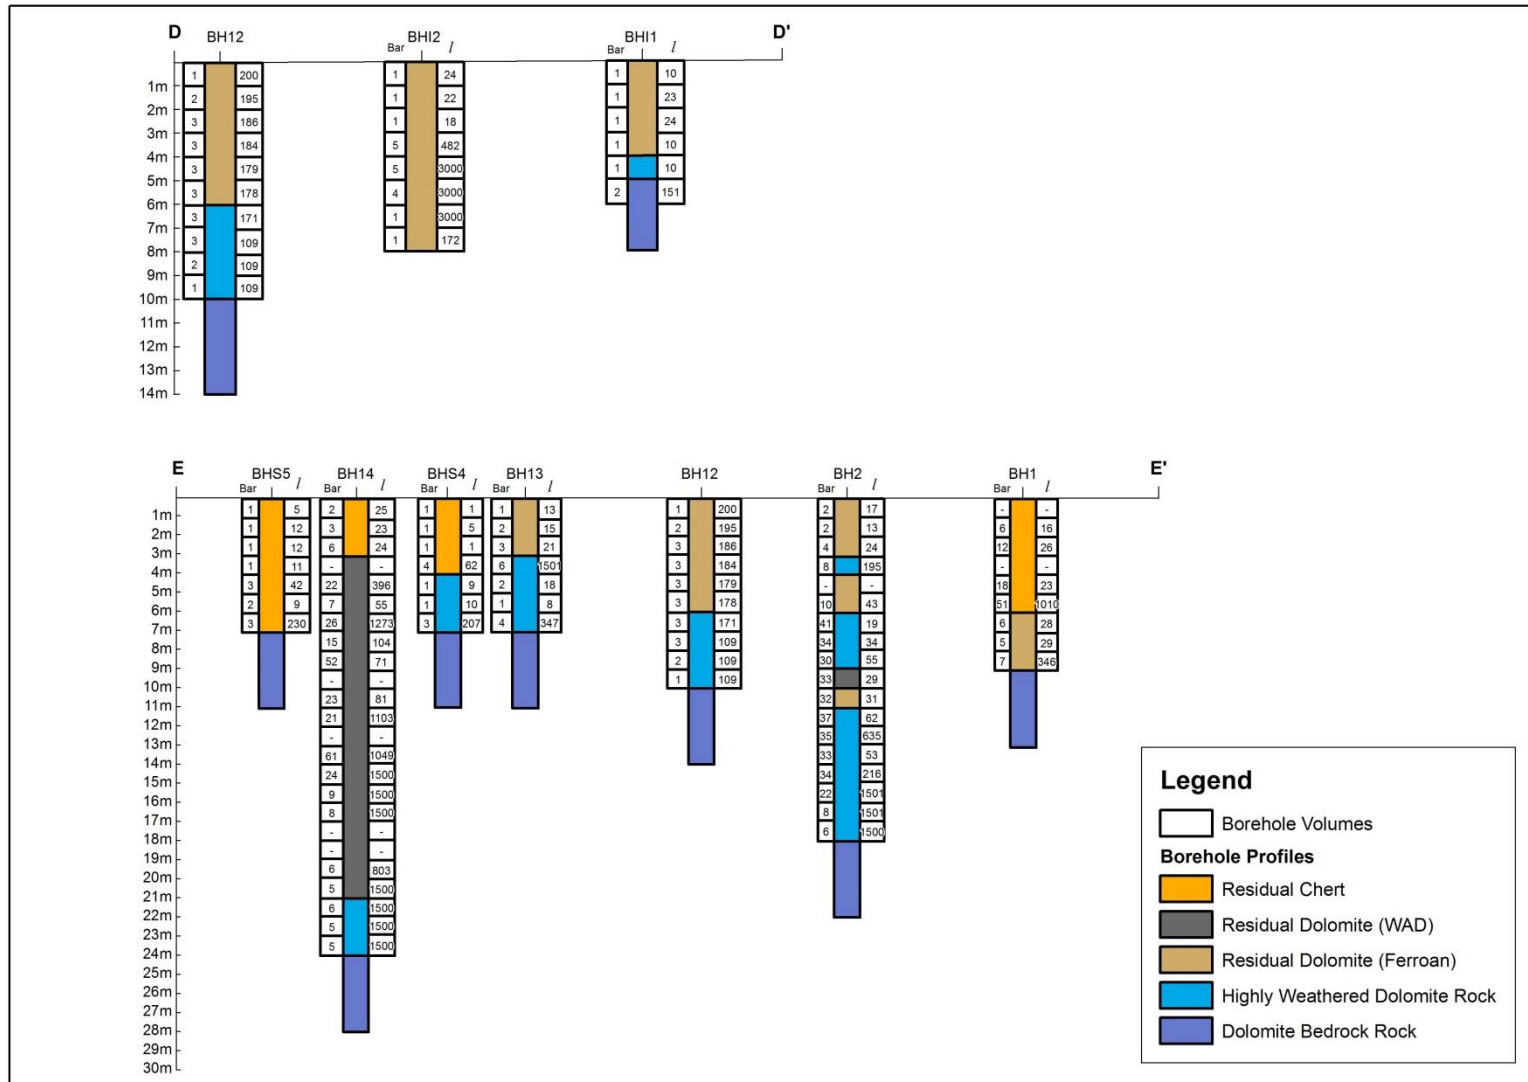
Figure H.6: Case Study 8 – Cross-Section D – D' and E – E' of grouting boreholes with geological profile, grout volumes and pressure applied.

As illustrated in Figure H.5 and Figure H.6, variable grout pressures were applied to inject the grout below ground surface ranging between 0,1 MPa (or 1 Bar) to 5,2 MPa (or 52 Bar).

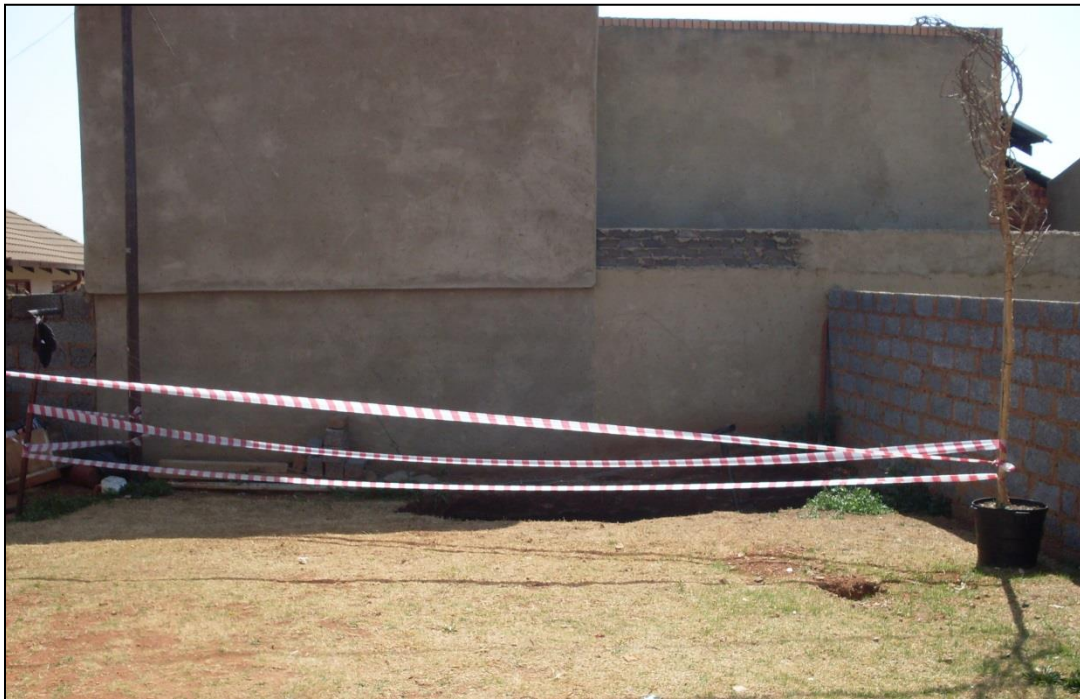
**Plate I.1: Sinkhole in north-eastern corner of Stand 20121, Vosloorus Extension 30.**

A sinkhole occurred in the north-eastern corner of Stand 20121 Vosloorus on 2 September 2009. The sinkhole, extending below a double storey house was caused by a leaking mid-block sewer line (Plate I.1). A sinkhole previously occurred on Stand 20121, due to a leaking internal sewer line in 2001 and the residential structure was demolished. The exact position and the rehabilitation process followed on the sinkhole that occurred during 2001, are unknown. A site inspection of the affected area was conducted on 3 September 2009 and revealed the following (Report Number VGI3118/245/1, September 2009):

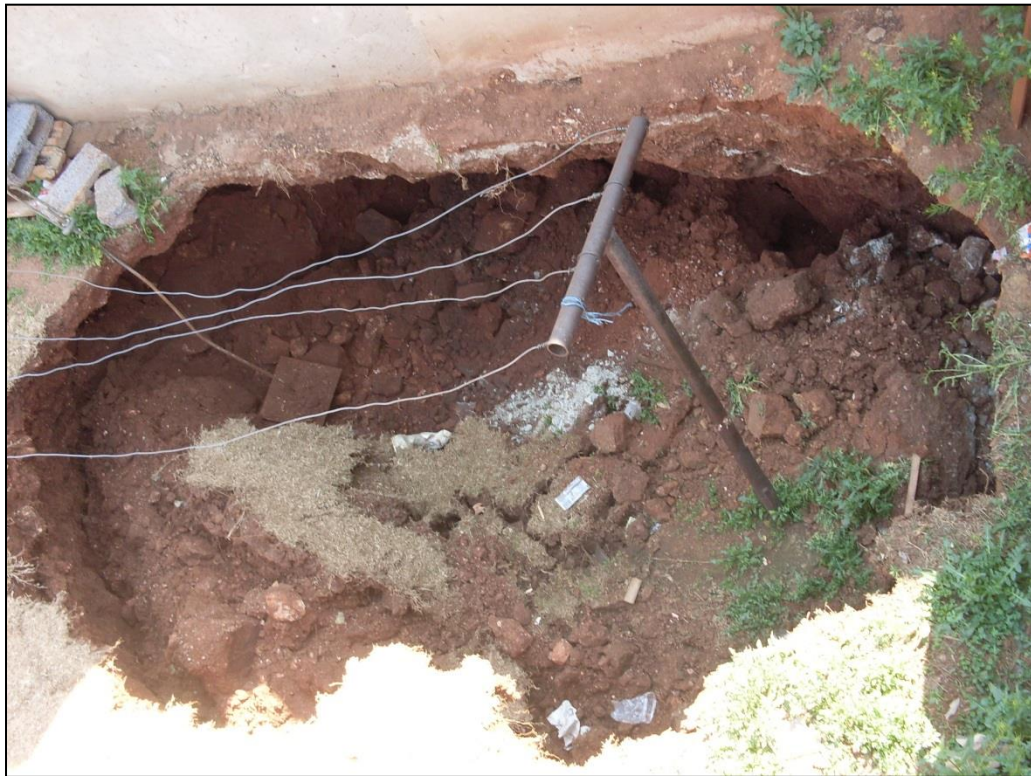
**Plate I.2: Close-up view of sinkhole on Stand 20121 Vosloorus Extension 30.**

- A sinkhole (dimensions of 4,5 m by 2 m extending to a depth of 2,5 m) occurred on the northern boundary of Stand 20121 and extended below the house on Stand 16303 (Plate I.2).
- East to west aligned wet services, including sewer and water were located within the area of the sinkhole. A sewer manhole is located directly east of the sinkhole.
- An east to west aligned overhead electrical cable is also located in the area of the sinkhole.
- Very recent additions (as observed from aerial photos) to the house on Stand 16303 including a double storey structure extending over the building line and wet services servitude area. The additions are not according to Building Regulations.
- No structural damage was observed to the house located partially on the sinkhole.

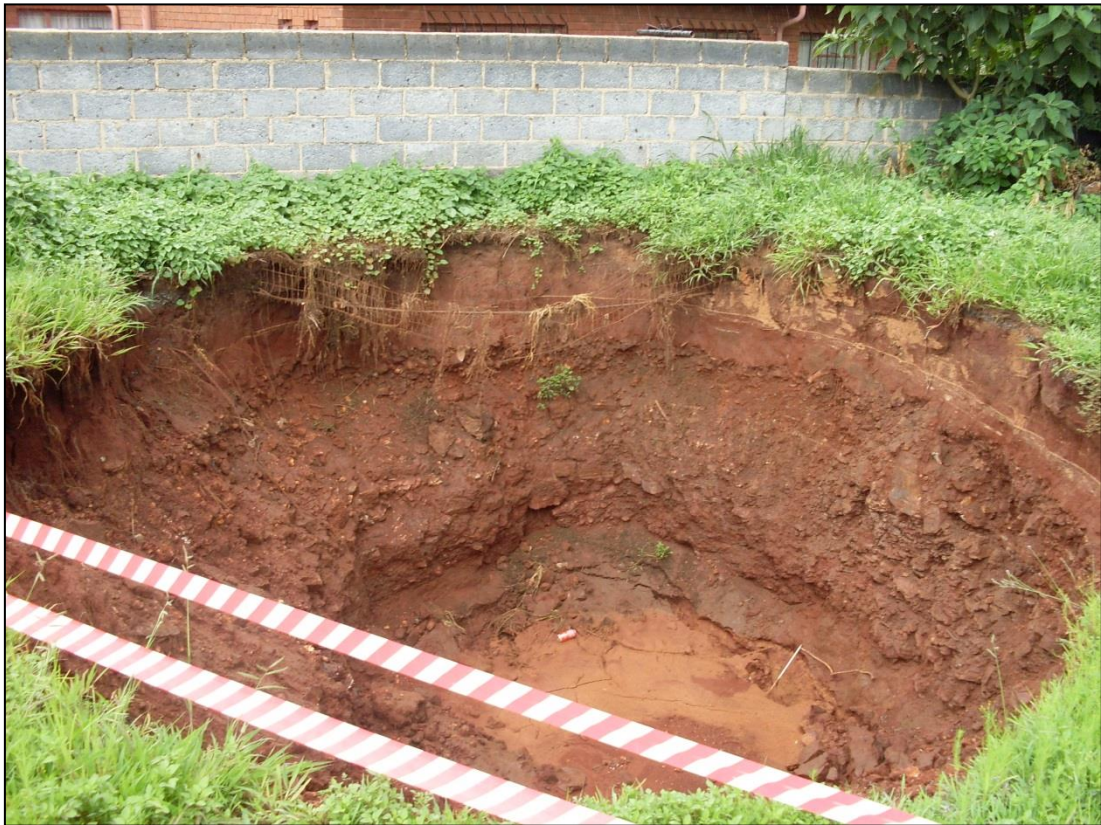
**Plate J.1: Sinkhole on Stand 2, Tembisa, photo taken towards the west.**

- A 7 m diameter sinkhole extending to a depth of approximately 5 m below natural ground surface (Plate J.1). Situated 0,5 m from the boundary wall between Stand 1430 and Stand 2 in an open field.
