**Advances in dolomite land risk assessment for safe  
development within the current legislative framework: the  
case of Khutsong North in Merafong City, Gauteng  
Province, South Africa**

Dissertation submitted in fulfilment of the requirements for the degree,

M.Sc. in Engineering Geology

University of Pretoria

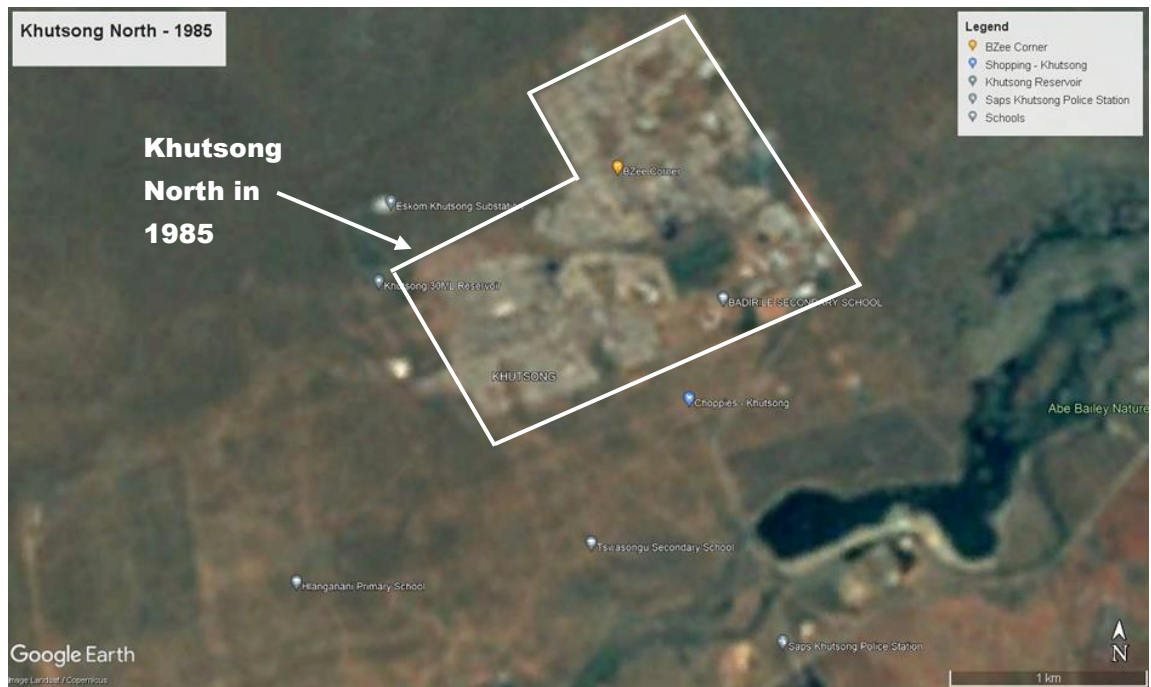
**Figure 1:** Shows only Khutsong Proper existed in 1985 (Google Erath Images, 2022).

However, the MCLM has continued to approve building projects in KNT’s without strictly enforcing the SANS 1936:2012 requirements. Therefore, a steady spatial densification at KNT’s has taken place since the first house was constructed over 60 years ago and that directly translates into an increased number of people per hectare and higher density of wet services network in the area. Google Earth images, Figure 1 to 3 were used to illustrate spatial change across Khutsong North over time.

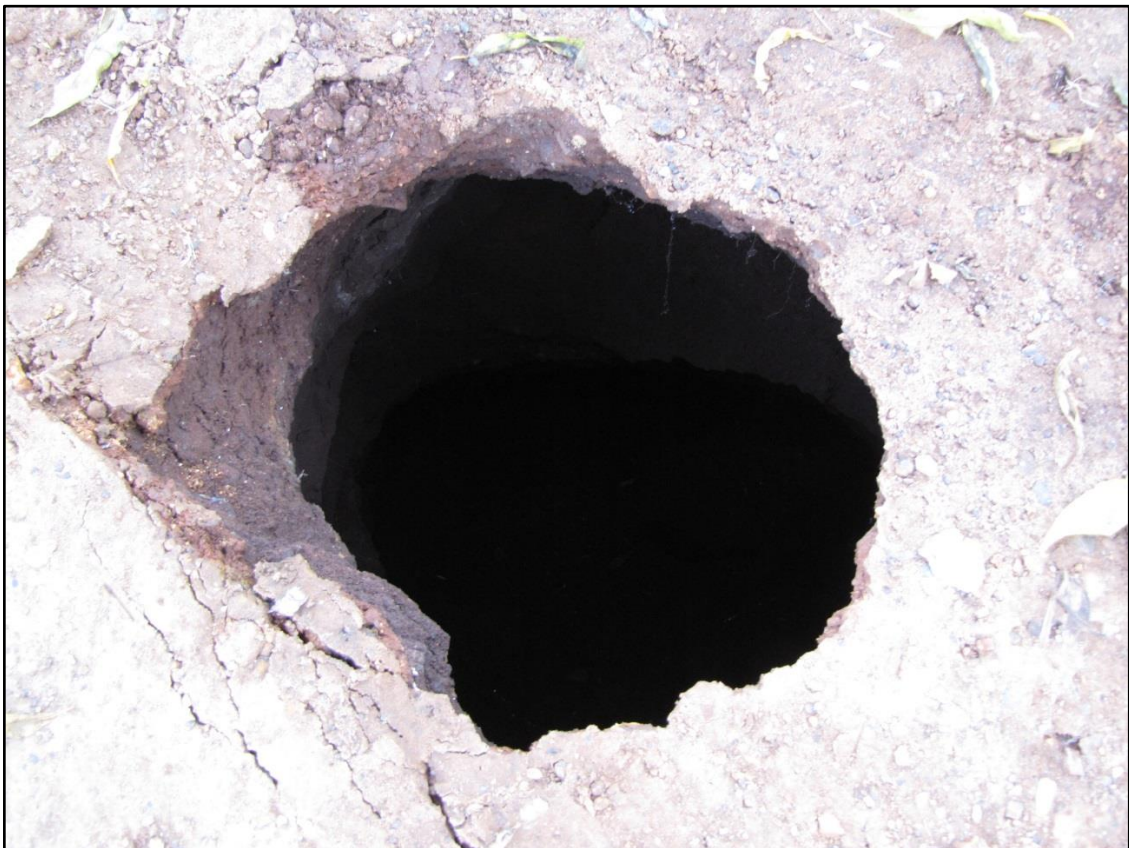
**Figure 11:** Recently collapsed arch forming a small sinkhole (Photo from CGS Database).

Figure 11 and 12 show a recently collapsed arch (crown) forming a small sinkhole in Khutsong North

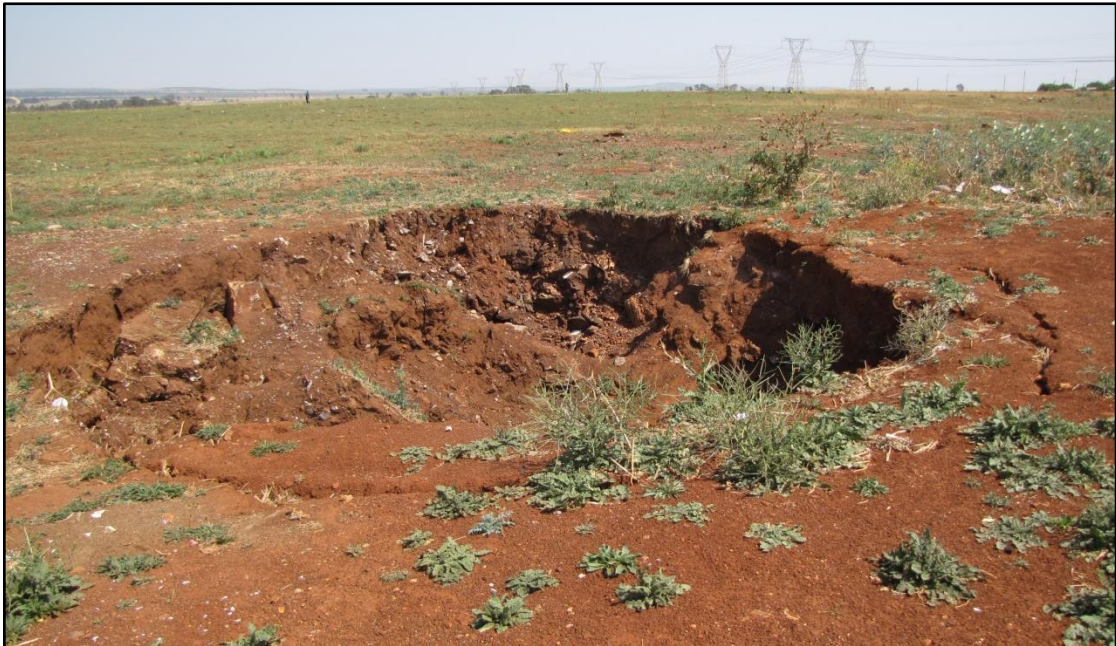
**Figure 13:** Recent caving of the ground surface forming a subsidence (Photo from CGS Database).

Figure 13 and 14 show a recent caving of the ground surface forming a small compaction subsidence in Khutsong North.

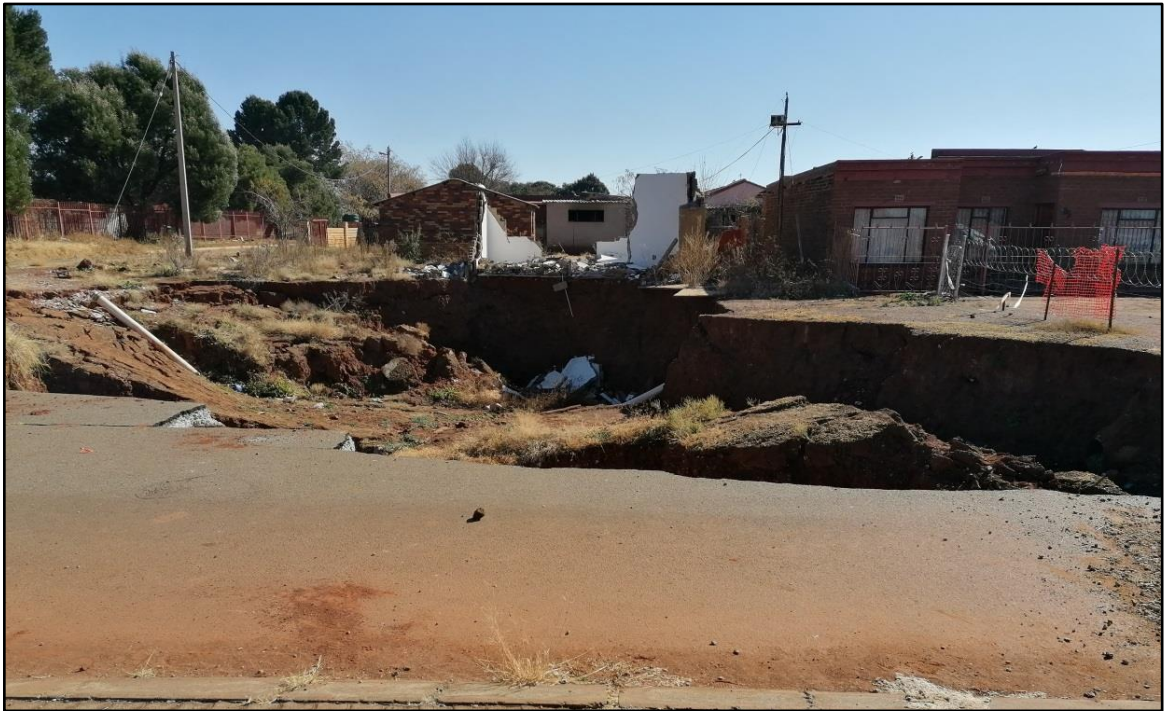
**Figure 22:** A very large sinkhole (>15m diameter) at Nxumalo Road, Khutsong Proper.

This sub-section encompasses site walk-over surveys, mapping of open sinkholes and sewer leakage and sewage ponding areas (Figure 22 and 23). Site walk-over surveys were conducted to allow first hand observations on the geology of the area and anthropogenic issues like the widespread ponding of sewage across KNT's. These

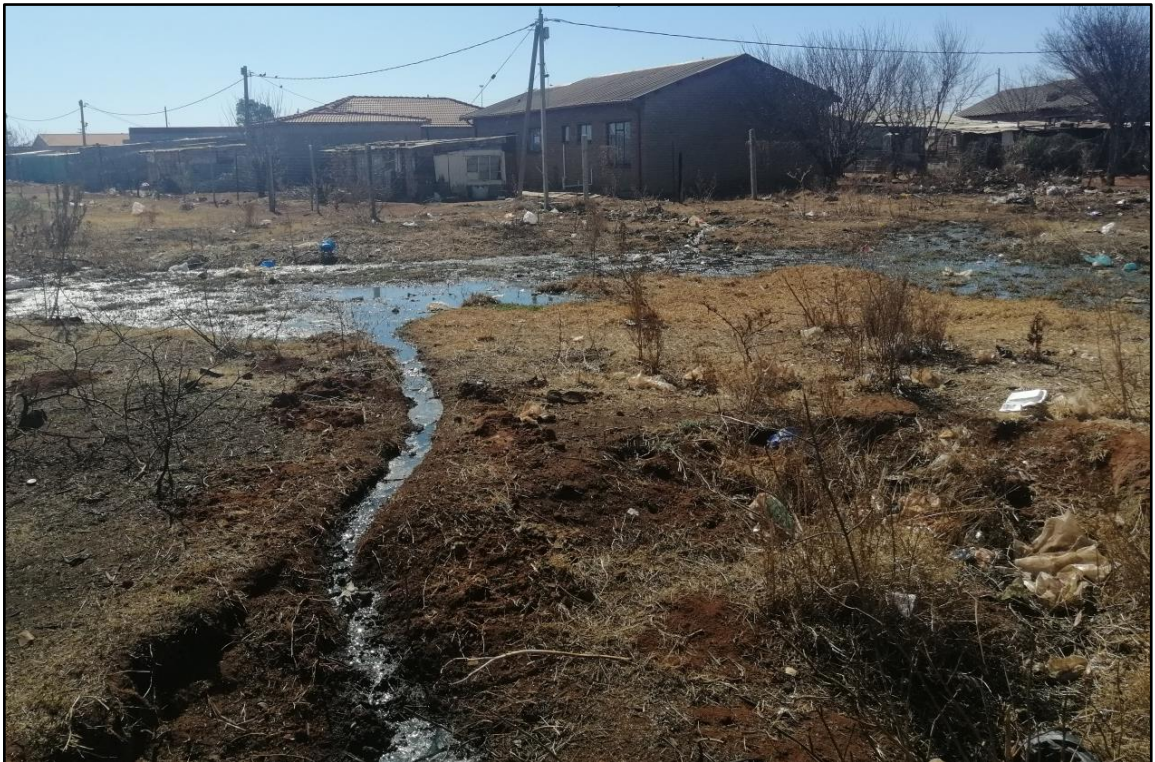
**Figure 23:** Blocked and back-ponding sewage effluent flowing into open field and sinkholes.

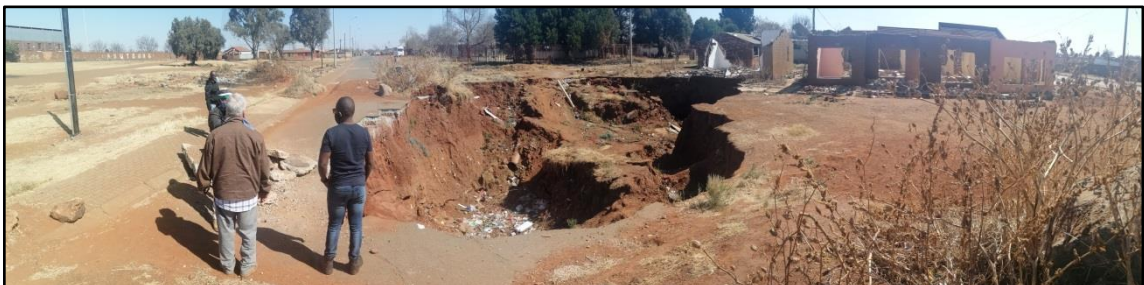
**Figure 37:** A very large sinkhole causing damage to main Nxumalo Road, Khutsong Proper.

Figure 37 indicates the damage to two houses caused by a very large sinkhole on a busy Nxumalo Road in Khutsong Proper. This sinkhole was reported as being caused by decaying old wet services infrastructure traversing the area.

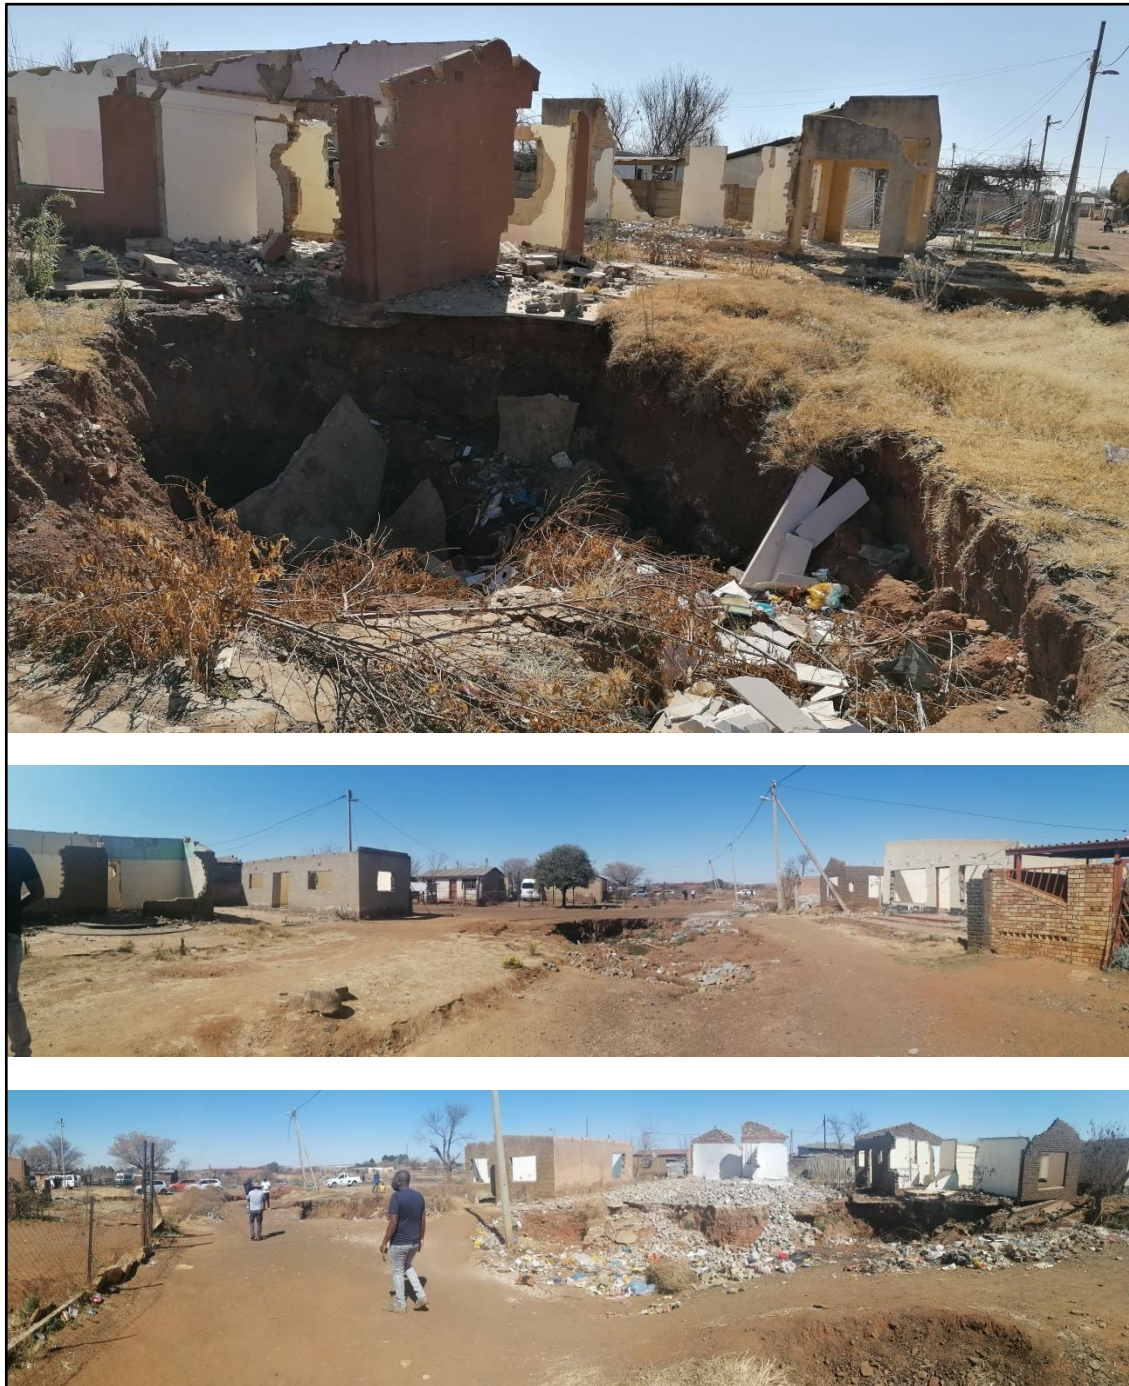
**Figure 38:** Trail of destruction to housing at Adatite Street, Khutsong Proper.

Figure 38 shows a trail of destruction caused by a series of sinkholes that occurred in Adatite Street, Khutsong Proper. These sinkholes occurred due to poor storm water management, which caused damage to water and sewer lines leading to widespread leaking and back ponding of sewage.

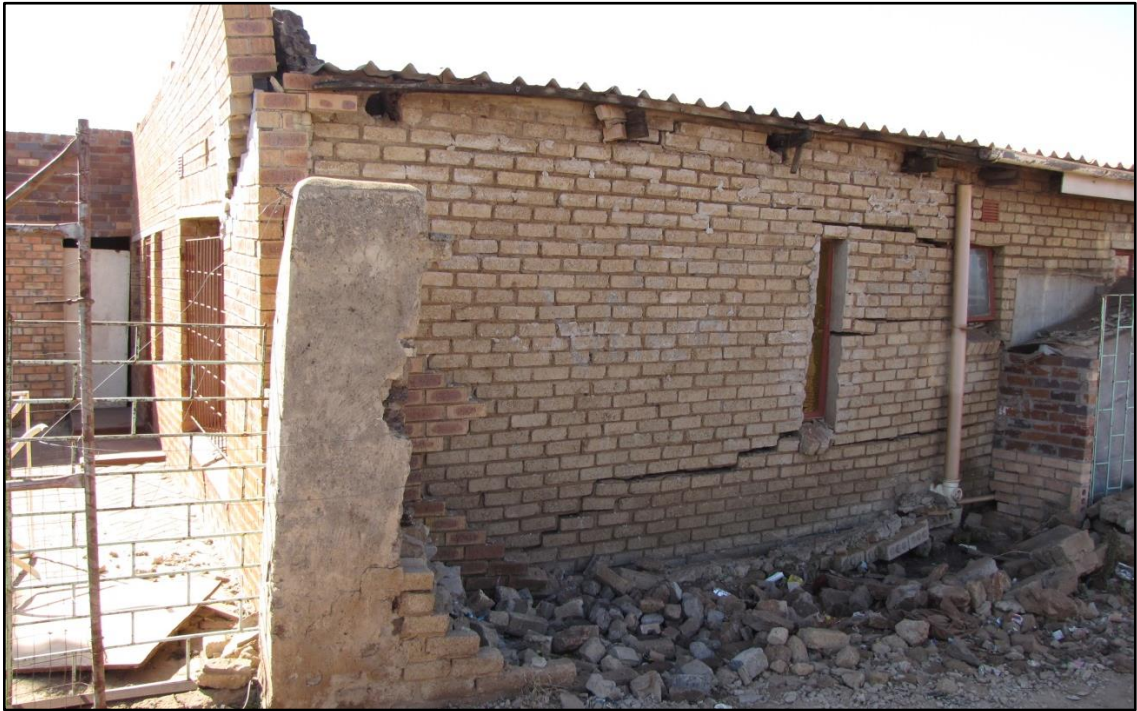
**Figure 39:** A subsidence forming against the house casing a severe wall distress, Khutsong Extension 3.

Figure 39 and 40 shows a subsidence forming against the house wall causing severe wall distress (cracks) and structural deformation in Khutsong Extension 3. This subsidence was caused by a leaking sewer/ waste water pipe from the house.

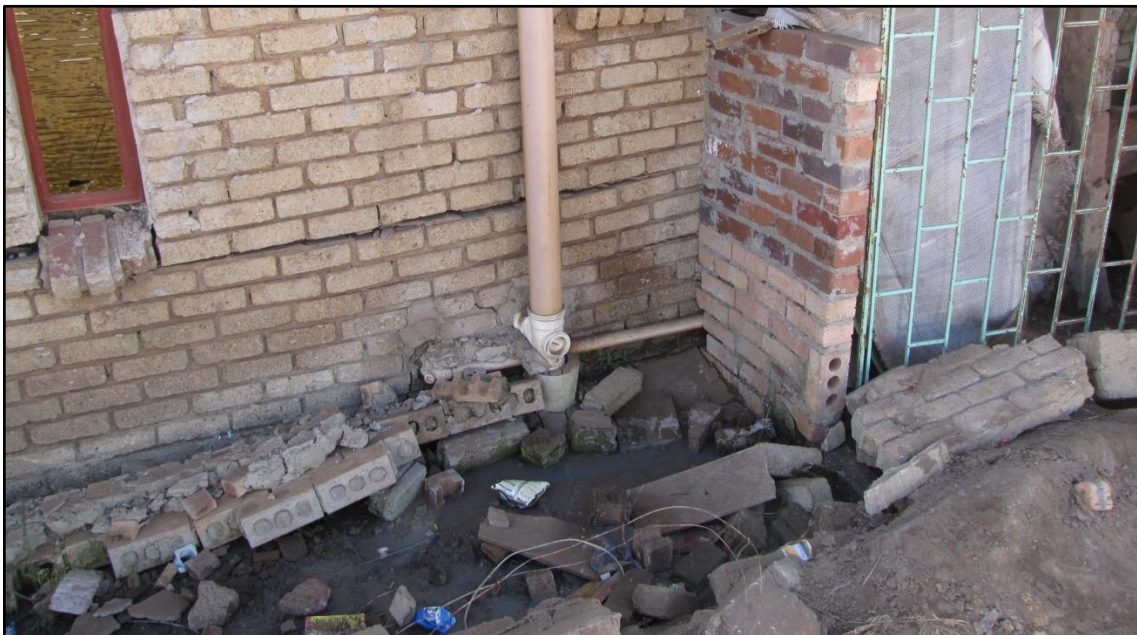
**Figure 40:** Sewage damming against the wall, Khutsong Extension 3.

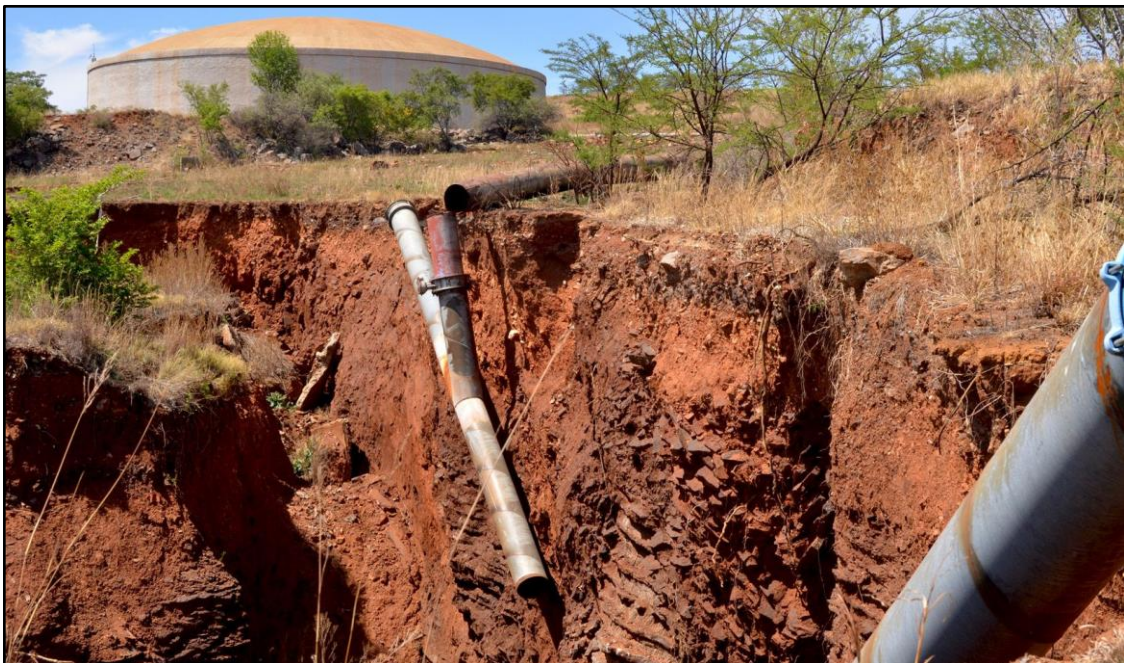
**Figure 42:** Damage to a bulk water supply pipeline, Carletonville area.

Figure 42 shows a bulk water supply pipeline linking a reservoir to Khutsong South, Khutsong North Extensions and Waverdiend that fell into a sinkhole, leaving many homes and businesses without piped water for months.

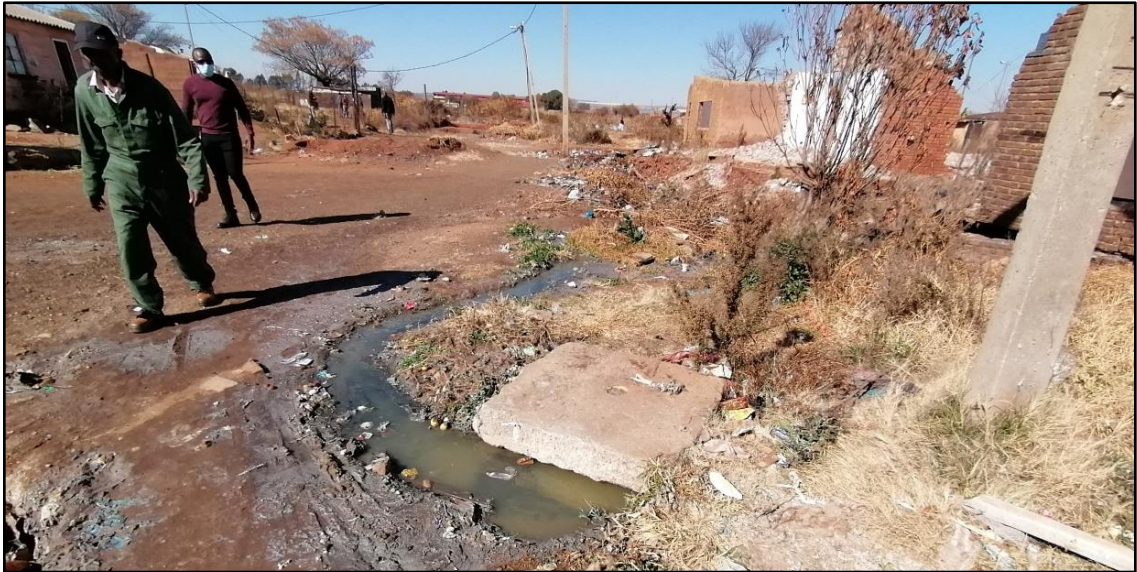
**Figure 43:** Broken, blocked and back ponding sewer line at Adatite Street, Khutsong Proper.

Figure 43 shows an overflow from a municipal manhole due to back ponding of sewer and effluent is now flowing into an existing sinkhole in Khutsong Proper. The back ponding has caused problems for residents in Adatite Street and the situation means that some basic human rights have been violated, i.e. the right to an environment that is not harmful to their health or well-being as sewer effluent is back ponding into house toilets.

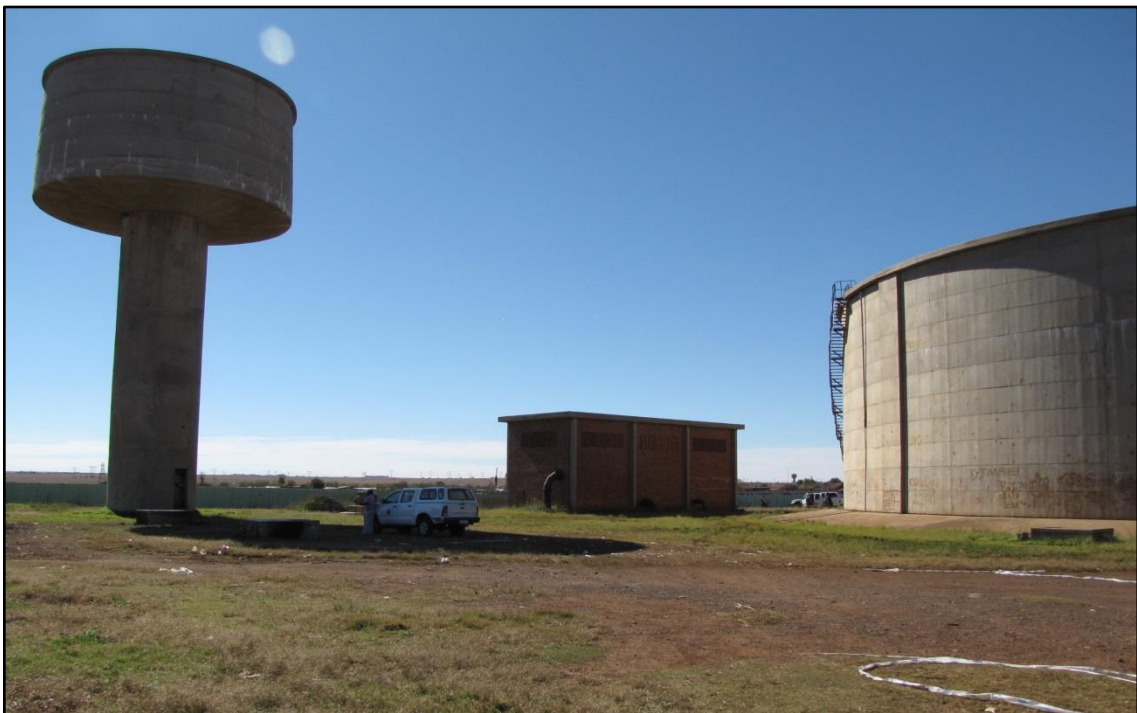
**Figure 44:** A decommissioned Khutsong Main Reservoir, border of Khutsong Extension 3 and 6.

Figure 44 shows Khutsong Main Reservoir (Khutsong North) and related infrastructure. In 2015, the floor of the main reservoir failed likely due to a sinkhole leading to a severe leaking and water losses. The reservoir was decommissioned in July 2016 due to flooding of the surrounding areas and subsidence formation.
