# 5

## DESIGN DISCOURSE

## 5.1 BUILDING EVALUATION

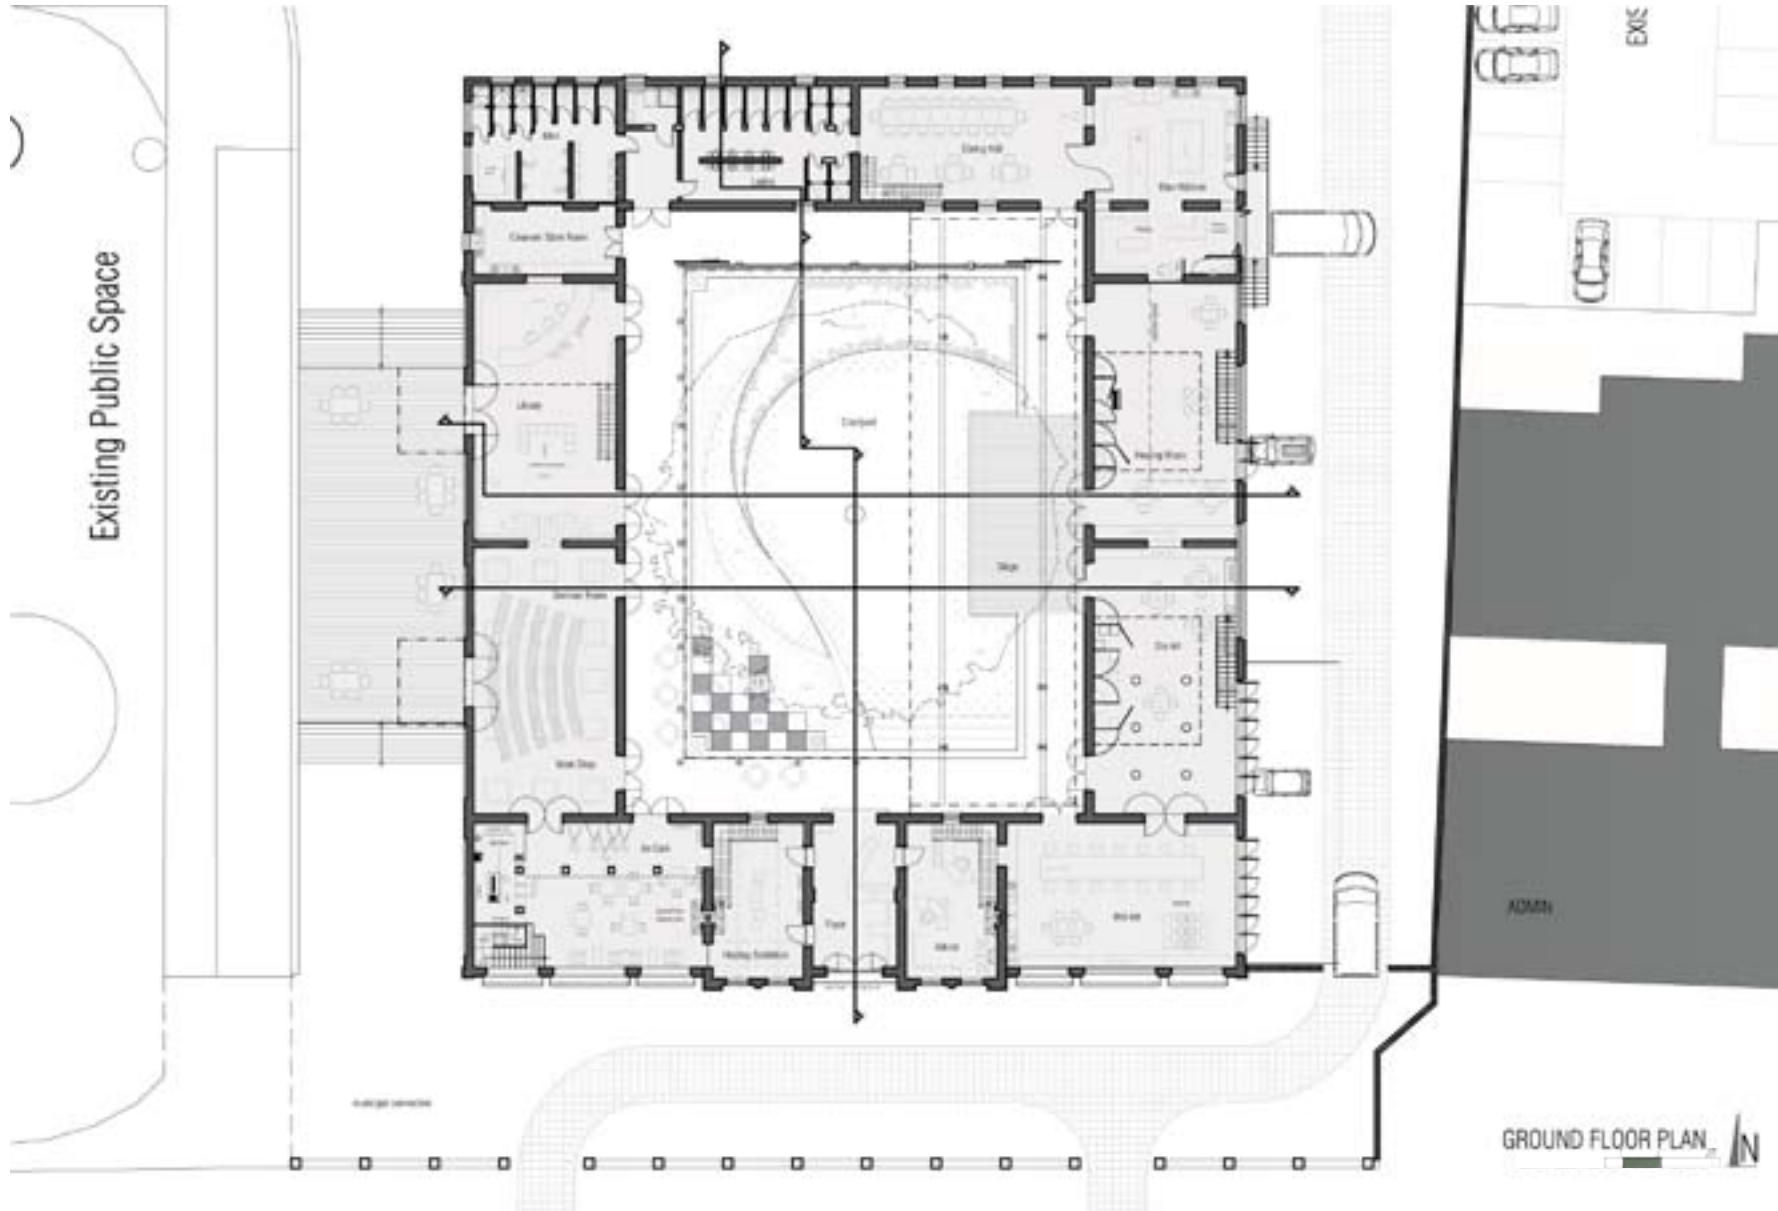
Figure 77: Ground Floor Plan of the Healing Activities Centre

Apart from the above mentioned zones, the centre needs other zones too to be fully functional. These include the reception and waiting area, the exhibition space, an admin block, accommodation facilities, delivery point, cleaner's store room and ablution facilities. (Figure 77)

Art therapy was split in two- the Wet Art and Dry Art. Wet art was placed in the eastern end of the street facade. The newly inserted 'window boxes' will allow the passerby to be drawn into the space, linking the outside with the inside. New doors are added to the eastern facade, where the participants have the freedom to move outside on the deck. The Wet Art room also provides for a corner, where aroma foot baths can take place. These are of course moveable and can happen anywhere. Placed in the Wet Art room, the scent will travel out luring the pedestrian in. All wet types of therapies are grouped in this room. (Figure 74, 77)

Dry art is located in the southern half of the eastern wing, having direct access to the Wet art room. This room makes spaces for occupational therapy forms and quieter therapy. Due to enough floor to ceiling height (5.8 m) a mezzanine level is added, providing for additional therapy rooms and offices. The mezzanine system is later discussed in detail. As art therapy overlaps with drama, provisions for a stage are made. (Figure 74, 77)

Music therapy in turn flows over into dancing performances. Art- and Music therapy are therefore placed next to each other, so they can share a stage. Moreover, these two therapy types are placed in the eastern wing, which has been damaged by the former courtyard addition. (refer back to 'building evaluation') As a result, this wing allows for a greater design intervention. (Figure 74, 77)

The northern wing's ground- and first floor are seen as more private and are also treated accordingly. These floors would accommodate groups that book the centre for a specific time period. The main kitchen would provide them with meals, while it can also compliment the coffee shop. (Figure 74, 77)

Different levels and textures make up the courtyard. The aim of the courtyard is to bring all therapy types together, in order to optimize sensory integration. A sand pit runs along the western veranda edge. 'Chess' blocks, which are on the same height level as the veranda floor, are imbedded into the sand. Coffee tables and chairs will fill this surface as continuation of the coffee shop. (Figure 77, 82)

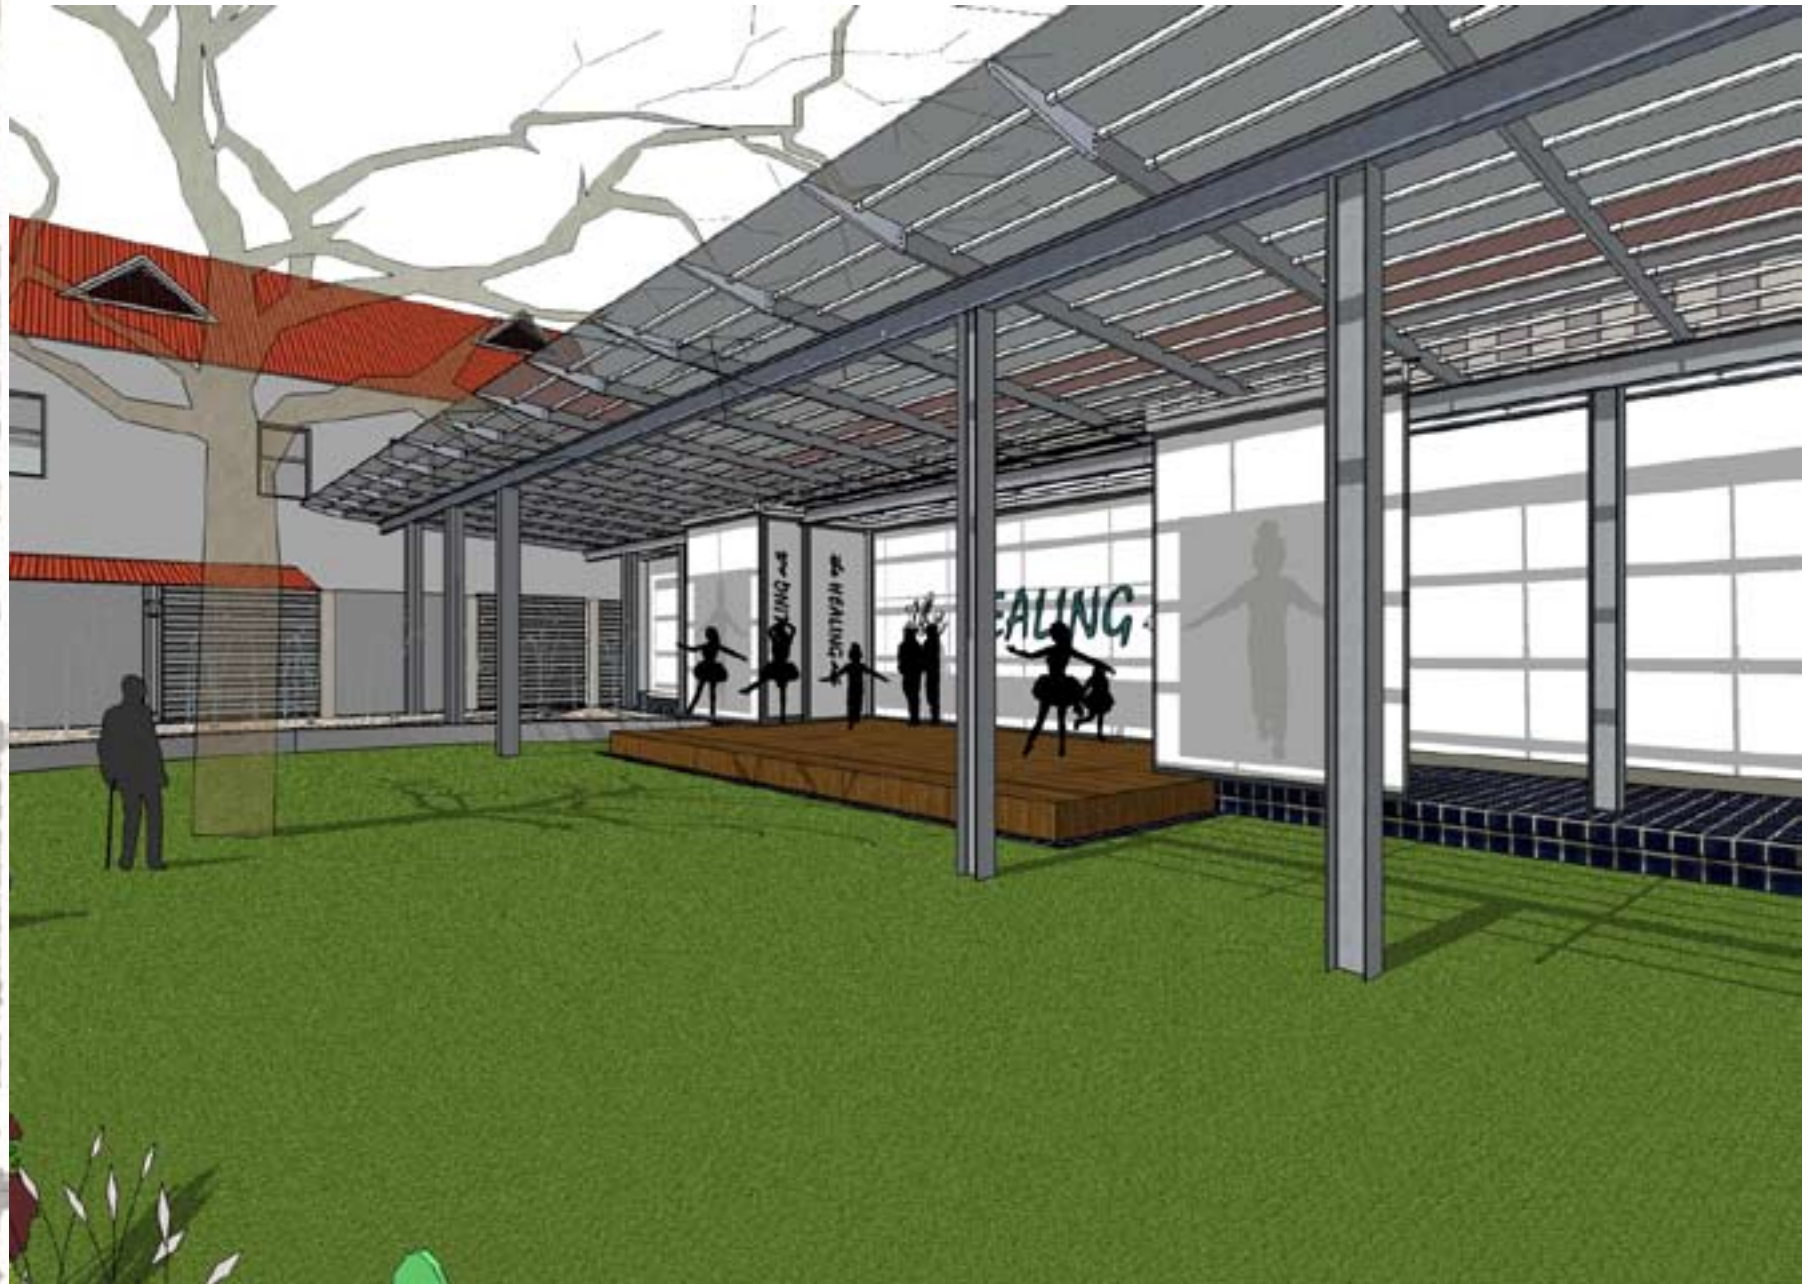
Figure 79(e): Pavilion Structure in context

SPATIAL ADDITIONS	Courtyard: By having added the this wing extension, the original veranda was destroyed, leaving the courtyard bleak to the eastern side. The overall courtyard atmosphere is broken and lonely (Image 4).	This later addition (1960's), for the purpose of the newly proposed therapy centre, will be removed and the veranda will be reinstated. A veranda roof will be added again, but speaking of a different time layer. A play of light is created by the use of material, casting rhythmical shadows.	
		Furthermore, a stage is added in front of the music and art therapy rooms. As these therapy types overlap with dancing and acting respectively, shows will take place inside the courtyard (Figure 79e).

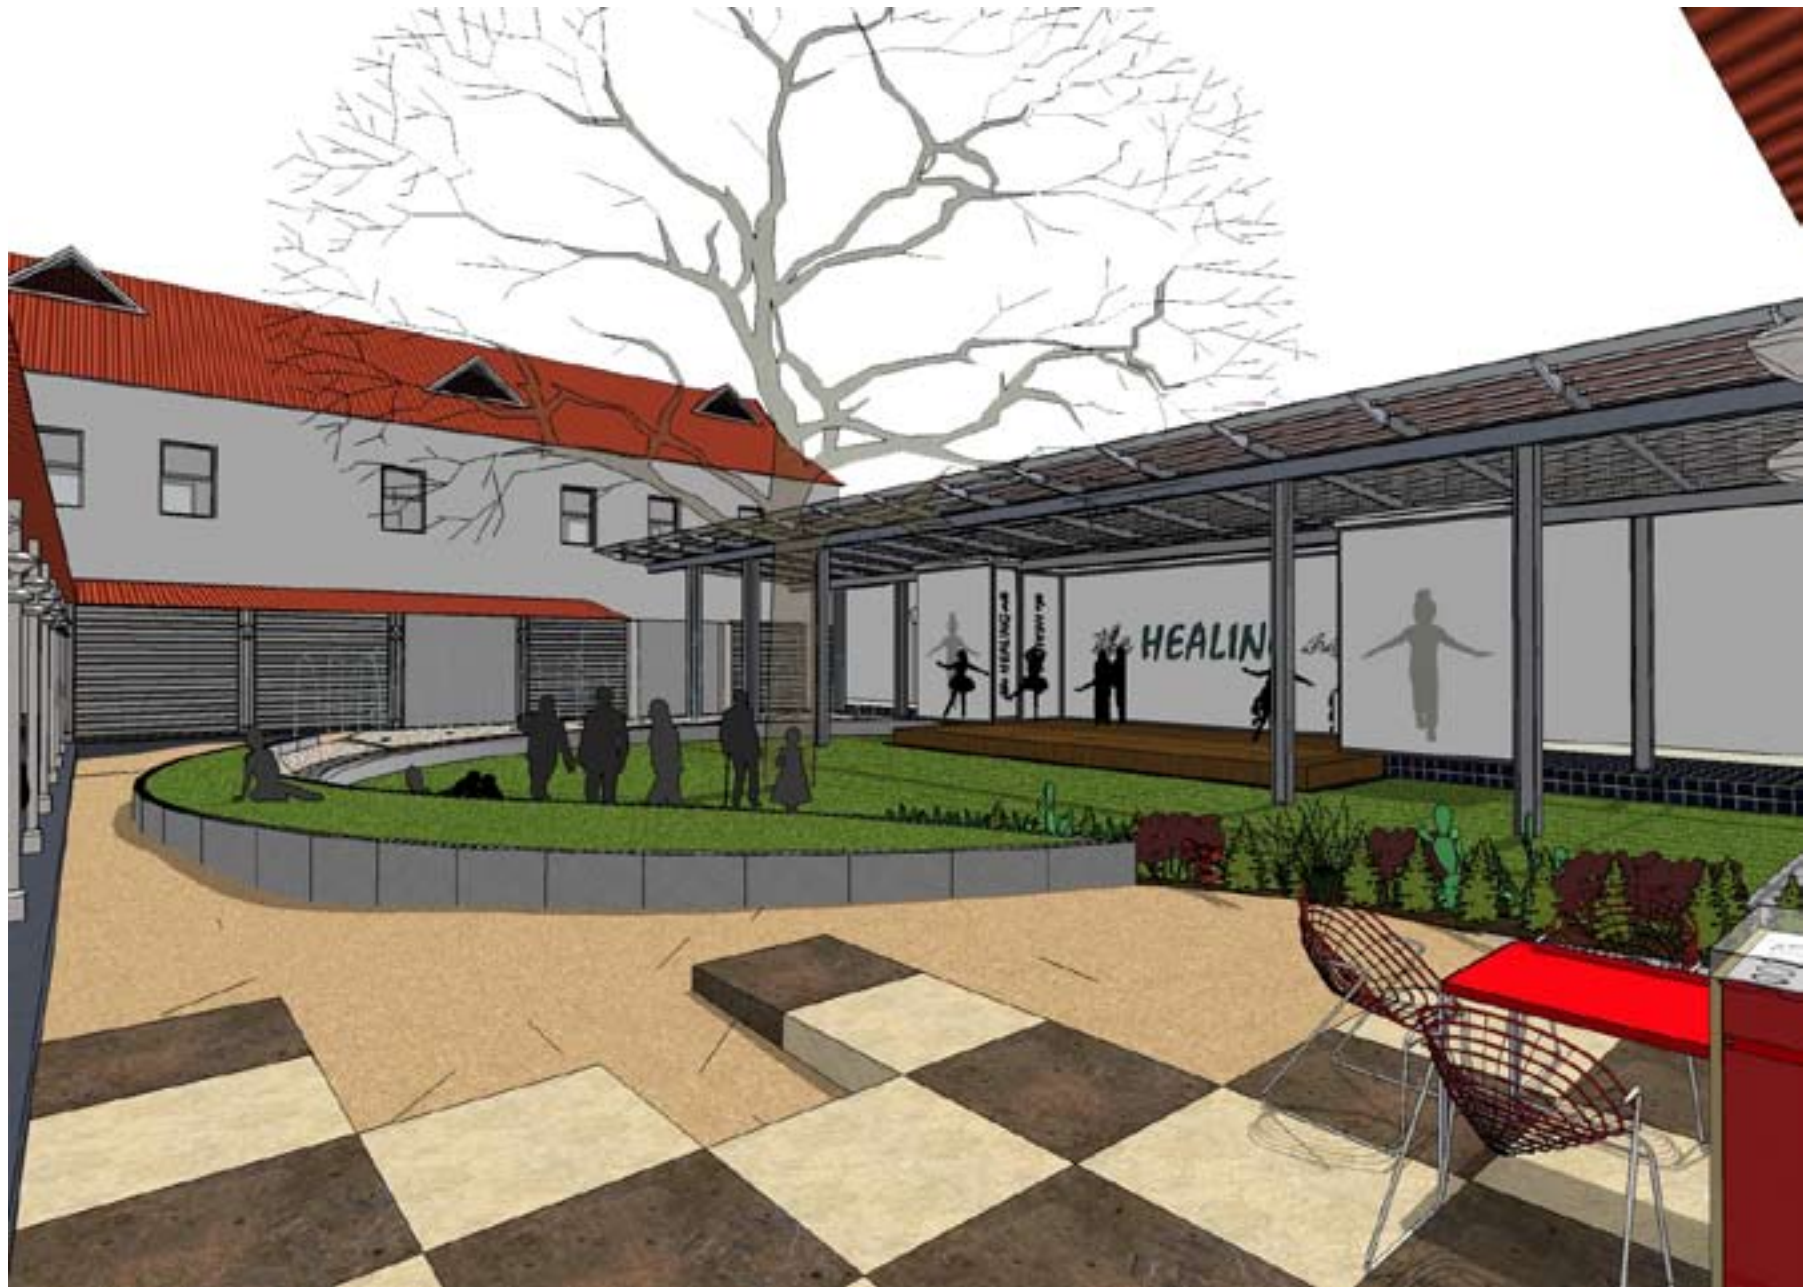
Figure 82: Extended coffee area into courtyard

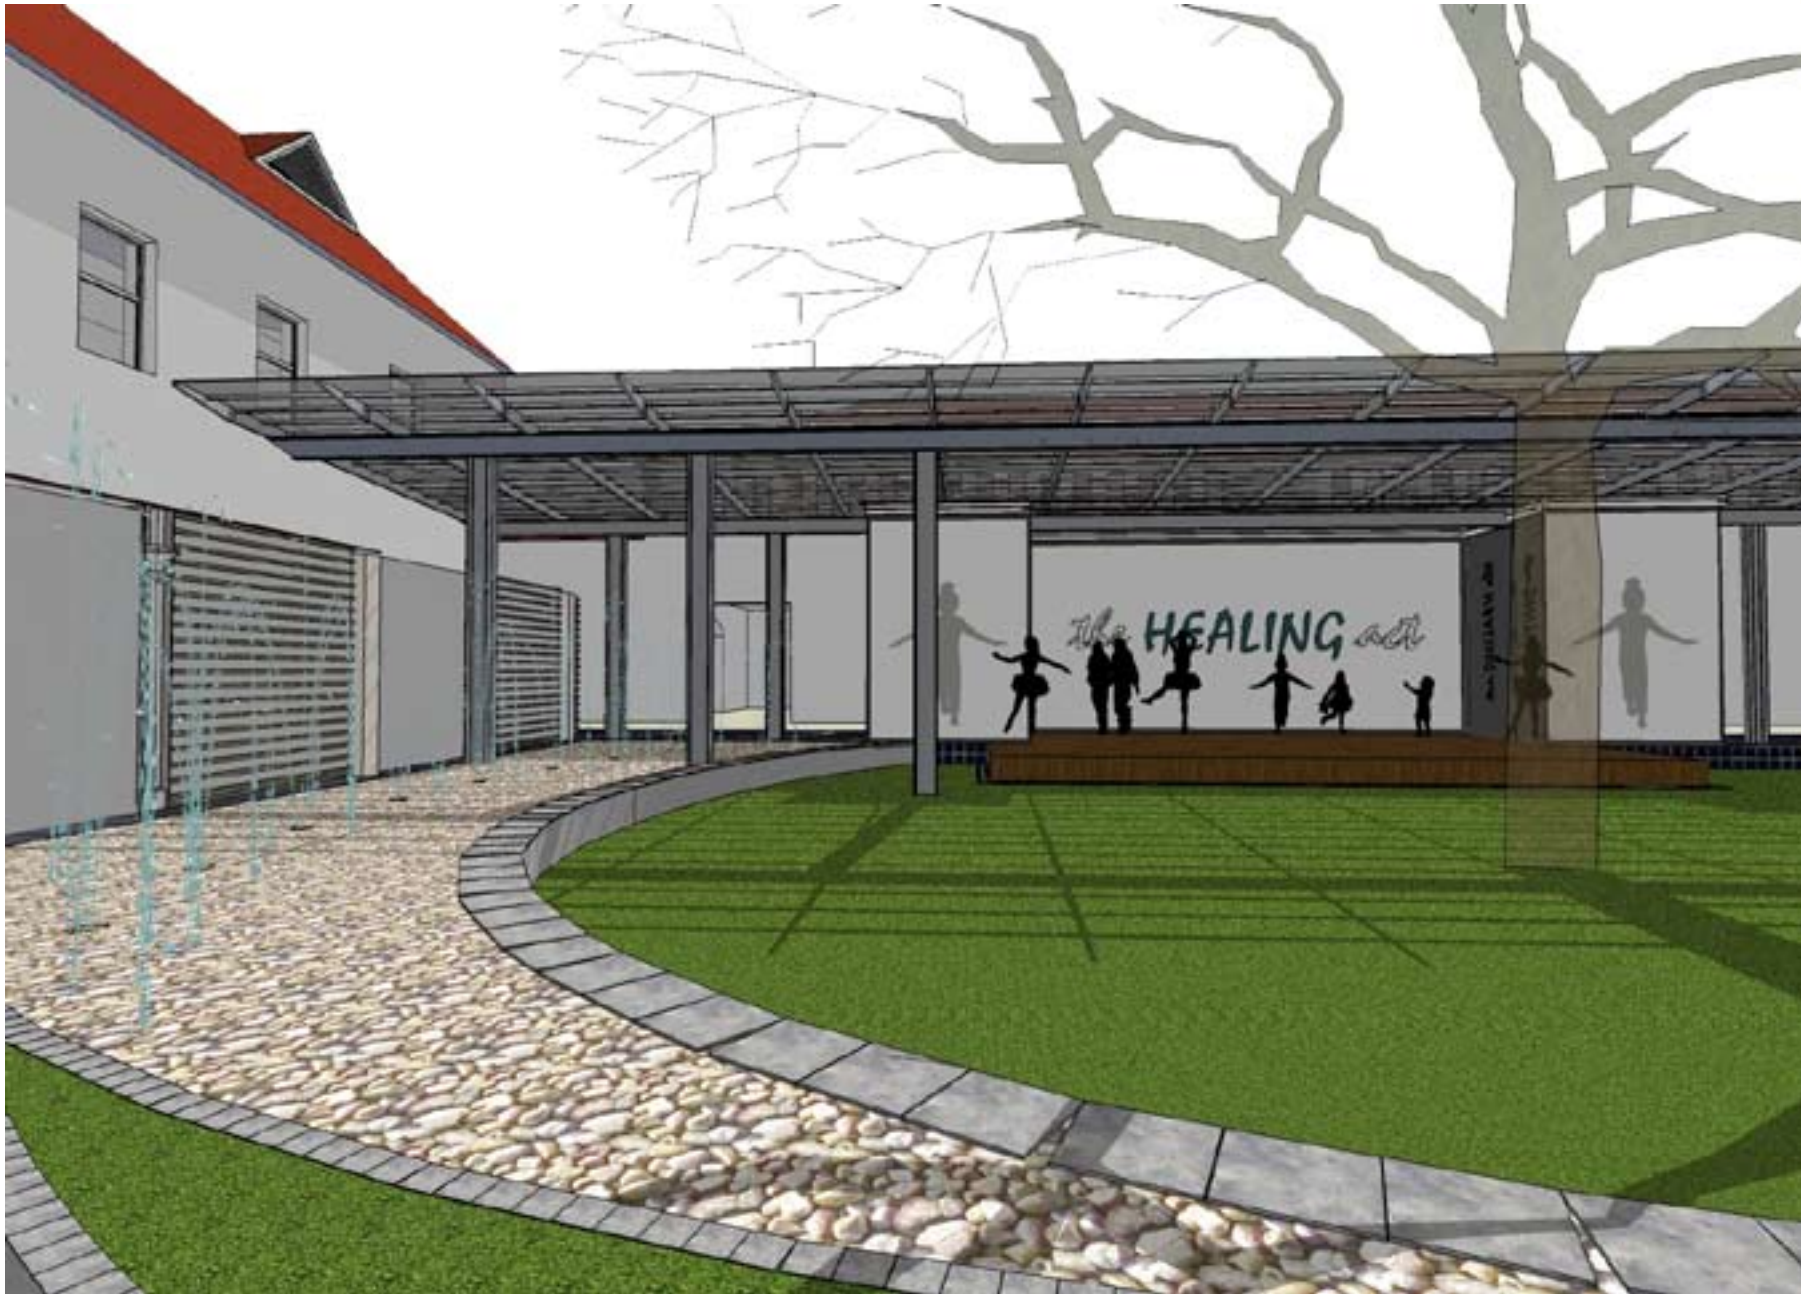
Figure 83: Pebble bed and water feature. The different hight levels create seating opportunity.

A pebble bed lines the northern edge. Water spouts are strategically placed inbetween the pebbles, so that water squirts form a pattern. This pattern changes height and rhythm, almost playing with onlooker. The sound of the water squirts collapsing onto the pebbles is therapeutic and will affect any person in the courtyard. (Figure 83)

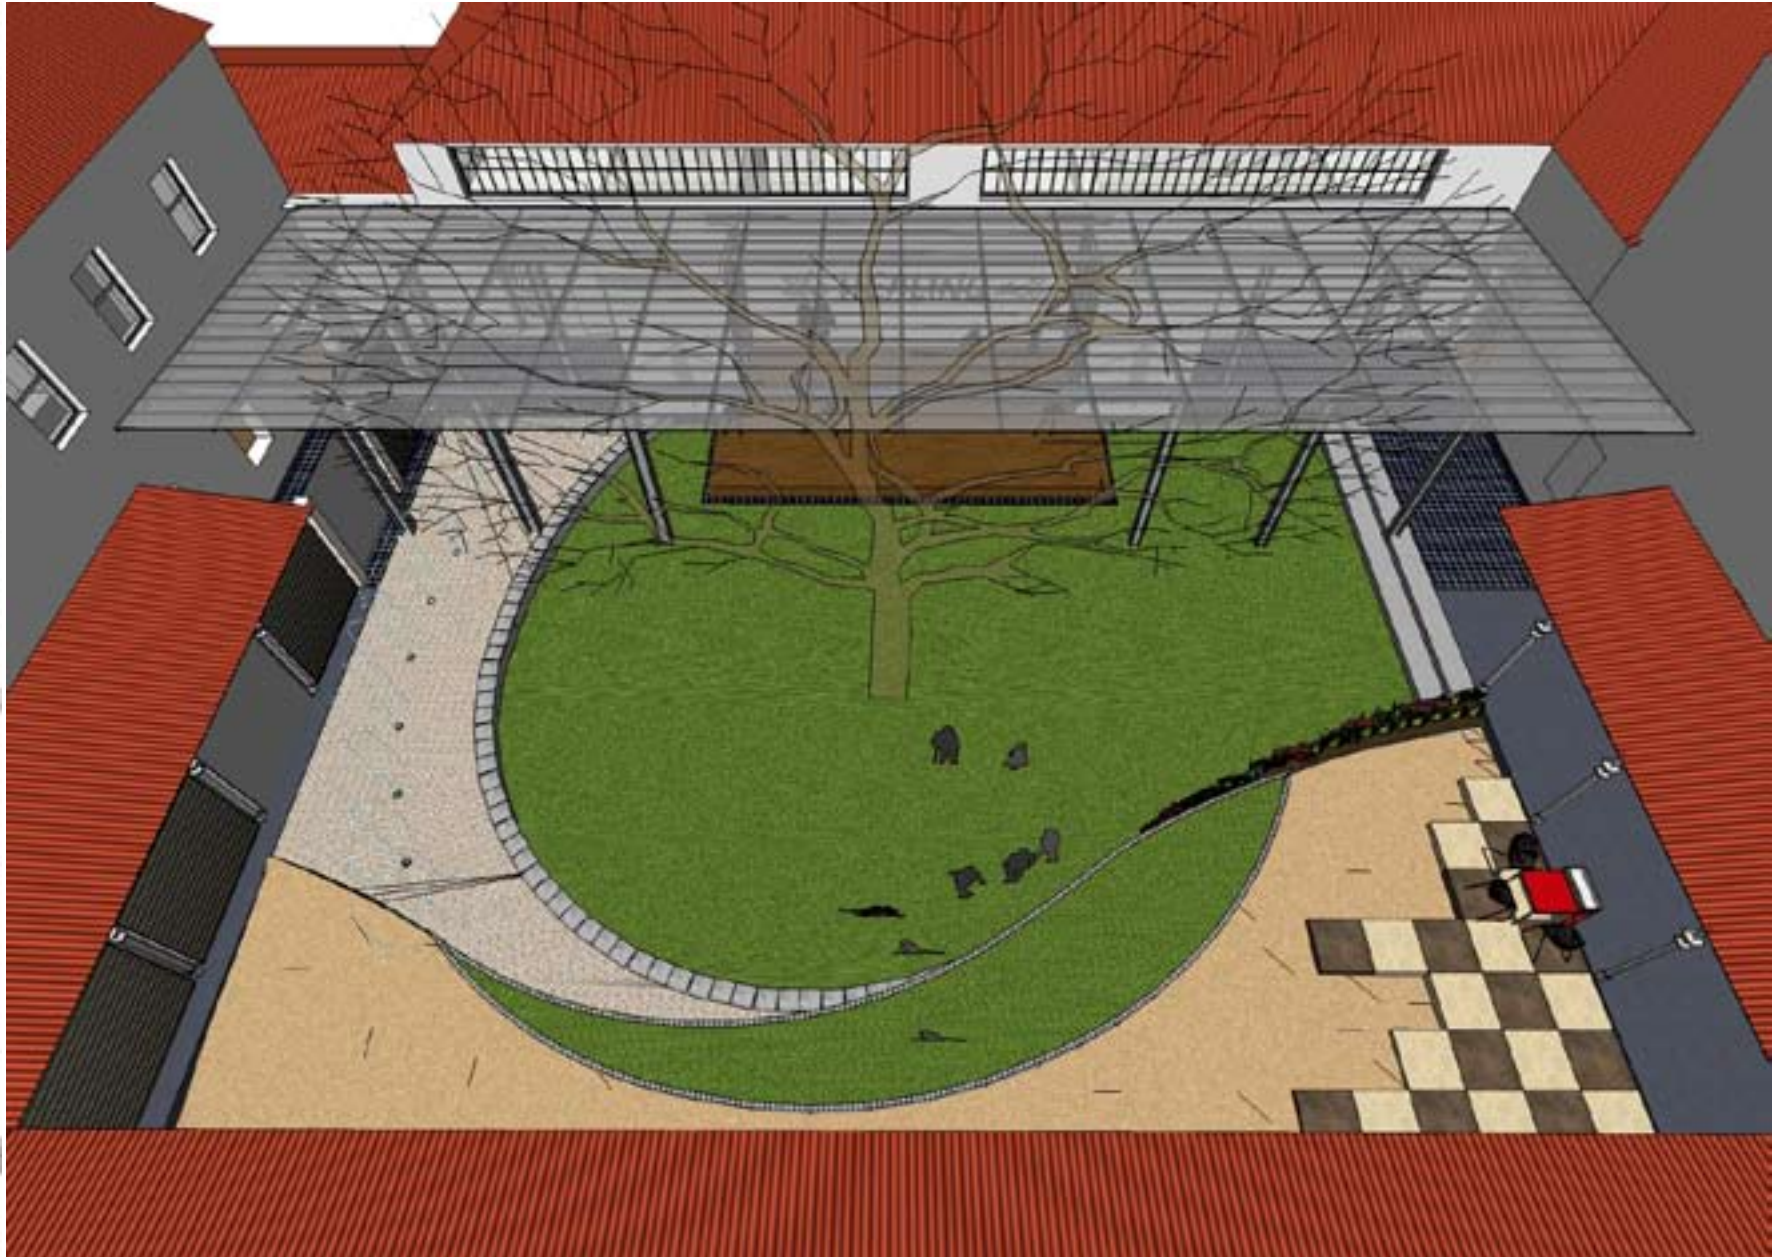
Figure 84: Different levels and textures inside courtyard

An amphitheatrical line shapes the central seating area. A circular seating level unfolds in front of the stage, which is split into two heights. The higher seating level is a lawn bed which stretches deeper in between the sand and pebbles; the other the pebble bed on which a masonry seating surface is mounted. The setup thus cater for all ages, invited by informal, spontaneous seating. The lowest courtyard level, also biggest area is topped with lawn. Many of the SI activities would take place on this level, but also on all other courtyard levels. (Figure 84)

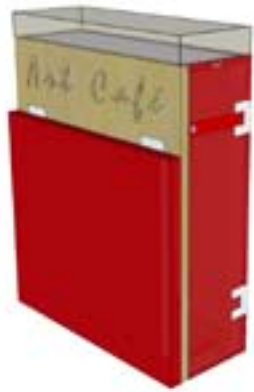
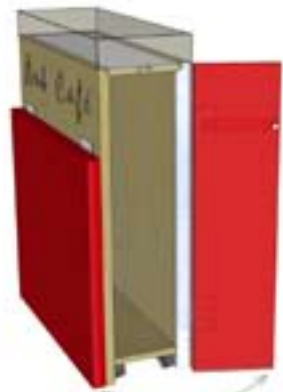
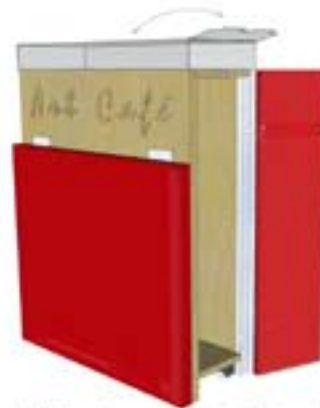
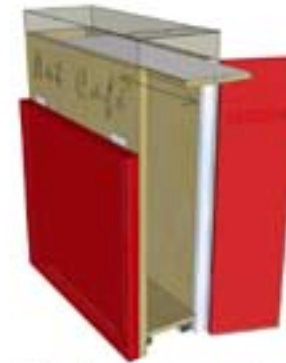
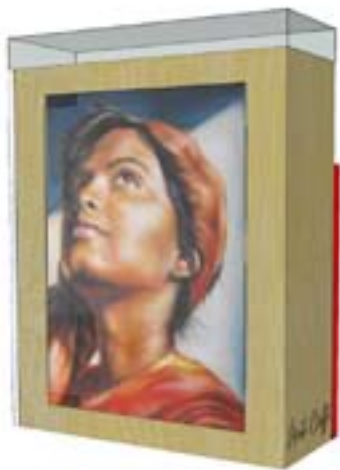
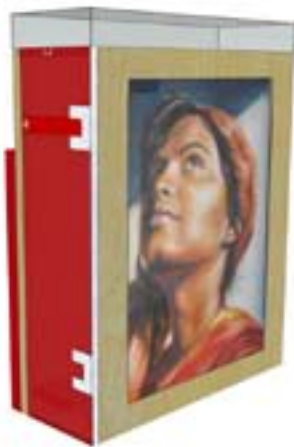
1 closed unit from front  
OPENING UP UNIT DOOR

2 opening the cupboard door

3 flipping open the display lid

4 pulling out display drawer

2 flipping up table top

Figure 86(a): A step-by-step guide as how to operate the seating unit

The seating unit consists of a container which unfolds to hold a table top and three chairs. The table top consists of red U463 perspex, into which a leuco dye is mixed while the perspex is still in a matrix stage. The dye is a powdered microencapsulated thermochromic dye made from encapsulated spiropyranes of fulgides. When leaning onto the table top or placing hot mugs etc onto it, the dye will react to the temperature rise by reversibly changing colour from transparent to coloured, eg. white. In so doing, the coffee drinker 'interacts' with the table top when it reacts to the temperature touch, giving back personal information.

The proposed chairs are already on the market- the specific one chosen folds flat to 40mm thick, are 440mm long and 920mm high. (Sold at Mr Price Home) Each seating unit can accommodate one to three persons. On the top of the seating unit is a glass box, which serves as display box for artefacts. The display box can be stocked by opening the container door in order to be able to pull out the display drawer. This would mean that all is locked and safe when the unit's door is locked. On the opposite side of the table top is more opportunity for display. The glass door can be opened, and a flat painting or drawing be placed inside. Thus, while seating visitors, art is displayed in numerous ways.

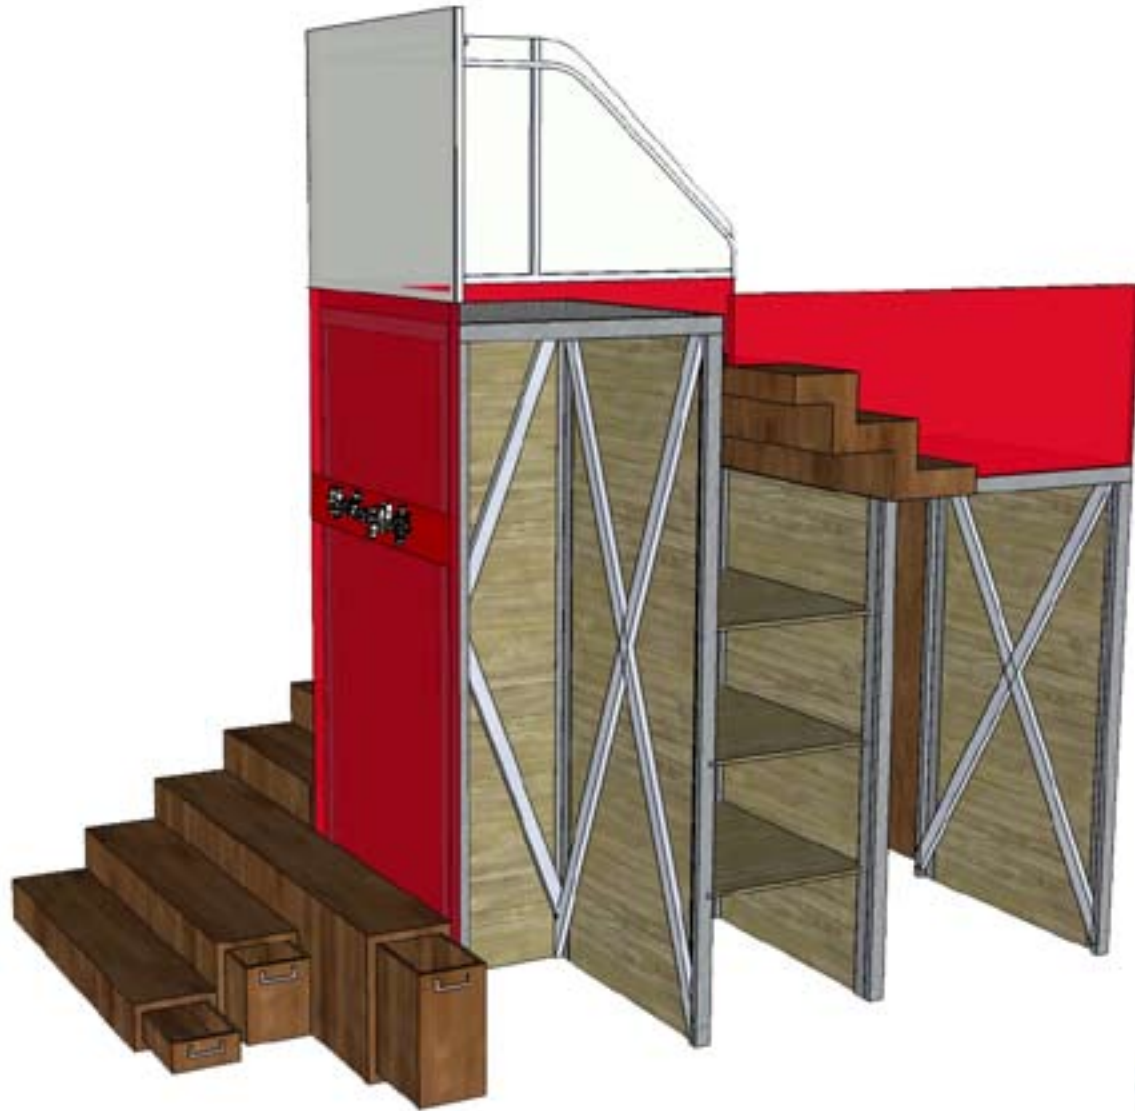
Figure 89(b): Back of staircase, showing storage facilities

While the staircase leads up to the mezzanine level, the space below it is used for storage purposes in the café kitchen. The bottom three treads serve as display surface, whilst they also function as drawer space. The act of moving up vertically is emphasised by having the staircase in front of the street window, where the passerby's will see the legs moving almost out of the building. To the kitchen's
