TECHNOLOGY SOLUTIONS TO ENHANCE VISUAL BRIDGE INSPECTIONS IN SOUTH AFRICA

**A dissertation submitted in partial fulfilment of the requirements for the degree of
MASTER OF ENGINEERING (TRANSPORTATION ENGINEERING)**

UNIVERSITY OF PRETORIA

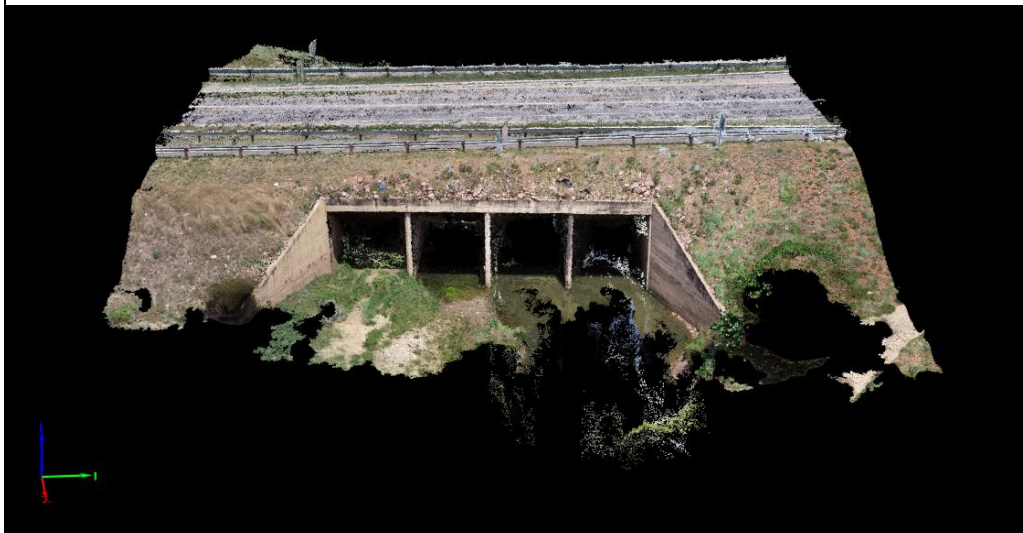
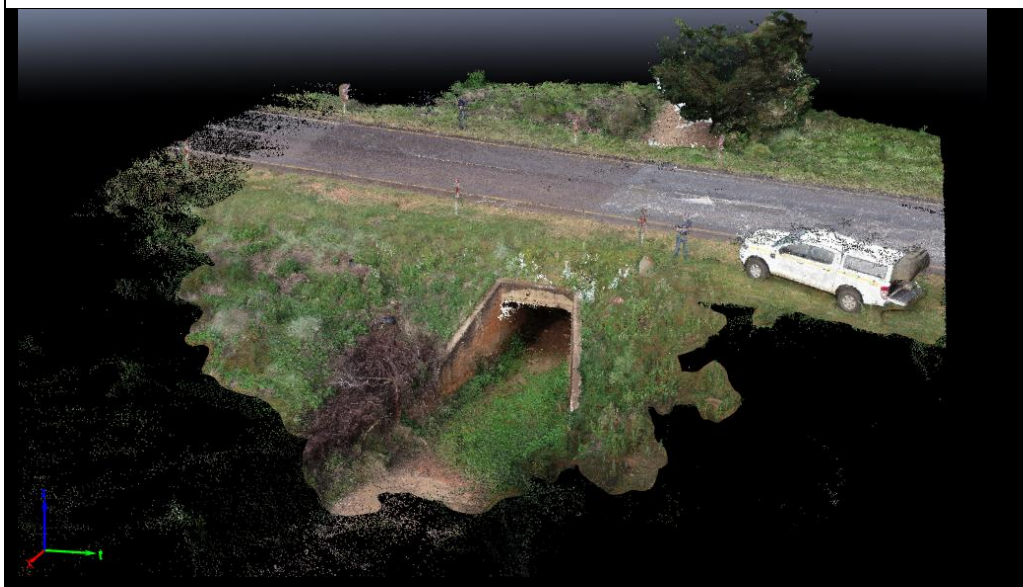
Figure 3-6: Generated point cloud models from captured images

After the images have been processed, a free software package, Pix4D Mapper, was used to view the point cloud models. The point cloud models created from the captured structure images are shown in Figure 3-6.

It should be noted that the normal hand camera georeferencing was not compatible with Pix4D and it was not possible to generate point cloud models from the captured images for Culvert 3 and 4.

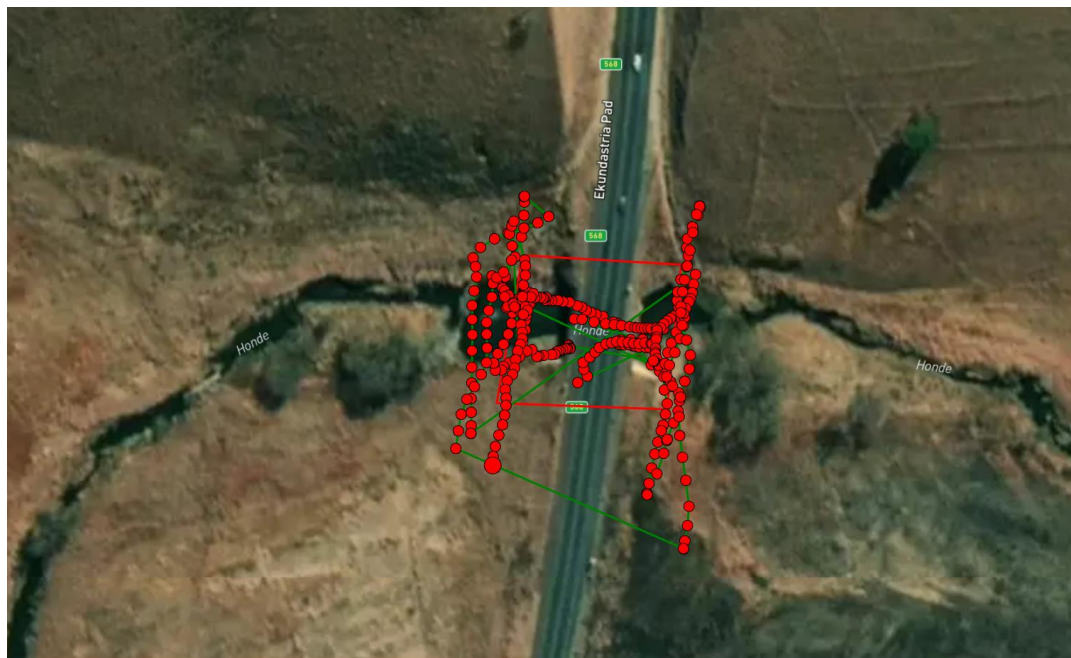
Figure 3-7: Spatial orientation of the structure

Pix4D Mapper opens a project in “Map View” and shows the structure location on a Google Earth base map. This location is based on the georeferenced images captured by the UAV and indicates the spatial orientation of the structure as shown in Figure 3-7.

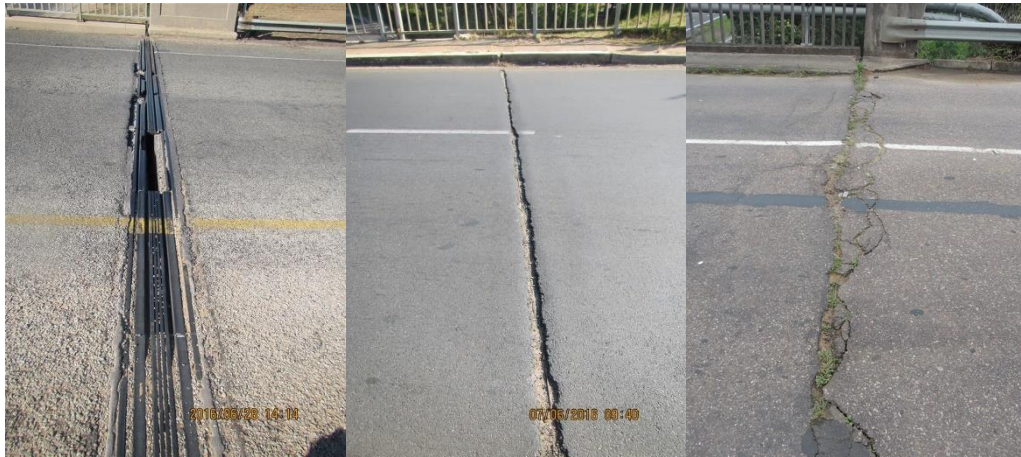
Figure 3-12: Examples of images in the Defect class

The CSIR BMS inspection and inventory image data were used to compile images of roadway joints of different type and size bridges in South Africa. The images were categorised according to Defect and No Defect classes. A total of 600 images were used, 400 images belonging to the Defect class and 200 images to the No Defect class. Examples of images from the two classes are shown in Figure 3-12 and Figure 3-13.

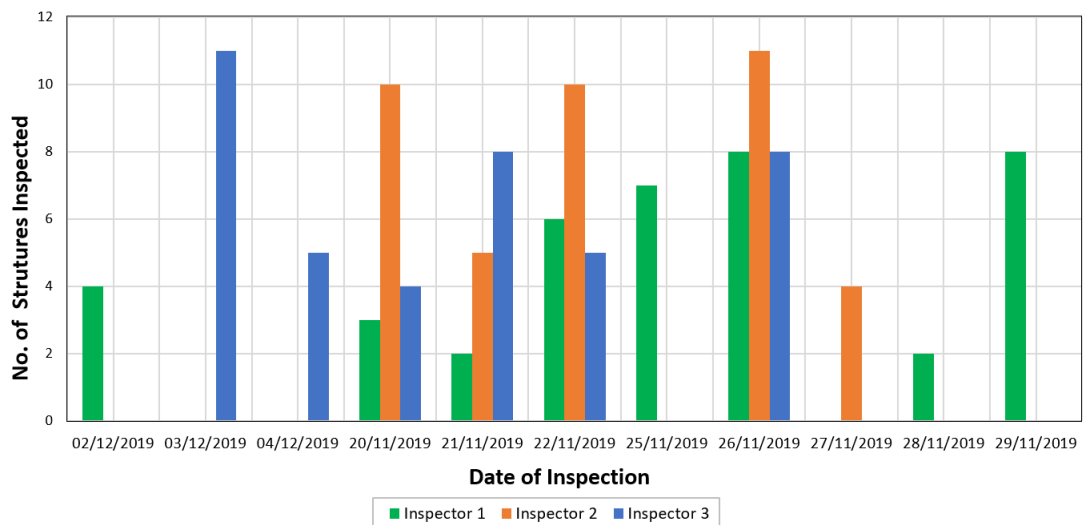
Figure 4-1: Number of structures inspected per day

The inspection took place in 2019 over a period of 11 days and included the visual inspections of 121 bridges and culverts. The number of structures inspected per day by each inspector are shown in Figure 4-1.

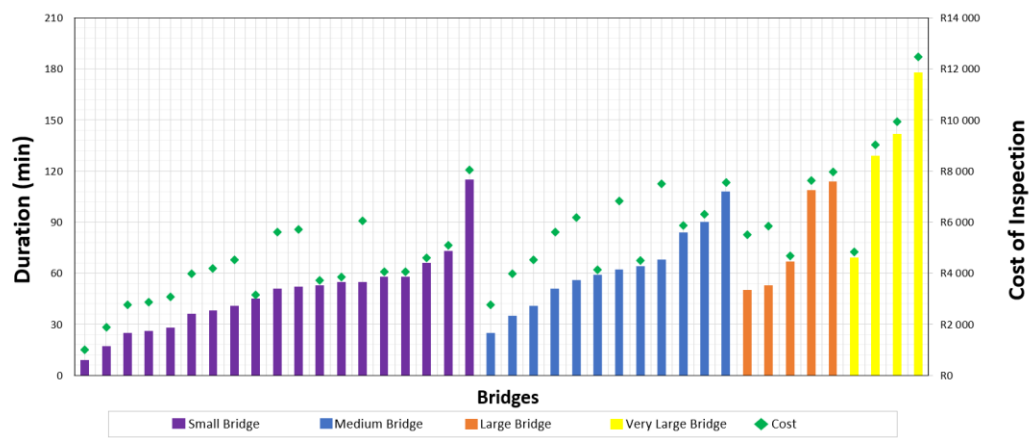
Figure 4-2: Cost and duration of inspected bridge structures

The cost of each inspected structure was calculated based on the actual time spent on the inspection and the inspector's and technical assistant's professional fees. The inspections were in close proximity of the consulting engineering company's offices and travel was charged as a lump sum and not included in the cost calculation.

Although the cost for each structure was calculated based on the actual time spent on each inspection, the total duration of the inspection was of interest to this study as it includes the preparation time on site. The cost and time calculations included the completion of inspection sheets on site. The inspection sheets were manually captured into the BMS on return to the office.

The associated cost and total duration of each bridge and culvert inspection are shown in Figure 4-2 and Figure 4-3. The calculated average cost and duration per structure class are summarised in Table 4-3.
