JAN: 1943.

ACCOMPANYING

F. WALTON JAMESON

REPORT.

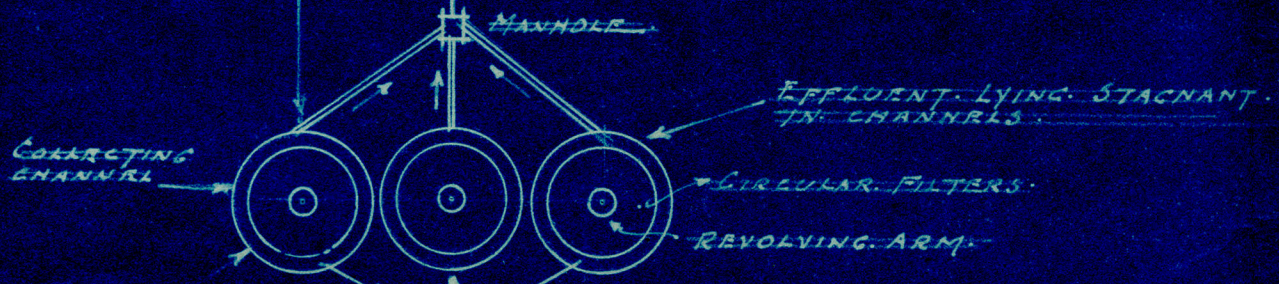
THIS SEWER IS THE
CAUSE OF STAGNATING
OF EFFLUENT IN

MANHOLE
FARM OUTLET

FILTERS. RTG. → 10 PIPE

2 FALL IN APPROX: 600 FT.
PRACTICALLY DEAD LEVEL.

THIS FILTER EMPTIED
NOT IN USE WATER LOCKED
WITH EFFLUENT.

SEE
DETAIL
BLOW X
