Figure 3-18: Pay Dam - Upper Beach: Photos of the full profile from 0 to 5.5 m in depth.

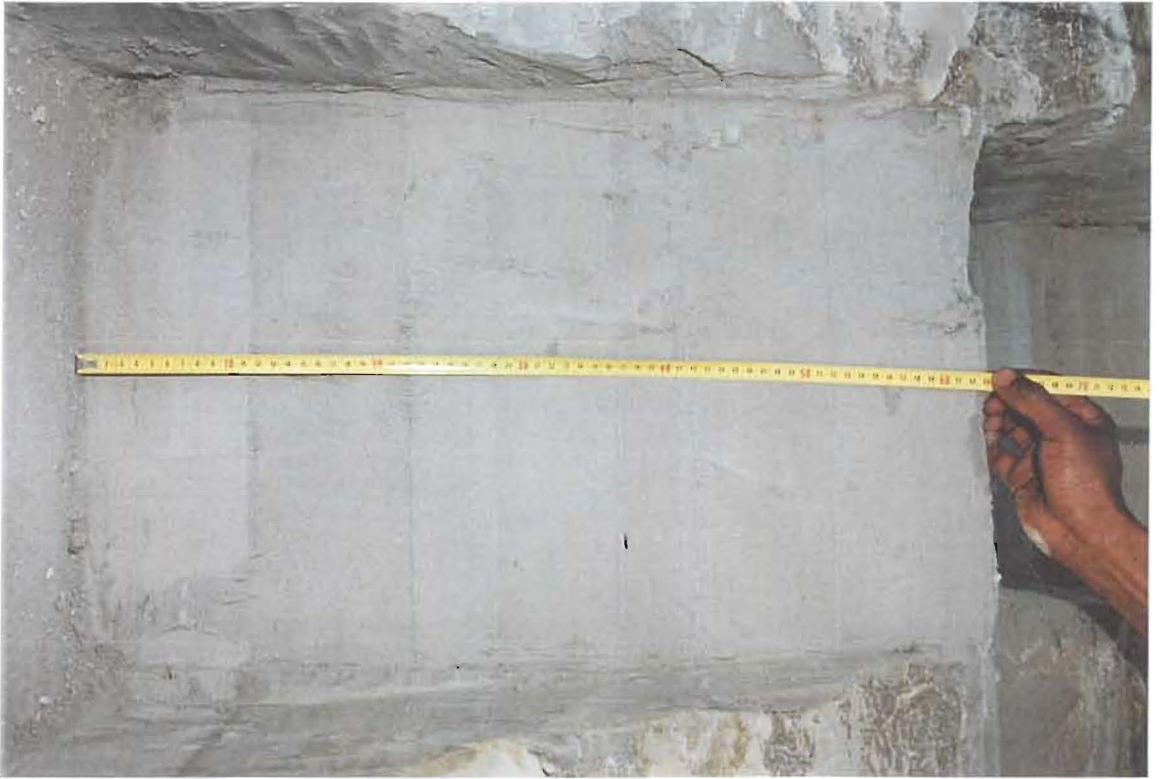
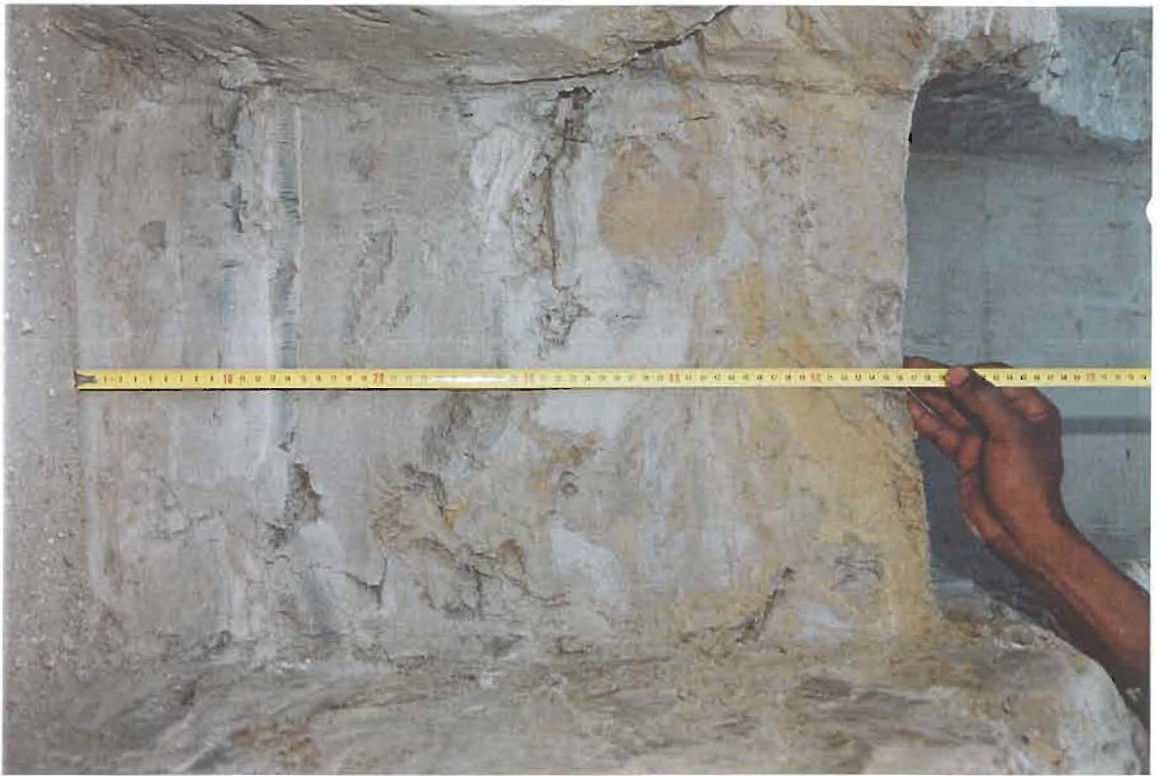
Figure 3-22: Pay Dam - Upper Beach: Photos of the profile from 3.6 to 4.8 m in depth.

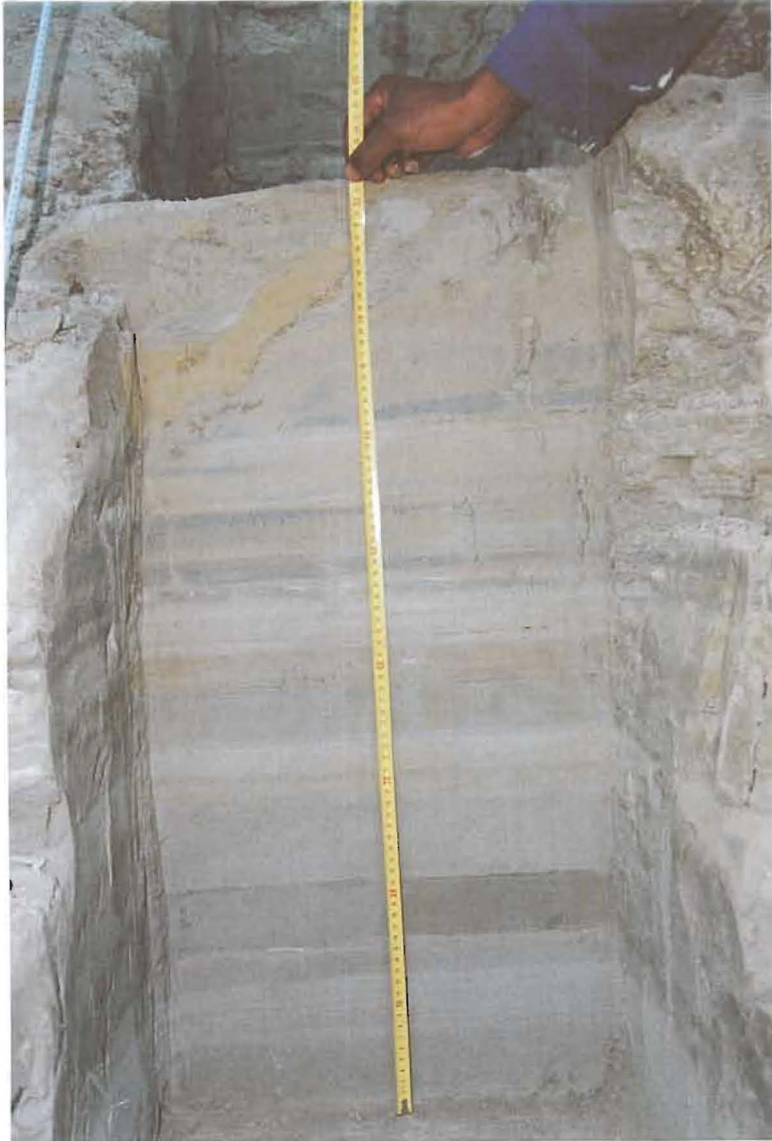
Figure 3-23: Pay Dam - Upper Beach: Photos of the profile from 4.8 to 5.5 m in depth.

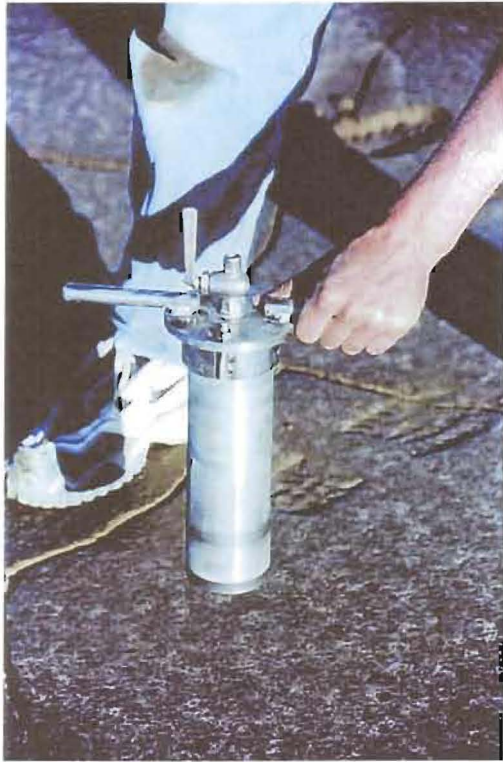
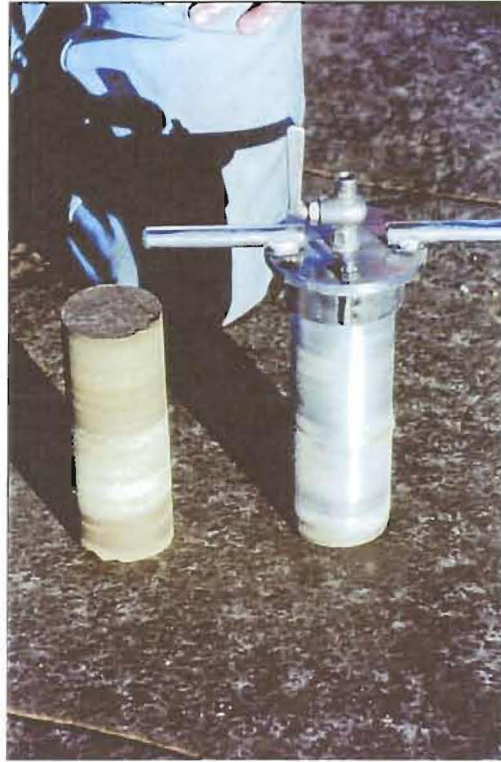
Figure 3-31: Stainless steel 75 mm diameter tube sampler.

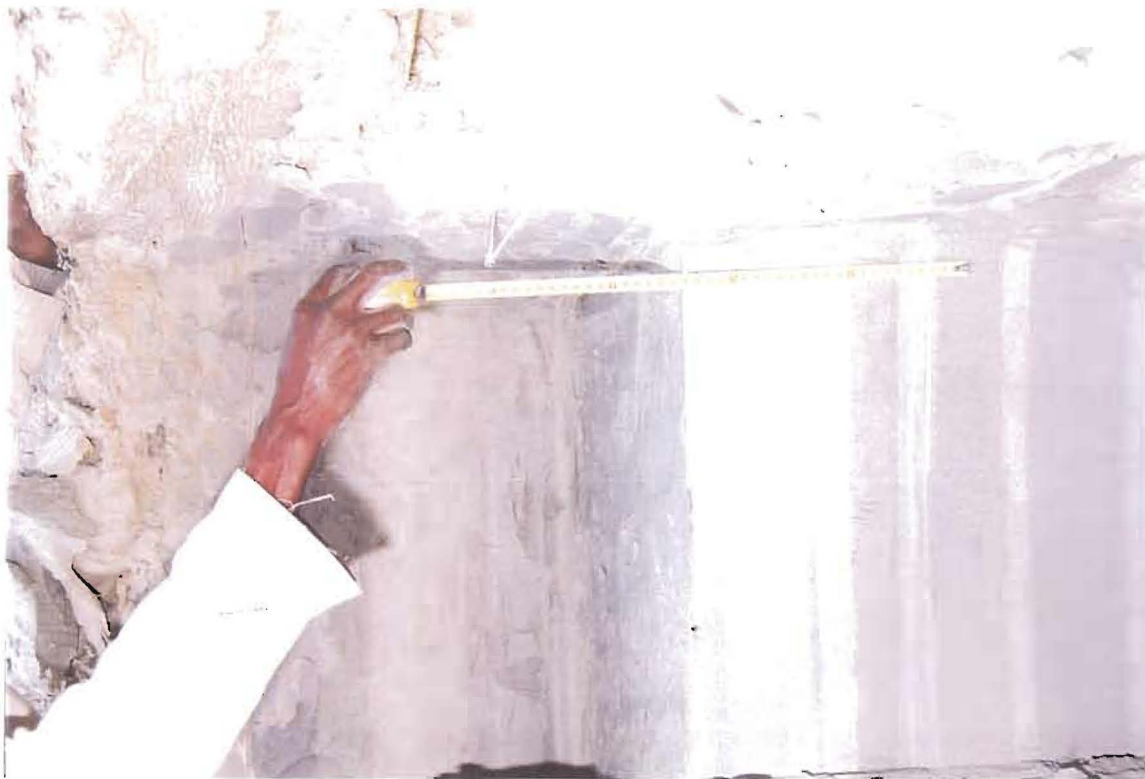
Figure 3-32: Sampling of Block Sample No. PPNBF at a depth of 4.3 m at the Pay Dam penstock.

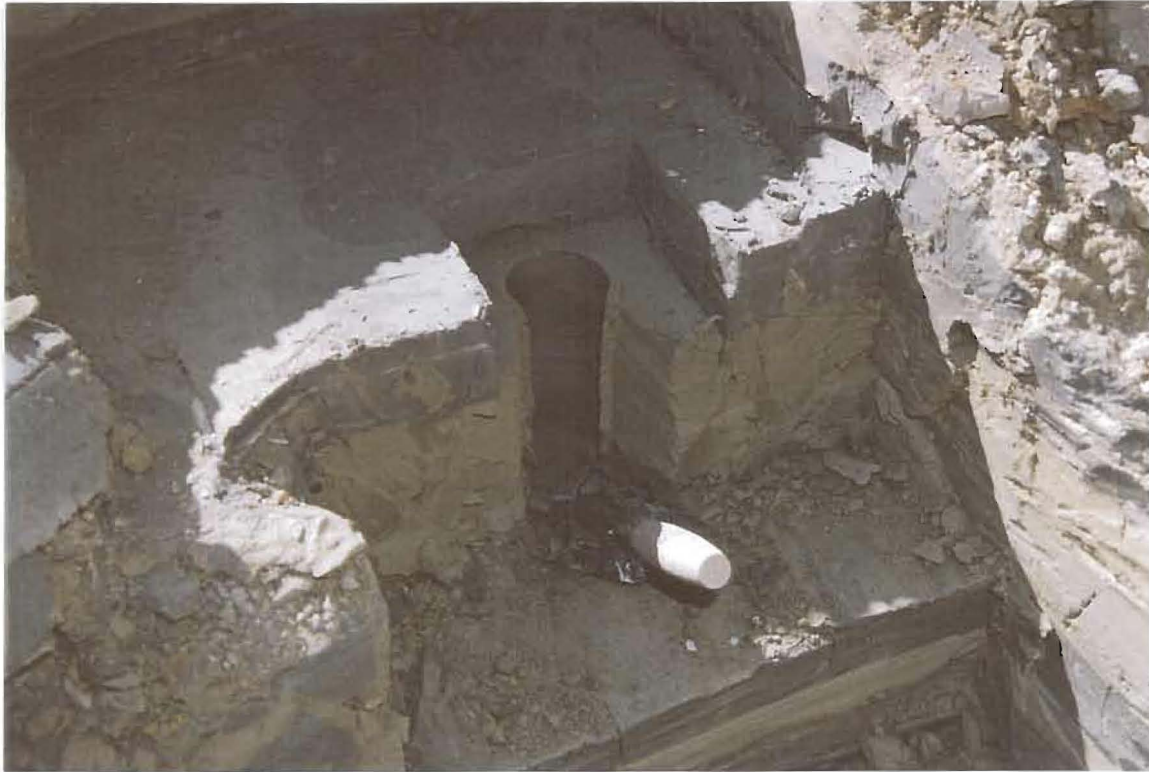
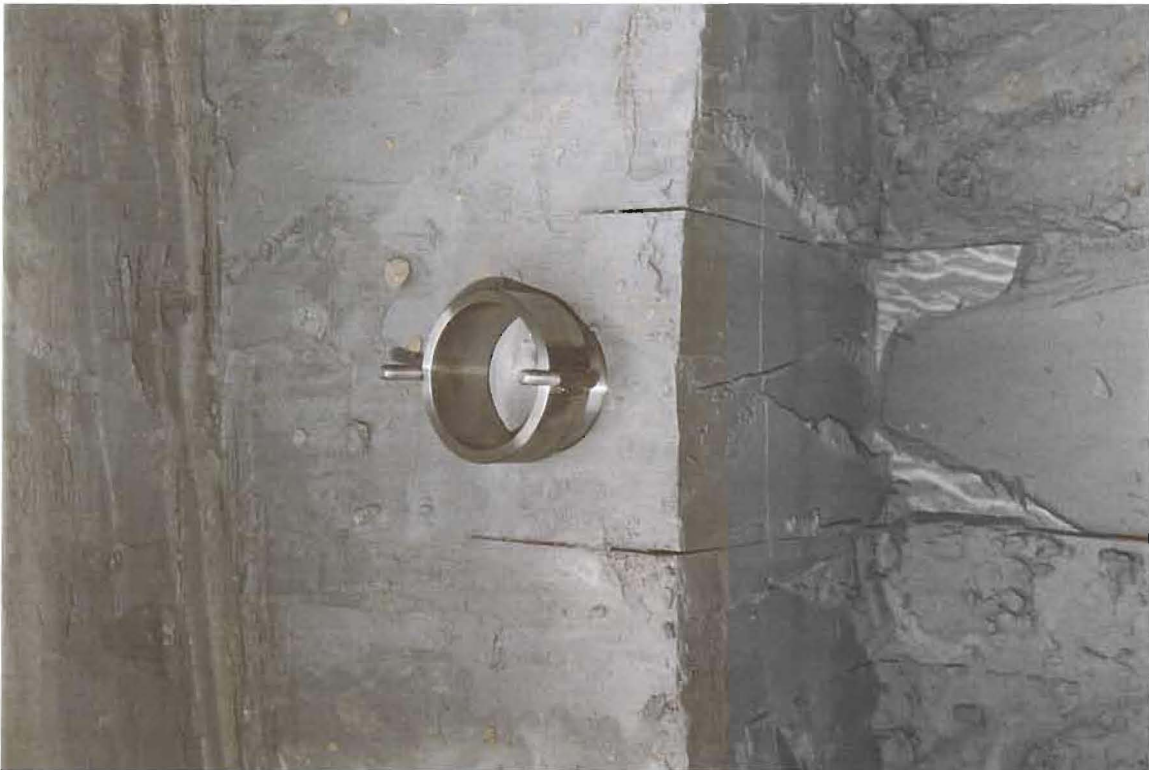
Figure 3-33: Sampling of Tube Sample No. PPNTF1 at a depth of 4.3 m at the Pay Dam penstock.
