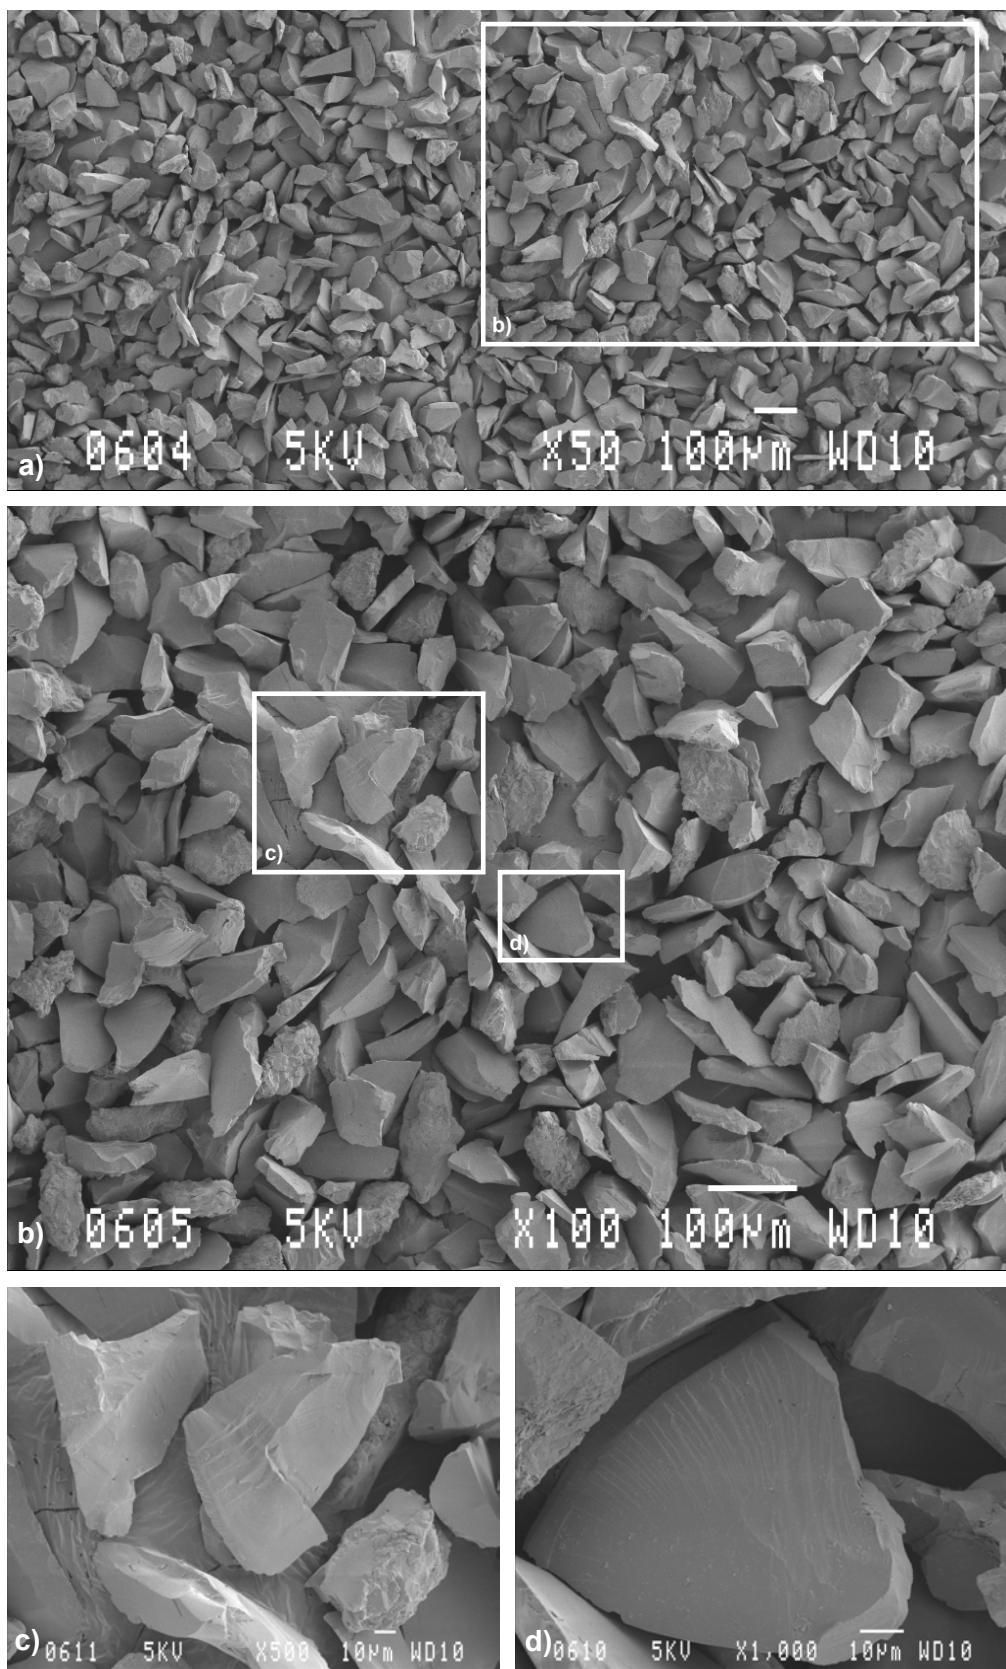
Figure 3.13 Images from SEM on classified tailings retained on 30 μm sieve.

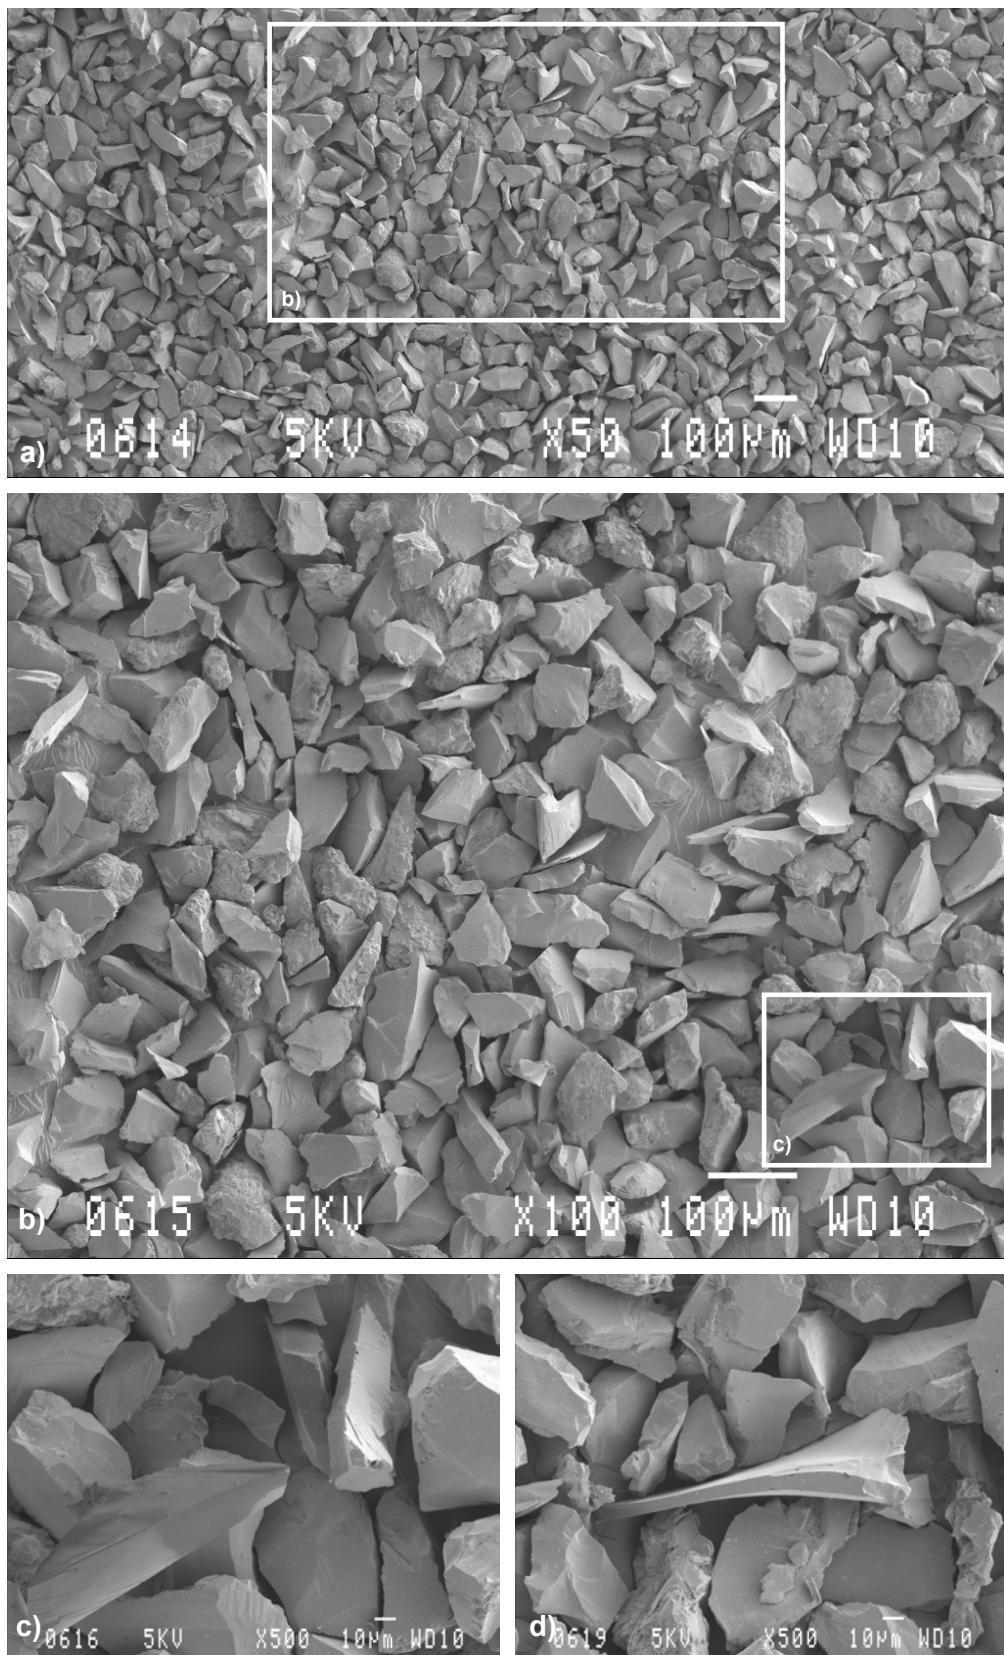
Figure 3.14 Images from SEM on classified tailings retained on 20 μ m sieve.

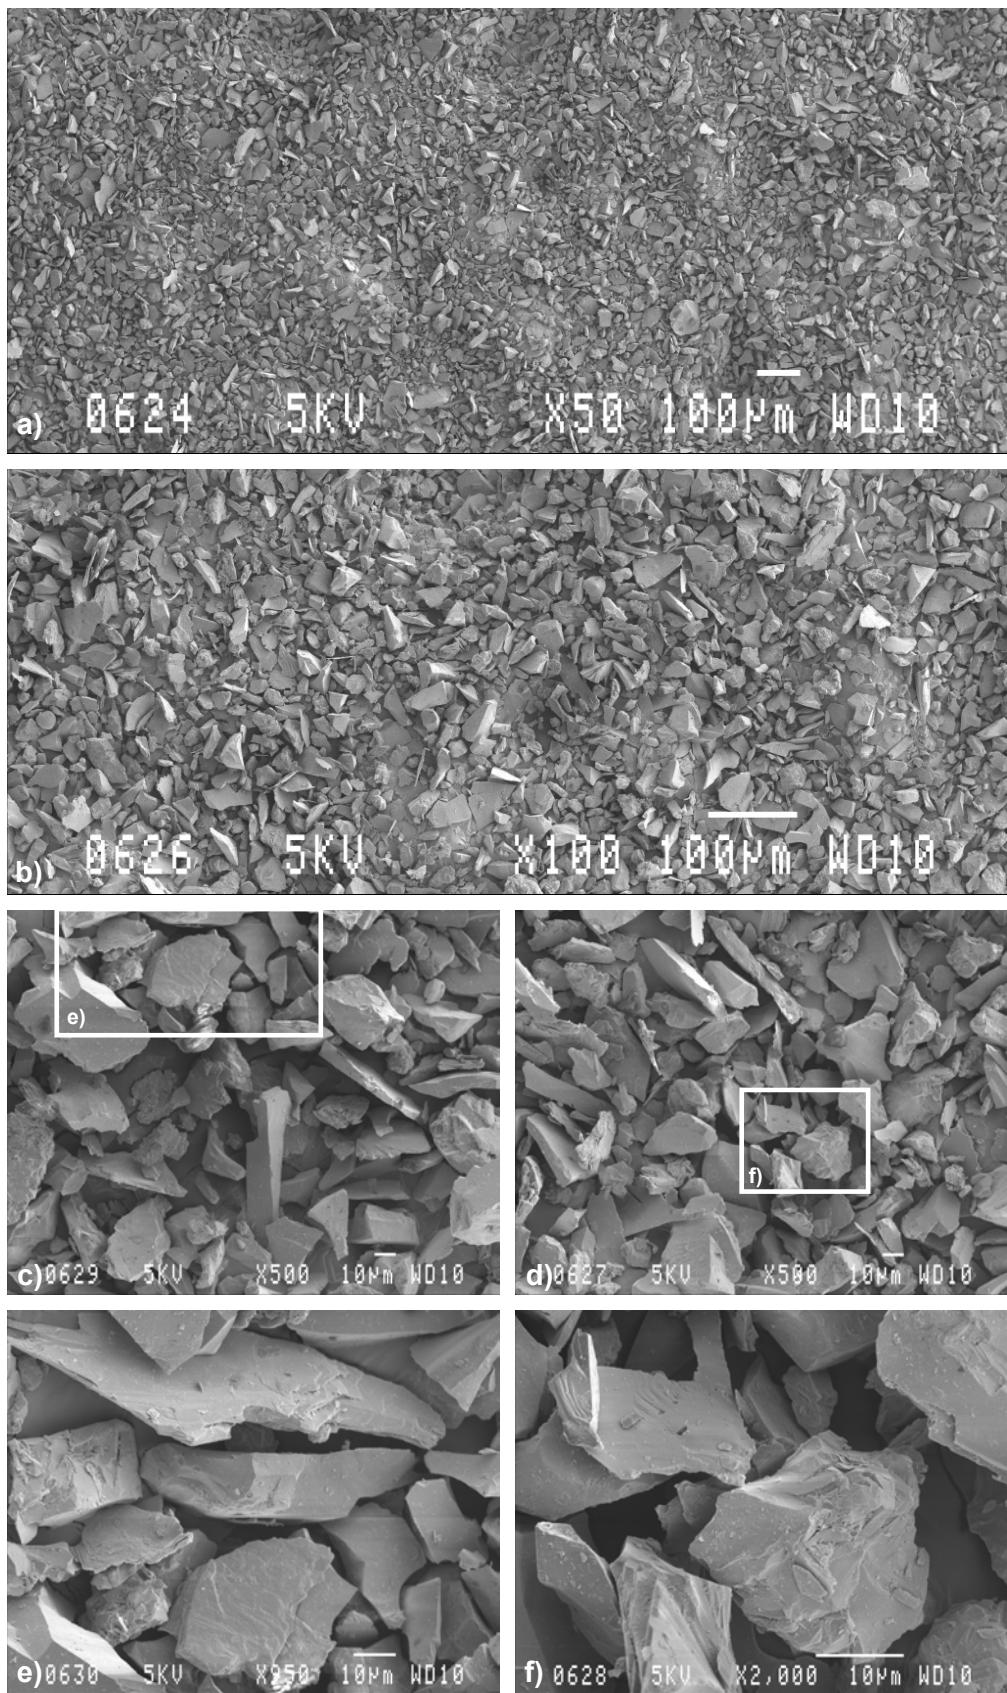
Figure 3.15 Images from SEM on classified tailings retained on 10 μm sieve.

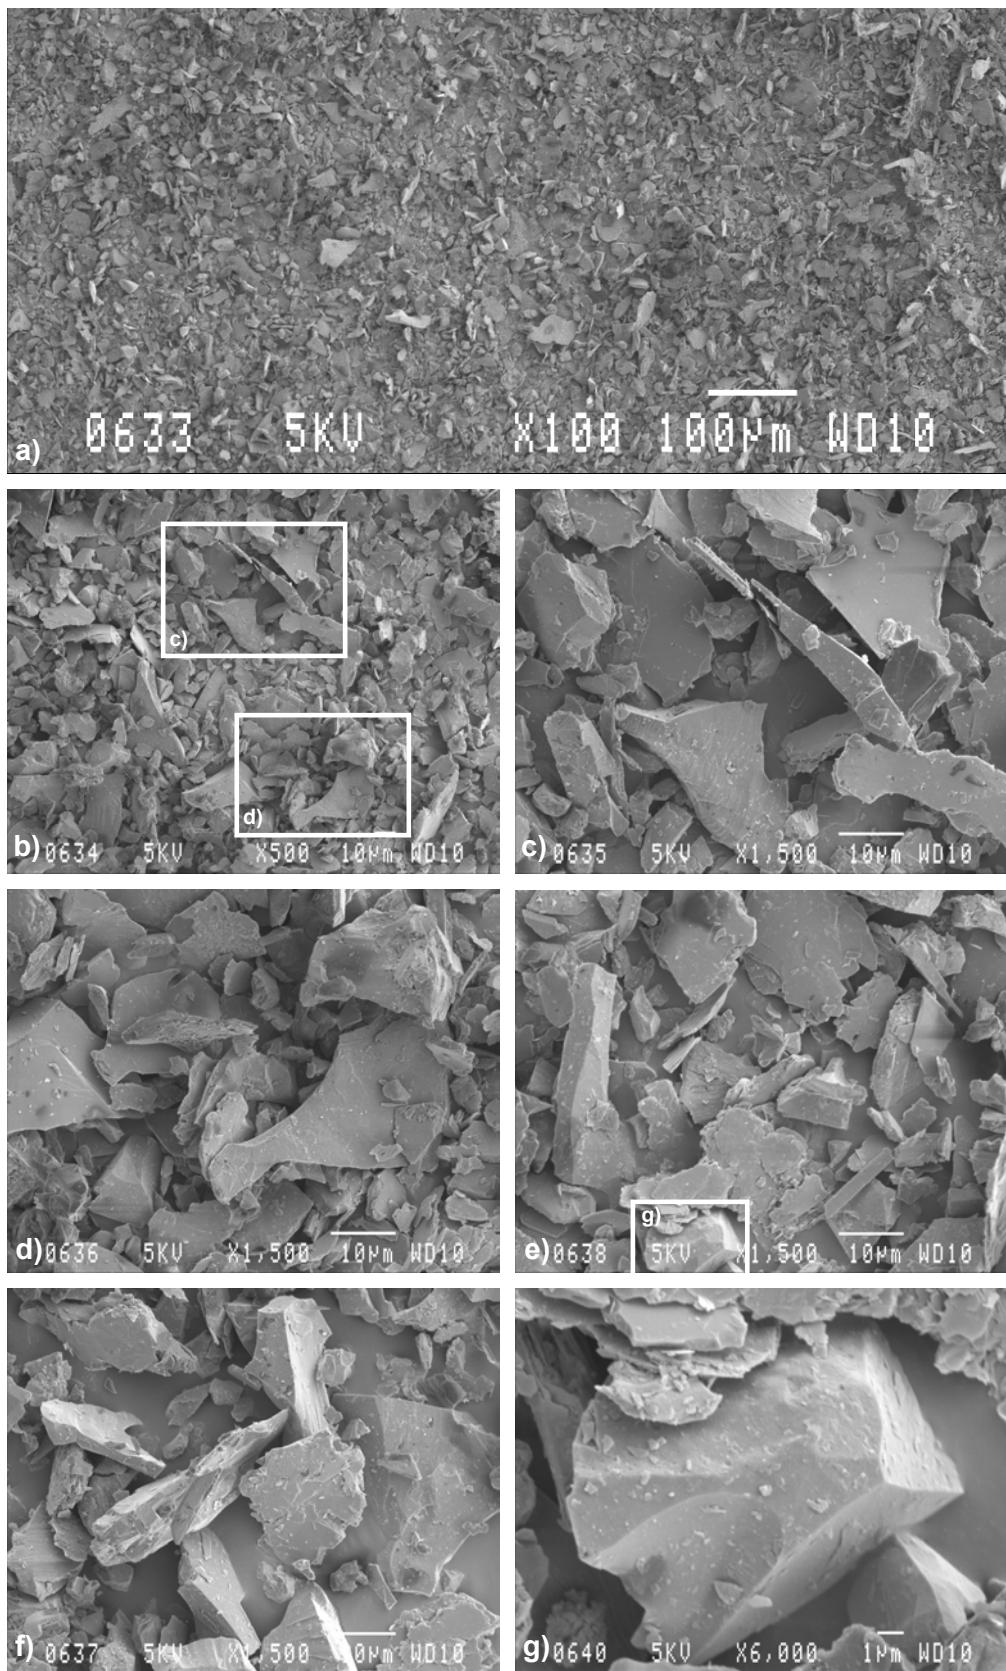
Figure 3.16 Images from SEM on classified tailings retained on 6 µm sieve.

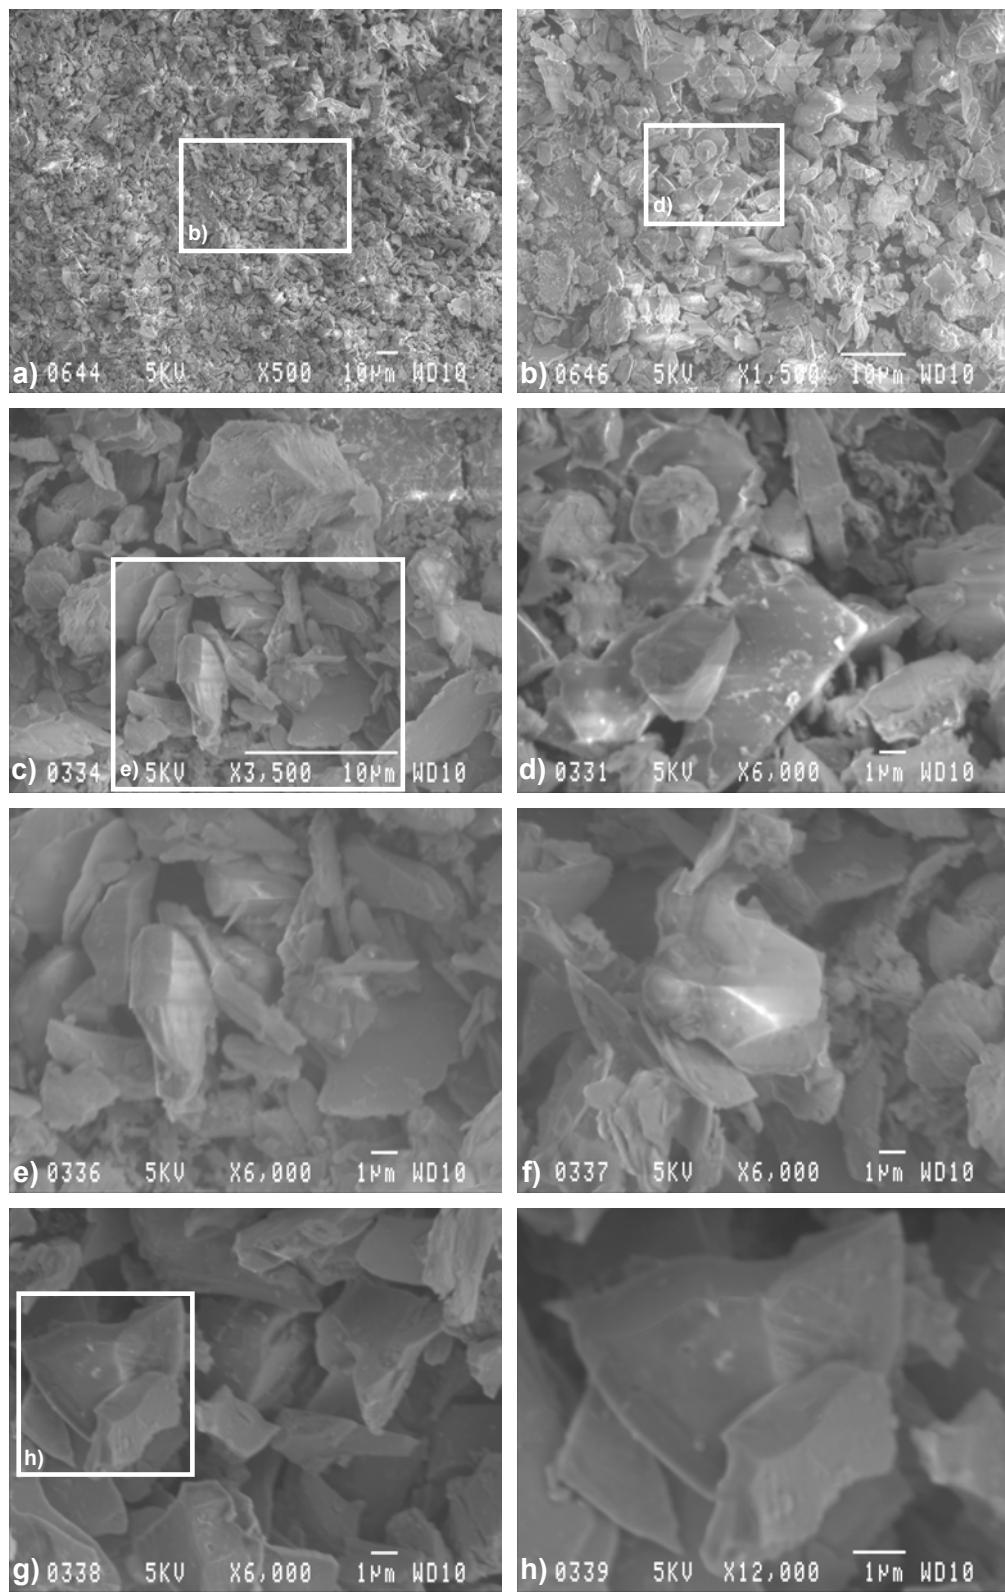
Figure 3.17 Images from SEM on classified tailings retained on 3 μm sieve.
