**Geotechnical and risk analyses for the positioning of shafts at the  
Wesizwe Platinum project**

A thesis submitted in partial fulfilment of the requirements for the degree of  
MASTERS OF EARTH SCIENCE PRACTICE AND MANAGEMENT

UNIVERSITY OF PRETORIA

November 2011

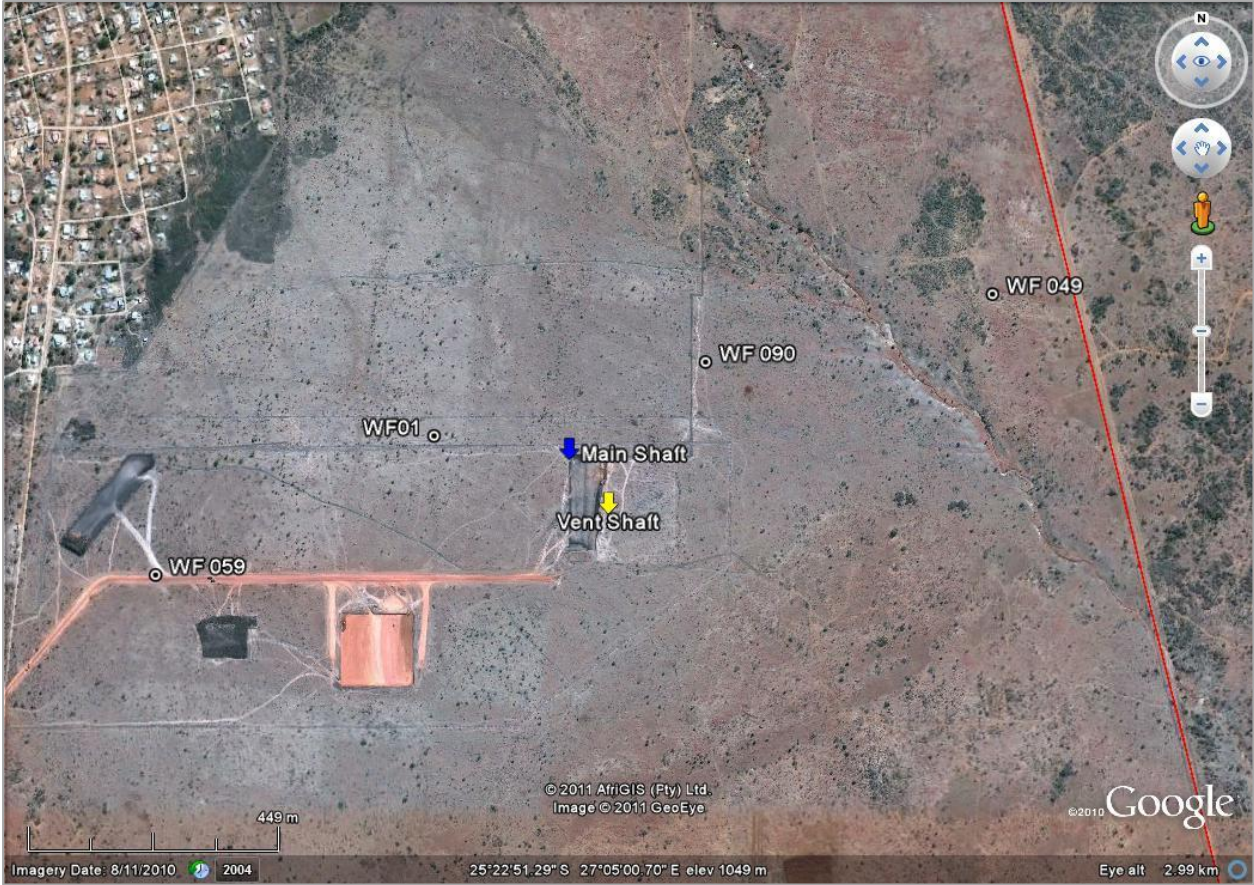
Figure 2: Google Earth image showing the positions of the boreholes that intersected the fault (note the town of Ledig to the west and lease boundary in red to the east).

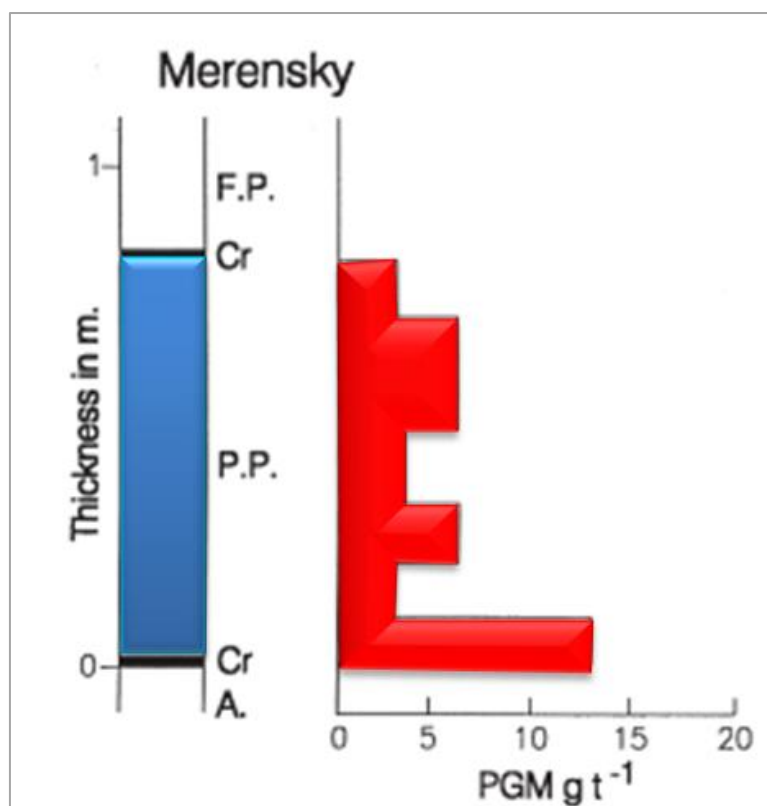
Figure 9: Generalised PGM grade through the Merensky Reef. A = Anorite, Cr = chromitite, F.P = Feldspathic pyroxenite. (Modified after: Cawthorn, 1999).

The Merensky Reef (MR) is a continuously developed lateral reef. Large variations occur in reef thickness, reef composition, as well as the relative position of the mineralisation within the reef which is very dependent on the location within the greater Bushveld Complex. The Merensky Reef is located 40 to 140 meters above the UG2 on the western limb, from north to south. (Cawthorn, 1999). In the northern section of the RLS's western limb, the MR has been found to be thicker to the north (Cawthorn, 1999). The general grade in the MR is presented in Figure 9.

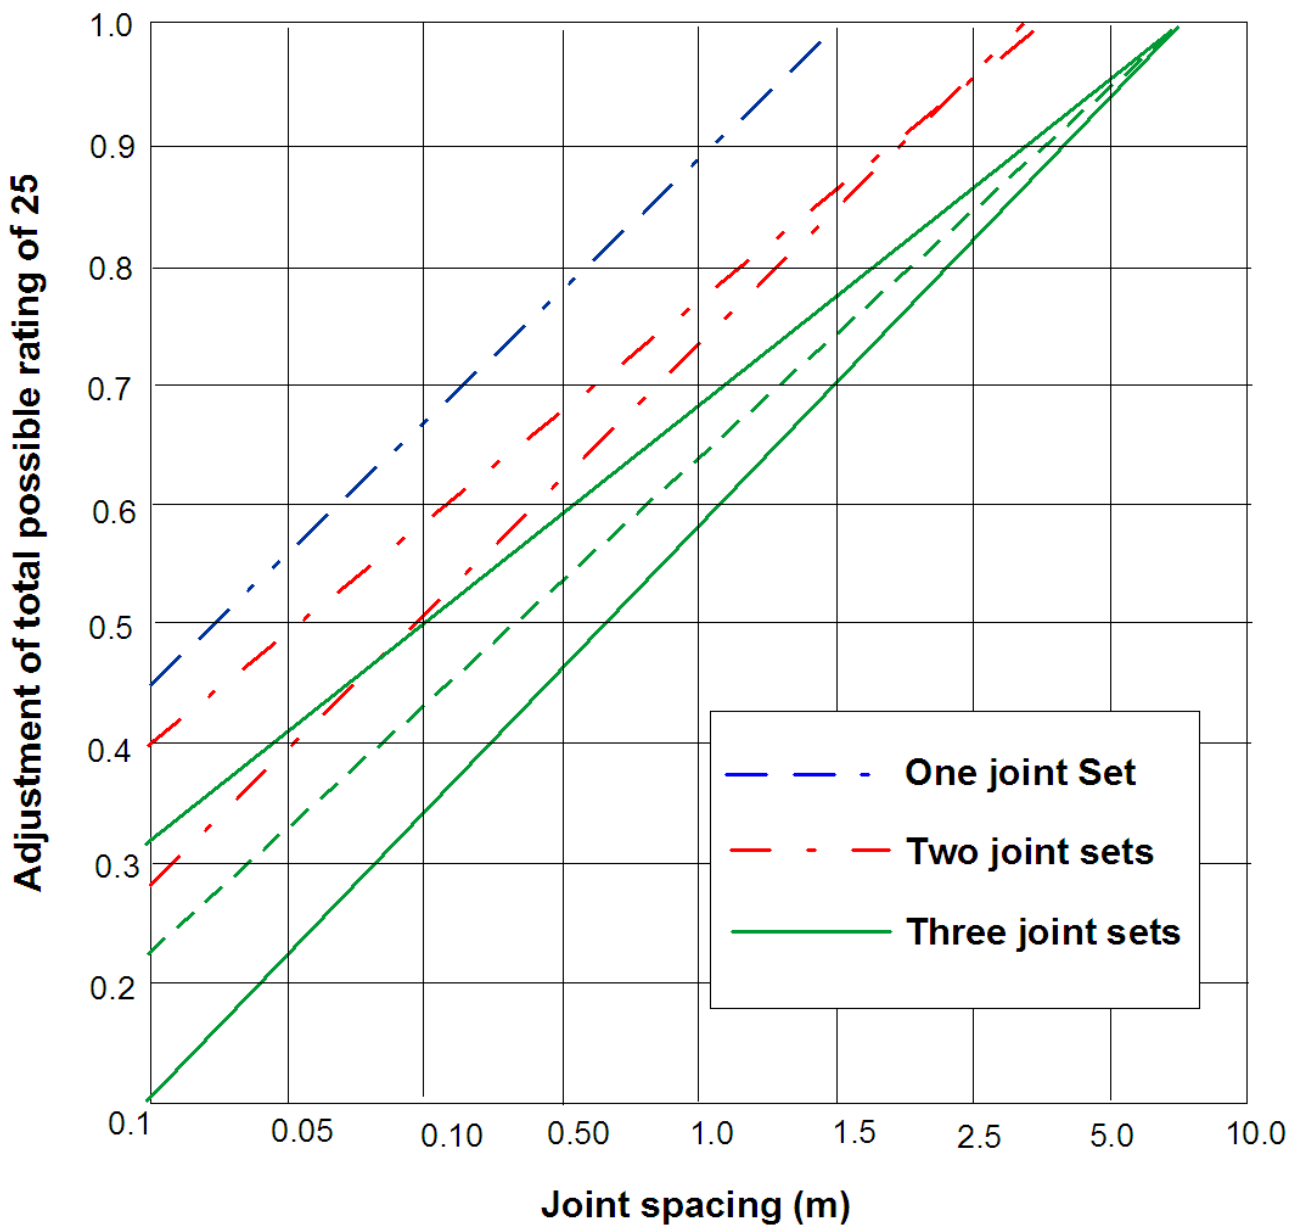
Figure 19: Ratings for joint spacing adjustment.

Figure 19 allows the values of the input parameters to be adjusted for the spacing measured of joints within the drill core.

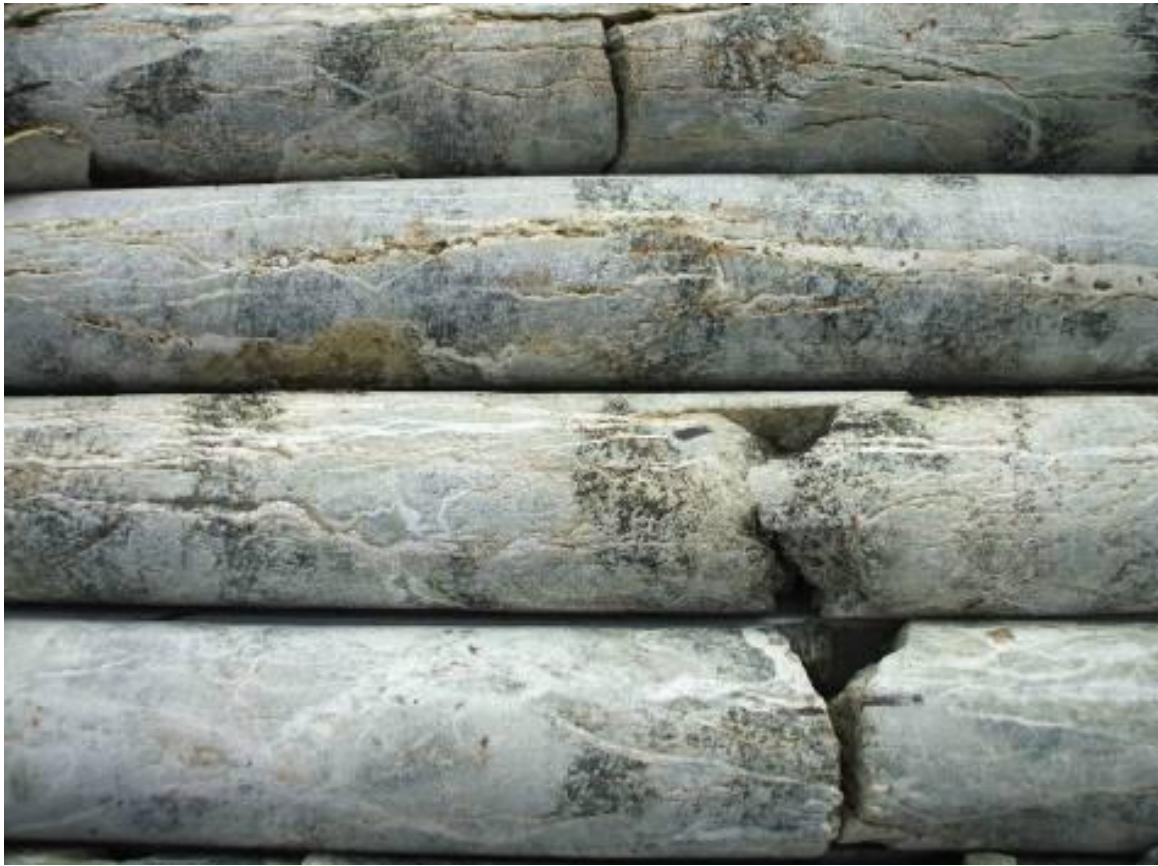
Figure 25: Shattered re-cemented core as was observed in WF90.

The fault-affected area was noted to be associated with a highly destructive (associated with large amounts of jointing and movement as indicated by slickensides and serpentinite clay infilling) lamprophyre dyke accompanied by a dolerite stringer. The lamprophyre dyke disintegrates within months of exposure to water and oxygen, and will cause great support difficulties. At some places the boreholes intersected cavities filled with minerals such as talc and gypsum precipitated from mineral bearing solutions. This, together with the noted green discolouration indicates that this faulted area must be water bearing. From the areas where the core intersected the fault, the dip can be interpreted to be nearvertical to vertical, thus 70° or greater (Figure 26). In places the core investigated had an appearance of re-cemented shattered joints and the rock quality was not rated very high in these sections (Figure 25).

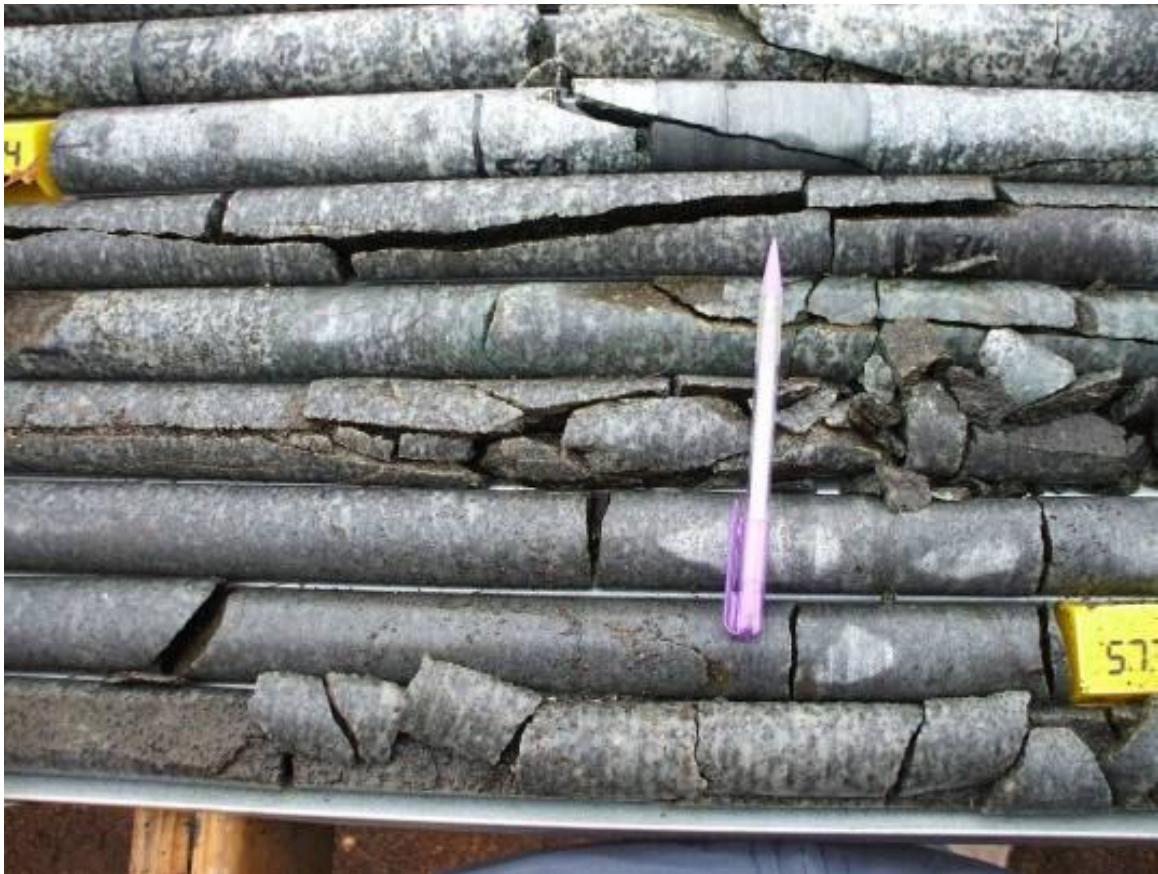
Figure 26: WF1 fault affected area.

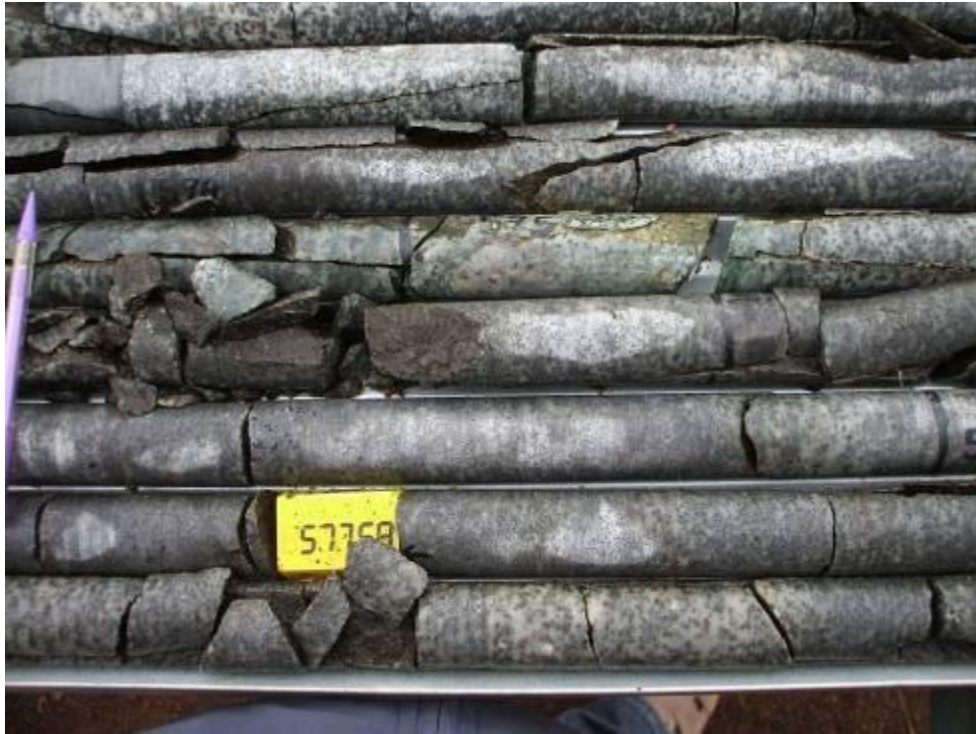
Figure 42: WF1 fault affected area.

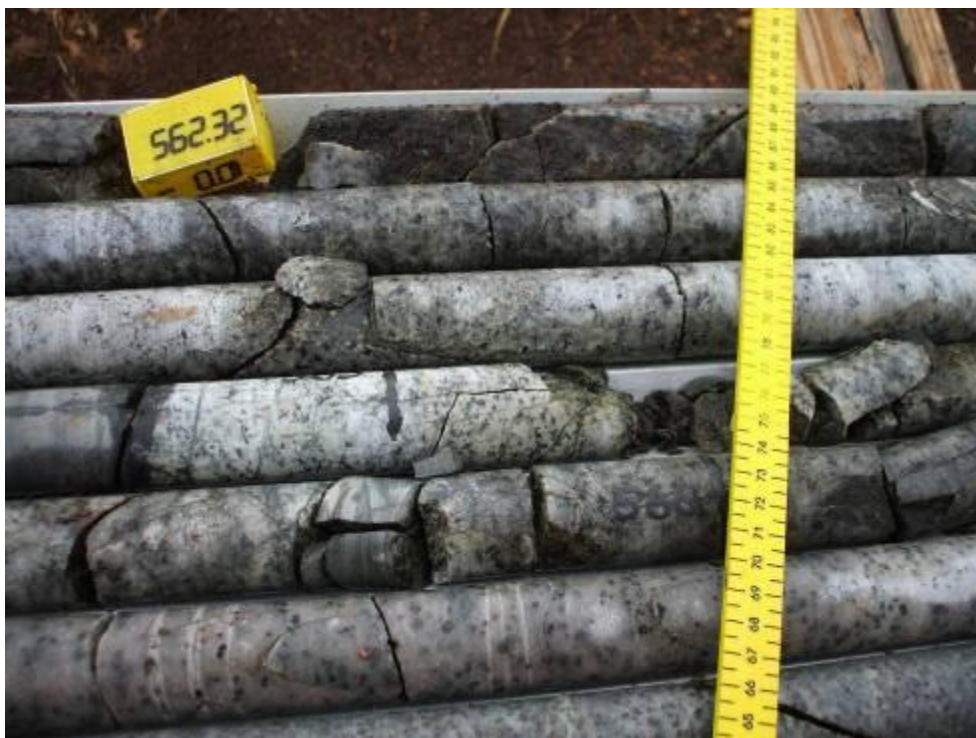
Figure 43: WF1 fault affected area.

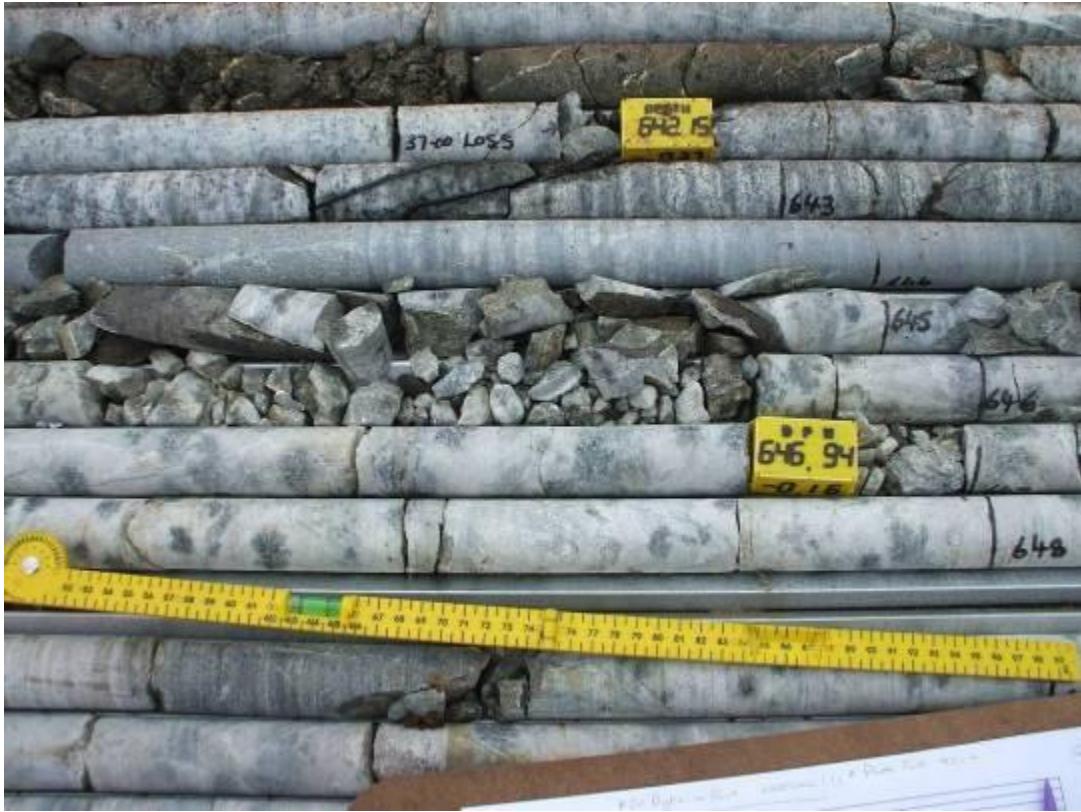
Figure 44: WF49 fault affected area.

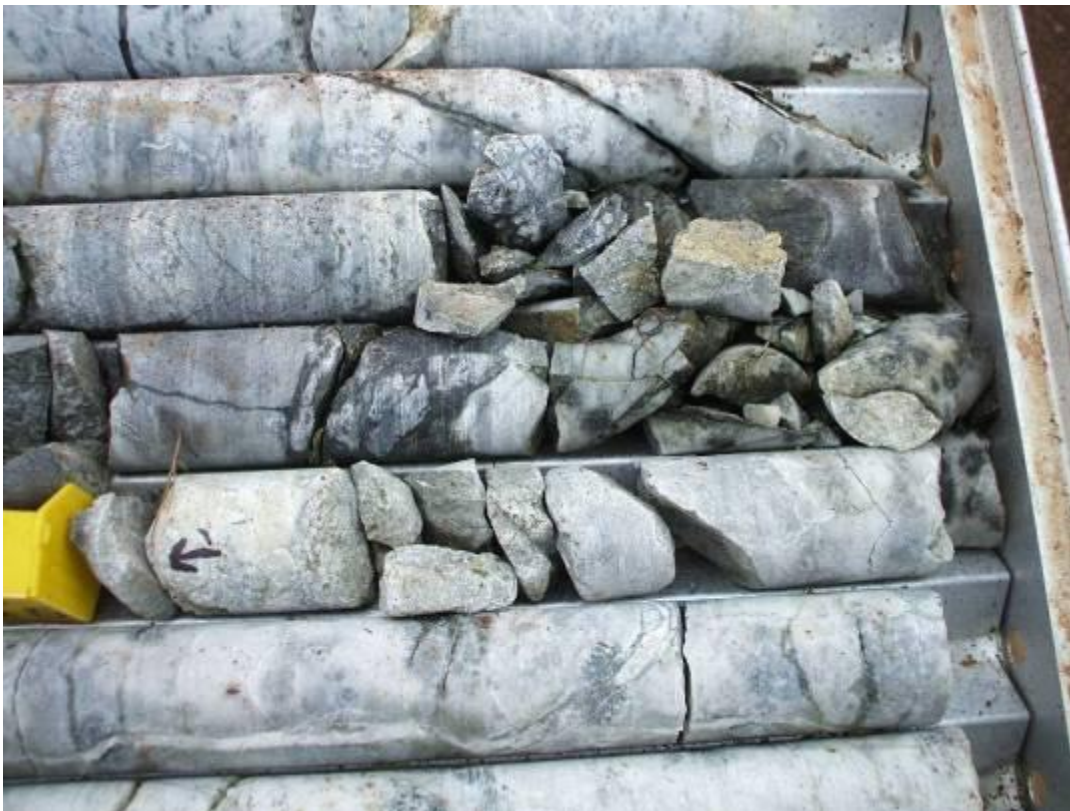
Figure 45: WF49 fault affected area.

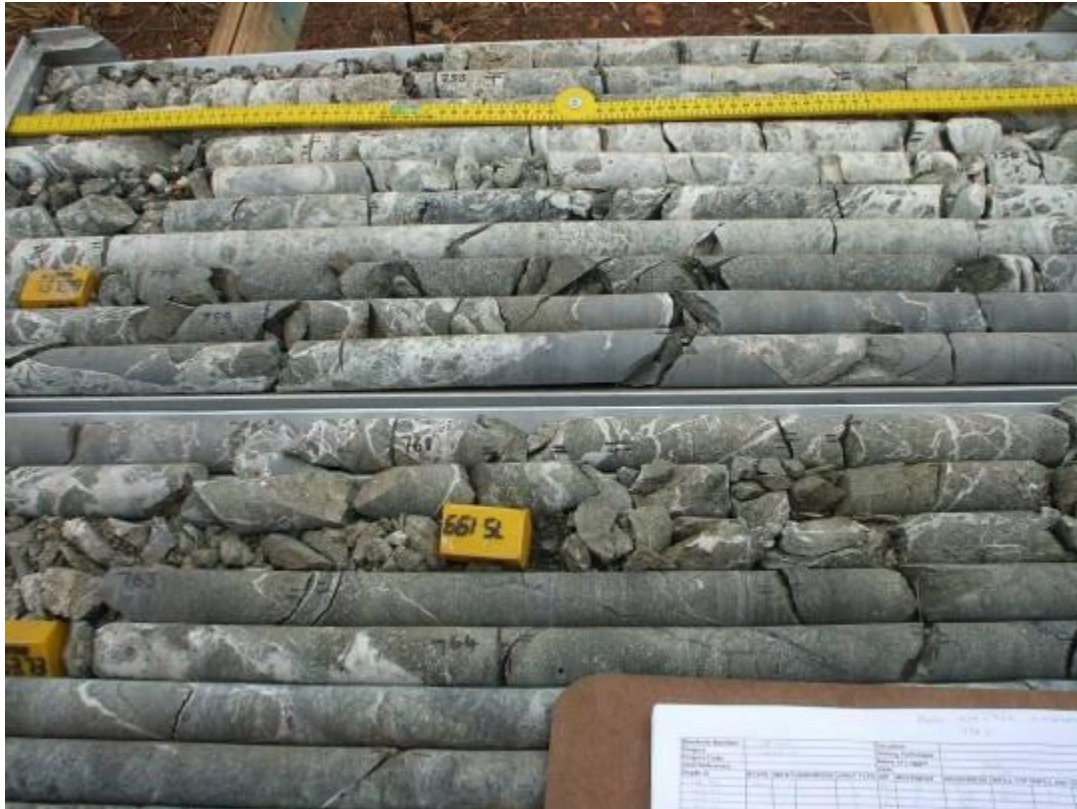
Figure 46: WF59 fault affected area.

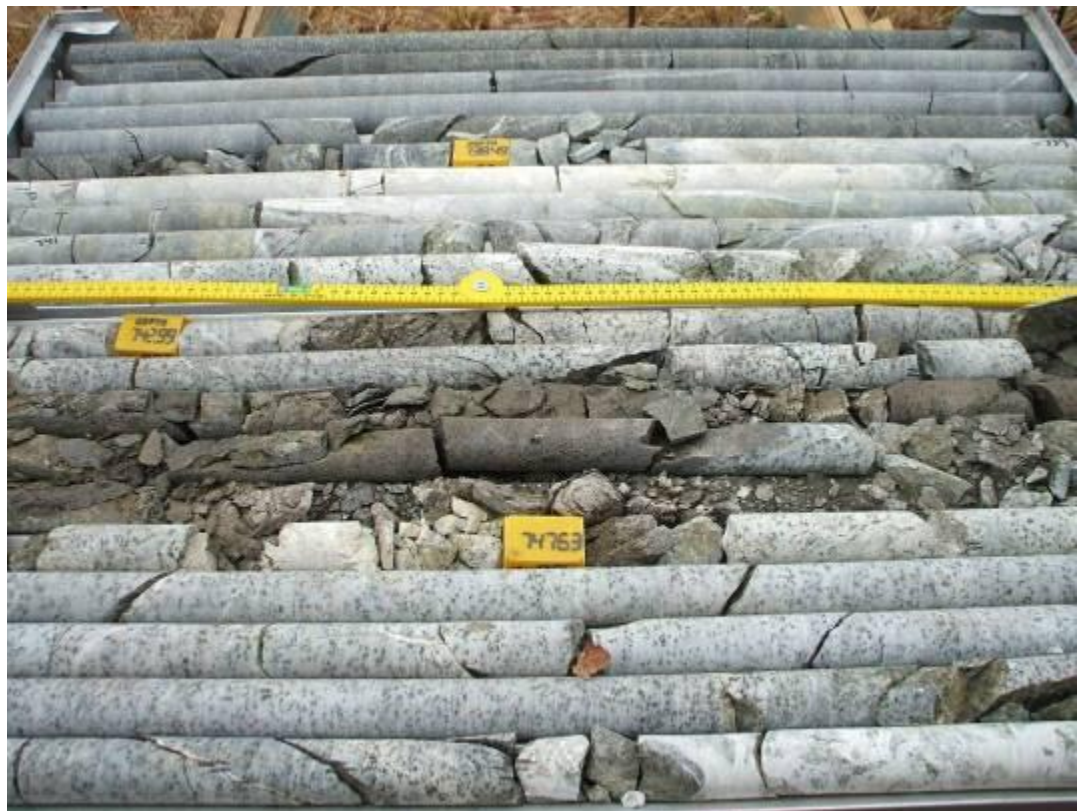
Figure 47: WF59 fault affected area.

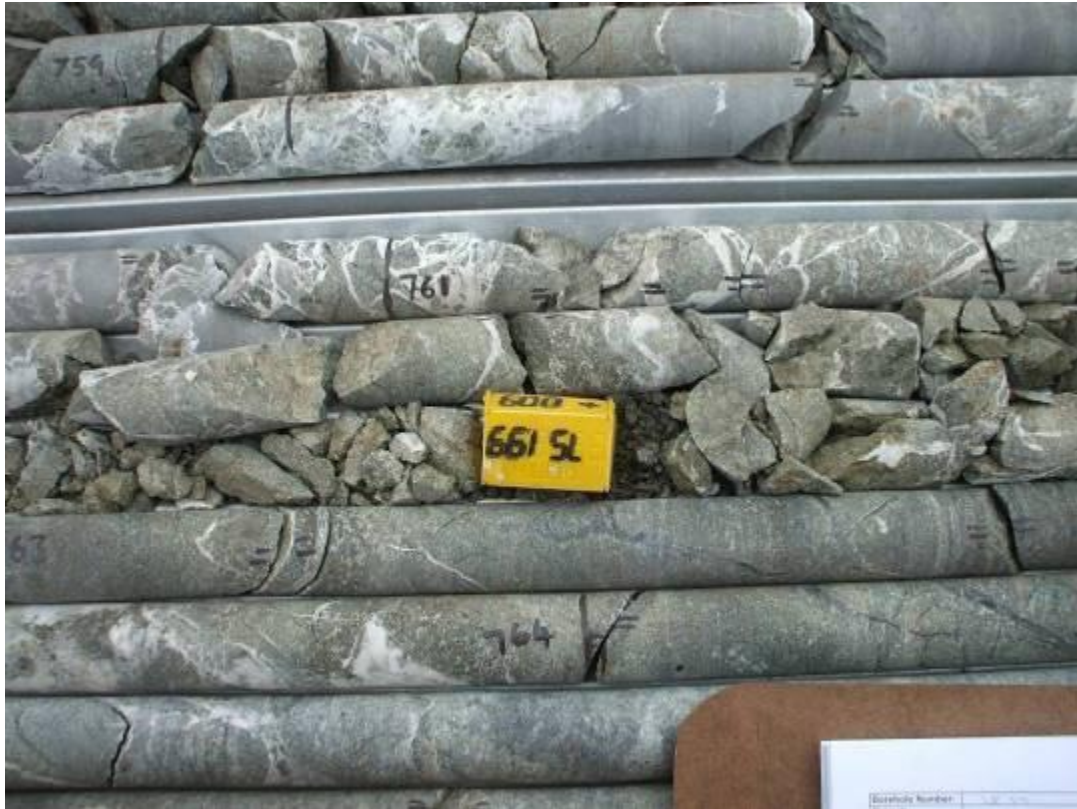
Figure 48: WF59 fault affected area.

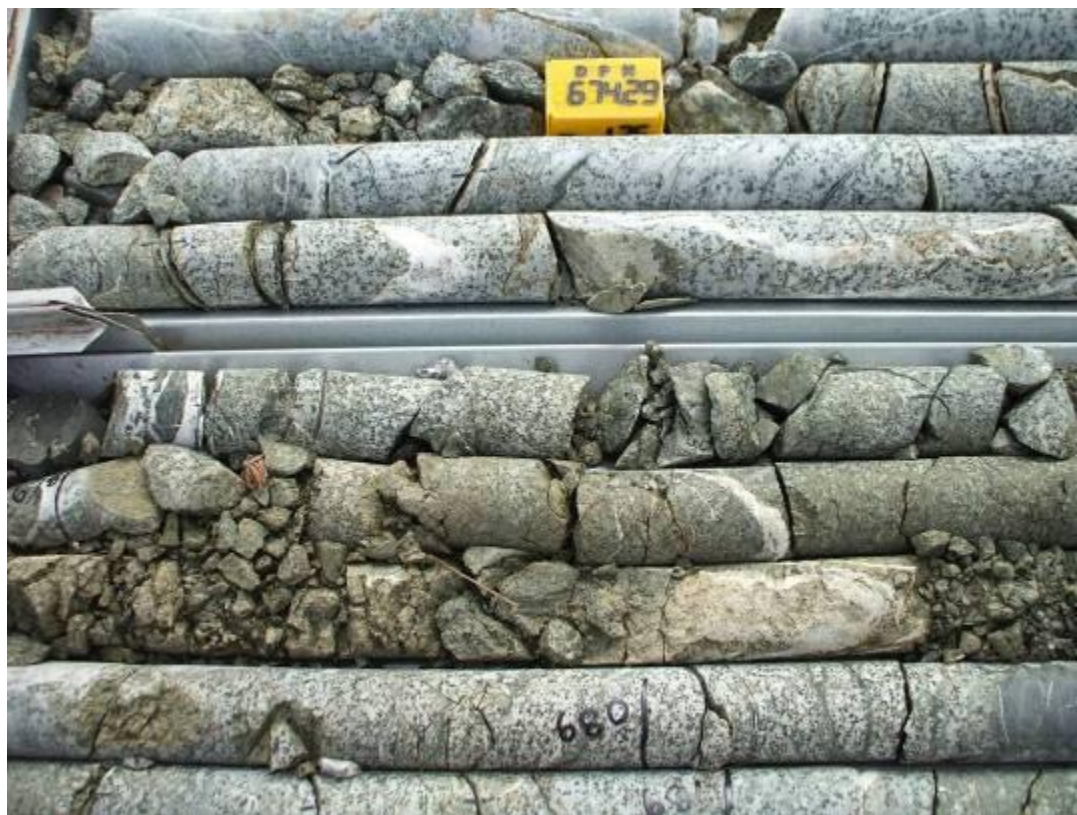
Figure 49: WF90 fault affected area.

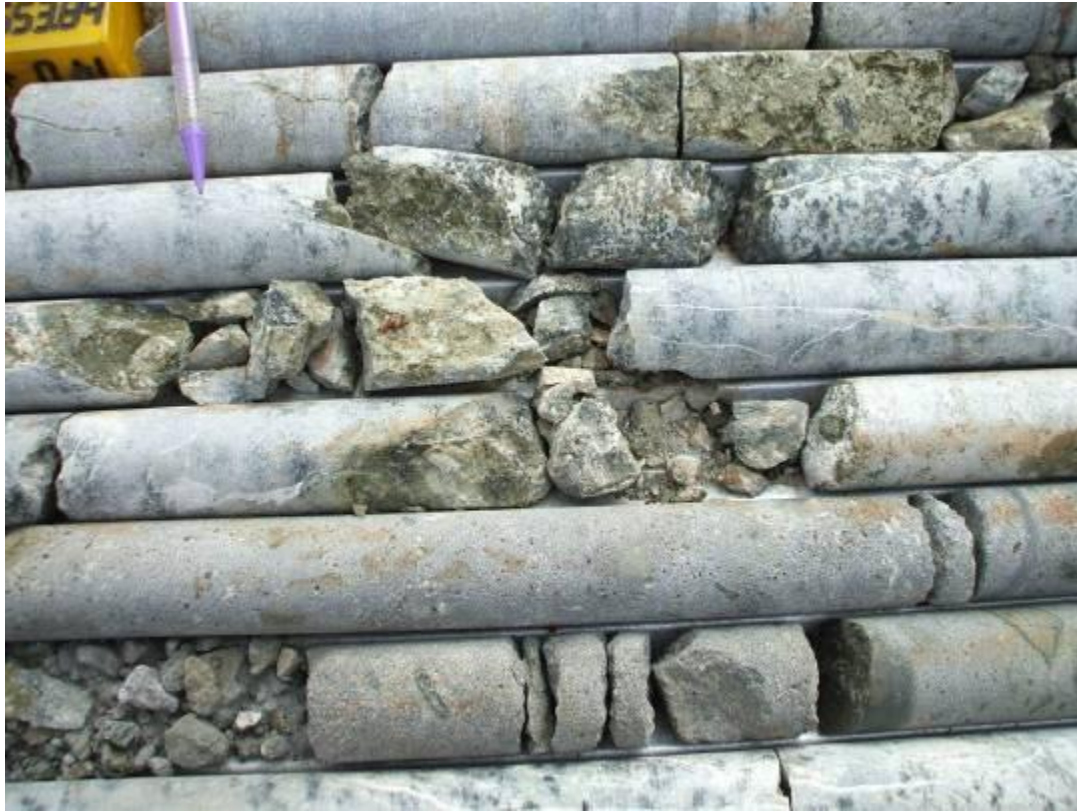
Figure 50: WF90 fault affected area.
