EVALUATION AND DESIGN OF OPTIMUM SUPPORT SYSTEMS IN SOUTH AFRICAN COLLIERIES USING THE PROBABILISTIC DESIGN APPROACH

İsmet Canbulat

Submitted in partial fulfilment of the requirements for the degree Philosophiae Doctor in the
Faculty of Engineering, Built Environment and Information Technology, University of Pretoria,

Pretoria, 2008

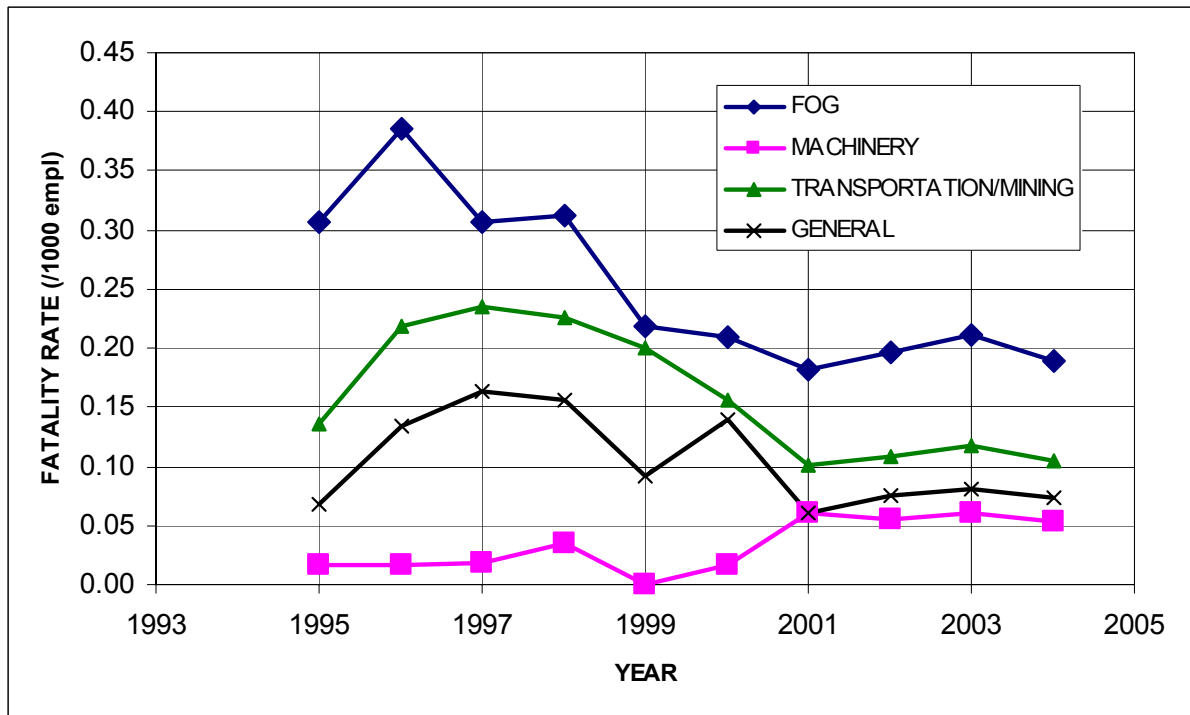
Figure 1-2 Cause for fatalities in South African collieries for the period 1995 to 2001

The cause of fatalities in South African collieries for the period 1995 to 2004 is shown in Figure 1-2. This Figure indicates that for this period FOG has been the major cause of fatalities in South African collieries, and the greatest reduction amongst all other causes for fatalities has been achieved in the FOG since 1996.

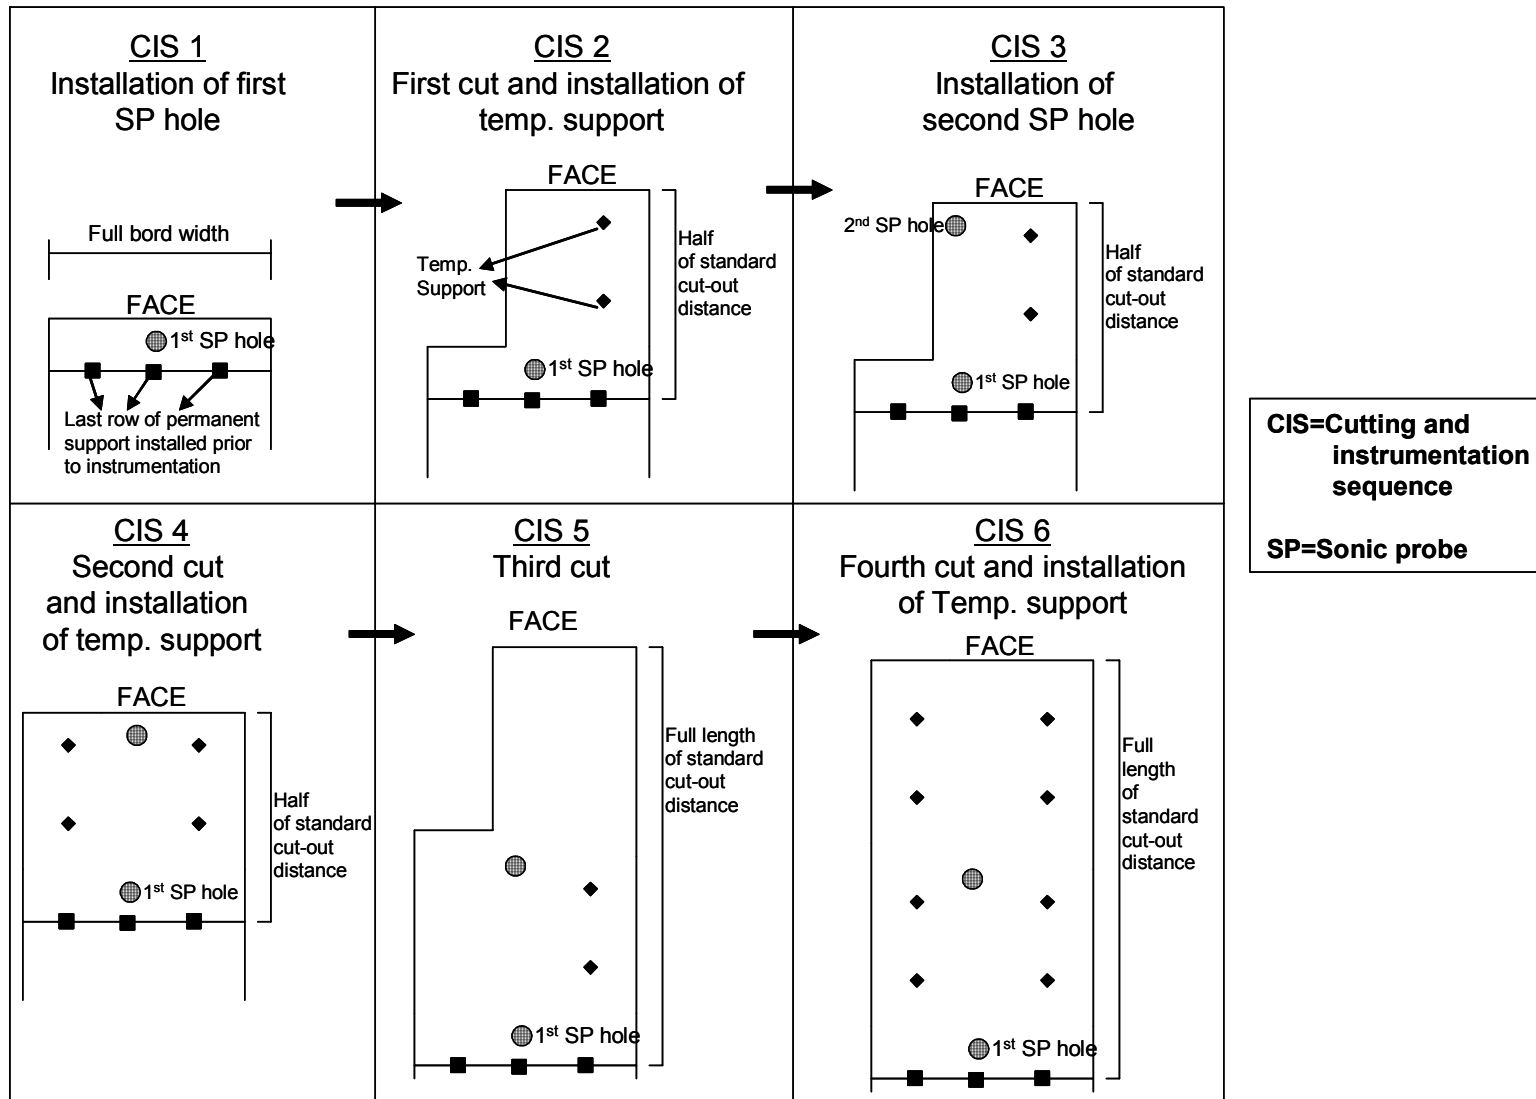
Figure 4-1 Cutting and instrumentation sequence in CM sections

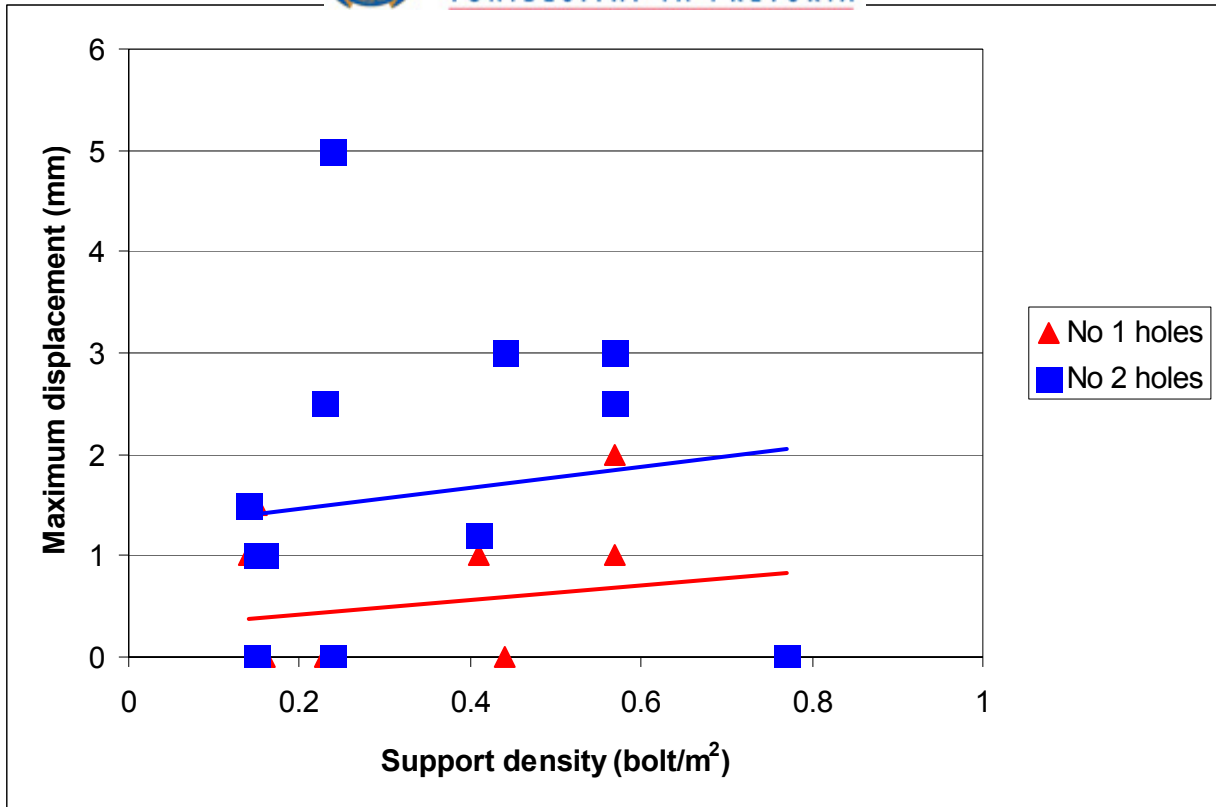
Figure 4-18 The relationship between the support density and total displacement

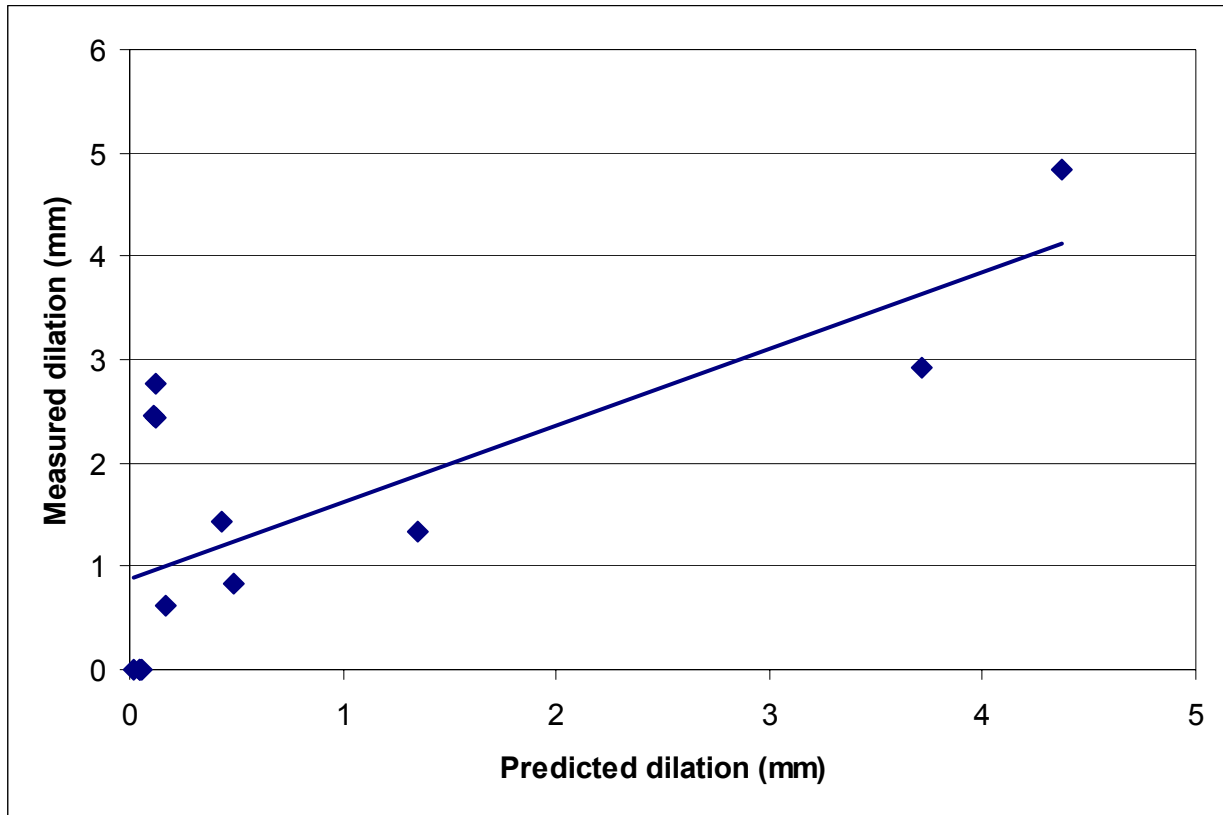
Figure 4-23 Relationship between measured and predicted dilation

roof behaviour in the study area. The correlation coefficient is affected by mainly two cases where very little deflection was predicted. This may have been caused by incorrect loading assumptions.

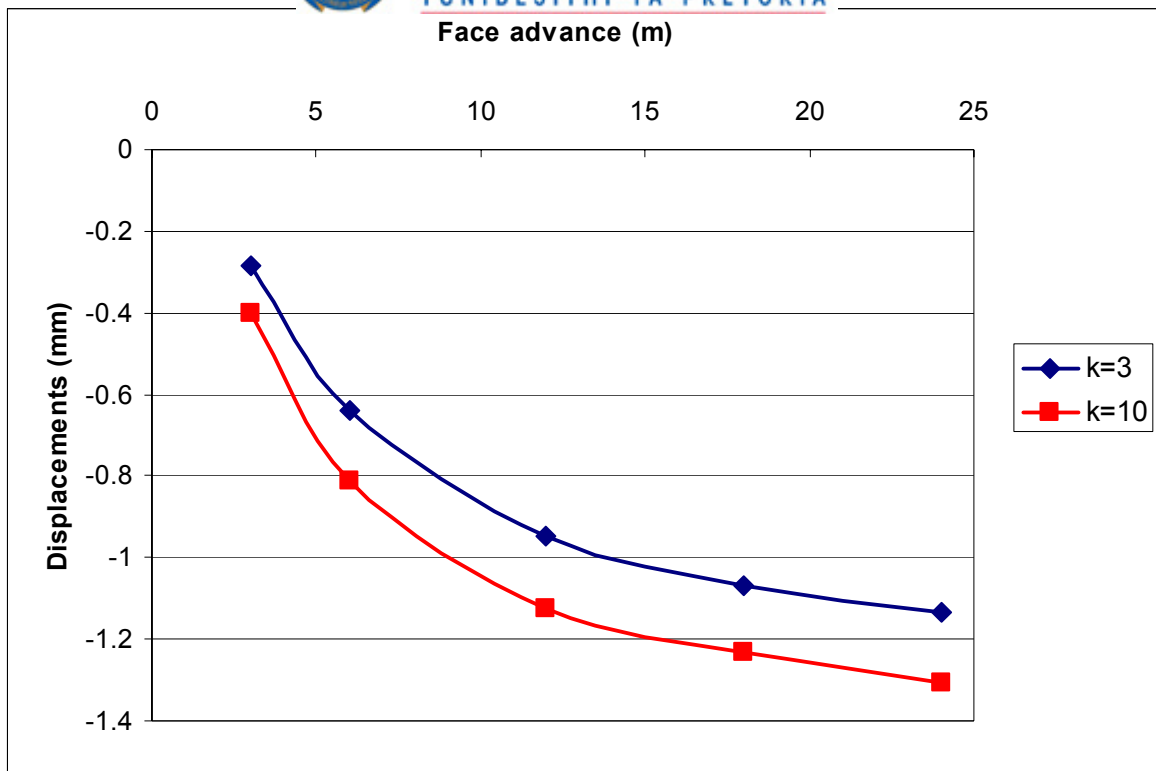
Figure 4-26 Effect of *k*-ratio on roof deformations

The effect of horizontal stress was investigated next. A 0.5 m thick immediate layer overlain by sandstone overburden was modelled, and the maximum displacements at 6.0 m face advances were measured in the centre of the bord. While all the parameters were kept constant, the model was run with two k-ratios (ratio of horizontal stress to vertical stress) of 3.0 and 10. The results are shown in Figure 4-26. This figure indicates that increasing horizontal stress by a factor of 3.3 increased the deformations in the roof by a factor of 1.3 at 6.0 m advance and by smaller proportions at greater advances. That increasing the horizontal stress did not accelerate the roof deflection is confirmed by observations at the three sites where horizontal stress was regarded as a problem. At those sites, the roof deflection did not differ significantly from that at any other site. However, the magnitude of the stresses at the sites was not known.

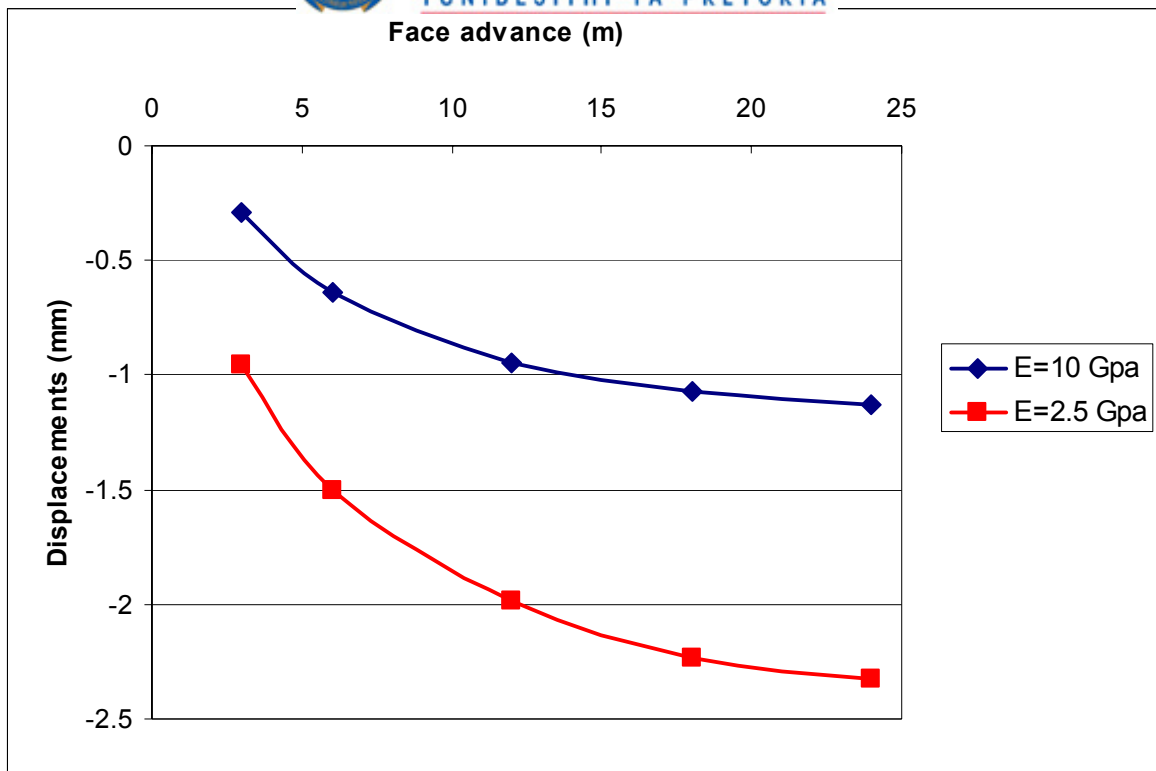
Figure 4-28 Effect of the strength of the immediate layer on roof deformations

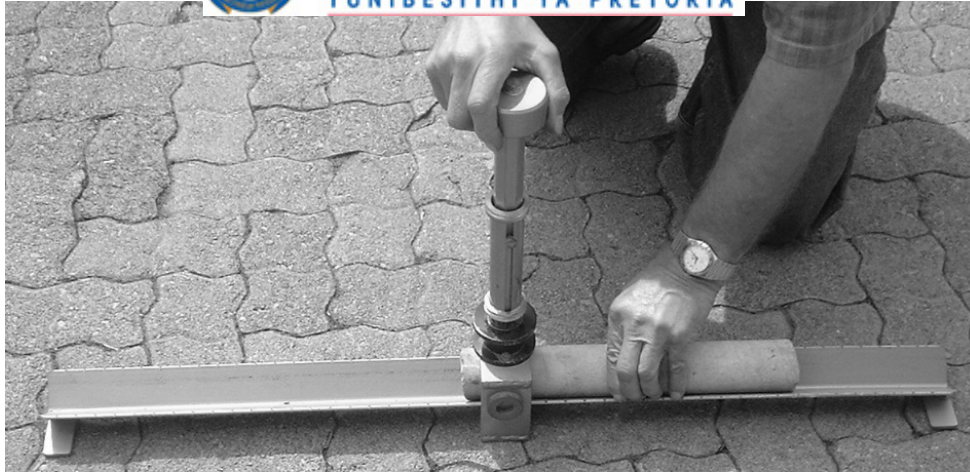
Figure 5-3 The Impact splitting equipment

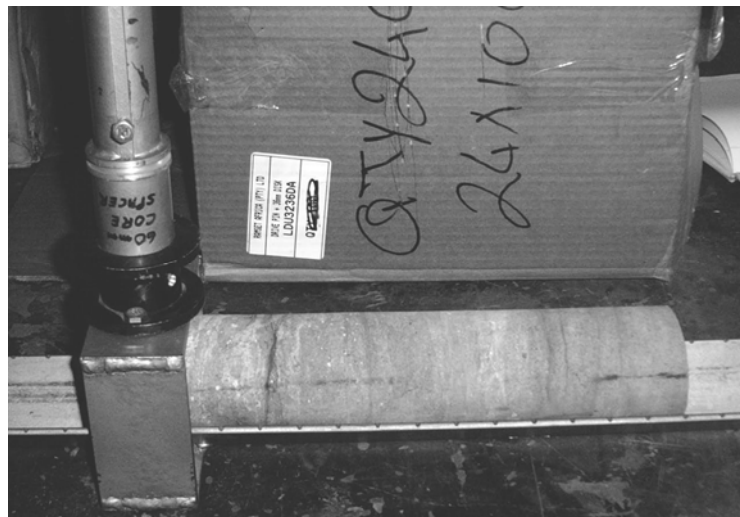
Figure 5-5 A fine to medium grained sandstone or “grit” unit before impact splitting, taken from borehole ARN 4968

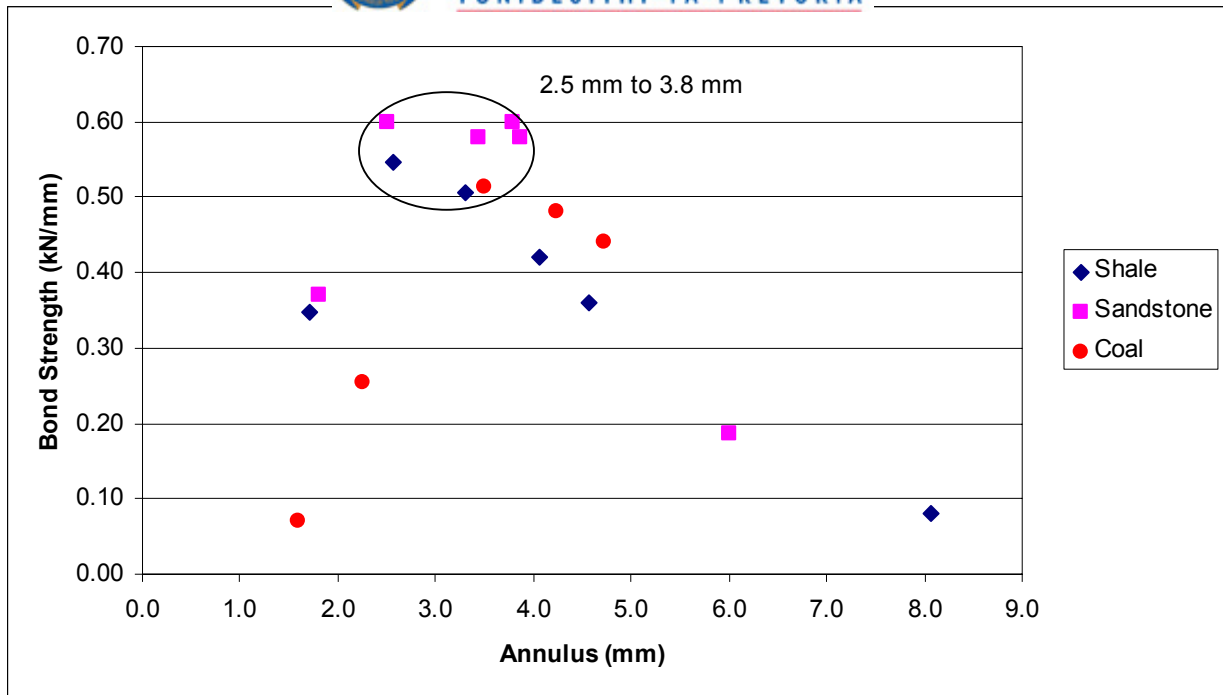
Figure 6-48 Effect of hole annulus on bond strength

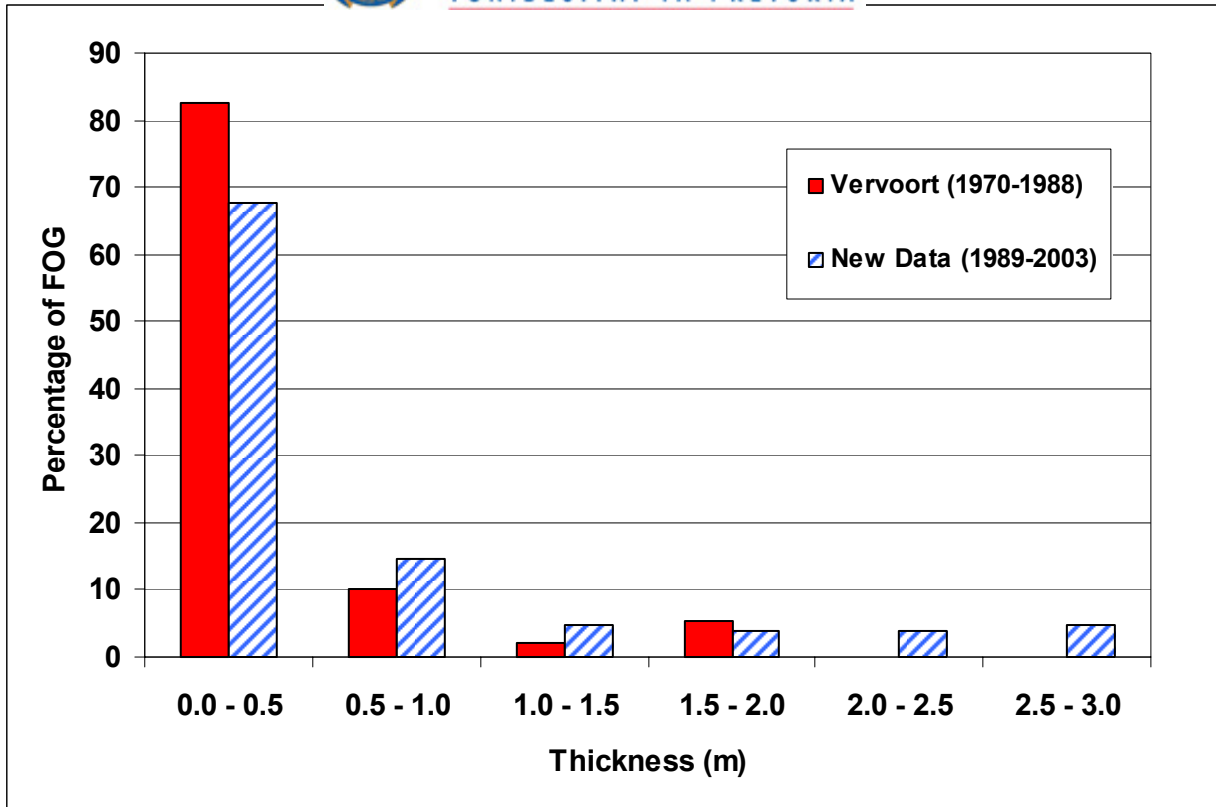
Figure 7-5 The vertical dimension (thickness) of FOG causing fatalities for the period 1970 – 1995

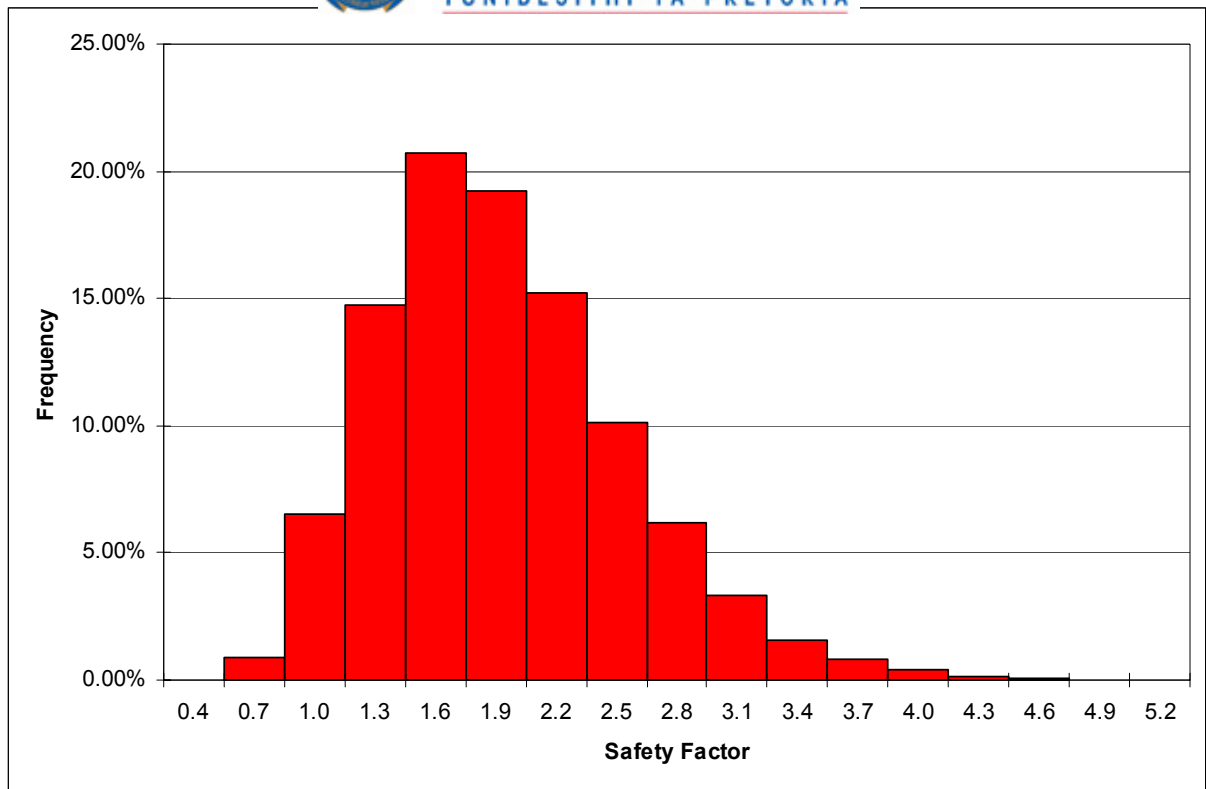
Figure 7-23 *Distribution of safety factors of upper coal layer in suspension mechanism*
