## CHAPTER 3

### STUDIES IN SELECTED COMMUNITIES

#### 3.1 MDANTSANE

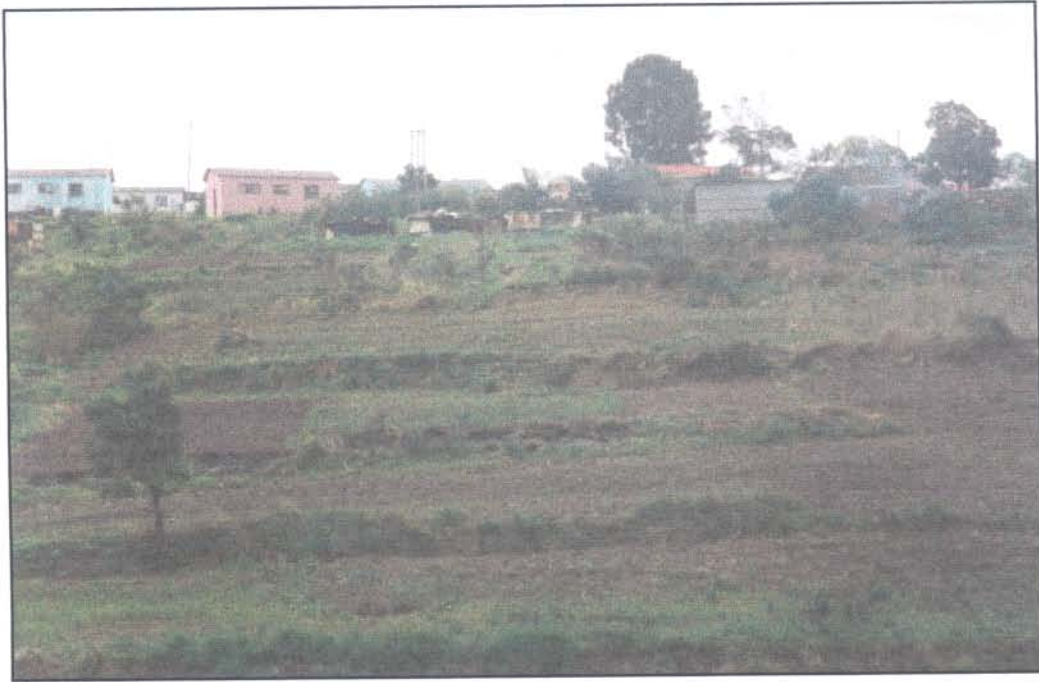
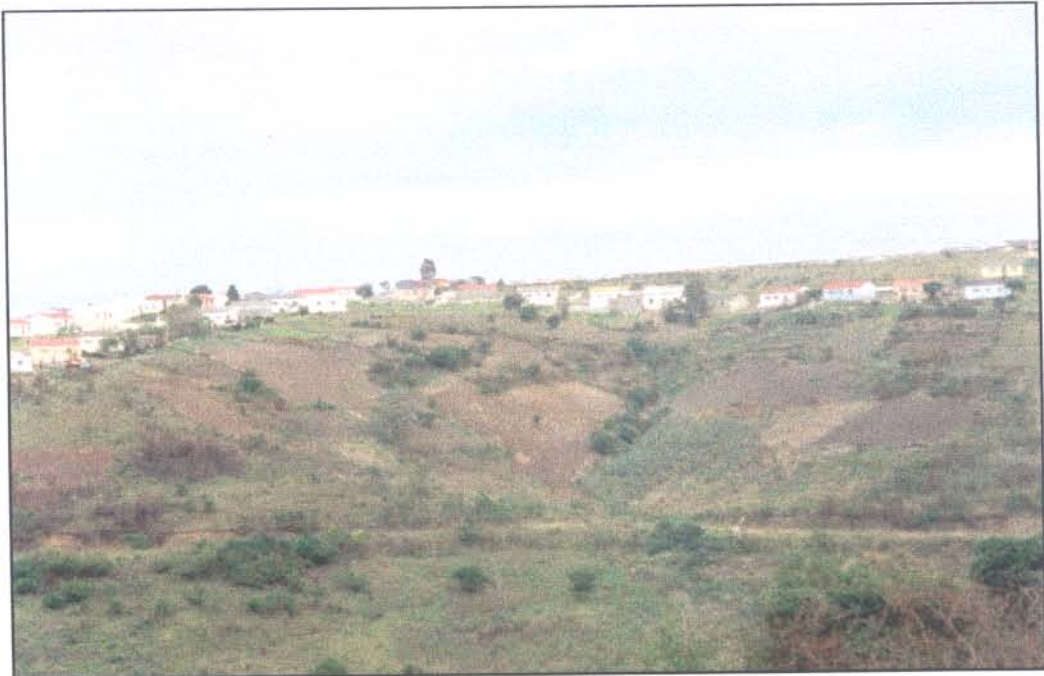
**Plate 3.1 – General layout of Mdantsane on hilltops (Photograph: N.N. Maswana)**

Mdantsane is the second largest township in South Africa and is situated about 15 km southwest from the city centre of East London. Mdantsane is situated in a steeply undulating area with hills with broad crests and deep, narrow gorges with very steeply sloping sides. The township has developed on the crests, with no residential development in the gorges, including their sides. This township is overpopulated and has got a very high rate of unemployment, hence people have resorted to intensive crop production in the open areas throughout the township, including the sides of the gorges where the terrain is very steep (Plate 3.1).

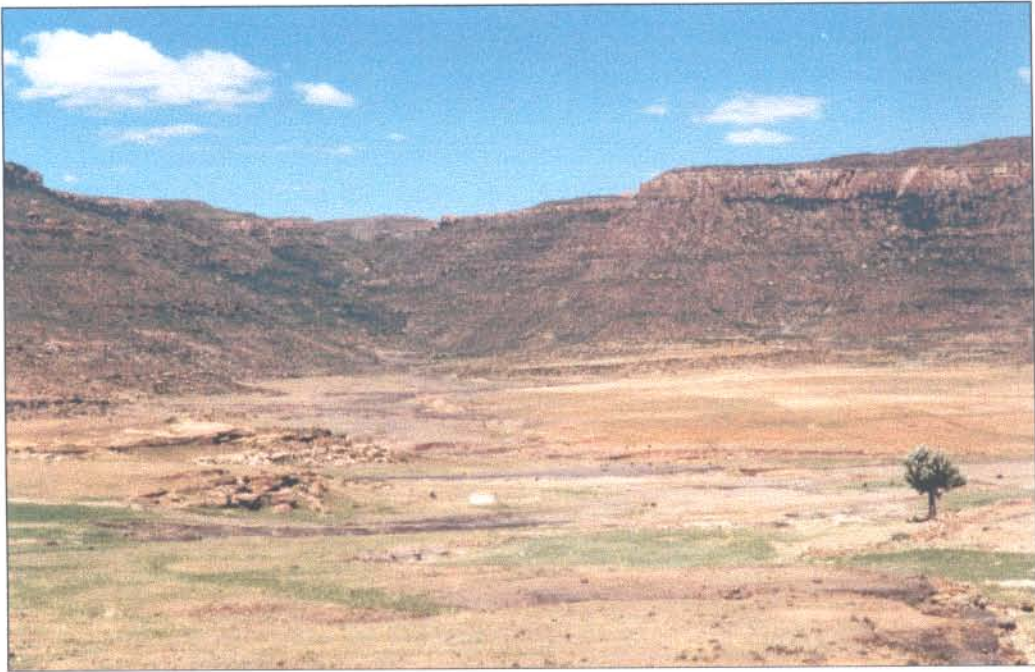
**Plate 3.2 – A typical Sterkspruit/Herschel scene with rocky mountains and severely overgrazed and eroded lowlands (Photograph: N.N. Maswana)**

More than 70% of the area consists of rock outcrops and very shallow soils (Hensley and Laker, 1975). The area is overgrazed and that has resulted in the exposure of the fragile soils to the rainstorms that are often encountered in summer (Plate 3.2).
