THE ORAPA UNTREATED KALAHARI SAND BASE EXPERIMENT: PERFORMANCE OVER 30 YEARS AND DERIVED MATERIAL AND PAVEMENT DESIGNS

F NETTERBERG¹, MI PINARD² and KJR MOTSWAGOLE³

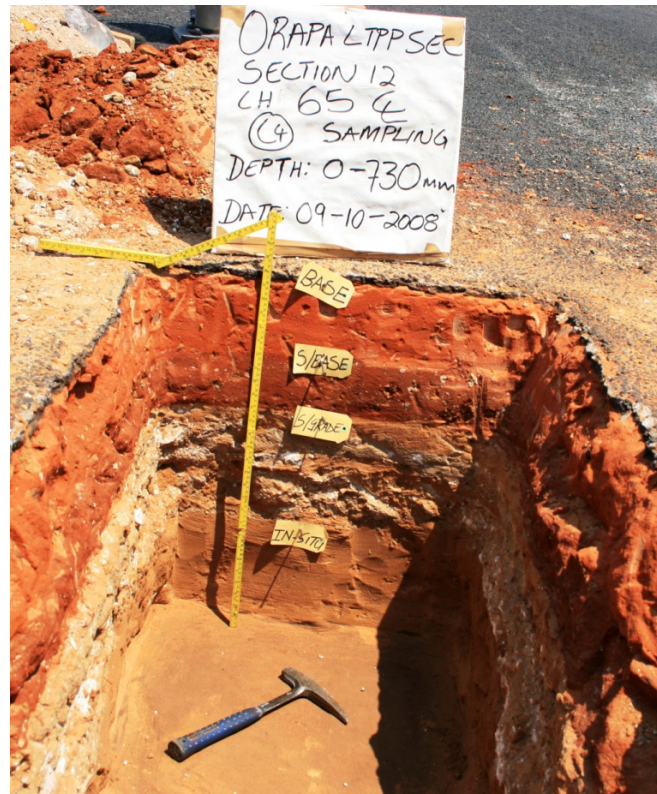
Untreated sand base (Section 12): This base is both a test and a control section and was not designed as such, but was to be an untreated, good, red sand complying with the sand subbase specification and compacted to at least 100%, with both shoulders similarly compacted and sealed. A typical profile is shown in Figure 1.

**Figure 1: Profile at CH. 65 CL on Section 12
(Photo: Mr S Pilane)**

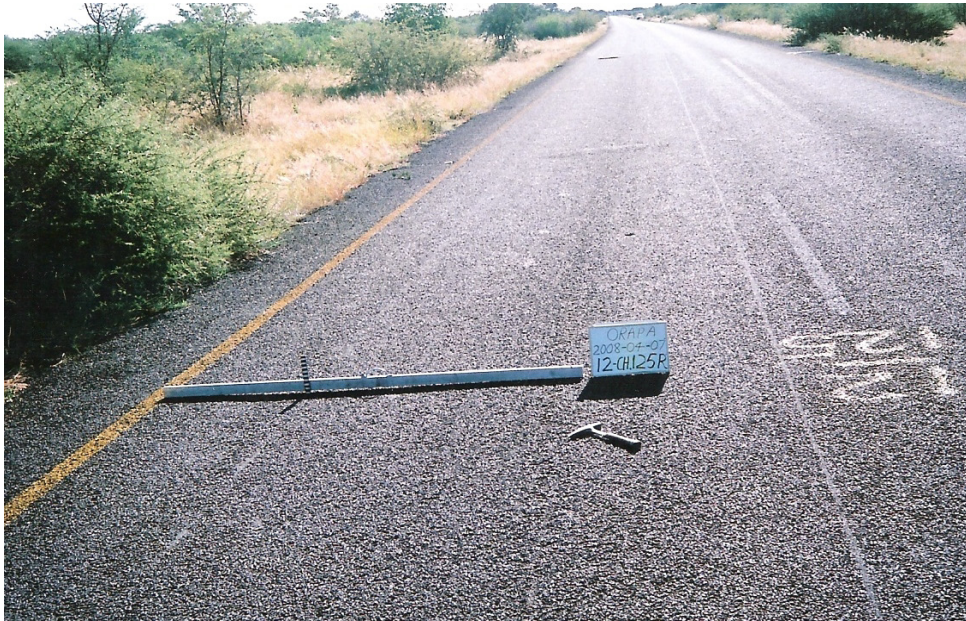
A view towards Orapa of Section 12 in April 2008 and 0,3 MESA with an 80 %-ile rut depth of 12 mm in the Orapa lane and 13 mm under the straight edge is shown in Figure 2.

Figure 2: View of Section 12 in Orapa lane after 0,3 MESA in 19 years

Although the general pavement condition of Sections 11 – 13 was still mostly very good, the right-hand (Orapa) lane of Section 12 was downgraded to ‘good’ because of only a fair riding quality owing to some corrugations caused by the shifting of the seal in places, and an 80%-ile outer wheelpath rut depth of 12 mm, i.e. just within the TRH 12:1997 warning range of 10 – 20 mm, although not within the 15– 25 mm of the BRD (2000). Whilst this was the most heavily loaded wheelpath, stringline and straight edge measurements in May 1990 indicated that some of this had been built in on both the slightly superelevated Sections 12 and 13. (The grader blade was also suspected to have been worn.) The 80%-ile rut depths were practically unchanged from the respective 7, 12 and 9 mm in 1990 and those of 12 mm on the neat sand Section 12 in 2008 were practically the same as the 10 mm on the adjacent ferricrete control Section 13, and both were slightly greater than the 8 mm of the non-superelevated ETB Section 11.
