APPENDIX D

PHOTOGRAPHIC RECORD OF HEAVY VEHICLE SIMULATOR (HVS) TESTS
ON PAVEMENTS WITH LIGHTLY CEMENTITIOUS LAYERS

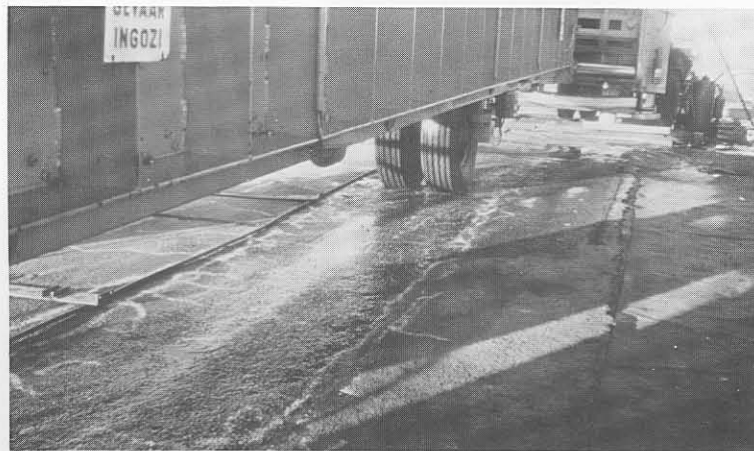
(b) Artificial surface water introduction on section.

(c) Excessively high degree of potholing owing to the loss crushed cemented base material after introduction of surface water.

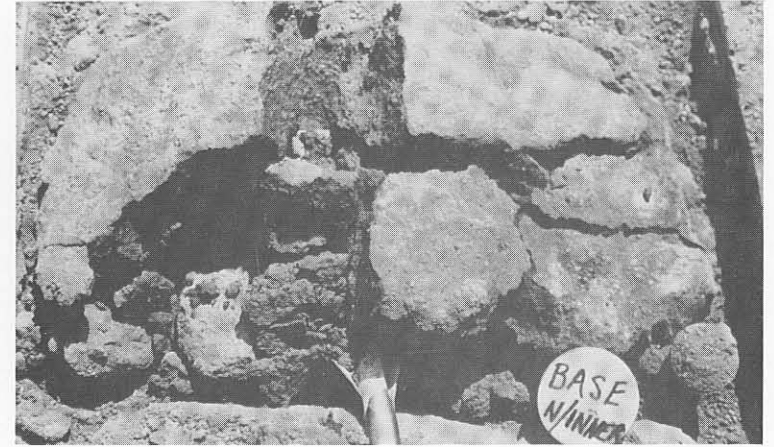
(b) Fatigue cracking in cemented base layer.

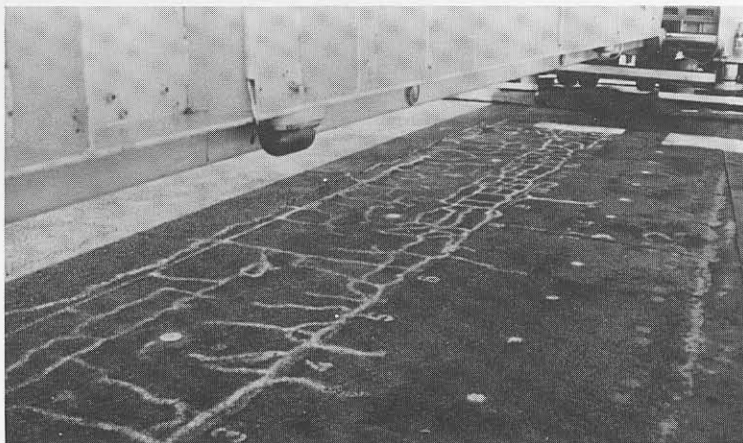
(c) Fatigue cracking after approximately $2,45 \times 10^6$ 70 kN repetitions.

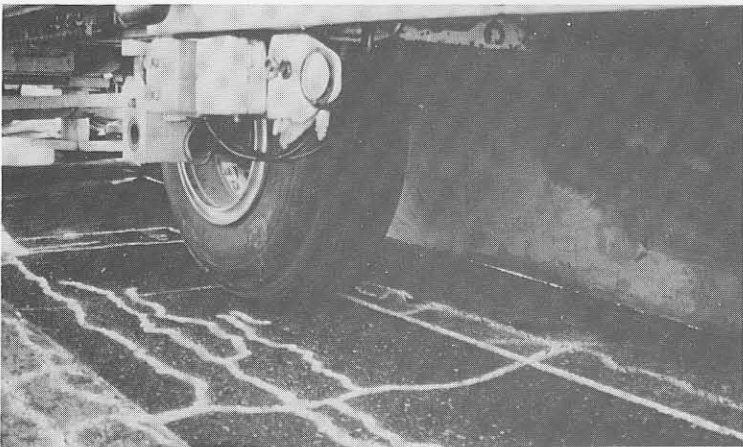
(b) Fatigue cracking and deformation (approximately 40 mm) after 11 331 repetitions of a 150 kN, 1445 kPa single aircraft wheel load.

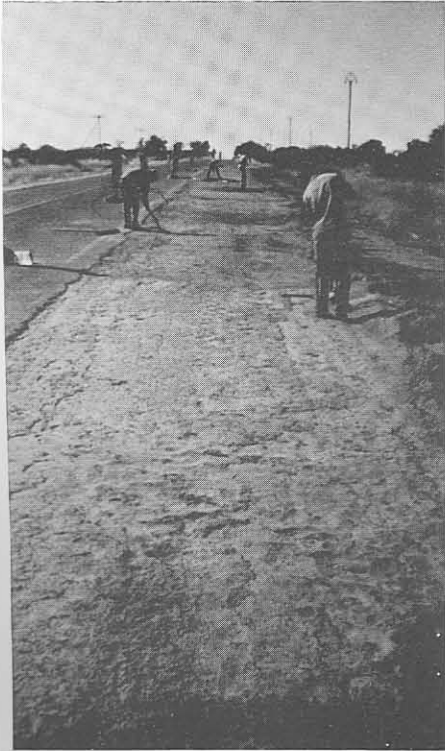
(a) Brooming of surface of the cemented base layer after the "crack and seat" operation, before the application of the prime coat.
