UNIVERSITEIT VAN PRETORIA  
UNIVERSITY OF PRETORIA  
YUNIBESITHI YA PRETORIA

A P P E N D I X A

PHOTOGRAPHIC RECORD OF HVS TESTS

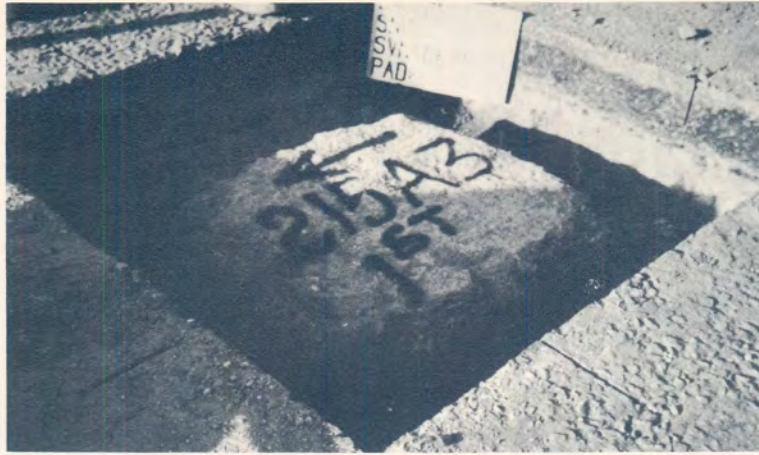
(a) Successful recovery of a solid block of stabilized material from the upper stabilized subbase layer.

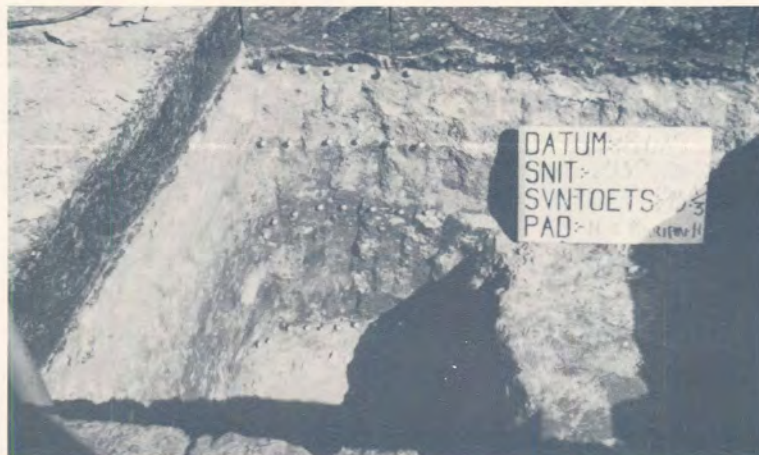
(c) Excavated depth profile of the road structure.

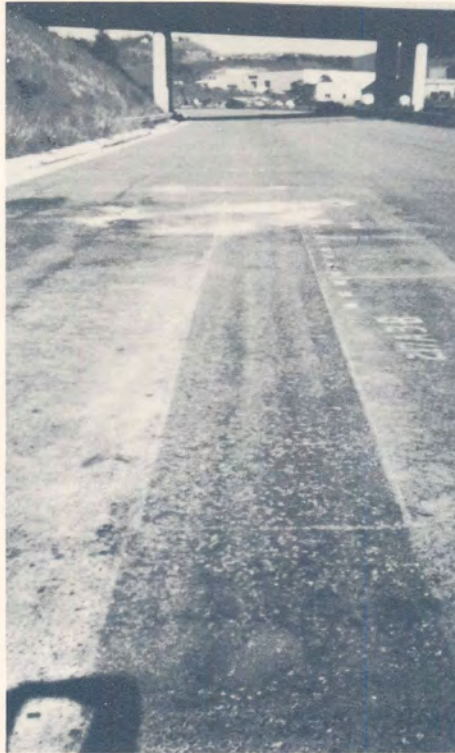
(a) General view of the surface of Section 2 (217A3) after  $32 \times 10^6$  E80s in the dry state.

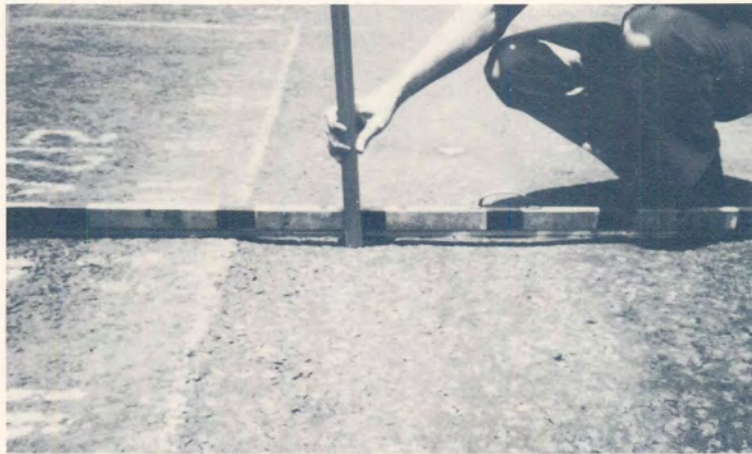
(b) Maximum rut of 20 mm on top of the asphalt layer. Rut originated from the asphalt surfacing and base layer only. ( $32 \times 10^6$  E80s)

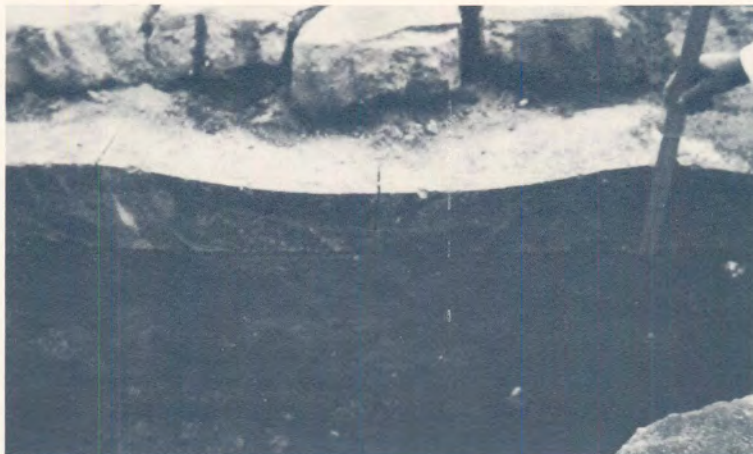
- (b) Trench across test section after test. Note the excessive asphalt deformation, and the minimum amount of rut on top of the upper stabilized subbase. (No carbonation within stabilized subbase layers.)

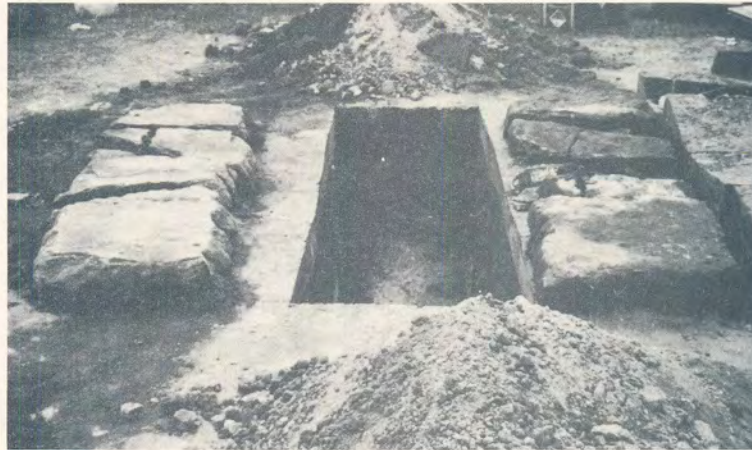
(a) General view of the recovered blocks of subbase material. Upper subbase on the right, lower subbase on the left.

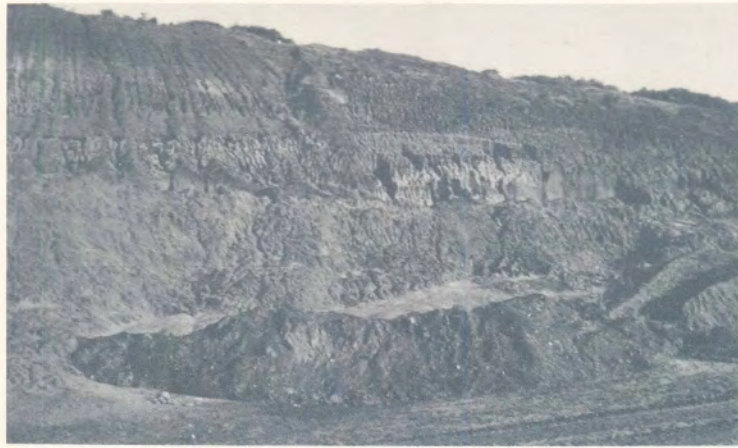
(a) Famous Berea Red Sand in a cutting at Umgababa HVS site.

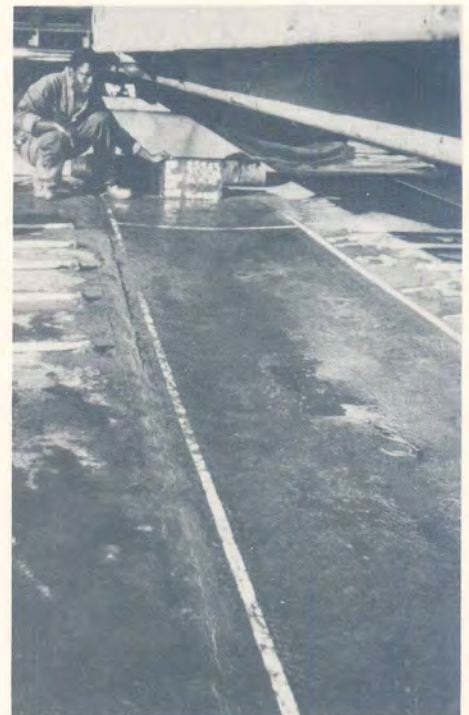
(d) Pumping through longitudinal fatigue crack on Section 2.

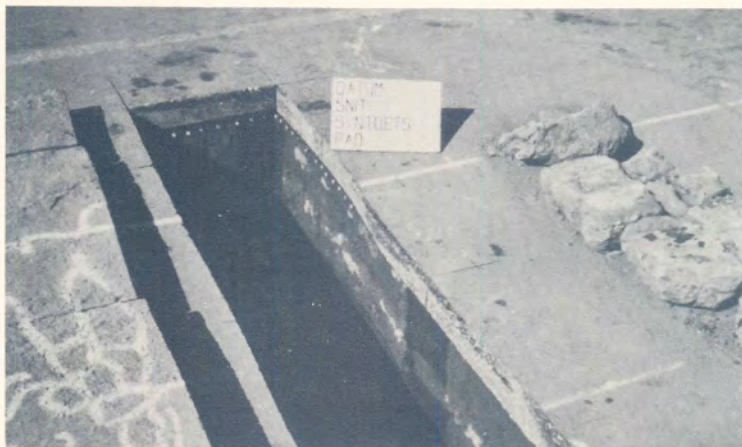
(c) Phenolphthalein indication of continuous relative high pH within both the upper and lower stabilized subbase layers.

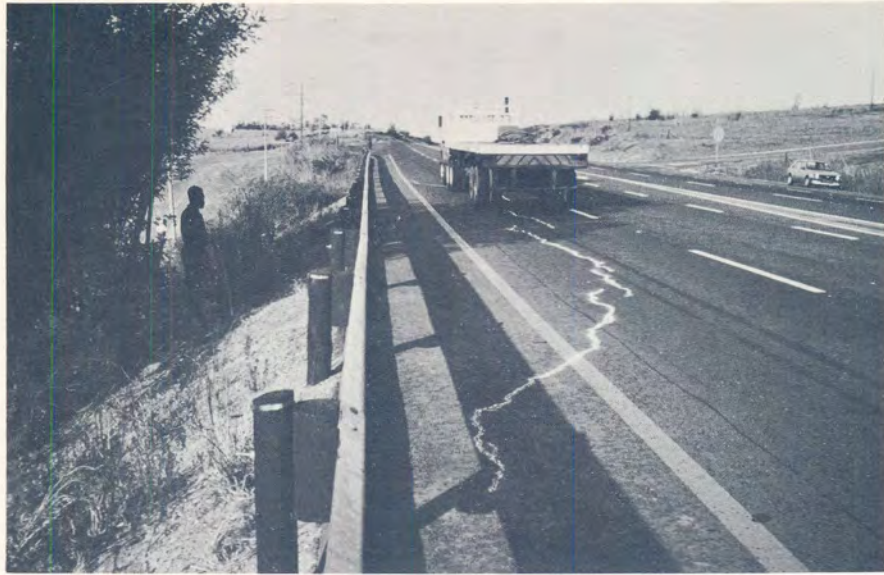
A.

**PLATE 1:** Slope instabilities on National Route N3, at Van Reenens Pass. Note the crack width and the horizontal permanent deformation showed by the yellow line in photograph B.

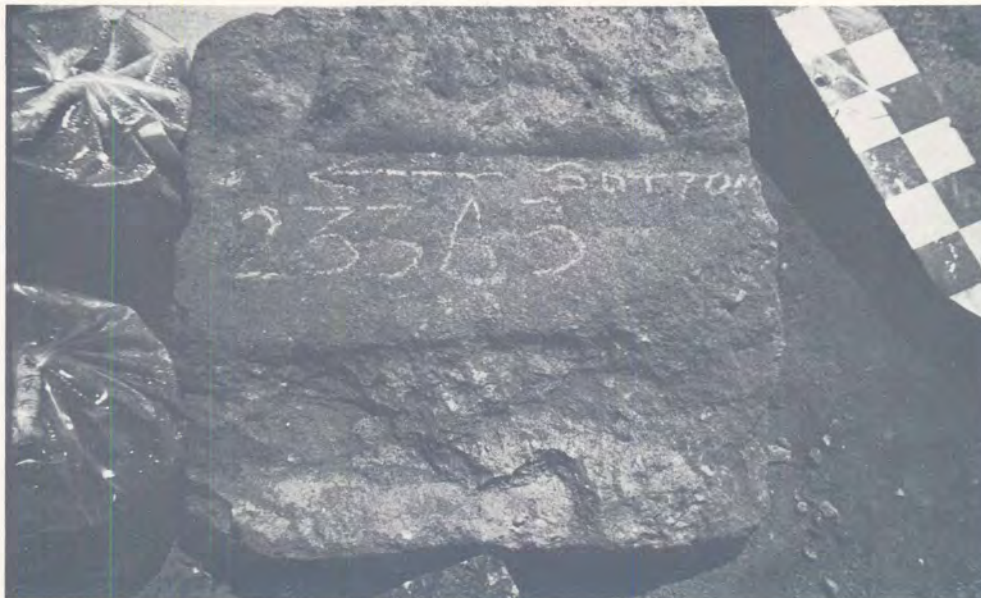
B. LOWER SUBBASE

**PLATE 2:** Upper and lower subbase material recovered from the test pit at Section 1 before any HVS trafficking. Note the white spots of badly mixed stabilizing agent in the upper subbase. The lower subbase show better cementing.

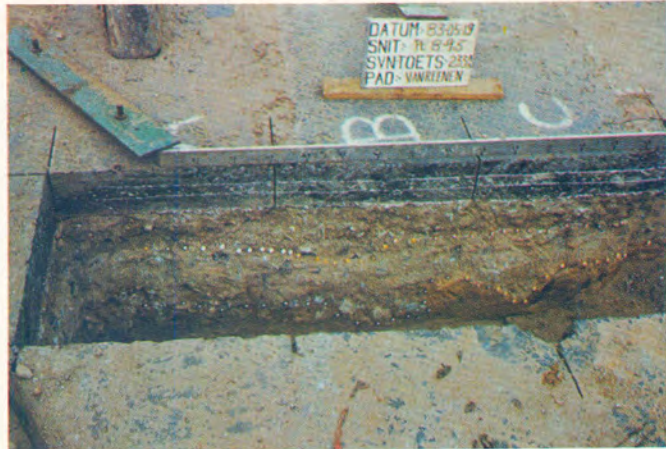
- PLATE 4:**
- A. Chemical phenol-test indicate well stabilized lower subbase, and poor stabilized upper subbase on Section 1.
  - B. Cross section profile on Section 1 after HVS test. Note the irregularities at the layer interfaces, and also the two recycled asphalt layers above the upper subbase.
  - C. Temperature rut at measuring point 8 on HVS Test Section 1. Note that most of the deformation was caused in the wearing course and not in the recycled asphalt base layer.

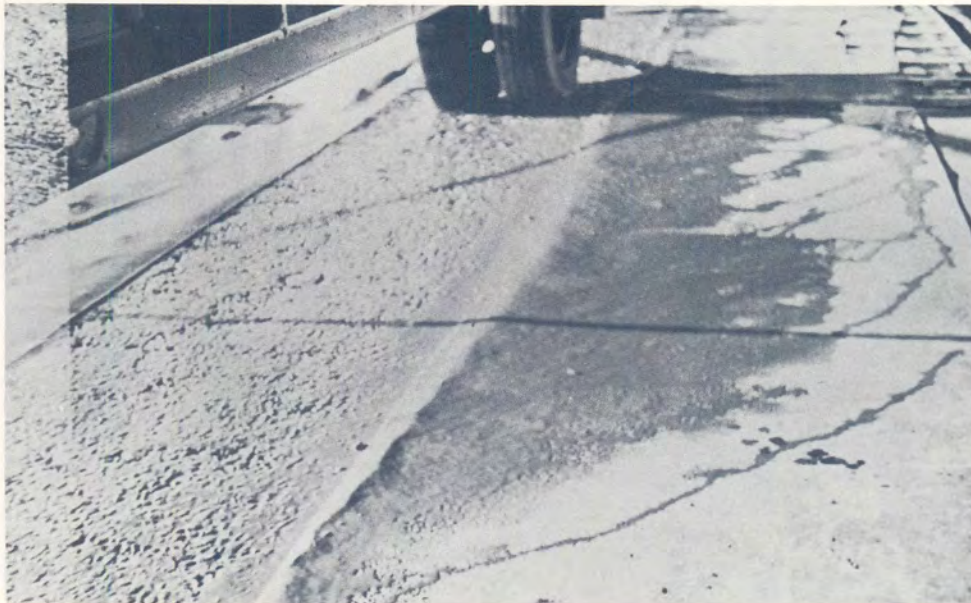
B.

**PLATE 7:** Surface and subsurface water introduced on Section 2 after 396 979 total repetitions.

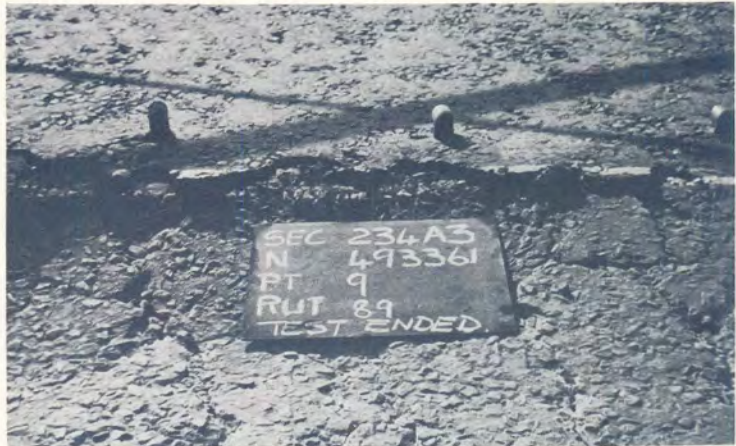
- PLATE 8:**
- A. Final crack pattern and permanent deformation on Test Section 2.
  - B. Longitudinal cracks on edge of Test Section 2 at point 9, where a local rut of 89 mm was formed.
  - C. Stripping and total failure of the upper recycled asphalt base layer, where poor aggregates was used.
